## **The African Community Access Programme (AFCAP)**

### **Research Consultant to Support the Design, Construction and Monitoring of Demonstration Sites for District Road Improvements in Tanzania**

Bago - Talawanda- Bagamoyo District - Pwani Region

## **Construction Report**

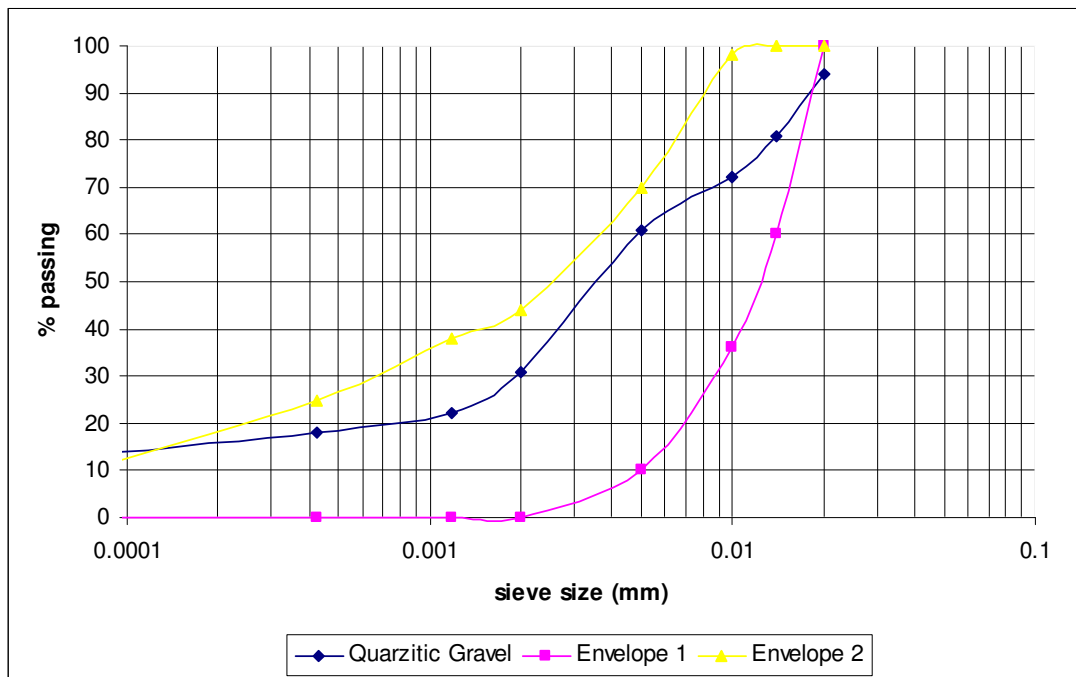
**Figure 4 Grading Envelope for the Quartzitic Gravel**

Figure 4, below, shows the grading envelope for an Otta seal aggregate as stated in the TPMDM. The curve indicates that the gravel is too coarse and too fine and that it is not suitable for an Otta seal. However, for this project a mosquito net was used to screen some of the fines and the oversize material was removed by hand to adapt the material to meet the grading specification. Furthermore, the material does not meet the PI and TFV requirements, as shown in Table 8. By screening the fine material from the gravel it also reduced the PI. The ten percent fines values also do not meet specification requirements but are considered suitable for low volume rural roads.

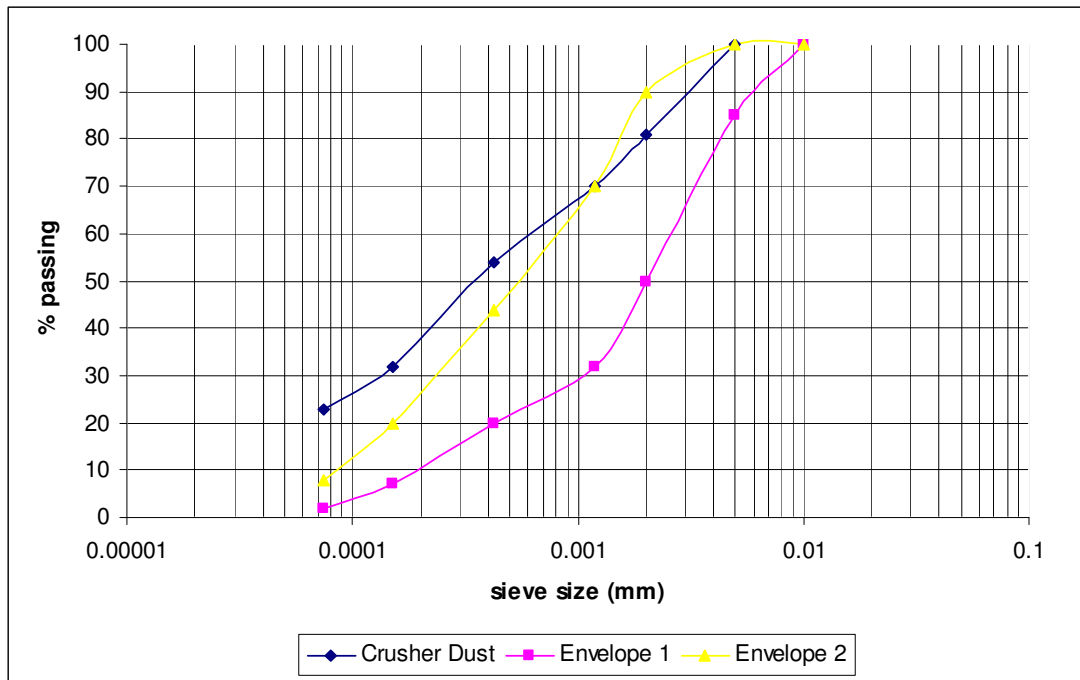
**Figure 5 Grading Envelope for the Crusher Dust**

Figure 5, below, shows the grading envelope for crusher dust in a slurry seal, as stated in the TPMDM. The curve indicates that crusher dust is too fine to be used in a slurry seal. The result meant that additional water needed to be added to the slurry to make it flow easily.

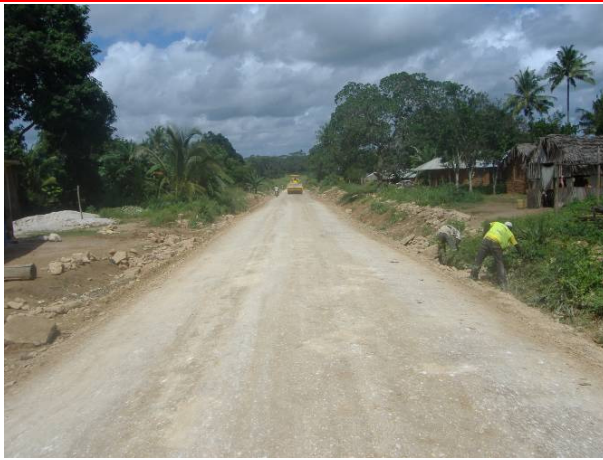
4: After spreading and compaction of layer 150mm of G60 pavement layer  
Date: 18/05/2011

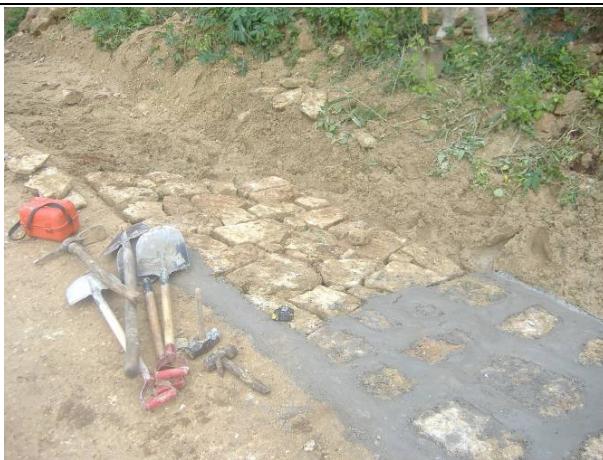
6: Construction of stone-masonry lined ditch  
Chainage: 0+030 km  
Date: 19/05/2011

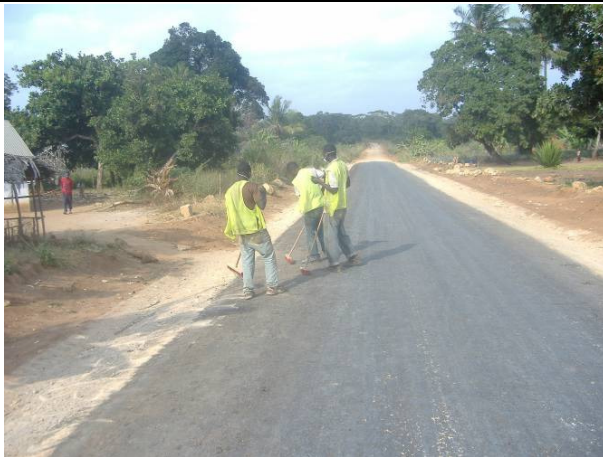
9: Sweep clear all loose material from the surface  
Chainage: 0+030 km  
Date: 23/07/2011

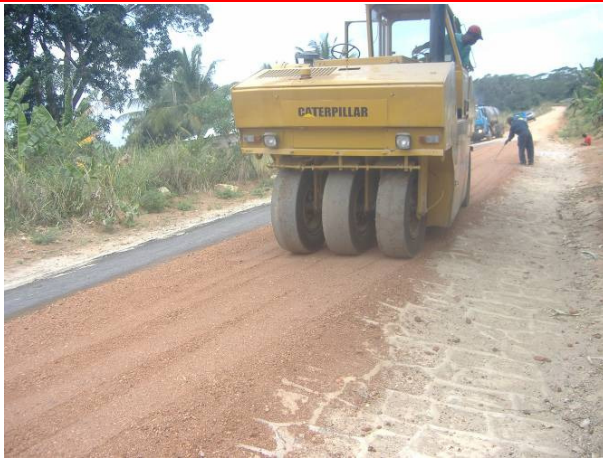
13: Roll the aggregate into the bitumen using a 12 tonne pneumatic tyred roller  
Chainage: 0+030 km  
Date: 23/07/2011

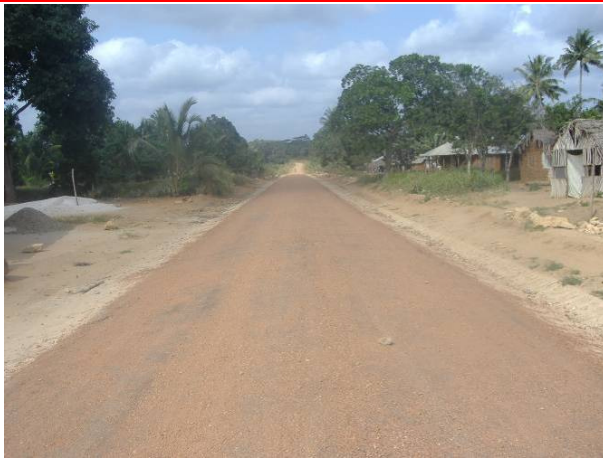
16: The road should be trafficked for as long as possible before the next seal  
Chainage: 0+030 km  
Date: 26/07/2011

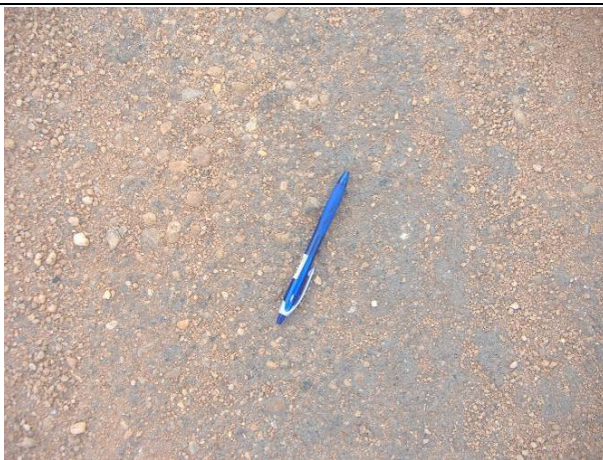
18: The Otta seal surface texture three weeks after construction  
Chainage: 0+030 km  
Date: 15/08/2011

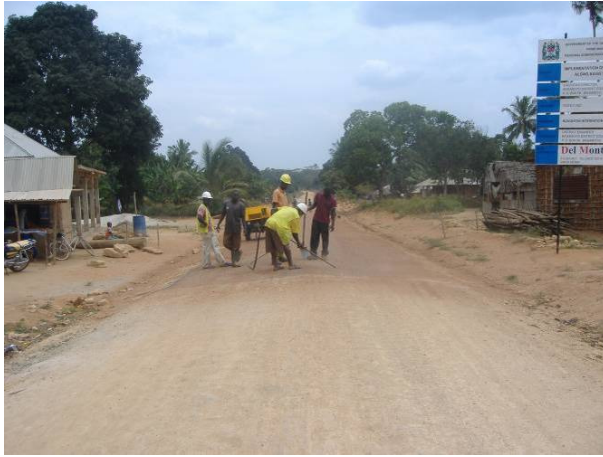
19: Clear the surface of any loose material  
Chainage: 0+030 km  
Date: 17/08/2011

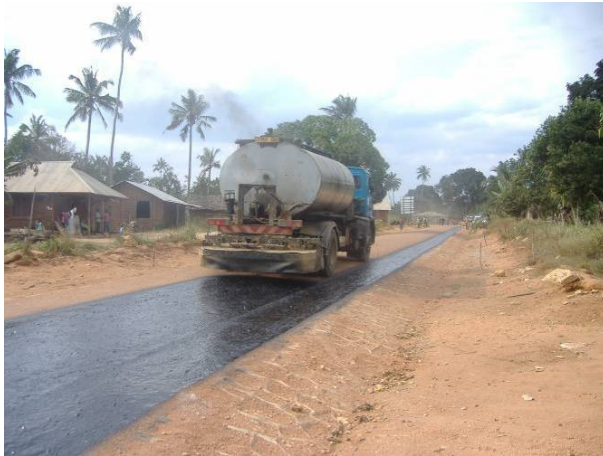
20: Spray MC-3000 bitumen at a rate of 0.8 l/m<sup>2</sup>  
Chainage: 0+030 km  
Date: 17/08/2011

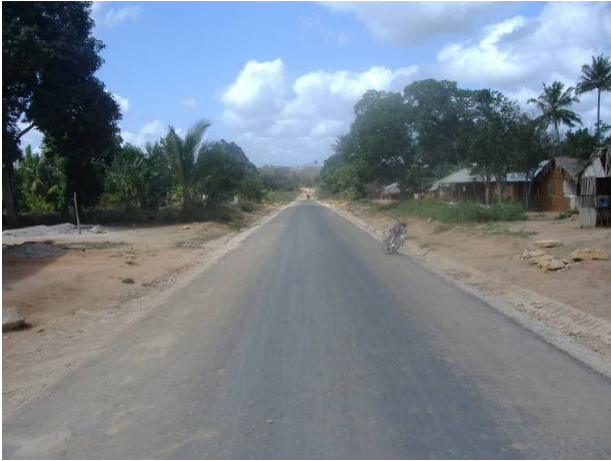
22: Completed Otta seal with sand seal section  
Chainage: 0+030 km  
Date: 04/10/2011

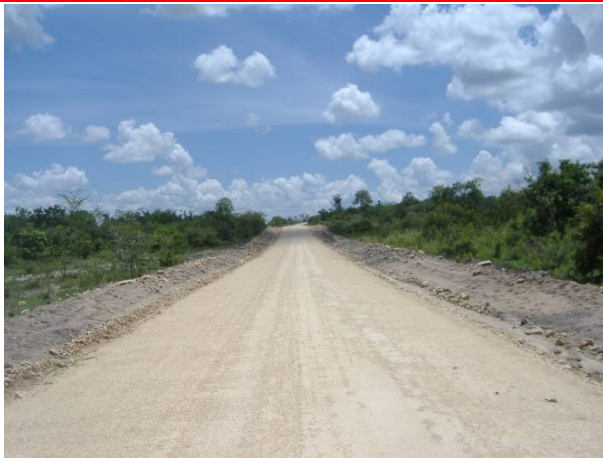
4: After spreading and compaction of 100mm of G15 improved subgrade layer  
Chainage: 5+880 km  
Date: 25/03/2011

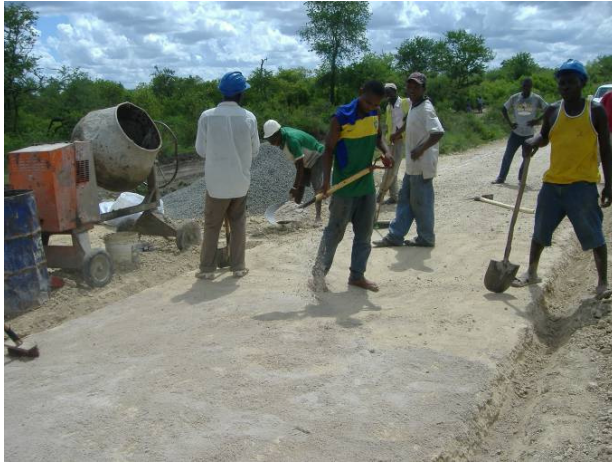
10: Spreading thin layer of sand to level base  
Date: 07/11/2011

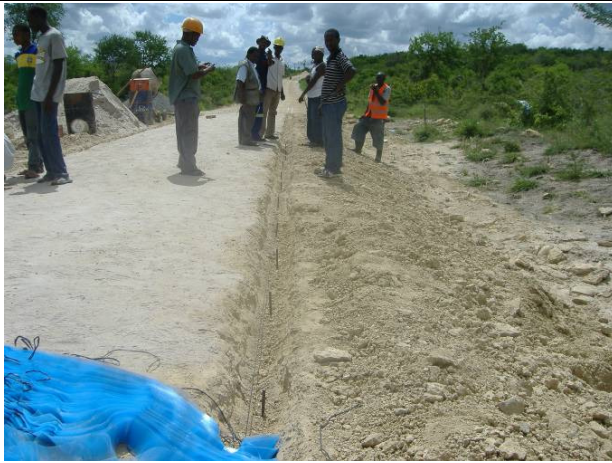
11: Setting out pegs to secure geocells  
Date: 07/11/2011

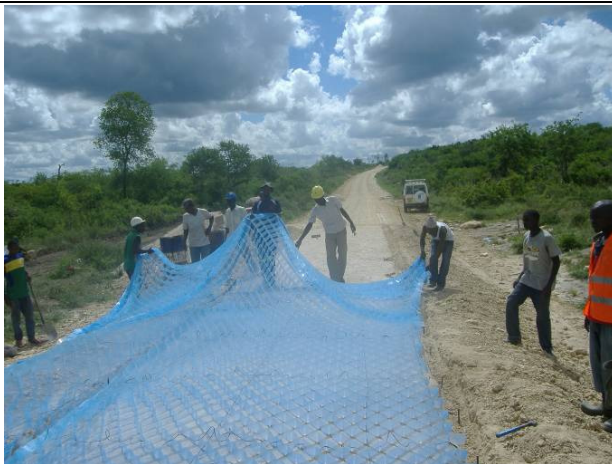
12: Laying out of geocells  
Date: 07/11/2011

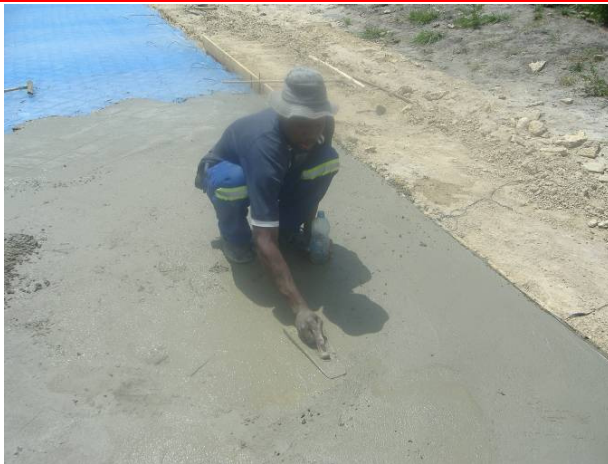
16: Smoothing concrete finish  
Date: 08/06/2011

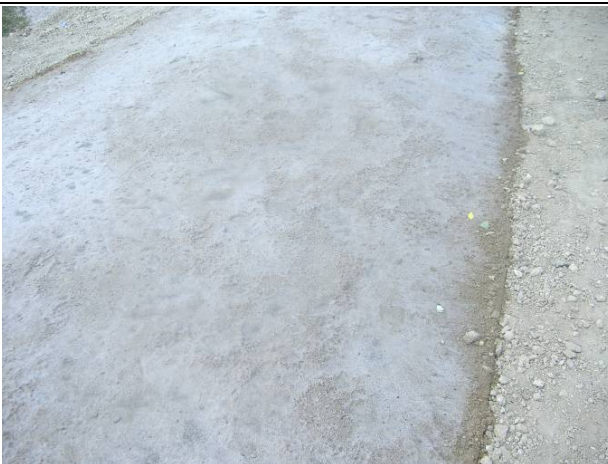
18: Curing of concrete with sand  
Date: 09/11/2011

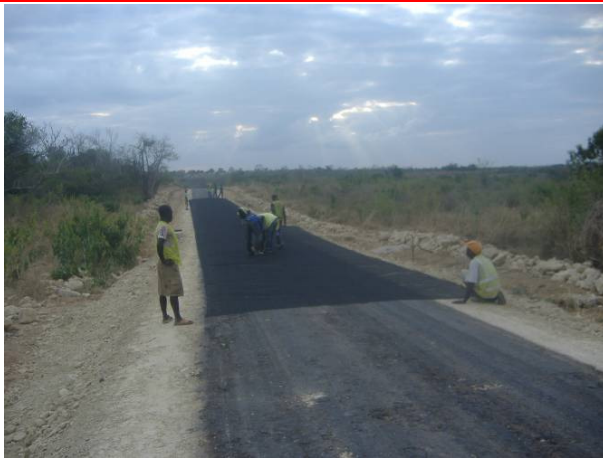
10: Place Fortrac 3D-30 geosynthetic on to reduce erosion of the surface dressing  
Chainage: 8+150 to 8+220 km  
Date: 26/07/2011

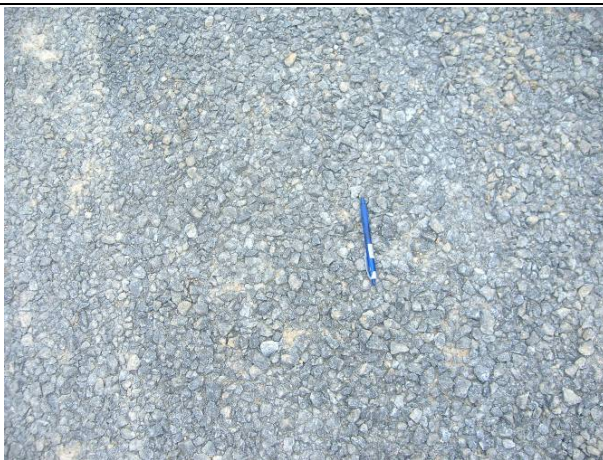
9: Surface texture of first layer of surface dressing  
Chainage: 8+080 km  
Date: 15/08/2011

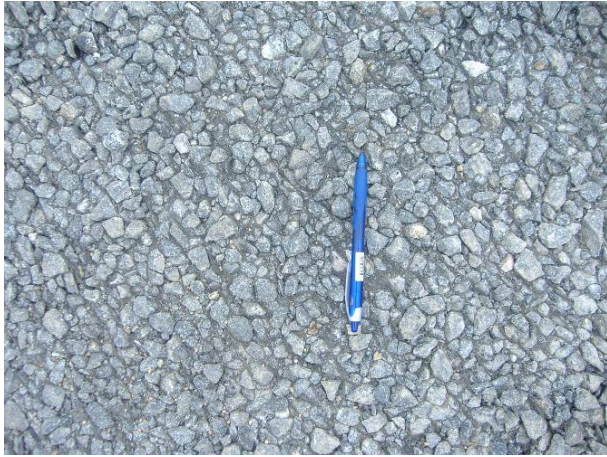
10: Surface texture of surface dressing including Fortrac 3D-30 geosynthetic  
Chainage: 8+150 to 8+220 km  
Date: 26/07/2011

The second geosynthetic that was used on section 5 was the Fortrac 3D-30 surface erosion control geosynthetic. This material is used to reduce the wearing of the bitumen surface, and reduce the period between reseals and prolong the life of the pavement. The geo-grid was laid flat on the base course and a standard double surface dressing was laid directly on top of the geo-grid.

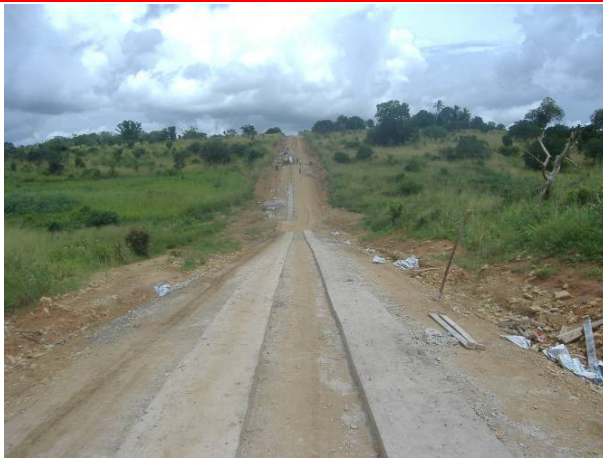
13: Partially completed concrete strip section (100mm thickness)  
Date: 16/05/2011

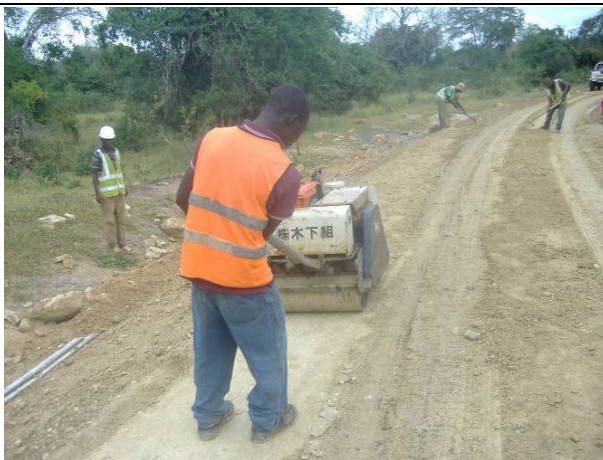
15: Compact the shoulder and intermittent gravel with a pedestrian roller  
Date: 23/06/2011

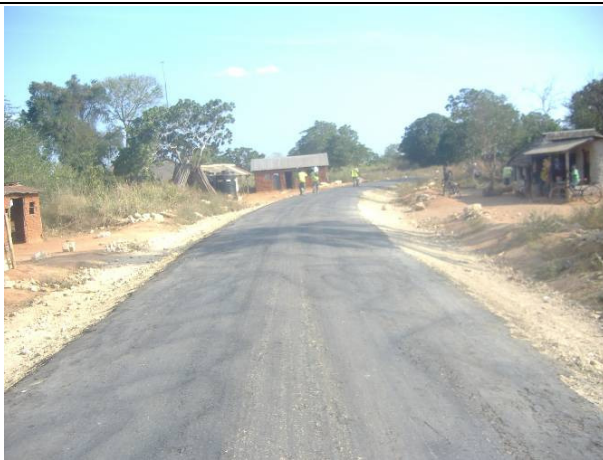
6: Completed MC-30 prime coat sprayed on 4. 6 m width carriageway  
Chainage: 11+200 km  
Date: 24/07/2011

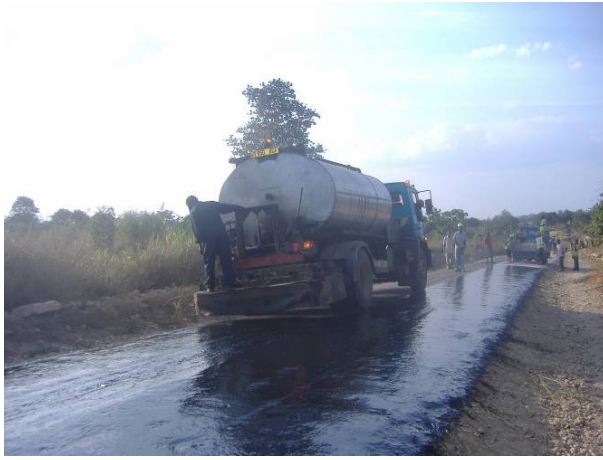
7: Spray MC-3000 bitumen at a rate of 1.2 l/m<sup>2</sup>  
Chainage: 11+260 km  
Date: 24/07/2011

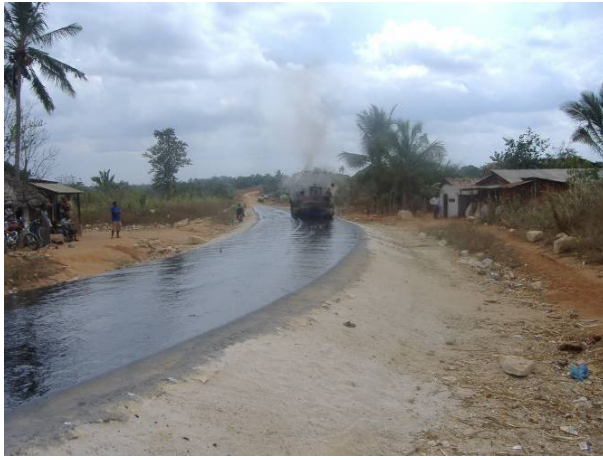
13: Spray MC-3000 bitumen at a rate of 1.2 l/m<sup>2</sup>  
Chainage: 11+300 km  
Date: 17/08/2011

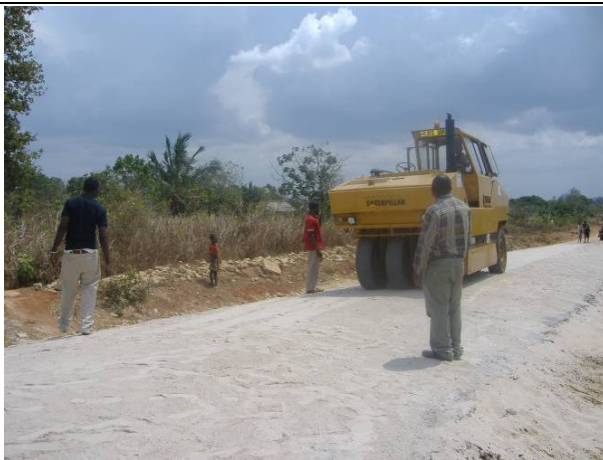
15: Compact the sand as soon as possible using a pneumatic tyre roller (12 tonnes)  
Chainage: 0+030 km  
Date: 17/08/2011

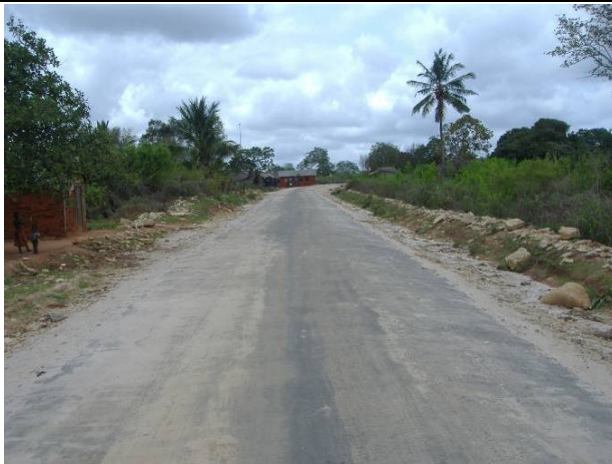
15: Completed double sand seal section  
Chainage: 11+200 km  
Date: 06/10/2011

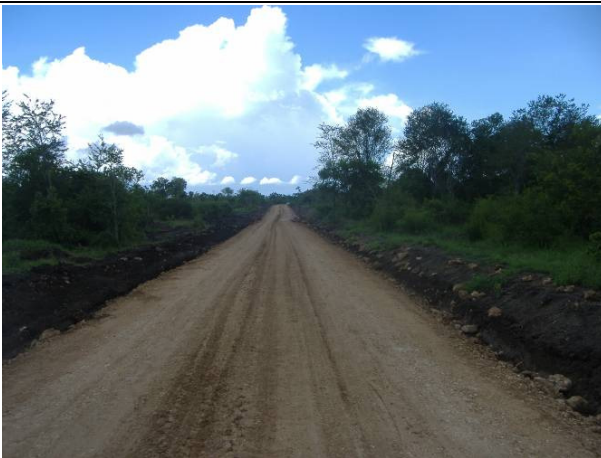
3: After spreading and compaction of  
150mm of gravel wearing course  
Chainage: 12+540  
Date: 31/03/2011

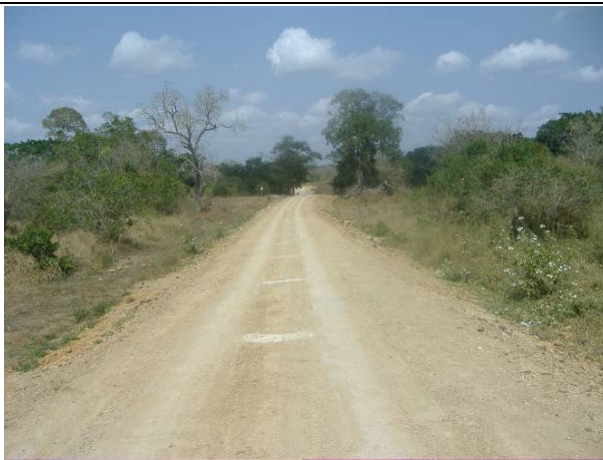
6: Completed concrete strips section  
Chainage: 18+480 km  
Date: 18/08/2011

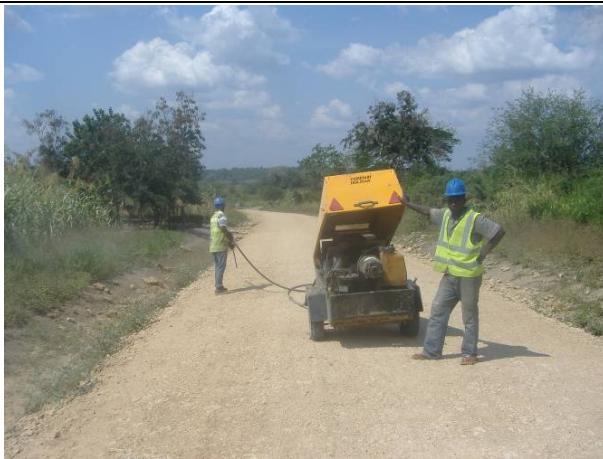
5: Clear the surface of any dust and loose material  
Chainage: 20+180 km  
Date: 05/07/2011

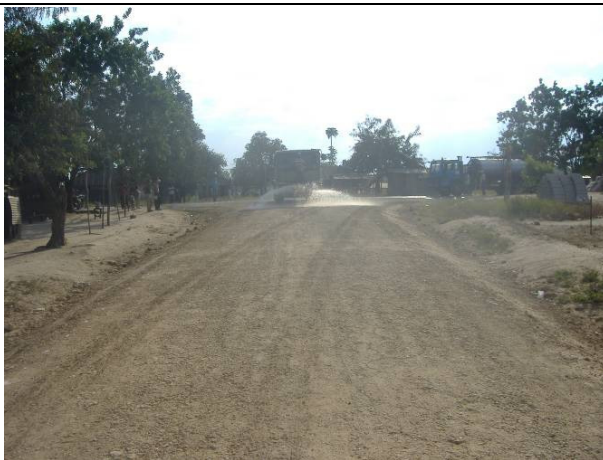
6: Lightly wet the roadbed before prime coat  
Chainage: 20+240 km  
Date: 05/07/2011

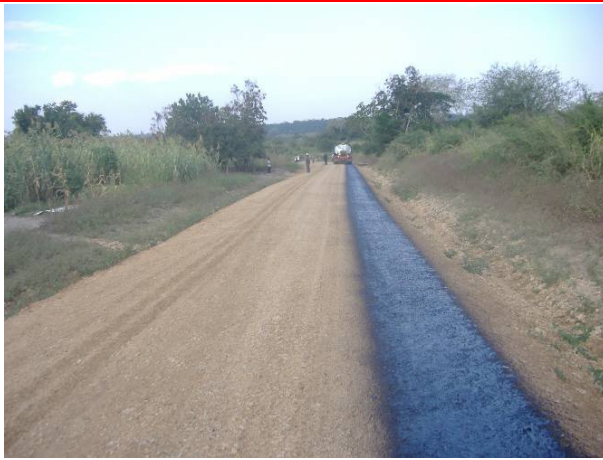
7: Spray prime coat of 700 mm width  
Chainage: 20+260 km  
Date: 05/07/2011

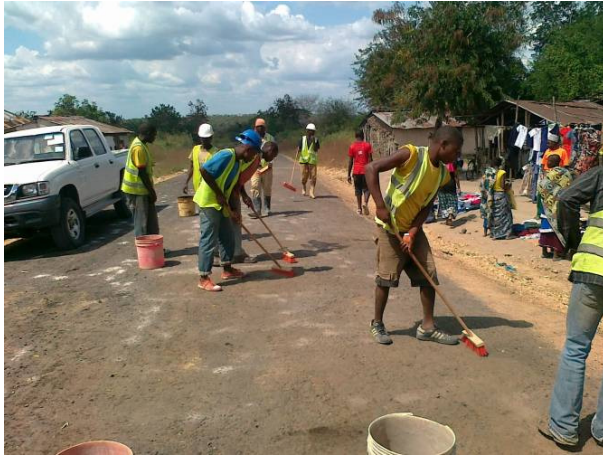
13: Sweep the dust and loose material from the road surface  
Chainage: 20+240 km  
Date: 15/07/2011

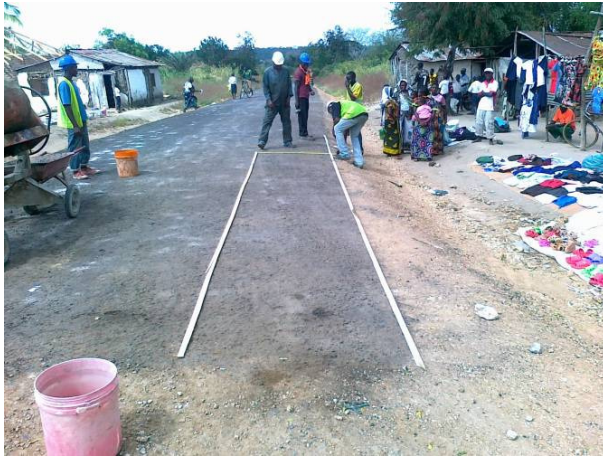
14: Place wooden strips of 8 mm thickness to ensure the correct thickness is achieved  
Chainage: 20+240 km  
Date: 15/07/2011
