Towards Improvement of Surface Dressings in Ethiopia

Background to this paper

- Review of surface dressings in Ethiopia
 - ERA concerns regarding performance
 - AFCAP initiated project
 - Analyse and understand the cause of surface dressing failures in Ethiopia
 - Interviews, Field investigation, Workshop with practitioners
 - Review of Design methods, Manuals, specifications
 - Recommendations for improved practice

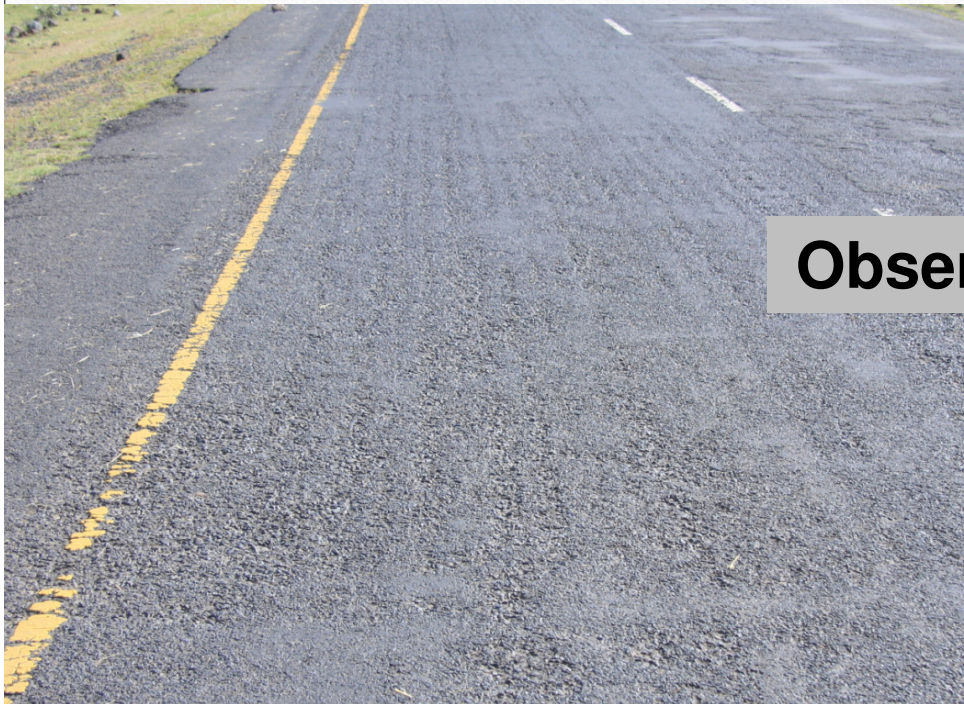
Poor transverse distribution

Observed

**Too low binder
application**

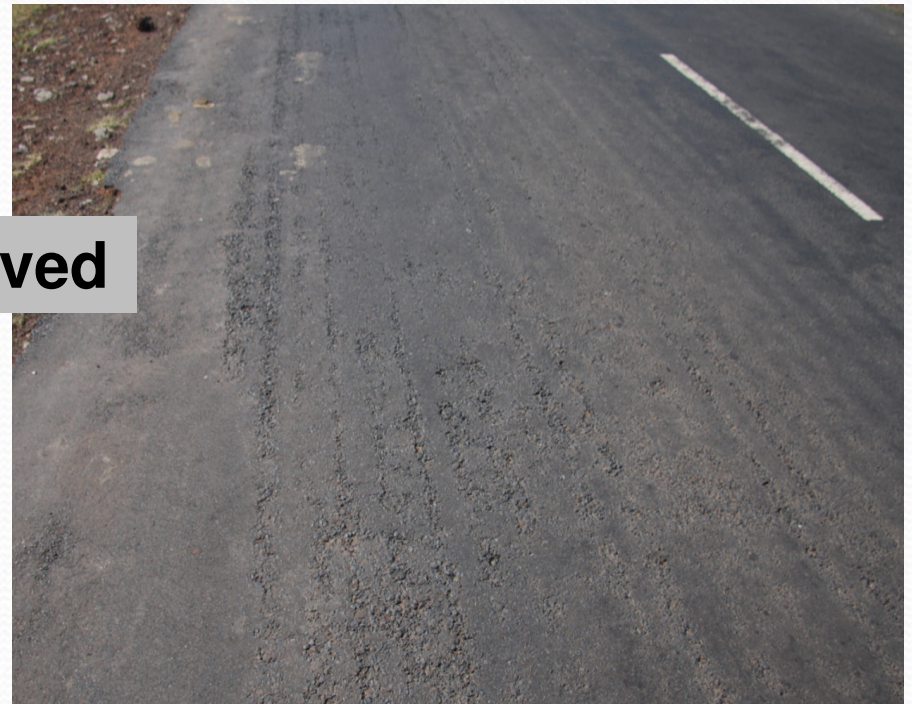
**Too high binder
application**

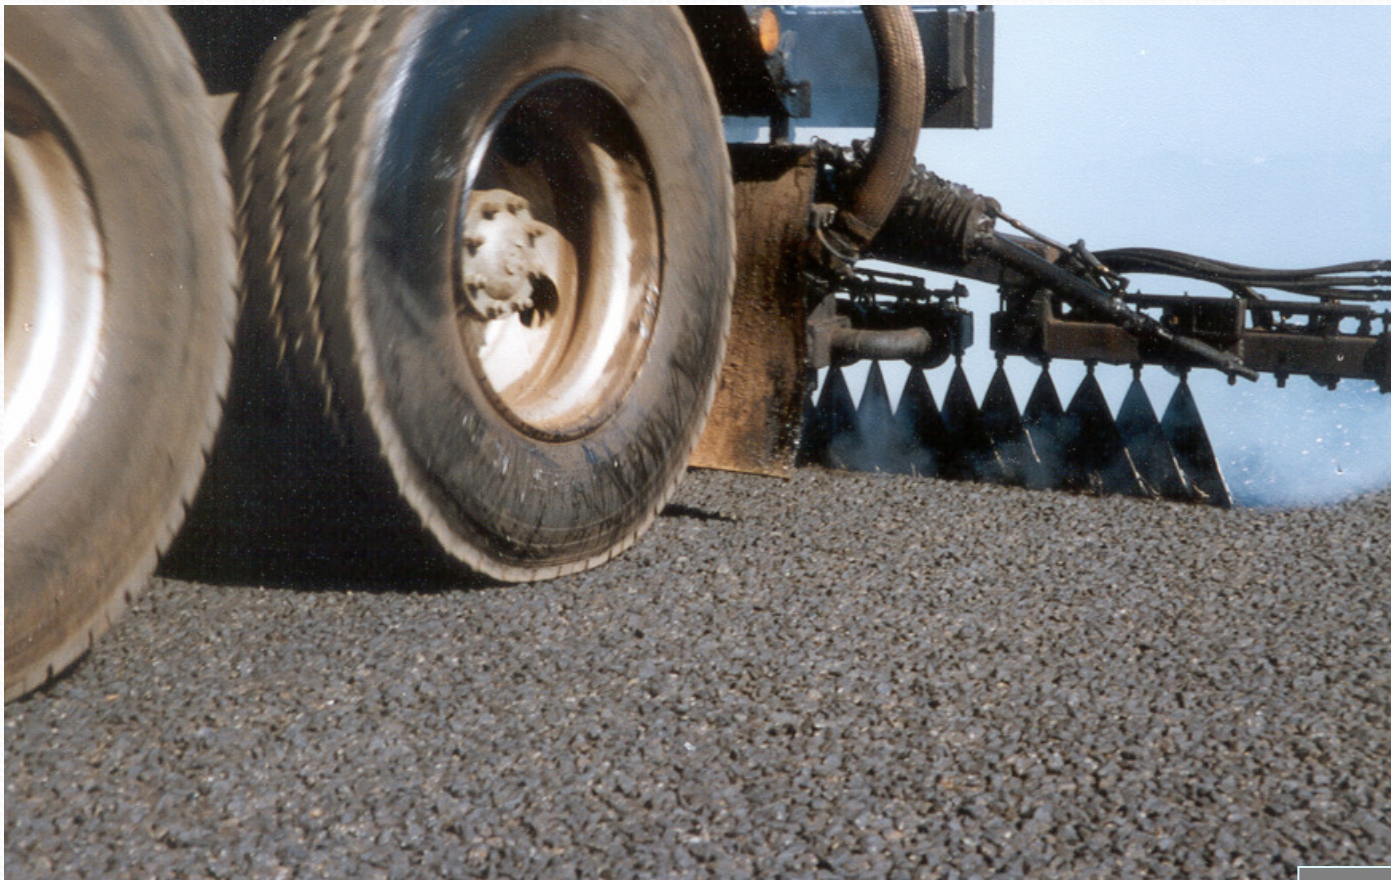
Transverse distribution (Proper flair & overlap)

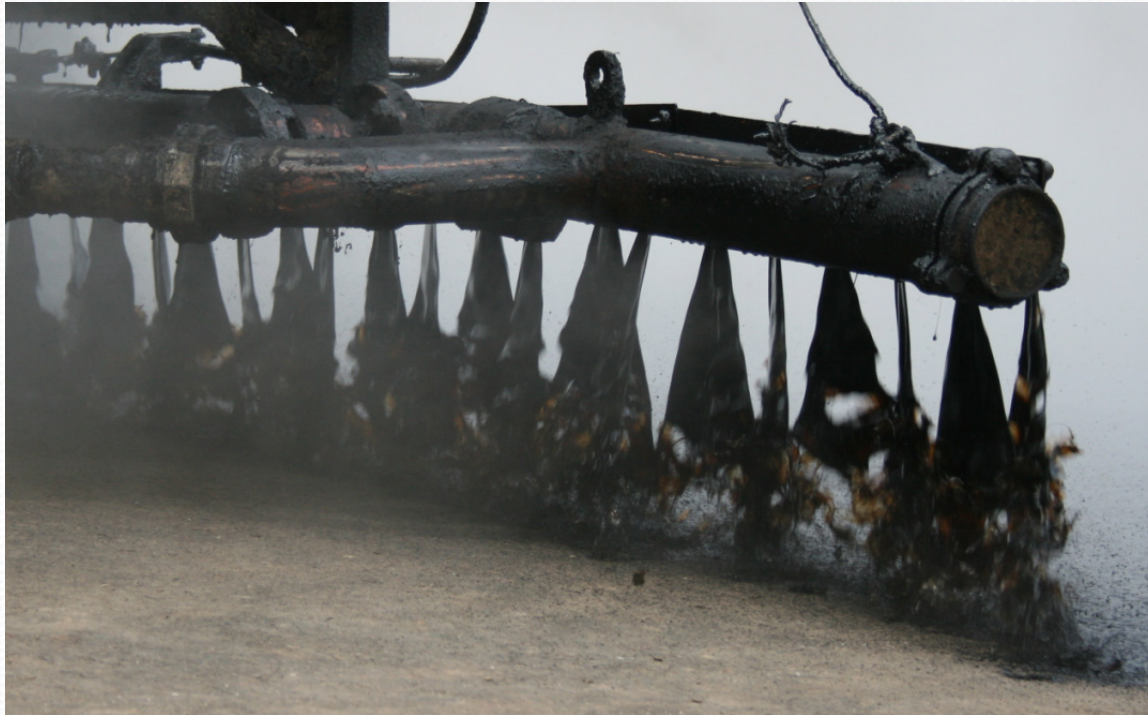
Transverse distribution

Nozzle angles

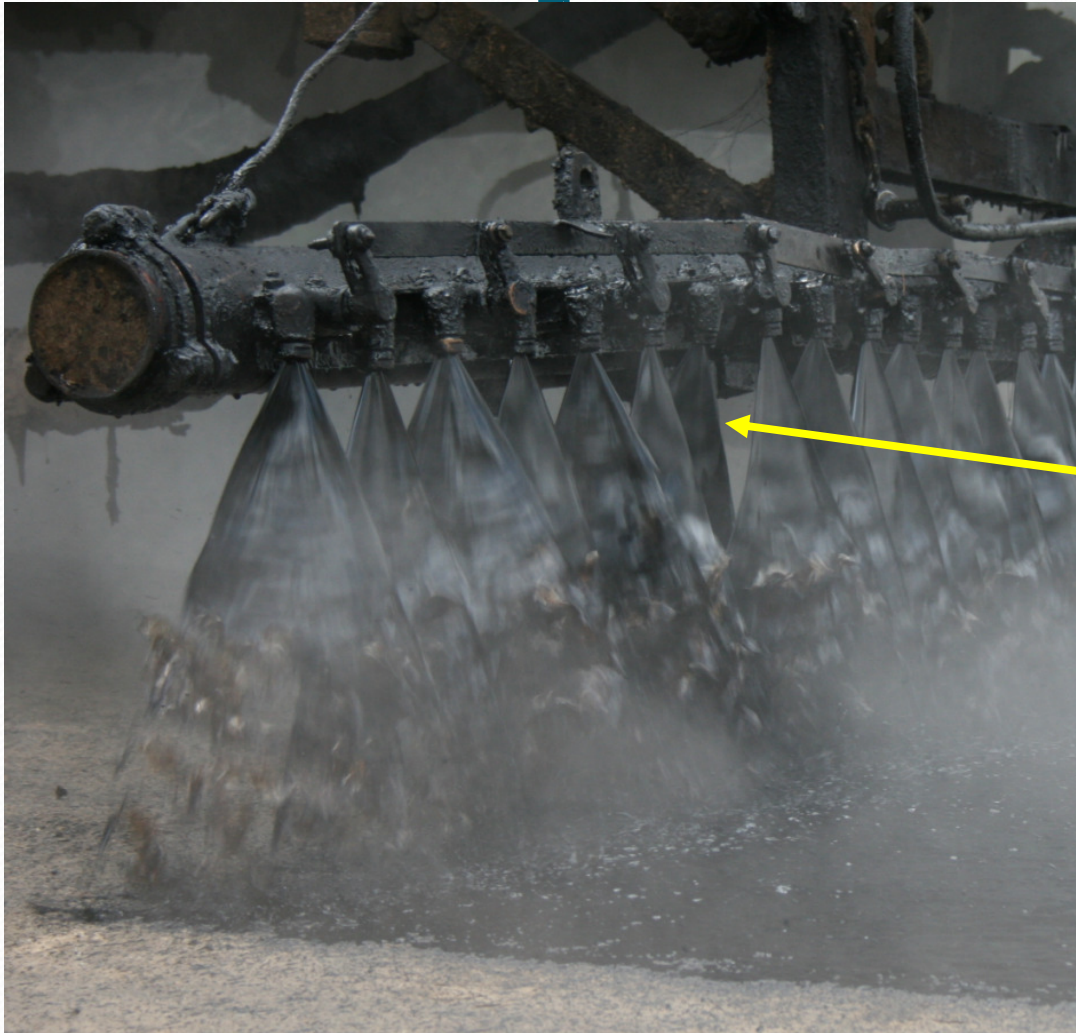
Nozzle alignment

Observed

ERA Specification Clause 6104 (a)

“Before each separate application of binder, the spray bar shall be reset to **the height required to ensure the necessary uniformity of nozzle spray overlap (double or triple)** and distribution is maintained.....

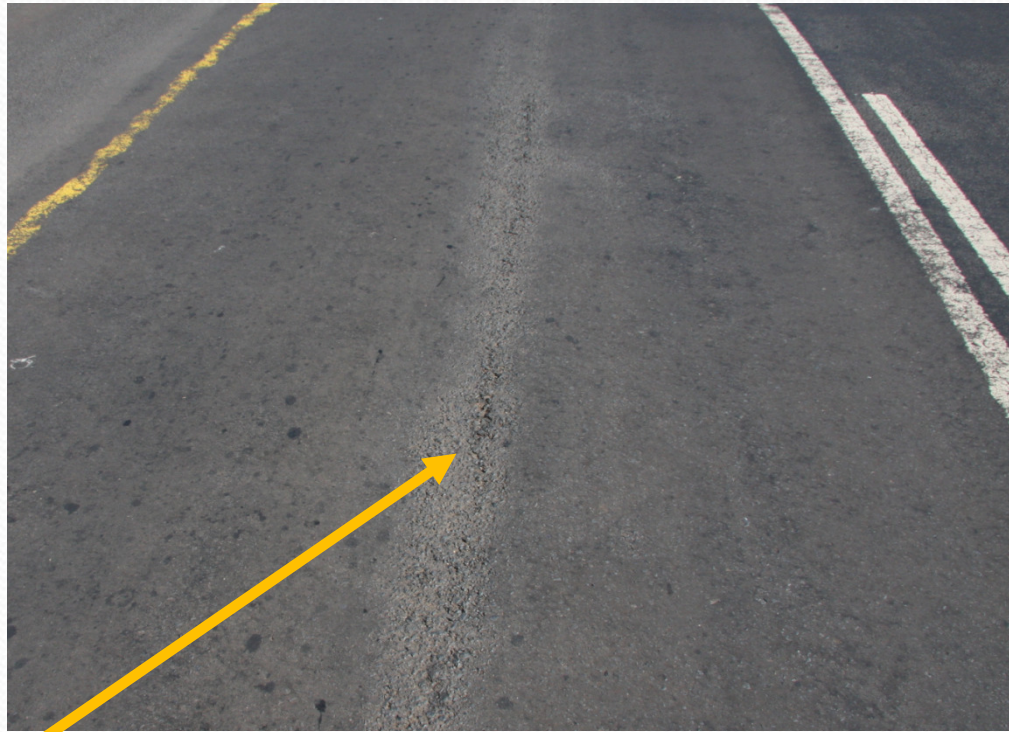
Poor Longitudinal Joints

Main Cause ?
•Construction

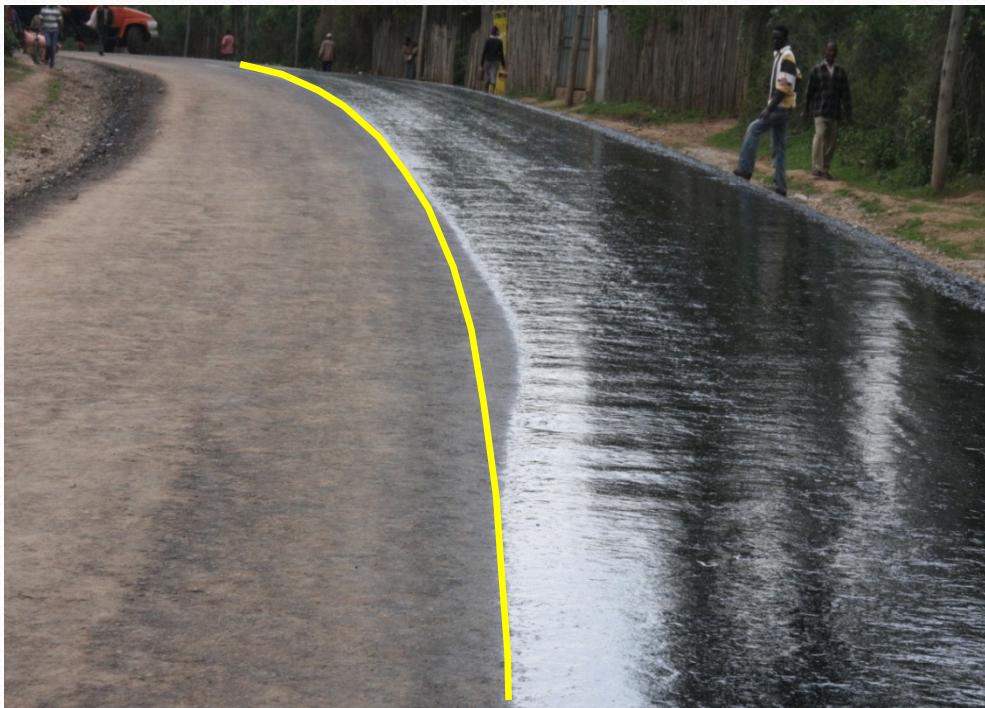
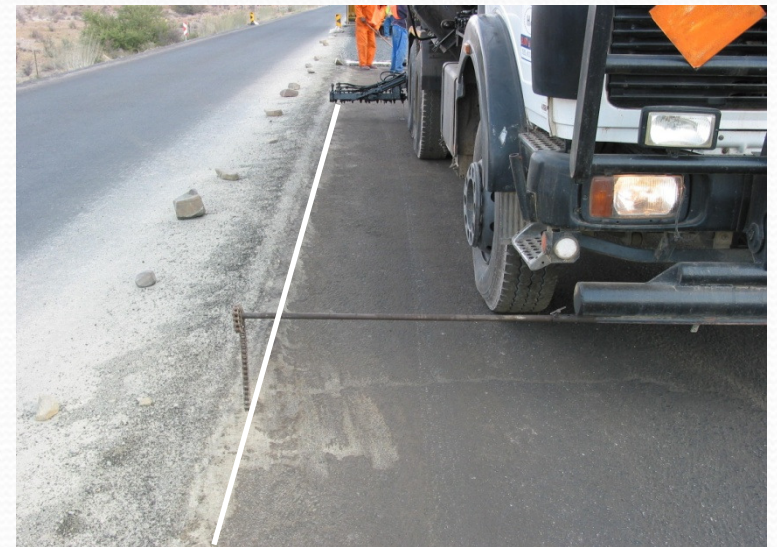
Stringline could help

ERA Specification Clause 63A08 Demarcation of Working Area

The Contractor shall demarcate the area of the primed roadbase to be surfaced by means of setting out wire, or **string lines** down each edge of the proposed surfaced width. The control intervals for the setting out of horizontal curves shall be as agreed by the Engineer.

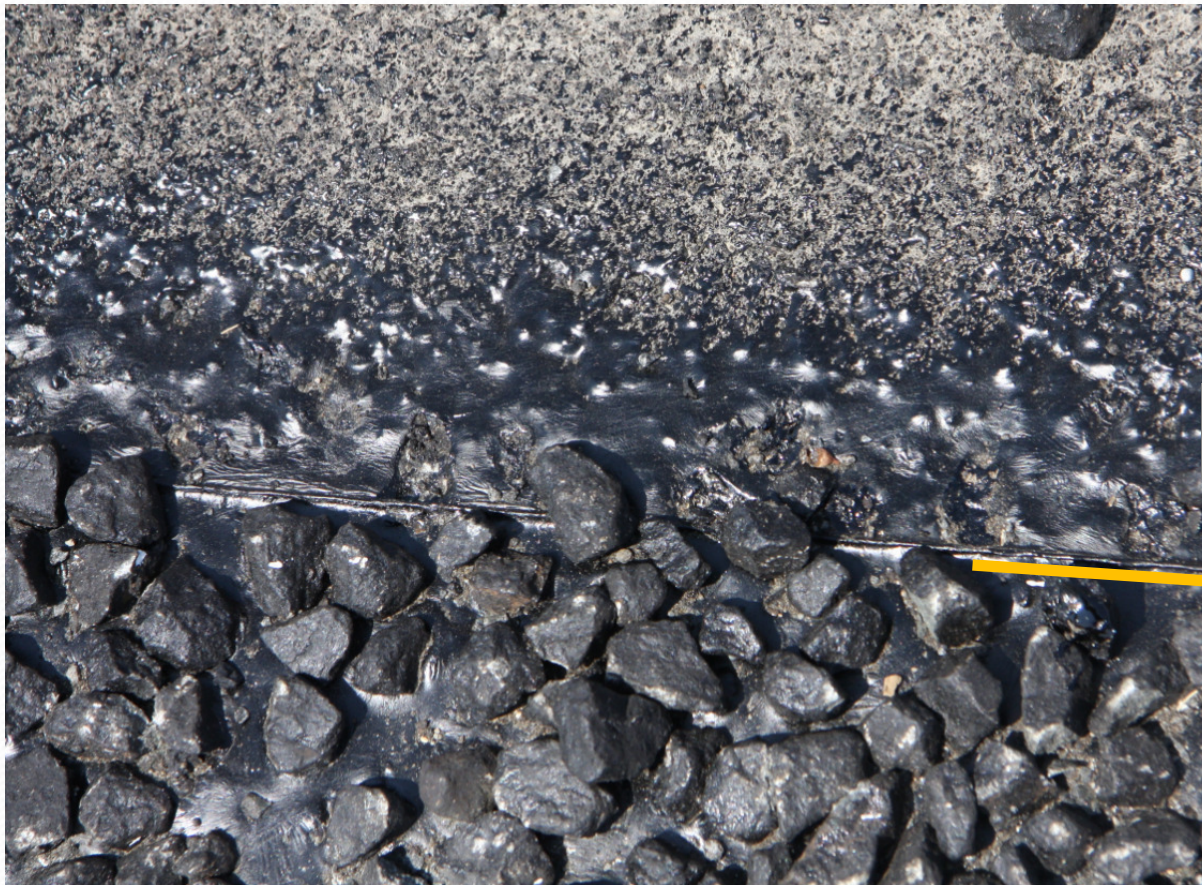
Stringline position

Half application

Full application

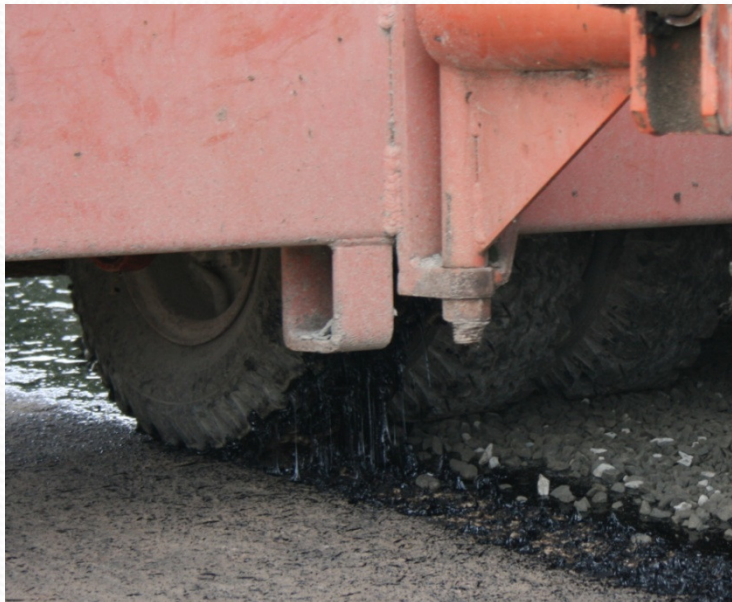
- Damage caused
 - Chip spreader wheel running on bitumen

*Chip spreaders shall commence spreading the chippings as closely as possible behind the distributor. The chip spreader shall be operated in such a manner that the binder shall be covered with chippings and the **wheels of the chip spreader or truck do not pass over the uncovered binder**.....*

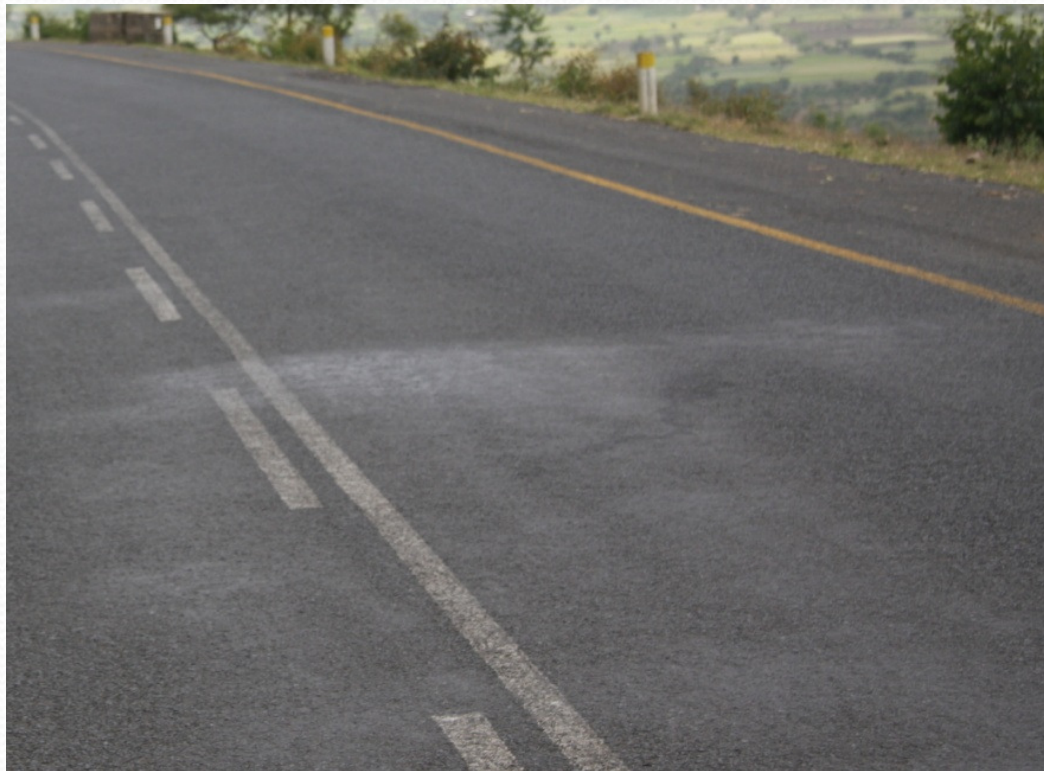
Transverse Joints

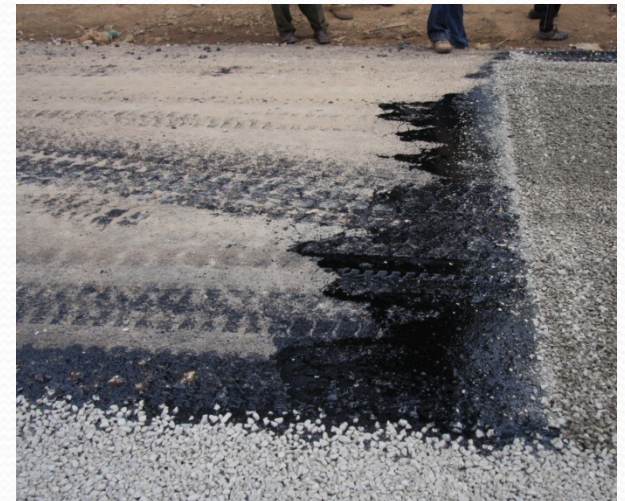
Fattiness observed

Cause

*“In order to prevent overlapping at transverse junctions of separate binder applications, the previous work along **the joint shall be covered with twine-reinforced building paper** for a sufficient distance back from the joint to ensure that the spray bar of the bitumen distributor maintains the required rate before the untreated surface is reached to prevent additional binder application to the untreated section. The same method shall be used to seal the neat joint at the end of the run.”*

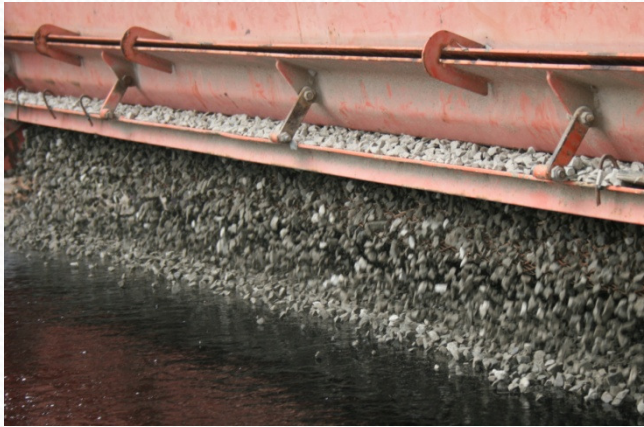
Over application of single sized aggregate

*Any areas deficient in chippings shall have additional material added to leave the carpet with a **single layer of chippings lying shoulder to shoulder**. It is essential to ensure that **only one layer of chippings is applied** and every care shall be taken to avoid over-application of chippings”.*

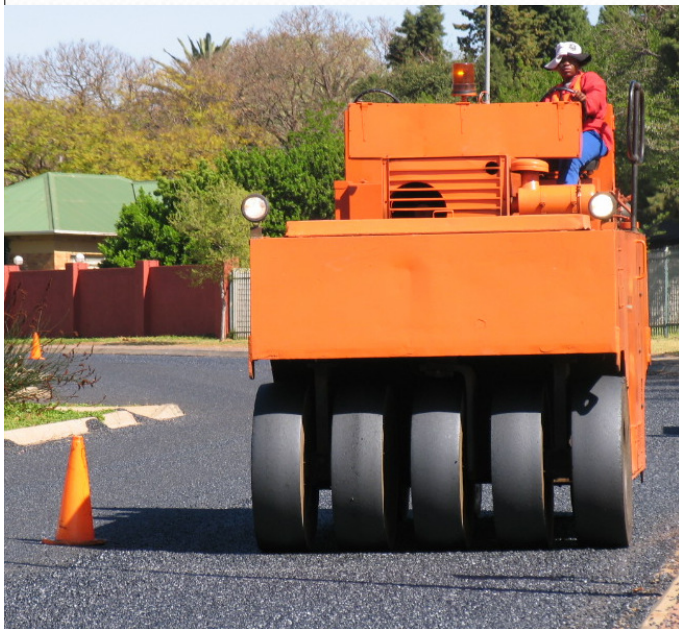
Flaky Aggregate on ALD "In Contact"

Impact

Rolling

**More binder
required**

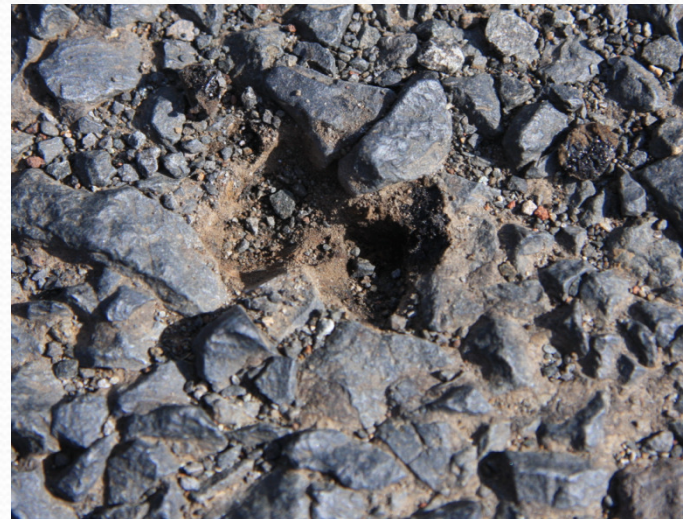
- Too little binder
- Aggregate loss

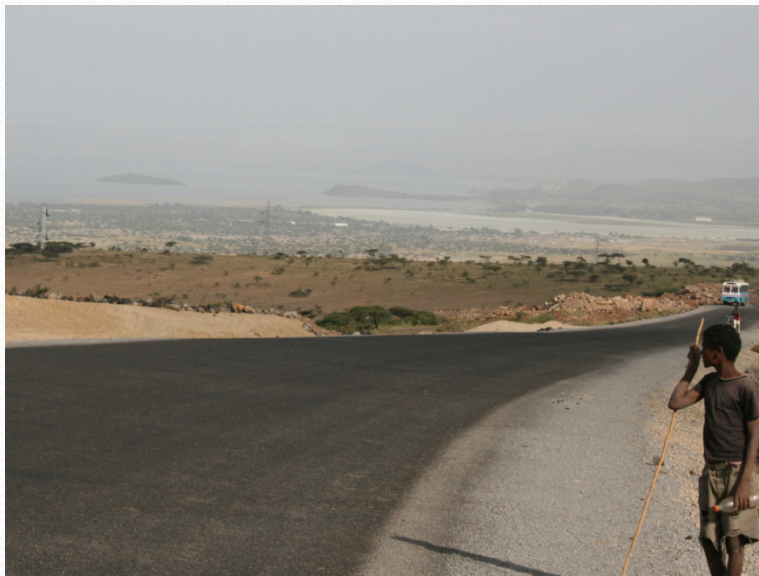
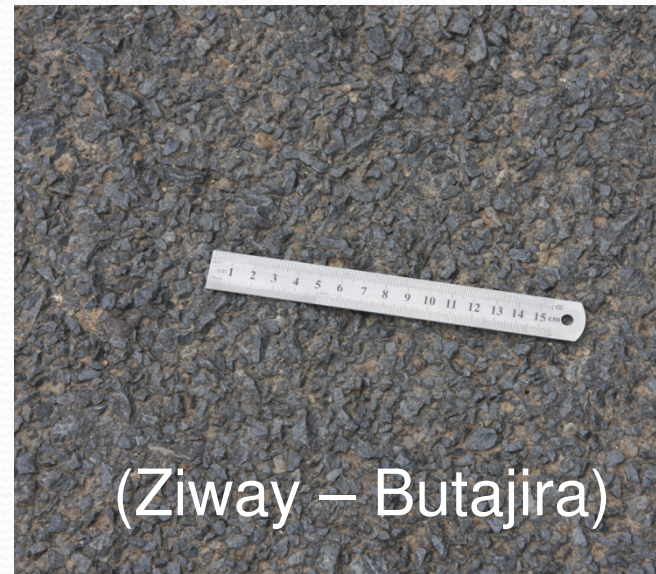
- Local Ethiopian Contractor and consultant got it right (Ziway – Butajira)
