**SEACAP 27**  
**MID TERM PAVEMENT  
CONDITION MONITORING OF  
RURAL ROAD SURFACES**

**INTRODUCTION & KEY ISSUES**

**SEACAP 27 - BACKGROUND**

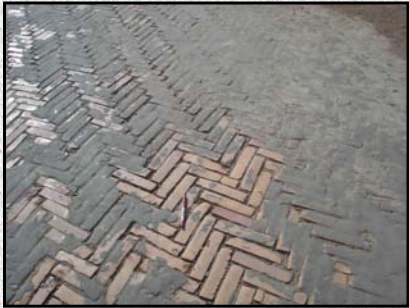
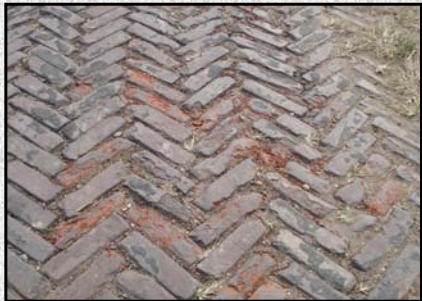
### Summary: Block Pavements

- The single sand seals have performed poorly.
- The minimum strength requirement of 20-25MPa for manufactured engineering quality bricks is important.

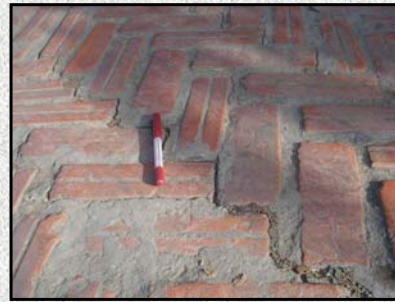
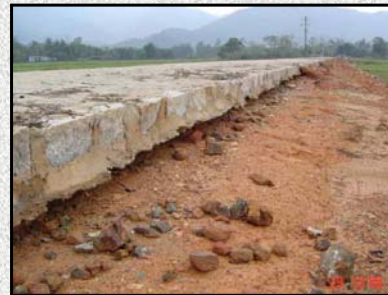
## Summary: Block Pavements

- ❑ Mortared jointed options are probably more appropriate than sand joint options.
- ❑ Stone options: robust but rough

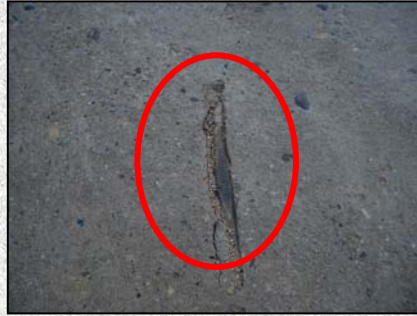
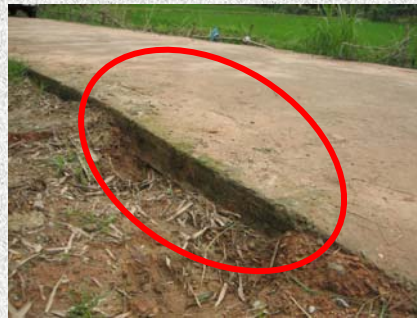
## Summary: Concrete

Two principal causes for poor performance stand out:

Poor quality concrete and poor support for the concrete slabs (sub-base or eroded shoulders).

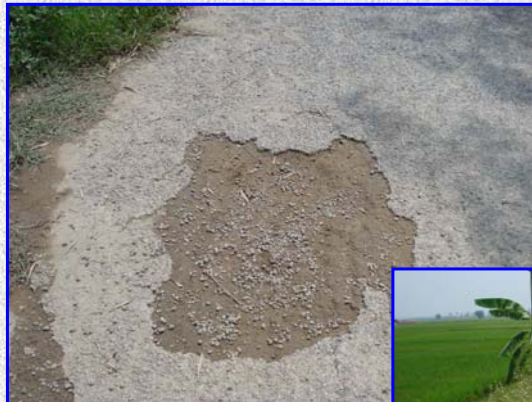
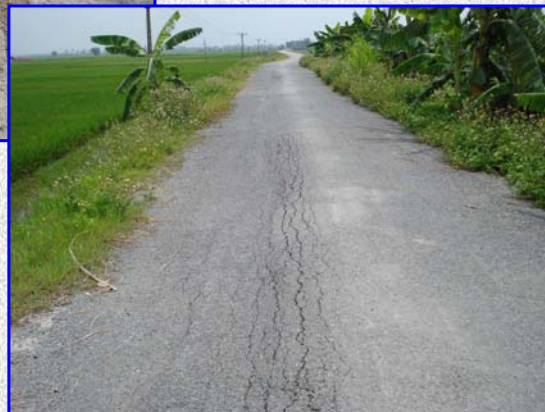
## Surface Failure

### Flexible Pavements

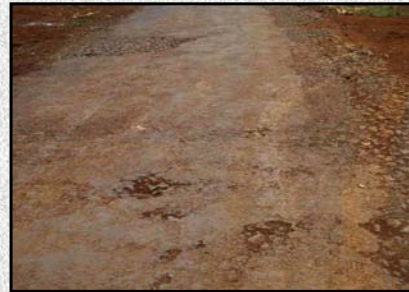
## Summary: Flexible Pavements

Evidence indicates that the combination of emulsion DBST over DBM is performing better than the standard option of hot DBST over WBM.

Poor construction is major issue with the flexible pavement sites, particularly with regard to the seals. Less than 50% were satisfactory as-built.

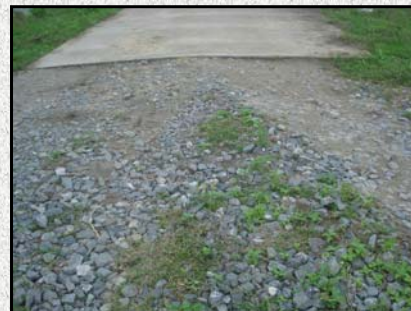
## Summary: Unsealed Gravel

The majority of gravel control sites performed poorly- however there are clearly areas where unsealed gravel surfaces are a sustainable LVRR option provided they are constructed correctly and MAINTAINED.

Unsealed WBM is not a realistic option because of loss of cohesive fines and surface loosening.
