**TRIALLING THE NEW STANDARDS AND
SPECIFICATIONS AND EXTENDING THE LAO
LVRR SURFACE AND PAVING KNOWLEDGE
BASE**

**FINAL REPORT
JUNE 2009**

Prepared for: Project Record: SEACAP 3.02-SEACAP 31.

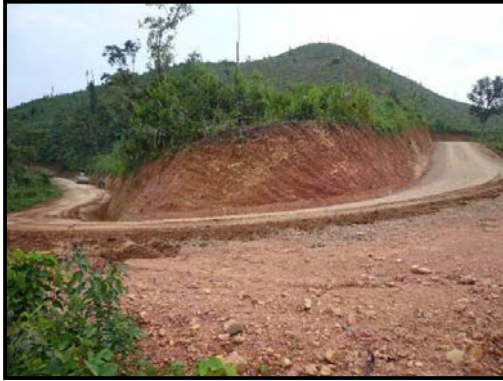
Plate 1. Spot improvement section. Climbing curve at km 2.000

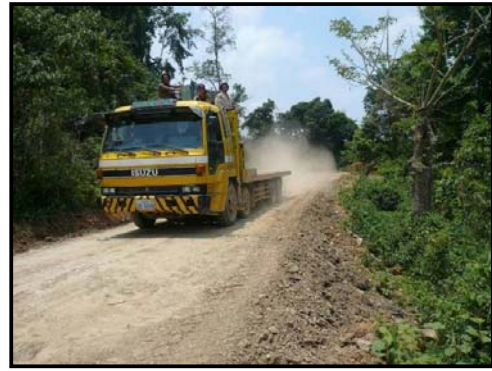
Plate 2. Heavy contractor plant on the Samphan road. One big advantage of the delay in building the spot improvements will be the decreased risk of heavy plant using the trial surfaces

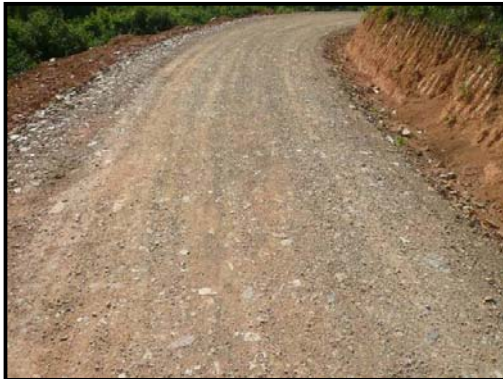
Plate 3 Coarse out-of specification wearing course materials evident in this section

However, the quality of the gravel, as indicated by the grading and plasticity of the samples, is poor, with most samples failing one or more criteria. There is considerable variation between tests in 2008 and 2009 from the same source.

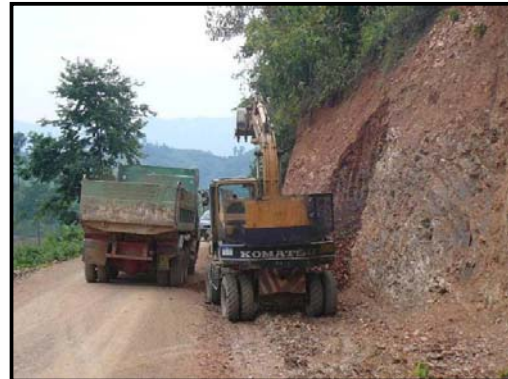
Plate 4 Over-steepening of cut-slopes in order to obtain out-of specification gravel using heavy trucks.

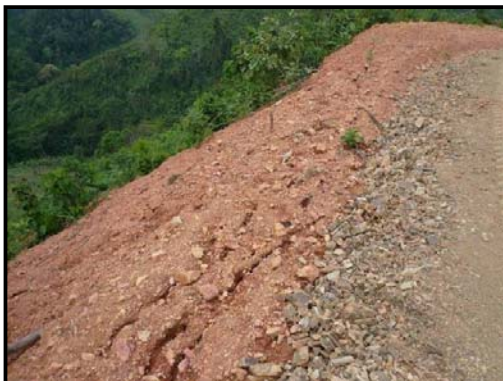
Plate 5 Tension cracks evident in failing materials dumped below road

Down slopes below the road should be no steeper than 1:2 and no loose material should be dumped on the down slopes.

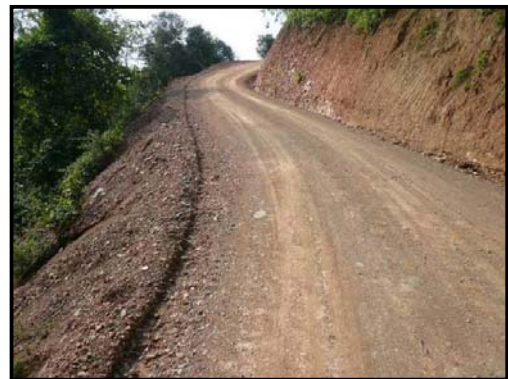
Plate 6 Poor compaction in shoulders evidenced by ruts and tyre marks

The width of the gravel carriageway is generally adequate but is likely to reduce rapidly as the segregated and poorly compacted shoulders deteriorate.
