SEACAP 8
CAMBODIA Low Cost Surfacing
Phase 2

INCEPTION DOCUMENT

LCS WORKING PAPER No **20**

PUOK MARKET TRIAL ROAD: PROPOSALS FOR MAINTANCE AND REPAIR

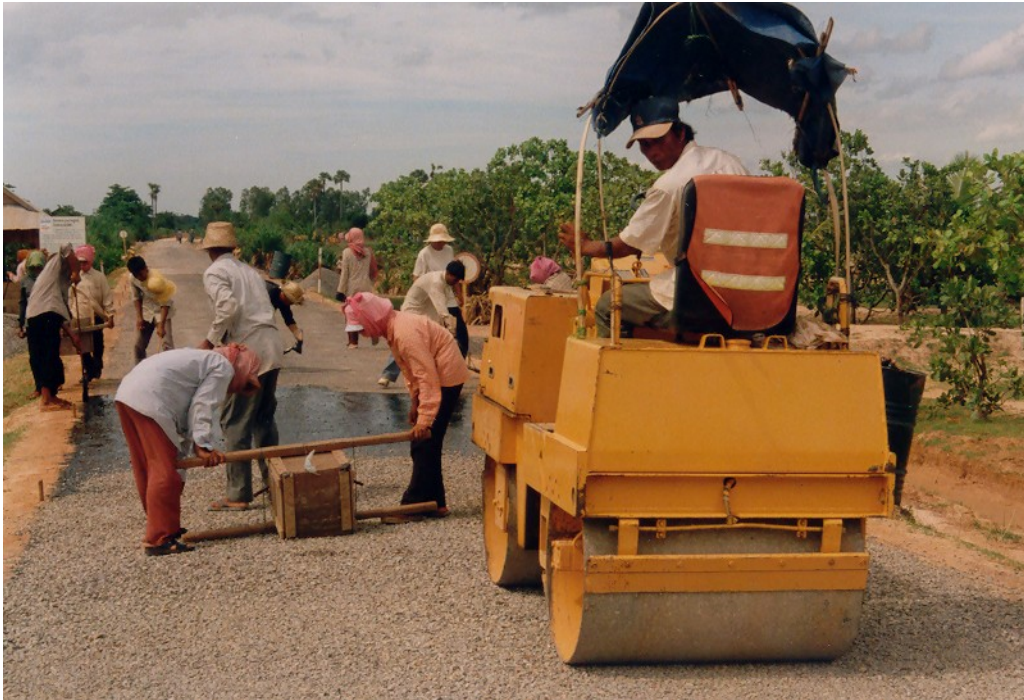
Figure 1.2 Puok Trials construction works

As part of the Phase 1 work, 10 sections of alternative paving were constructed at Puok Market, Siem Reap Province in Cambodia on a tertiary rural route, Figures 1.1, and 1.2. The Puok Market paving trials have been constructed under a cooperation initiative between Intech Associates, ILO Upstream Project, Ministry of Public Works & Transport and Ministry of Rural Development, Cambodia, with principal funding from DFID and SIDA. Two local contractors, using the minimum of equipment and the maximum input of local unskilled and skilled labour, constructed the trials in mid 2002.

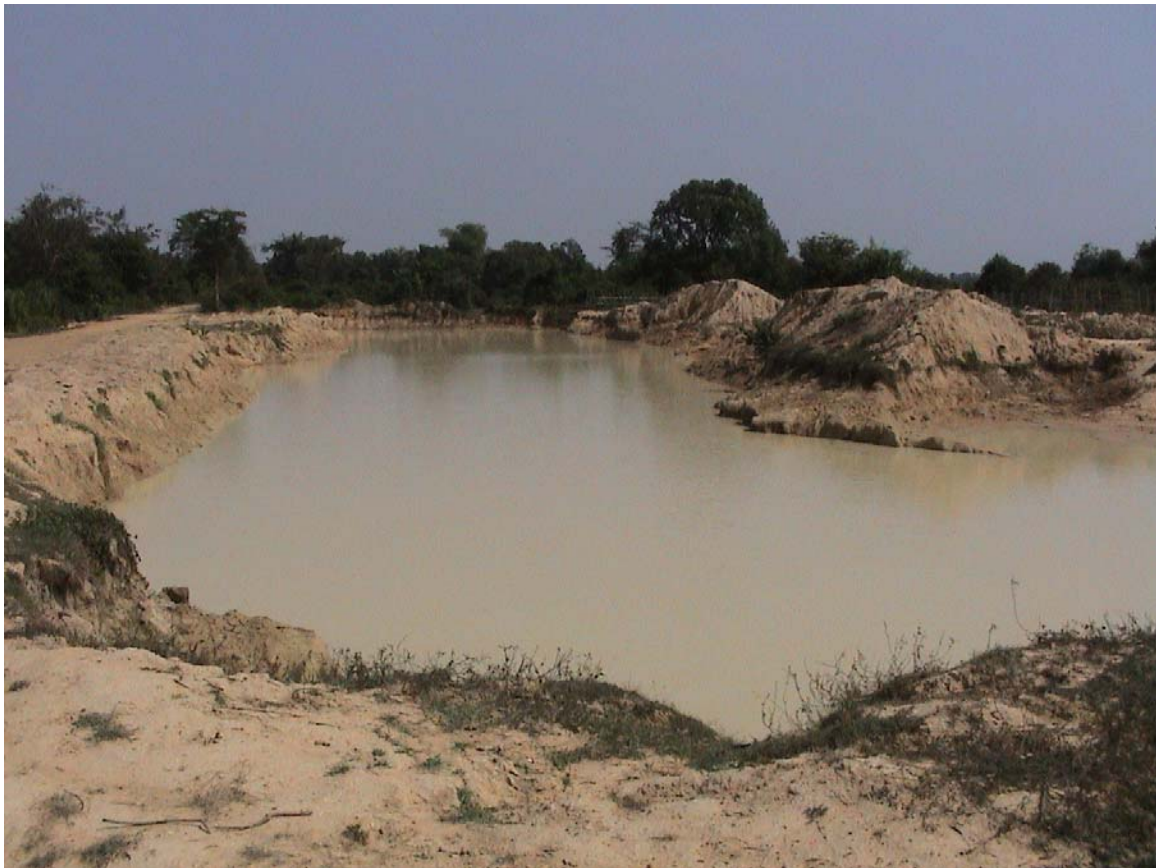
Figure 3.1 – Part of the Sand Pit area

The trials pavement damage had been caused principally by 17 – 20 m³ struck capacity, 3 axle trucks hauling wet sand from a new pit opened up in the area which the trials road services. A visit to the sand pit allowed an estimate of the quantity of hauled material to be assessed. This was calculated to be approximately 30,000 tonnes.

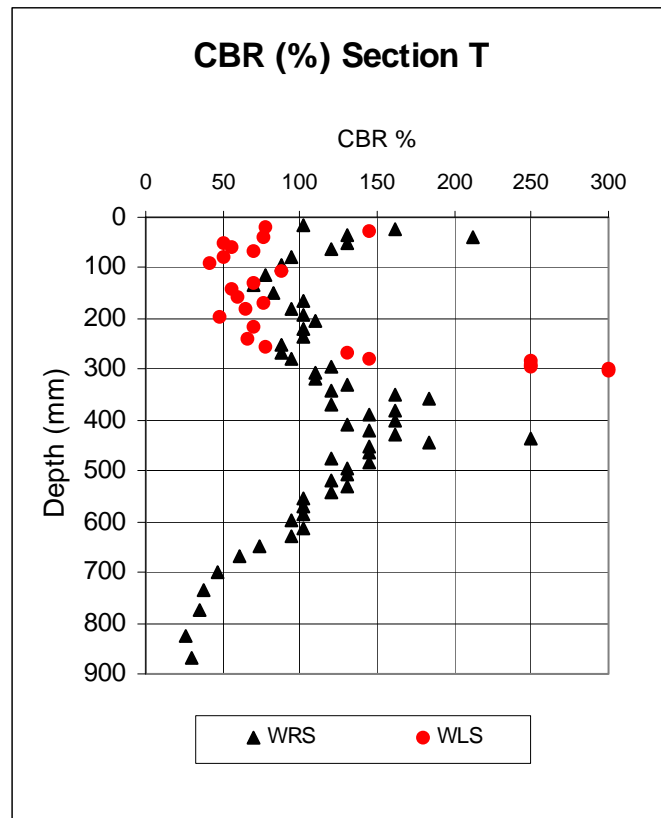
Figure 3.2 DCP Test in Section T

1. Visual inspection of the ILO road section
2. In situ testing by DCP profiling of the short unsealed transition section (T) between the trials and the ILO section. Results are presented in Figure 3.2
3. Detailed visual survey of the surface condition of trial sections 4 and 9. Figures 3.3
4. Walkover survey of other trial sections, summarised in Table 3.1
5. Rut depth measurements in trial Sections 6, 7, 8 and 9 wheel track areas, Figures 3.4, 3.5 and 3.6.

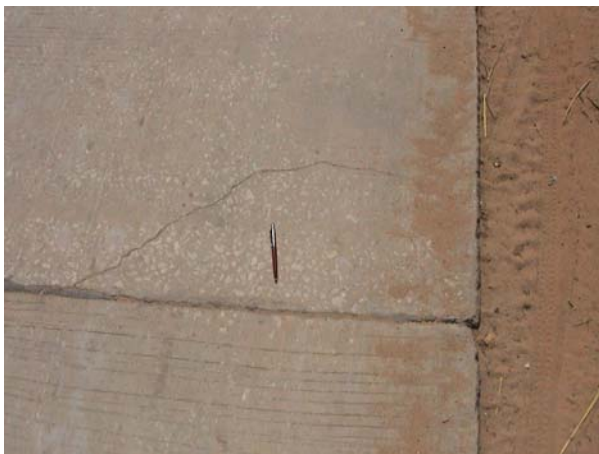
Figure 3.7 Single slab crack

Cracks only exist on two of the concrete slabs in the entire BRCP network. One is a small crack across the corner of one slab. The other is the final slab laid travelling northwards along the trial road, at the transition to the Intech managed trials. This slab has settled substantially and has probably failed due to a combination of poor foundation conditions, and being subjected to high loads as trucks impact onto this slab.

Section	Description	Condition Summary	Rehabilitation and Repair Option	Associated Risks
ILO	Bamboo Reinforced Concrete Pavement	No deterioration apart from cracking at the end of last (transition) slab and one other slab with a minor crack. Minor cracking of bitumen seal joints	Reconstruction of last 3m of last slab. Band seal on other minor crack. Ongoing condition monitoring Repair to shoulders and drainage	None anticipated
Transition	Laterite	Pavement level below adjacent sections. Some surface erosion	Excavate approx 150-200mm existing laterite, place/ & compact 200mm sand aggregate, overlay with diluted emulsion prime, and emulsion chip and sand seals.	Deterioration risk from overloaded trucks
1	Bamboo Reinforced Concrete Pavement	No deterioration apart from minor cracking of bitumen seal joints	Monitoring of construction joints	None anticipated
2	Sand-Aggregate Roadbase & Single Bitumen Stone Chip Seal		Small areas of patching to be identified on site. Sand seal overlay	Deterioration risk from overloaded trucks

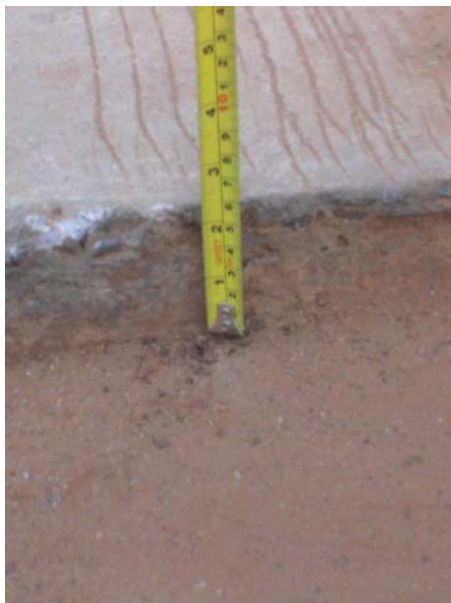
Figure 3.9 Maximum shoulder erosion

The shoulders are generally in good condition, although in isolated locations erosion of up to 6cm was apparent. One section of the side drain in the Puok Market area had collapsed. Apart from this there are no defects to the paving despite no evidence of road maintenance since construction in the year 2000. The drains around Puok Market require to be cleaned.

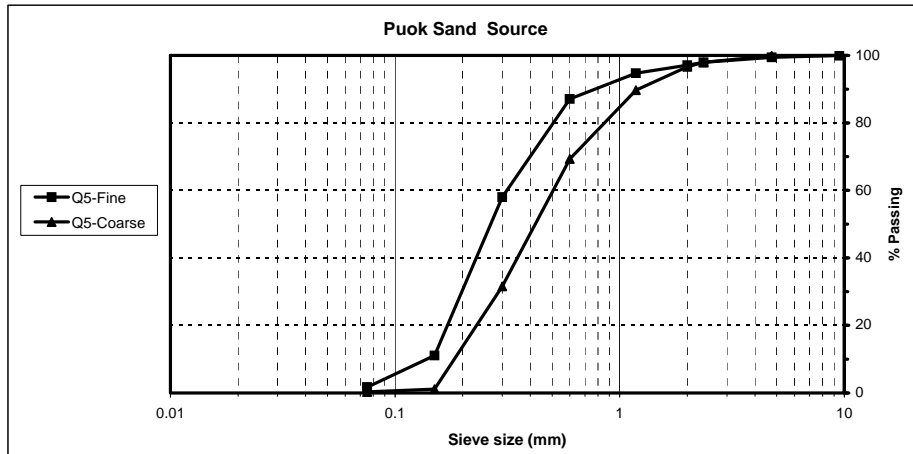
Figure 7.1 Grading of Sand Samples from Doun Jaov (Puok)

Preliminary testing of local sand sources (Q5 in Table 3.2) indicates that it could be suitable for cement stabilisation as a sub-base or basecourse material, Figure 7.1. Further testing, however, would be required to fully evaluate engineering and economic parameters for this option.

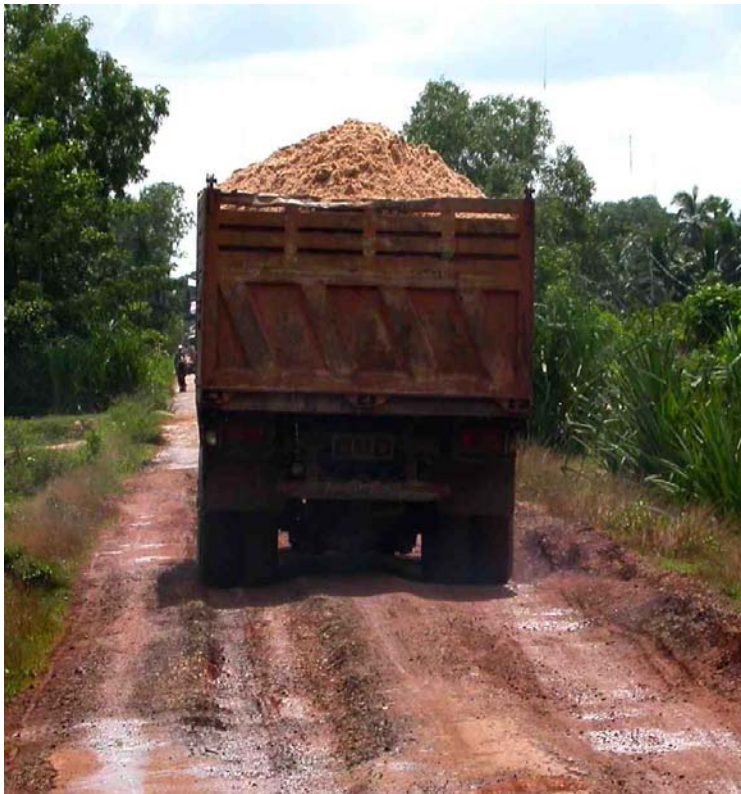
Figure 9.1 – Overloaded truck on the Puok Trial Road.

During the 2003 mid year wet season and continuing during the October field surveys, the Puok Trial sections were subjected to significant numbers of sand haulage trucks. It was apparent during the field survey work that these trucks are heavily overloaded, hauling wet sand, and were using the road on a regular daily basis, Figure 9.1.

These trucks were not weighed, however from physical measurements and manufacturers' specifications the following assessment of axle loading has been made. The standard haulage trucks are modern 3 axle tippers (Hyundai, Hino, Daewo etc.). The bodywork on the trucks has been extended (as most materials haulage trucks are in Cambodia) to a struck capacity of 20m³. However the trucks often transport the material in a heaped condition, which is equivalent to an additional 4m³. Therefore total material load can be 24m³ for a 3 axle truck. The unladen weight of these trucks is about 9 tonnes for the chassis and cab, plus about 2 tonnes for the tipping body and fuel, i.e. approximately 11 tonnes. The wet sand being transported would have a specific gravity of more than 1.6. The total operating weight of the loaded trucks can therefore be up to about 50 tonnes. This compares with the current legal limit of 20 tonnes for 3 axle trucks on secondary roads. It is clear that axle load control is not practiced.

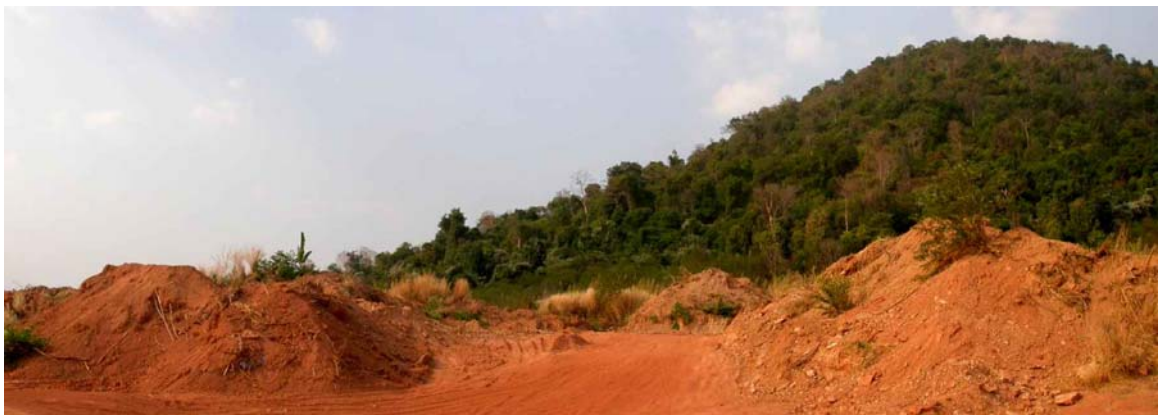
Plate 1

A Laterite borrow area of variable quality on the footslopes of Phnom Dei (Plate1). Composed of plinthite, honeycomb (vermiform) and some hardpan materials (Plate 2). Engineering Character varies from weakly cemented plinthite with abundant kaolinite to locally moderately strong hardpan with included nodules (Plate 3).

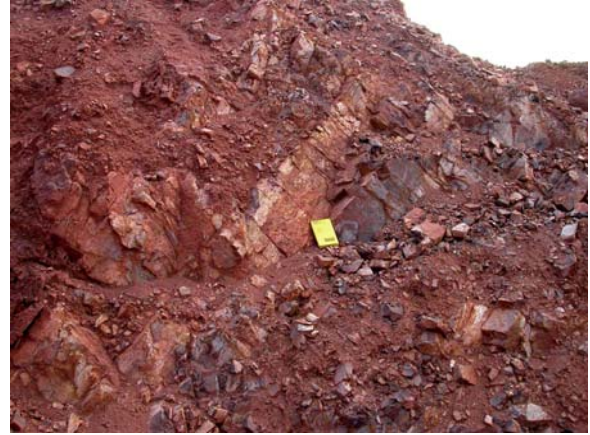
Plate 4

Location Q2 is a small drill and blast operation working along the strike of the stronger rock beds (Plate 4), and feeding a small portable jaw crusher with revolving screen (Plate 5). Secondary crushing and sorting is a manual labour-based activity. Current small stockpiles comprise nominal 10-20mm (\$9/m³) and 6-8mm (\$8/m³) materials composed of reasonably clean and apparently strong particles, however the shape of the aggregate is poor and consequently so is the size control (Plate 6). The material however is perfectly adequate for low volume rural roads construction.

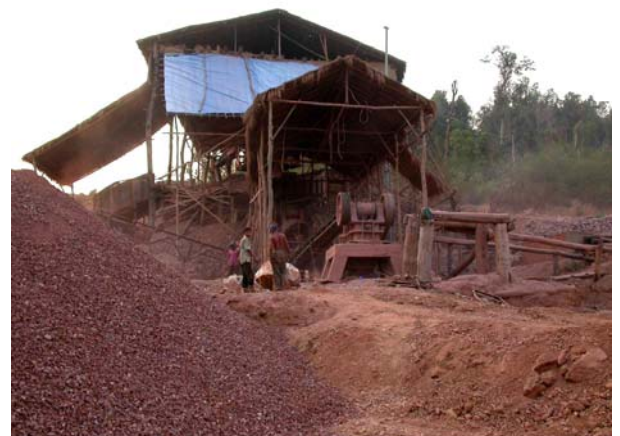
Plate 7

Source Q3 is located close to Q2 on the same hill, but is a larger operation with a greater production capacity (Plates 7 and 8). Cost 10mm aggregate \$7.5/m³ at site, \$11.7/ m³ at Puok Market.

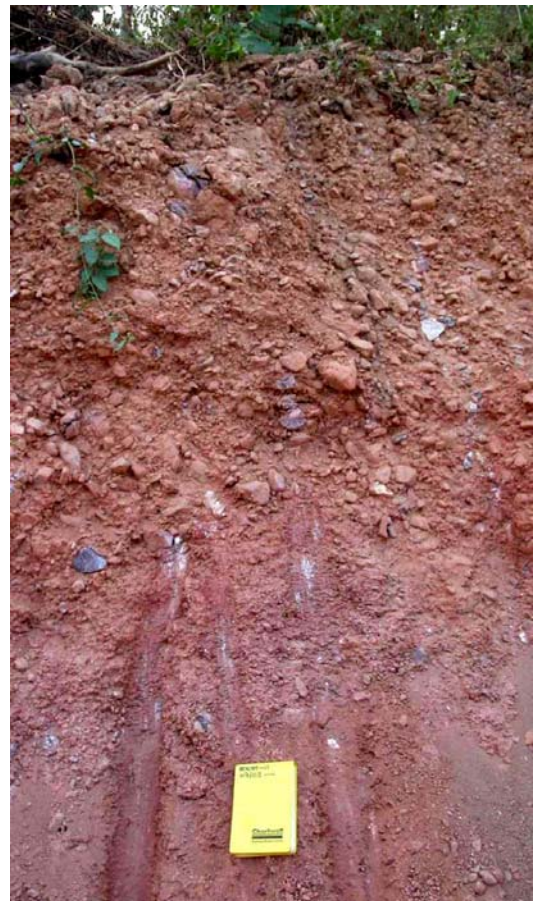
Plate 9

Source Q3 also has the potential to produce a mixture of colluvial gravel and lateritic gravel from overburden on the adjacent hill-slopes. (Plate 9).

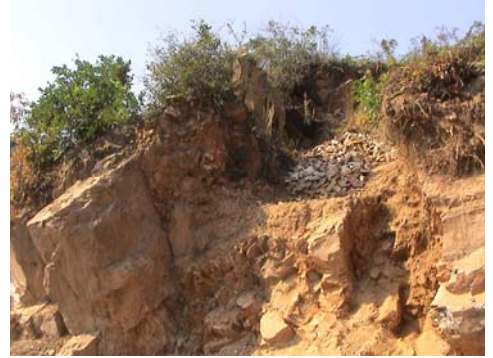
Plate 10

Moderately thickly to thickly bedded quartzite sandstone with some conglomerate being manually excavated by wedging and barring off 1-2m spaced joint planes and 30-40° dipping bedding planes (Plates 10 & 11).

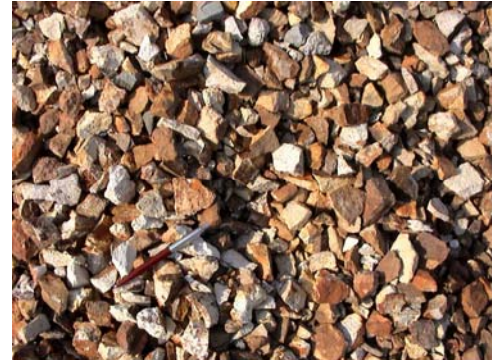
Plate 12

Several small concessions are working the same hill currently producing hand crushed aggregate (\$8/m³) and small 250mm blocks (\$5/m³).- (Plates 12 & 13). A suitable source for hand packed stone materials.

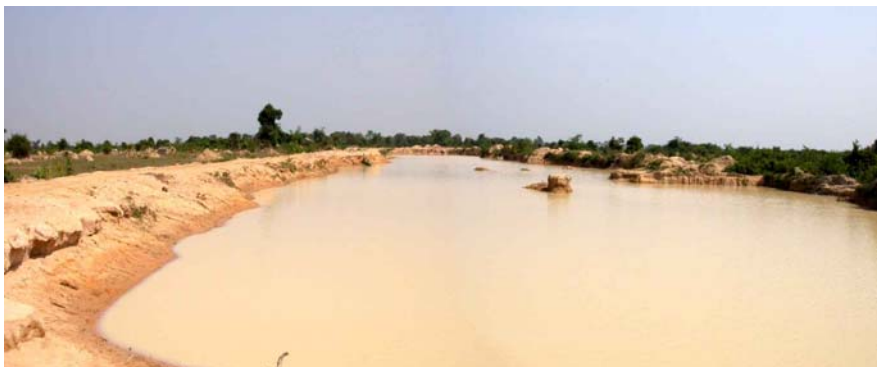
Plate 14

Fine to medium alluvial sand sources, 5km north of Puok market, (Plate 14)
