**NATURAL RESOURCES SYSTEMS PROGRAMME
FINAL TECHNICAL REPORT R7856
Strengthening Social Capital for Improving Policies and
Decision Making in Natural Resources Management**

**PARTICIPATORY LAND DEGRADATION
ASSESSMENT IN THE HIGHLANDS OF KABALE
DISTRICT, SOUTHWESTERN UGANDA**

**REPORT
SUBMITTED TO
AFRICAN HIGHLANDS INITIATIVE (AHI)**

SEPTEMBER 2003

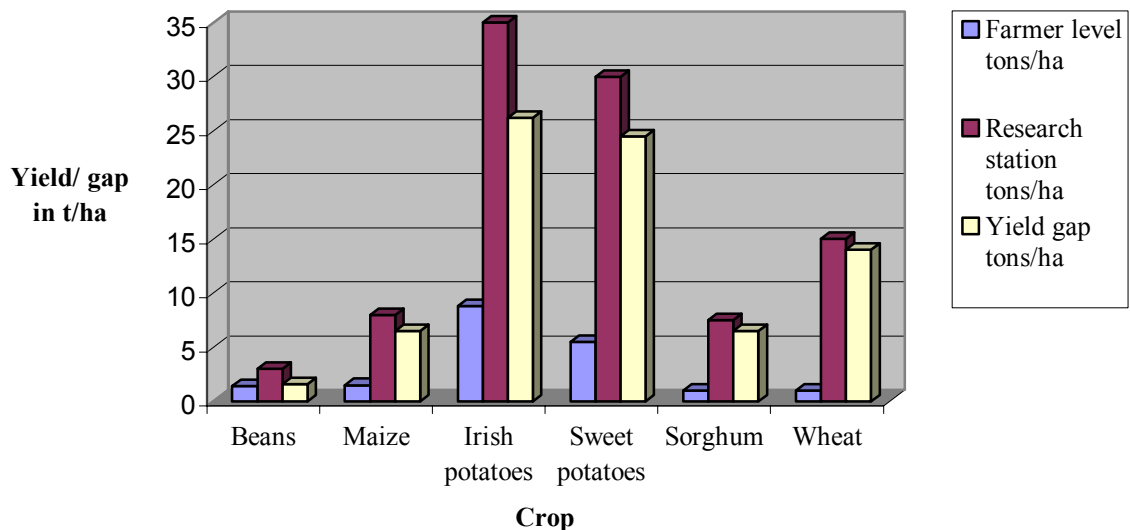
Figure 1: Crop yields at farmer compared to yields on research station, 1999

Data earlier generated in 1999 by Kabale district production department (Table 4 and Figure 1) indicated large yield gaps per hectare if farmer and research station output levels are compared. At research stations, land is better managed and chances of land degradation are minimised, good quality seed is planted and crop pests and diseases are controlled, thereby accounting for higher yields as compared to those at farmer level.

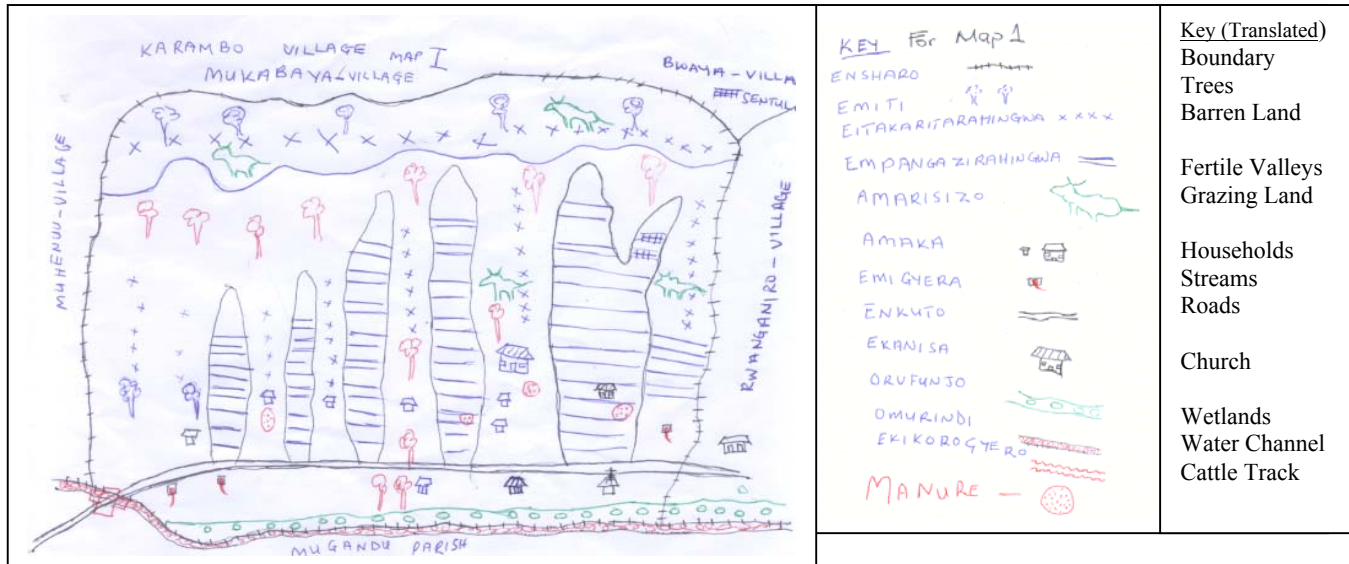
Map 5: Land use in the Buramba – Mugandu and Kitooma watersheds: An Example of Karambo Village

Generally, the hill slopes are fairly steep and the gradient is only low towards the valley bottom. Cultivation is also done in the wetlands.

The characteristic land uses highlighted in the Buramba – Mugandu watershed included:

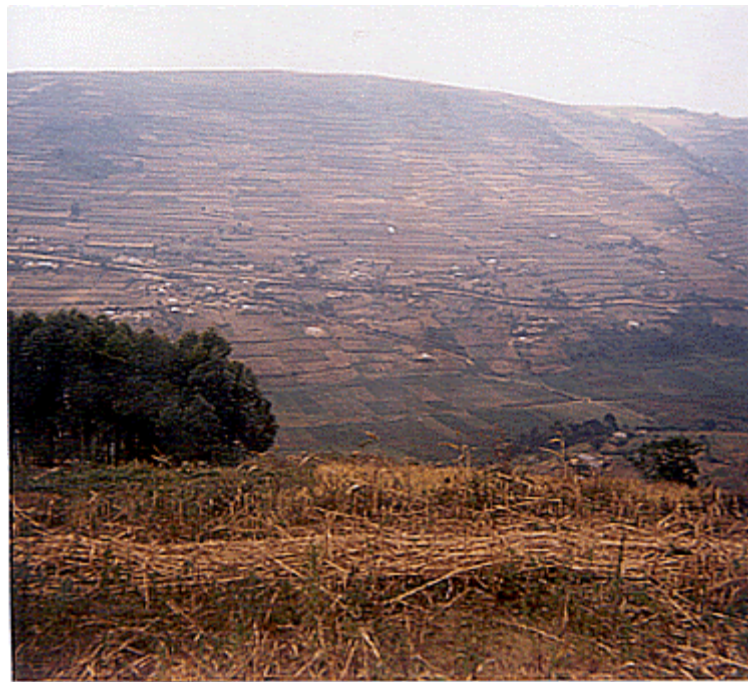
Plate 2: Land use in the Buramba-Mugandu and Kitooma Watersheds: A case of Karambo village

Footpaths in some of these areas have developed into deep gullies, which has forced farmers to create other footpaths. Soils in most areas are thin and stony. All these have manifested into problems for land users who rely on the land for their livelihood. Cultivation during the dry seasons is shifted from hill slopes to the valley bottoms (Plate 2).

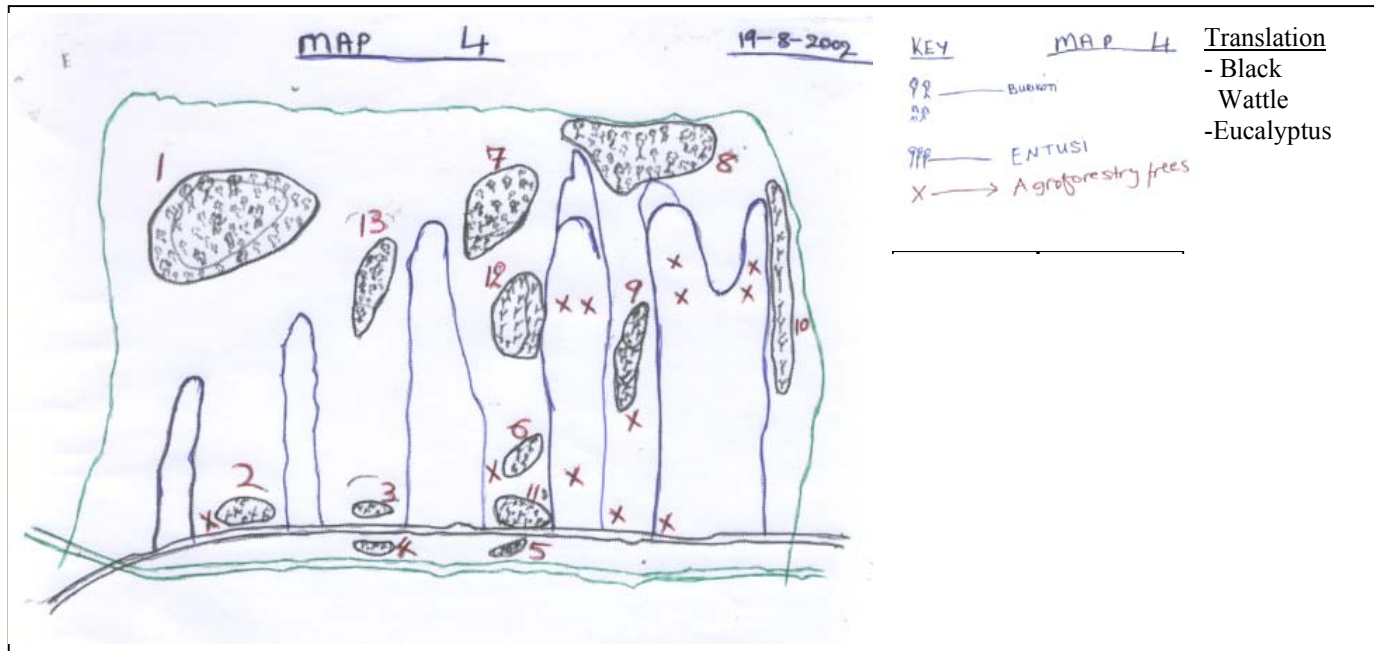
Map 9: Woodlot planted on degraded land and hilltops in Buramba-Mugandu & Kitooma watersheds: A case of Karambo Village

Tree planting is undertaken on the slopes, especially on areas that have been eroded and degraded, as well as hilltops. The most common types of trees grown in this watershed area are:

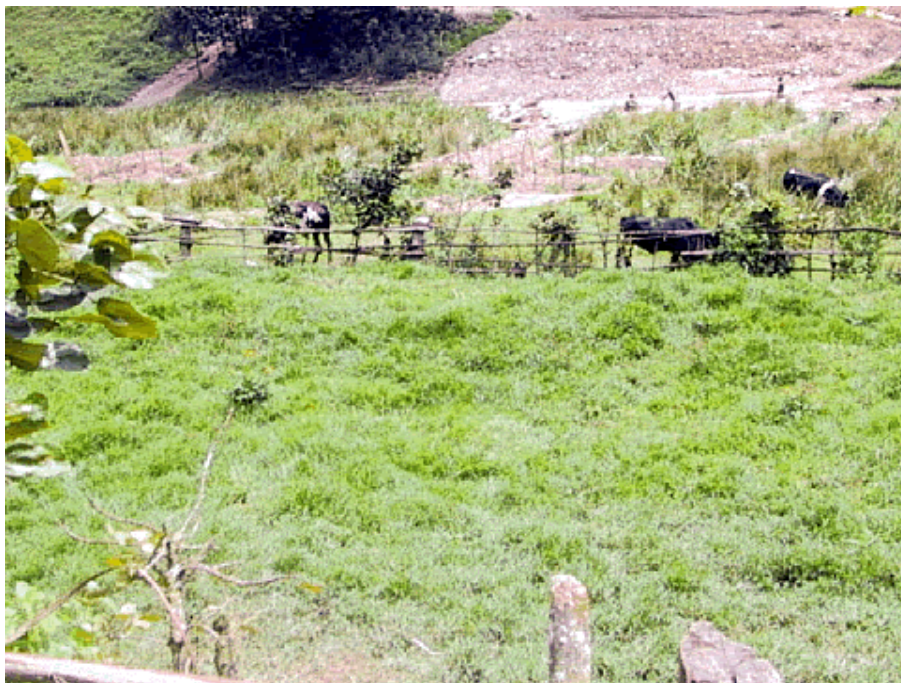
Plate 3: A cattle paddock in a reclaimed wetland in Muguli B village

Out of the approximately fifty households in the Karambo village for example, about thirty households keep livestock. Most people in the Buramba – Mugandu watershed do not own cattle and one of the reasons given was that it is rather difficult to get herdsmen to look after them as all the children go to school now with the recent introduction of Universal Primary Education (UPE). Besides, the available labour in the home is often required for cultivation in the fields as the activities undertaken are labour intensive. Lack of grazing land was indicated in all the villages as one of the limiting factors to keeping cattle and so was poverty. In Muguli B, however, it was noted that the limited grazing land available is accessible to everybody for free. Some farmers have converted wetlands into cattle grazing paddocks (Plate 3).

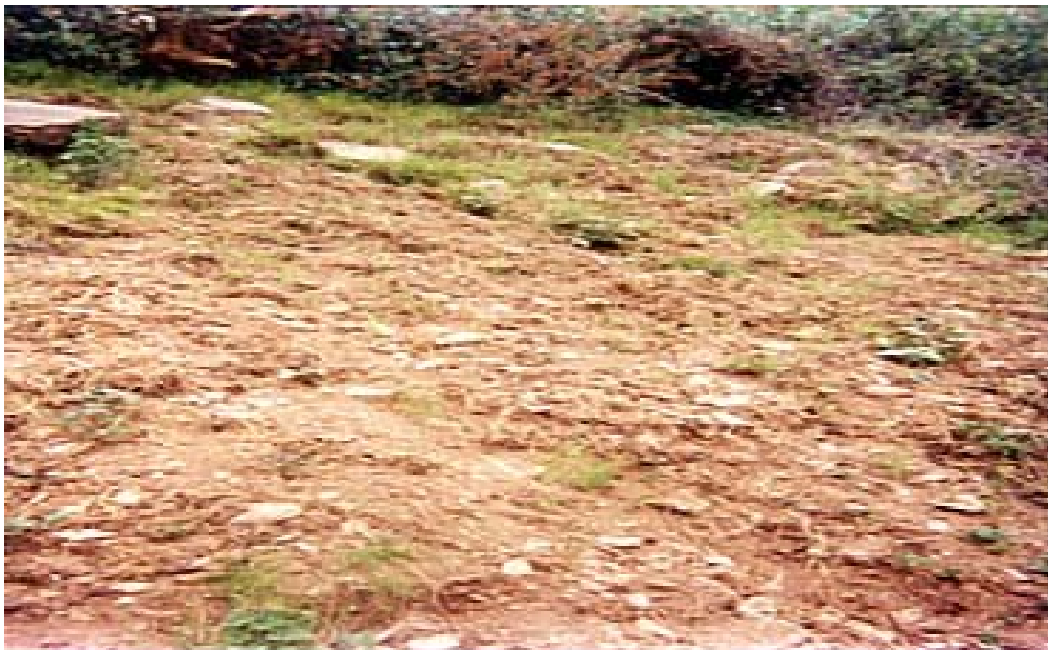
Plate 5: Stone/rock depositions in Karambo village

It was interesting to note that the lowland (swamp) areas within some of the villages in the watershed like Kagyera and Habugarama are not currently cultivated due to pronounced sedimentation and waterlogging. In some of these areas, soil depth due to sedimentation is at least 1.5 metres and above. There has been increased stoniness and rock cover as a result of land degradation on the hilltops and slopes. During heavy down pours, stones and rocks are usually brought down to the lowlands with the surface run-off.

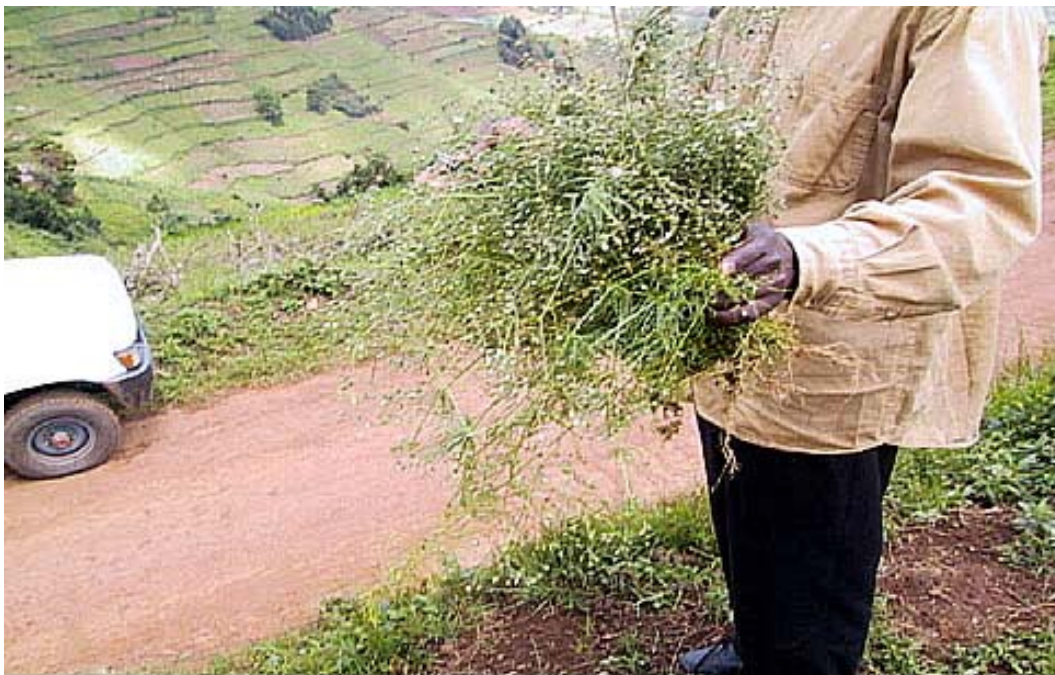
Plate 6: The “Okeza Ntakizire” weed, an indicator of soil infertility

Generally, throughout the transect walks, it was observed that crops in the fields of farmers with improved technologies were more healthy than those without. During the FGDs, the farmers had lamented about the declining crop yields over the recent years. In Muguri B farmers noted that there are plant indicators for exhausted soil which included *Mukaži murofa*, *Orusiru*, *Okeza Ntakizire* (Plate 6) and *Banuka* while those for medium soil fertility included *Empunika*, *Eitija*, *Eshwiga* and *Orubingo*. Most of these plants were clearly evident along the transect route especially *Orusiru* and *Banuka*.

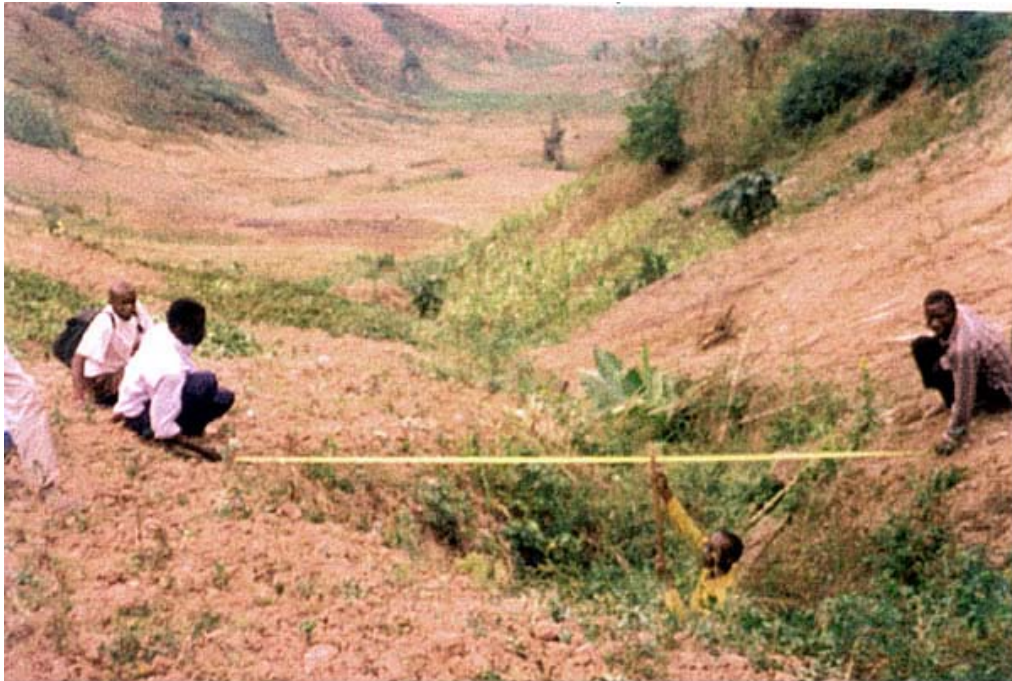
Plate 7: Measurement of soil loss through gully erosion in Karambo village

Many simple methods exist to calculate volumes of soil lost (e.g rill and gully method, root exposure, rock exposure and build-up against barriers) as assessment of the extent of land degradation on farms. However, in order to ensure uniformity so as to easily compare results from different farms/plots, calculations of volumes of soil lost were done only using the rill method on all farms (Stocking and Murnaghan, 2001).

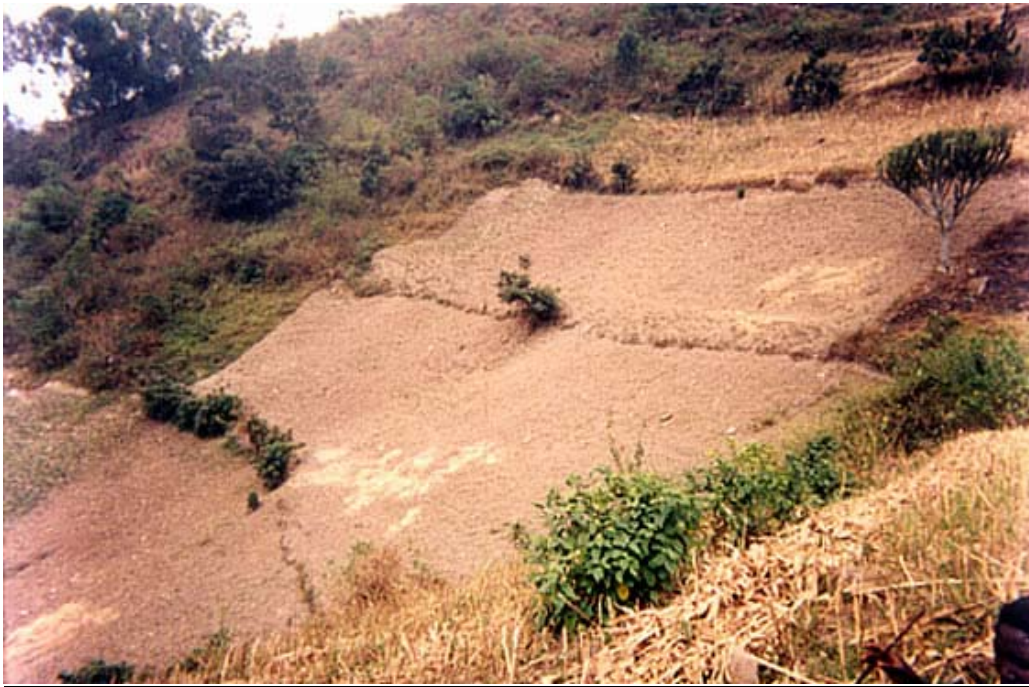
Plate 8: Bund destruction in the Buramba-Mugandu and Kitooma watersheds: a case of Karambo Village

In some villages like Muguli B, trenches have been constructed alongside some bunds but these are still generally few in the entire watershed. Because Muguri B village was the area most affected by floods and landslides in the recent past, local leaders and NGOs have tended to work more closely with the farmers in this village and have even established a byelaw requesting farmers to dig trenches. This has means that more local farmers have been able to adopt soil conservation measures like digging trenches in this village. It was established from the transect walks and focus group discussions that over 94 trenches (of varying lengths, depending on plot sizes) have been constructed in this village to reduce surface run-off. These trenches are often constructed individually. However, in cases where a farmer is defiant, local leaders in collaboration with the neighbours ensure that such a farmer complies by digging it collectively. The farmers appreciate the fact that it is useless to dig trenches in isolation of other neighbouring farmers, especially those neighbouring on the upper slopes. Running water from the upper slopes tends to destroy conservation structures on the lower slopes.

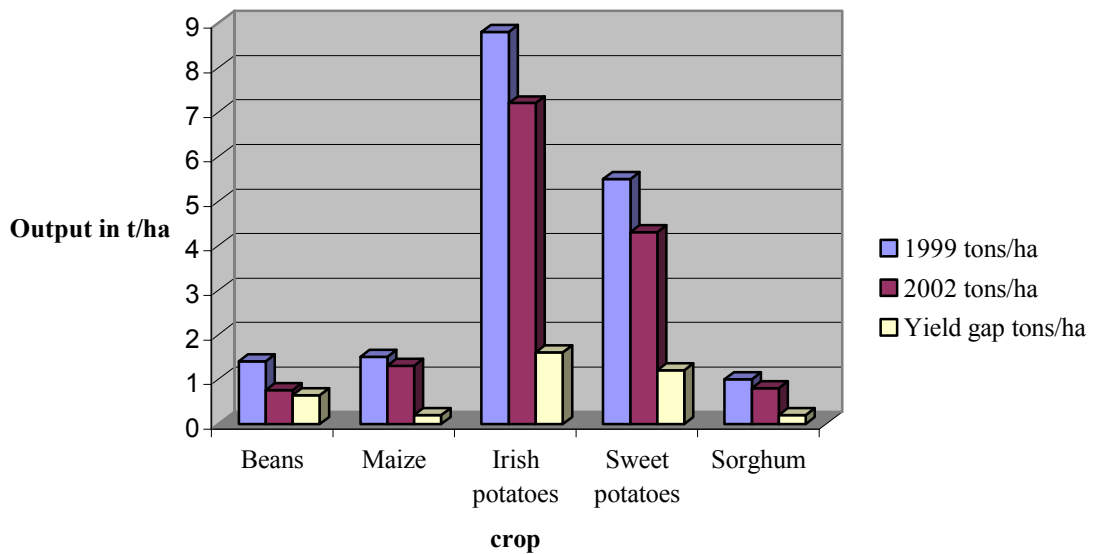
Figure 6: Crop yields at farmer level for 1999 as compared to 2002

Crop yield is dependent, in part, on the productivity of the soil. Seed quality, climate, pests, crop diseases and management by the farmer also affect it. The assessment of trends in crop yield, in association with farmers, may show that crop yields have fallen which, in turn, may indicate that land degradation has taken place (Stocking, 2001). Describing the relationship between land degradation and low crop yields per unit area in Kabale, KDLG (2002) states that:

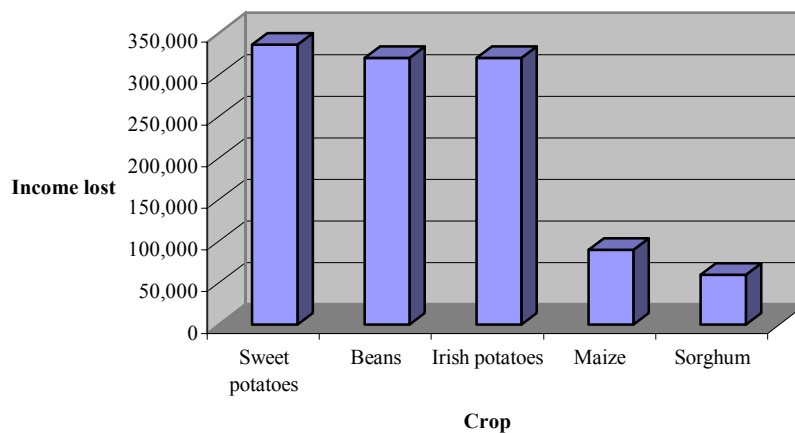
Figure 6: Income lost by farmers due to decline in crop yields (U.Shs/ha)

During FGDs, farmers indicated & confirmed that as a result of increasing land degradation in the watershed area and consequently, a decline in crop yields in terms of quality and quantity, household incomes have declined. Poverty has been on the increase and hunger and famine are always loaming in the area.

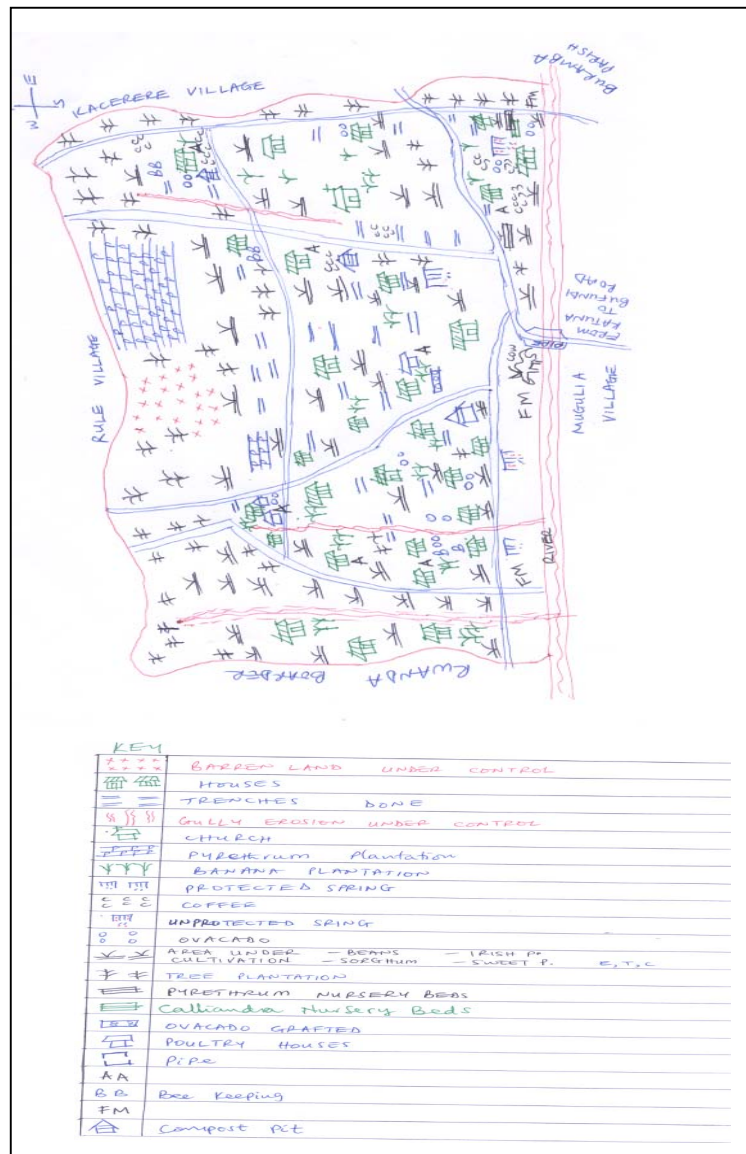
Map 14: Soil conservation practices in Muguli B village

In Muguri B, farmers indicated that because of increased awareness, there has been widespread adoption of digging trenches by all farmers to conserve their soils. This was because of the sub-county byelaw put in place since May 2002, supported by better enforcement in this village. NGOs like AHI and AFRICARE are helping farmers to dig these trenches. Quite a few farmers in the Kagyera and Karambo villages have begun to dig trenches or channels in their fields. The trenches reduce the speed of surface run off as they allow water to percolate through the soil. However farmers pointed out that there is a problem of siltation in the trenches. Group members often dig the trenches. The size of the trenches is 1 m wide and ½ m deep. This technology is spreading to other farmers in the villages despite the fact that only 5 members of the farmers group in Habugarama are practising this methodology on their own

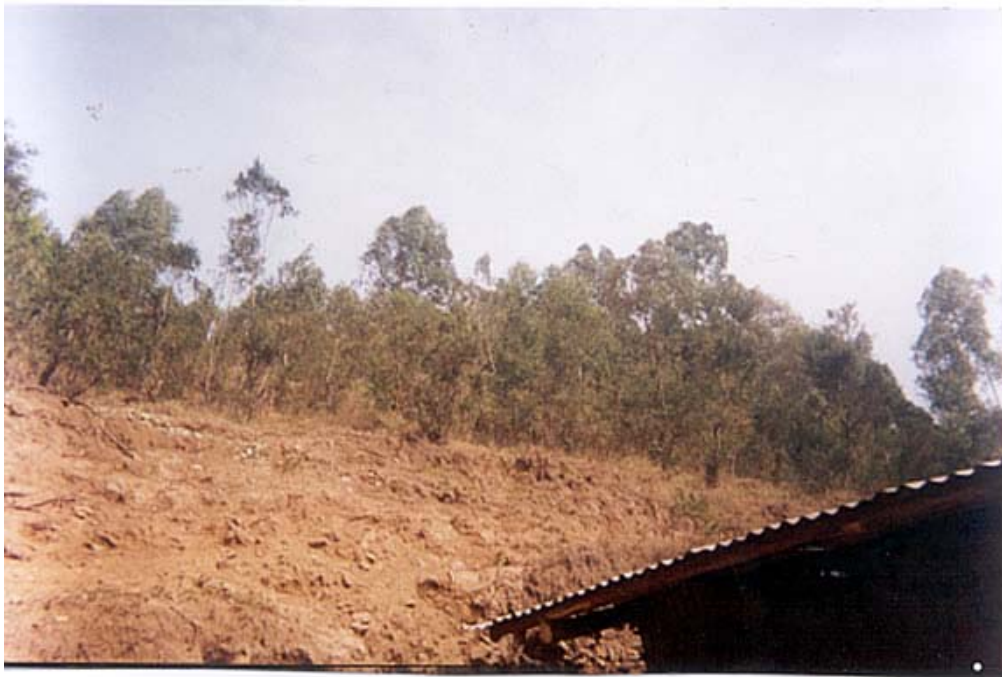
Plate 10: A woodlot in Karambo village

There are several woodlots in the watershed as mentioned earlier. These are mainly located on uncultivated hilltops and mid-slopes, which had been severely eroded (Plate 10). The oldest woodlots are slightly over 20 years while others are about 7 years old (minimum) with the rest range in between. Woodlots are largely of eucalyptus trees and some limited number of black wattle (Plate 10), which ranges in age between 2 – 15 years. Trees like *Grivellia* and *Alnus* are also being planted but these are still on a small scale.
