WINDPUMP COMMERCIALISATION: Assistance to existing partners

R7107

Final Report

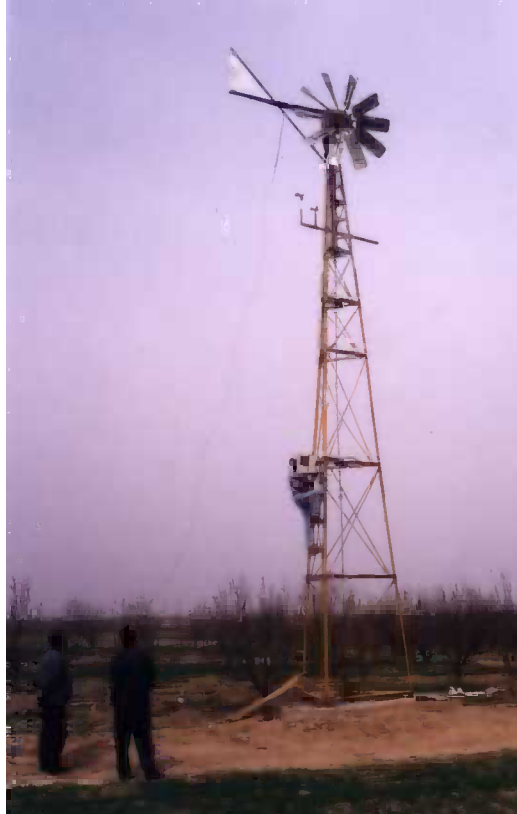
Figure 3.1: Machine installed on Chinese smallholding

The installed machine is shown in Figure 3.1.

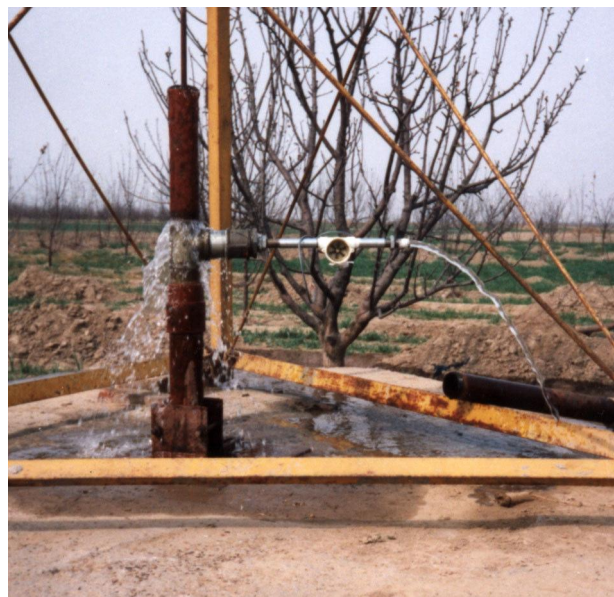
Figure 3.7: Problem of leakage out of the well head riser

Following the successful test installation of the monitoring kit in the UK the first overseas field-test monitoring kit was installed on the Chinese prototype machine during March 1999. The monitoring package was installed without difficulty. Unfortunately, however, a problem was encountered with the flow sensor, which became clogged with debris (dirt and rust from the bore-hole and pipe-work). In addition the flow sensor exerted a back-pressure on the outflow which caused water leakage; this was because the Chinese pump installation does not have a conventional well-head, in that there is no stuffing box. As a result, the resistance created by the flow-sensor caused some of the pumped water to be diverted out of the well-head riser around the pump-rod, rather than allowing the entire volume to pass through the outflow pipe, Figure 3.7.

Work was undertaken during April/May 1999 at IT Power's headquarters in the UK to establish an approach for resolving the problem.

Efforts to resolve the problem thereafter focused on specification of an alternative flow-sensor and a suitable in-line filter. This option required careful consideration such that re-specification of the flow-sensor would not require some re-design of the logger interface (with associated high cost). A higher-capacity flow-sensor using the same input and output signals was found to be available from a supplier in the USA. This unit did not have the same accuracy of the previous model at low-flow rates, but it did exert a much lower back-pressure on the flow. However, a considerable delay was encountered when ordering the units which had to be specially shipped from the USA.

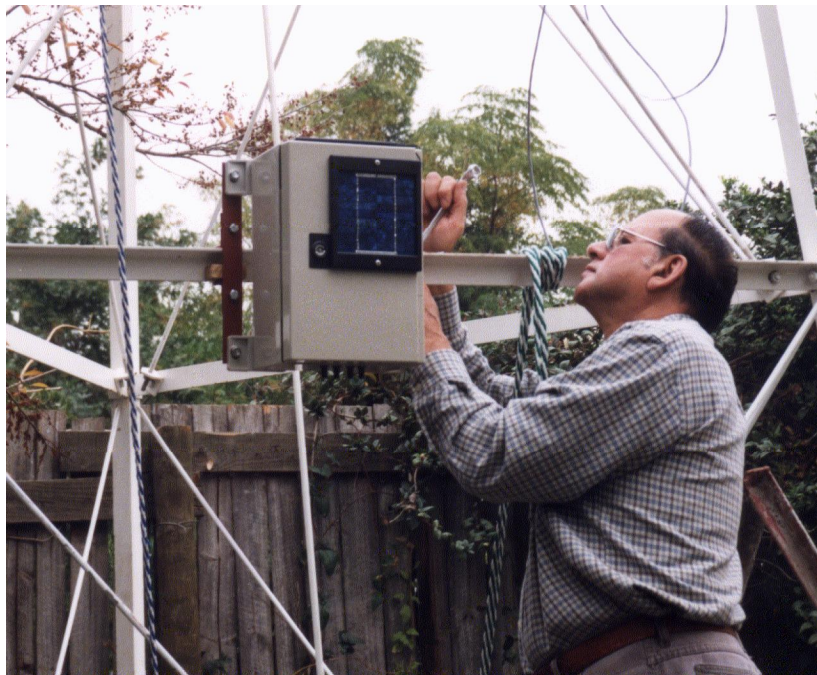
Figure 3.8: Installing the monitoring system in South Africa

The monitoring system, using the small flow-sensor, was installed in South Africa in May 1999 during IT Power’s visit, Figure 3.8. Initial tests indicated that the system was functioning correctly although it was not possible to test the machine fully because during this period wind speeds were very low. Low wind speeds dominated the period through May, June and into the early part of July so the machine was only running for short periods of time.

During July it was discovered that the battery powering the logger was not being charged correctly. Consequently flow data (which required sustained battery voltage levels for an output signal to direct the flow meter to take a reading) was lost due to low battery levels. The pattern of recorded wind data indicated that the logger was only operating correctly for a few hours around the middle of the day. The obvious conclusion was that bushes and other obstacles around the machine were not allowing enough sun to reach the PV panels on the monitoring equipment. The Logger enclosure was therefore relocated to improve this situation and the batteries re-charged.

Subsequently, it transpired that there was still a problem with the recharging of the logger battery, which was identified during the final visit. IT Power's engineer determined that the PV module (nominally 12V) was delivering insufficient voltage to allow the battery to recharge. The likely cause is a faulty module. This problem was only discovered late in the project because of the other delays mentioned previously.
