**FIELD TRIALS OF THE PROTOTYPE POUNDER RIG,
UGANDA, 20th AUGUST – 13th NOVEMBER 1999**

a human-powered drill rig for shallow small diameter wells
for domestic and agricultural water supply

Peter Ball and Kerstin Danert

November 1999

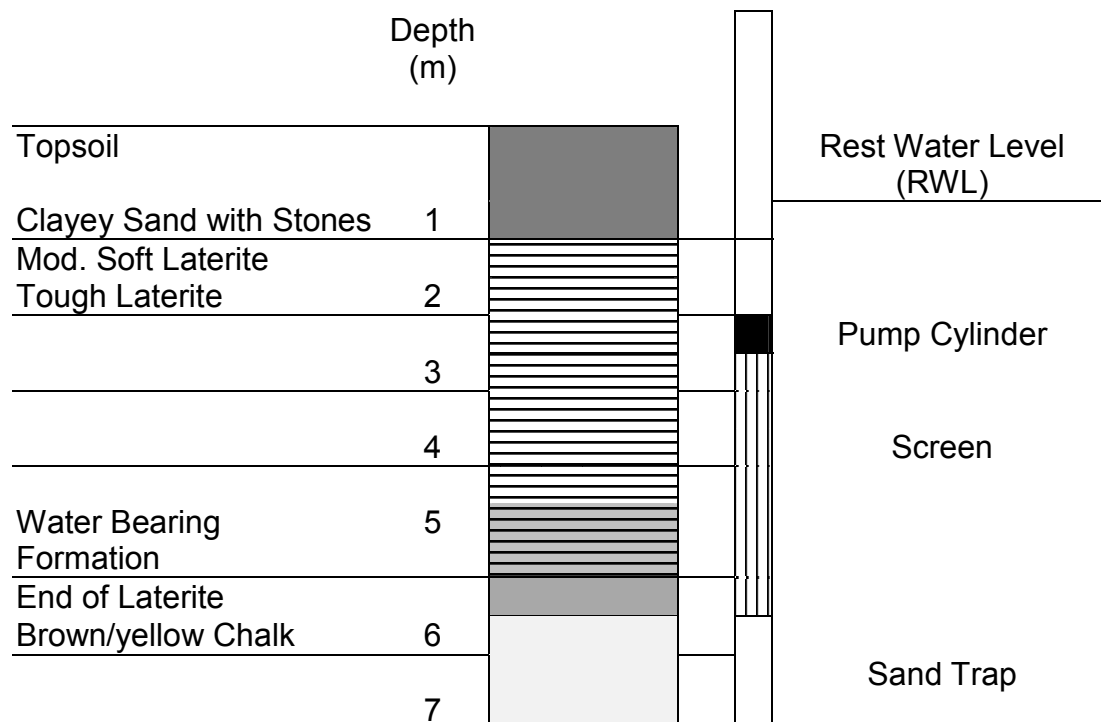
Figure 1: PW 2/7(2) Profile

Crew deemed the yield poor (in comparison to the last successful well), but sufficient for a handpump.

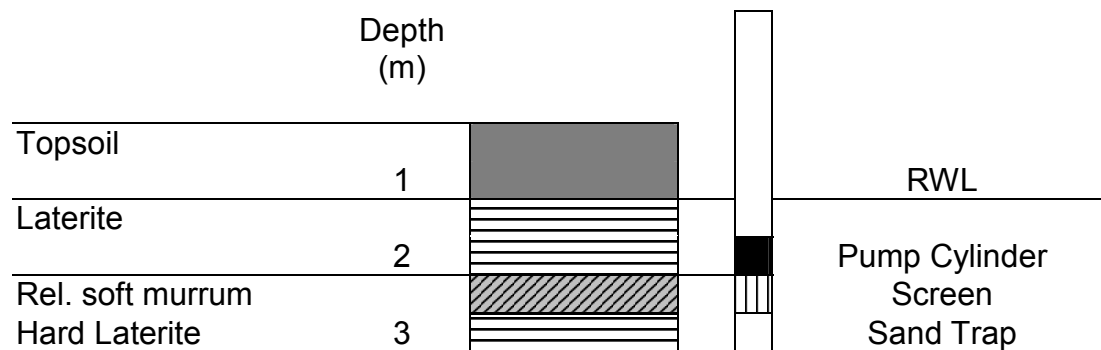
Figure 2: PW 2/8 Profile

Drilling: Total Depth = 3m
 Aquifer: 2.5m below ground
 Rest Water Level: 1m below ground level
 Drawdown: 50cm in 10 min
 Recovery to rest level takes 7 sec.
 Yield is good

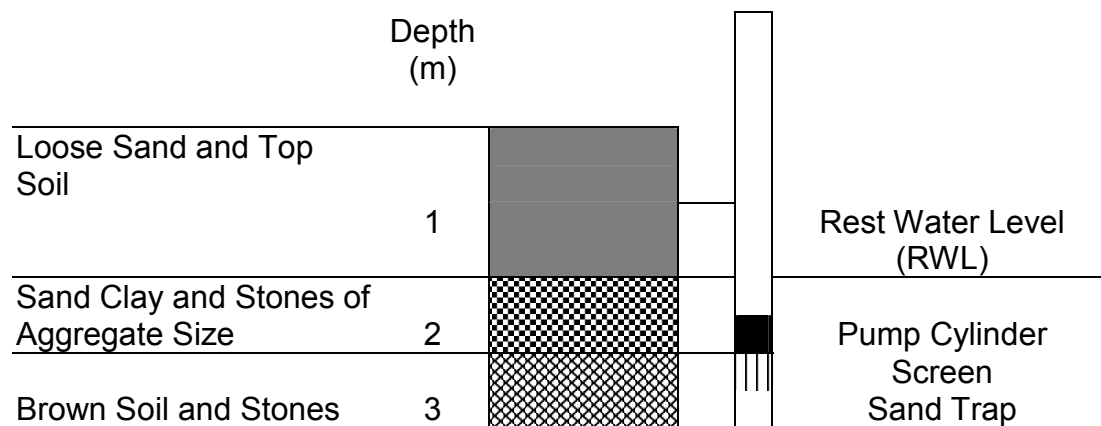
Figure 3: PW 2/9 Profile

Drilling: Reamed with 100mm button bit to 3m
 Total depth drilled: 3m
 Rest Water Level 0.9m
 Aquifer is at 2.5m
 Cylinder installed at depth of 1.8m
 Drawdown: 1m in 10 min
 Recovery to rest level takes 5 sec
 Yield is good

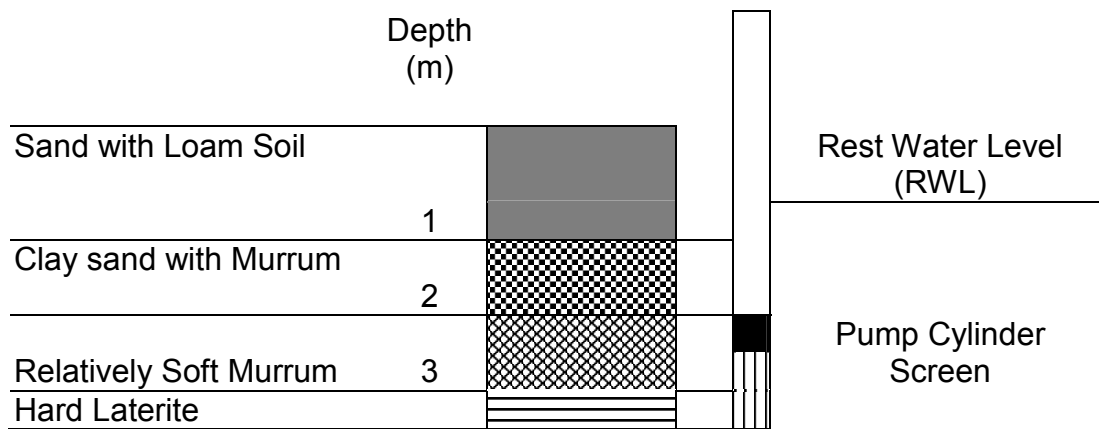
Figure 4: PW 2/11 Profile

Yield is relatively low but sufficient for a hand pump

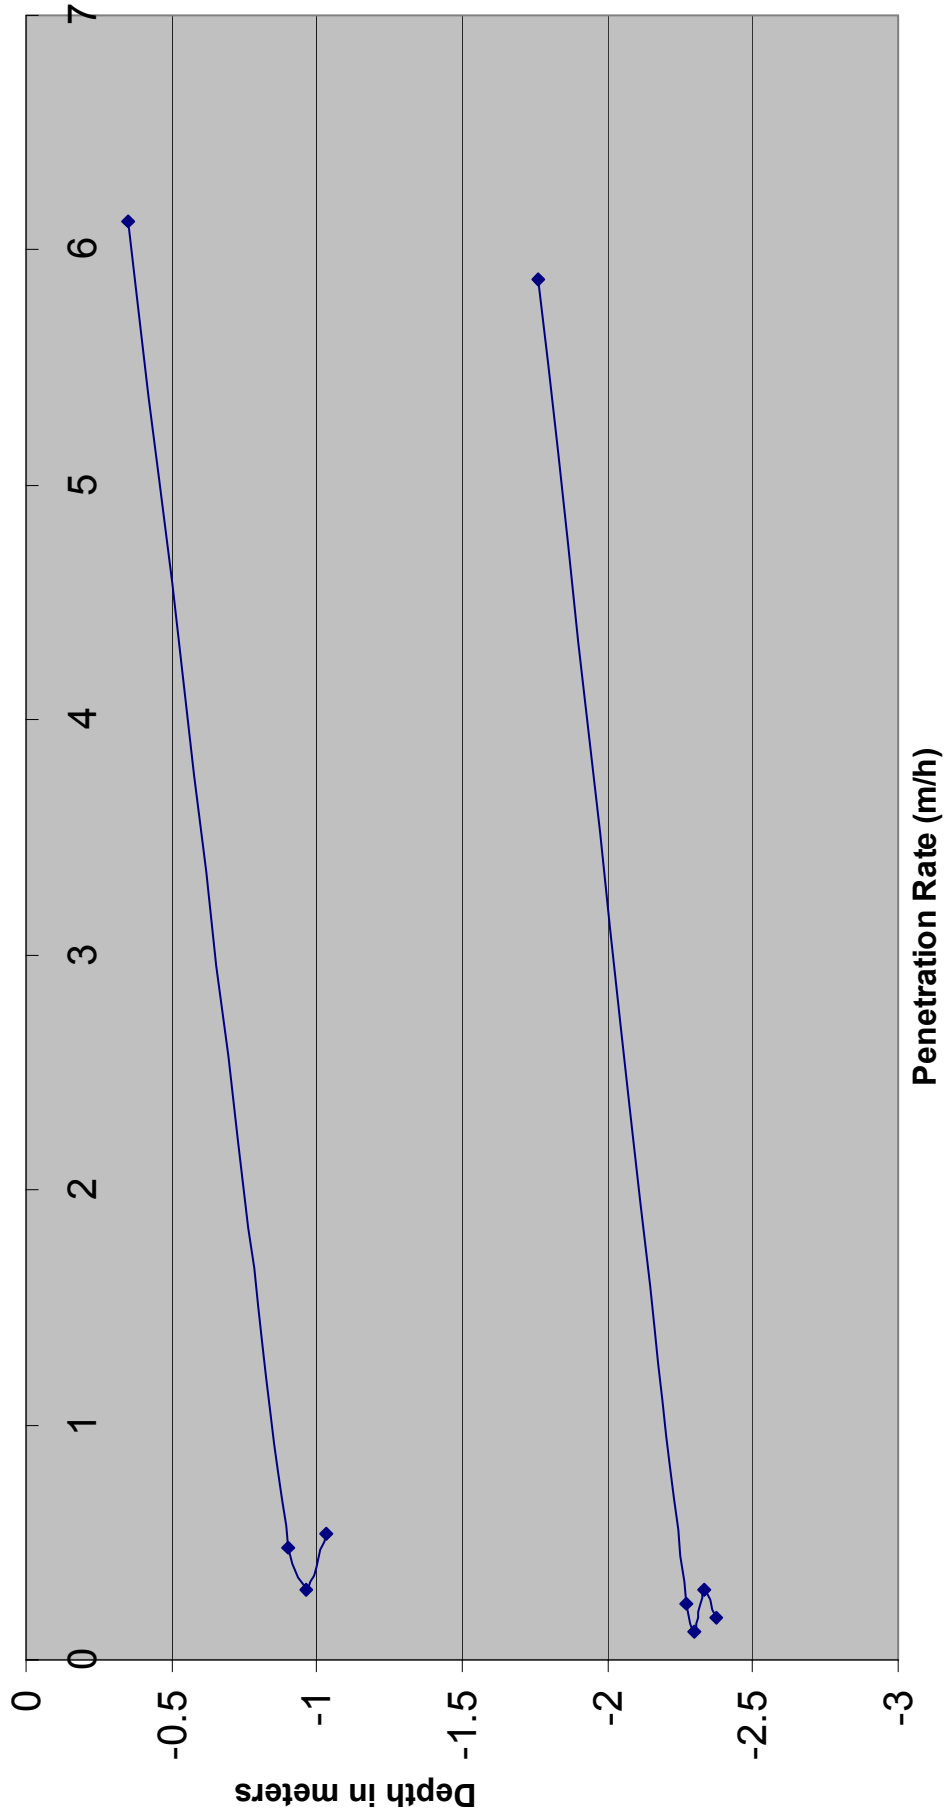
PW 2/8 - Penetration Log

| Penetration Data | Start time | Finish Time | Mean Time (min) | Start Height (cm) | Finish Height (cm) | Mean Depth (m) | Penetration per 100 strokes (cm) | Penetration Rate (m/min) | Penetration Rate (min/m) | Penetration Rate (m/h) |

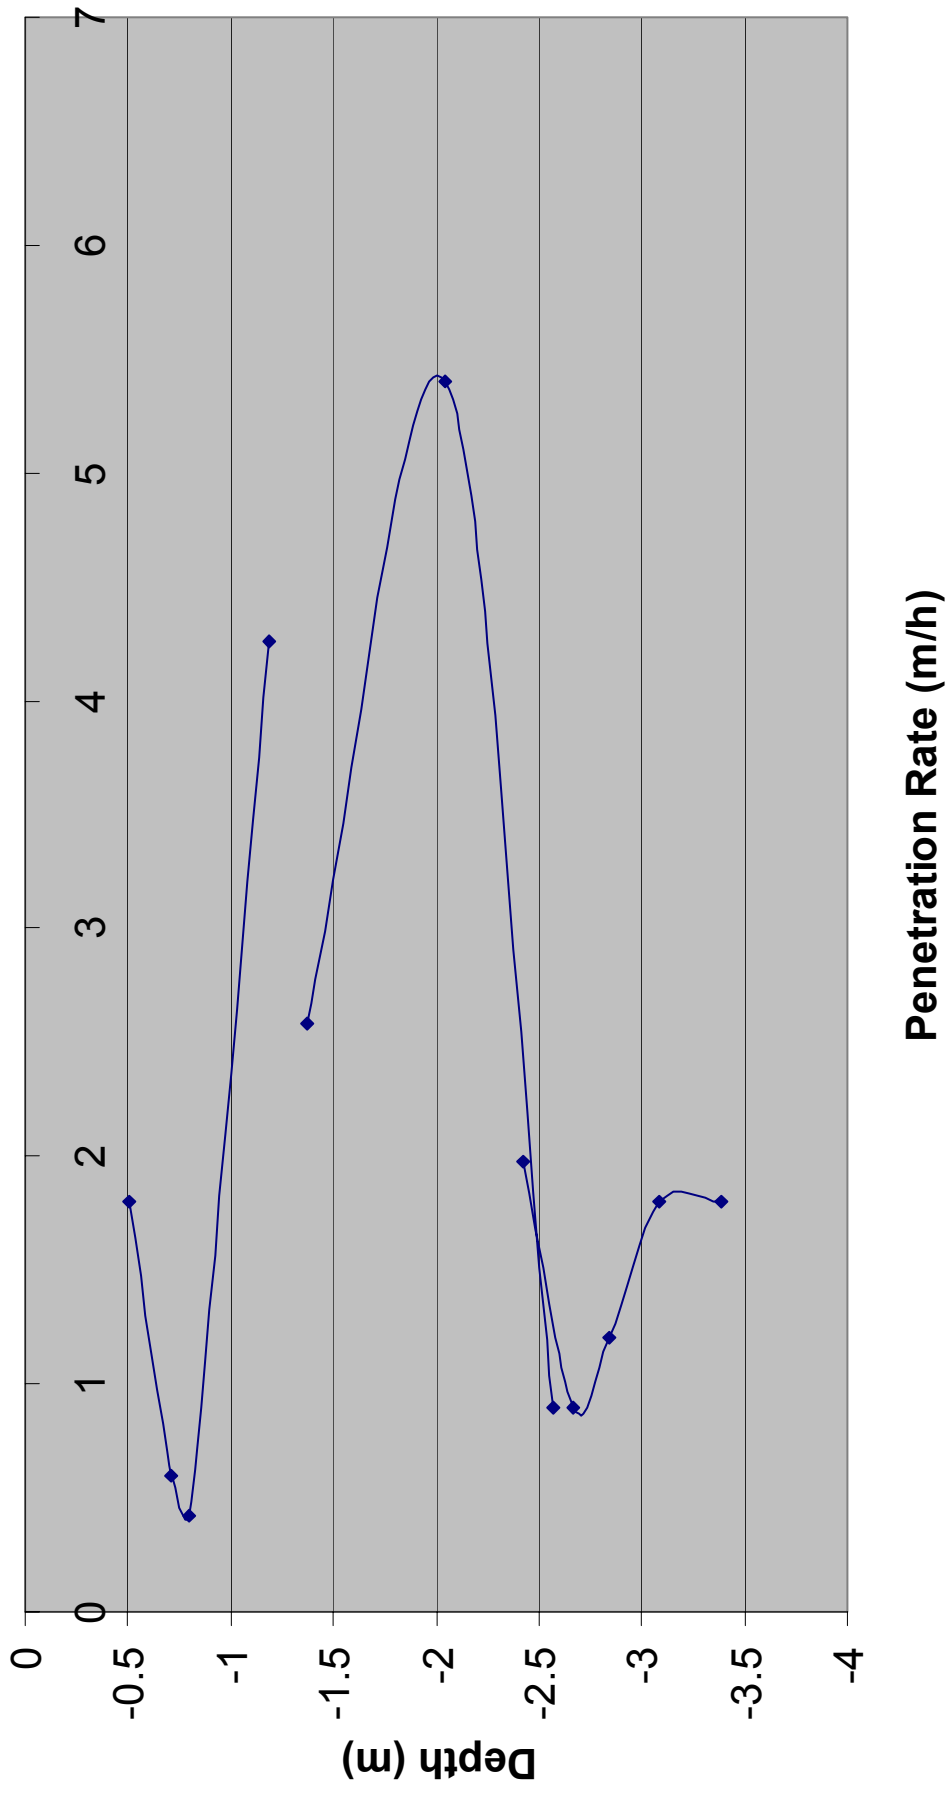
PW 2/9 - Penetration Log

| Penetration Data (all in cm) | Start time | Finish Time | Mean Time (min) | Start Height (cm) | Finish Height (cm) | Mean Depth (m) | Penetration per 100 strokes (cm) | Penetration Rate (m/min) | Penetration Rate (min/m) | Penetration Rate (m/h) |

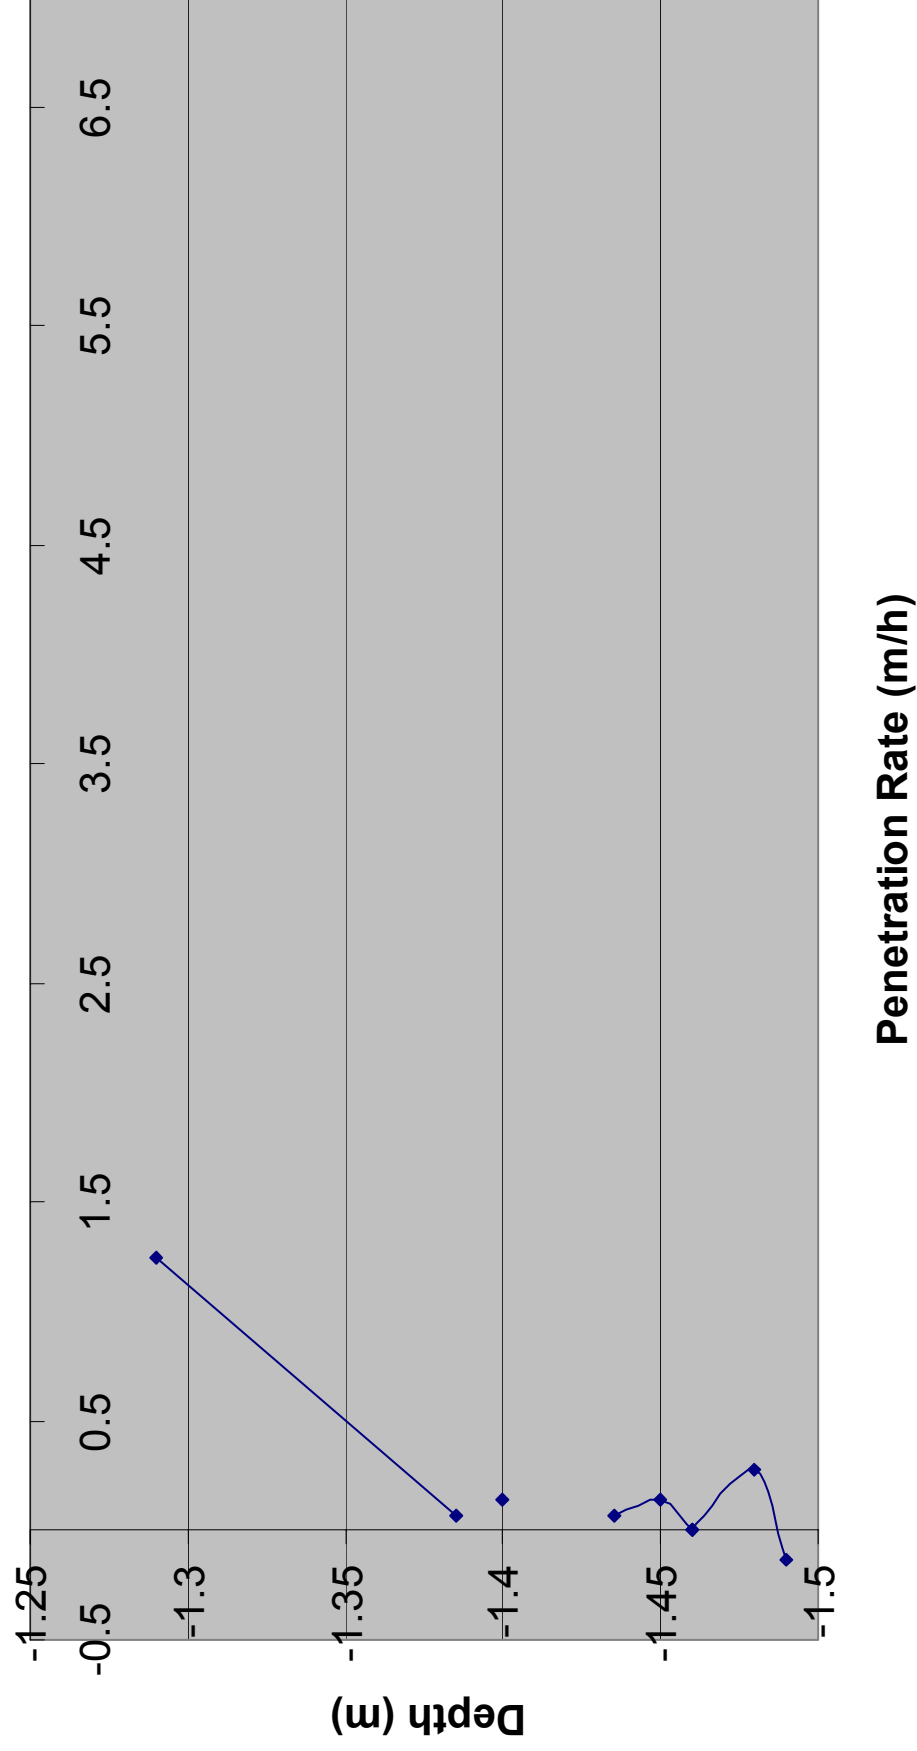
PW 2/10 - Penetration Log

| Penetration Data (all in cm) | Start time | Finish Time | Mean Time (min) | Start Height (cm) | Finish Height (cm) | Mean Depth (m) | Penetration per 100 strokes (cm) | Penetration Rate (m/min) | Penetration Rate (min/m) | Penetration Rate (m/h) |

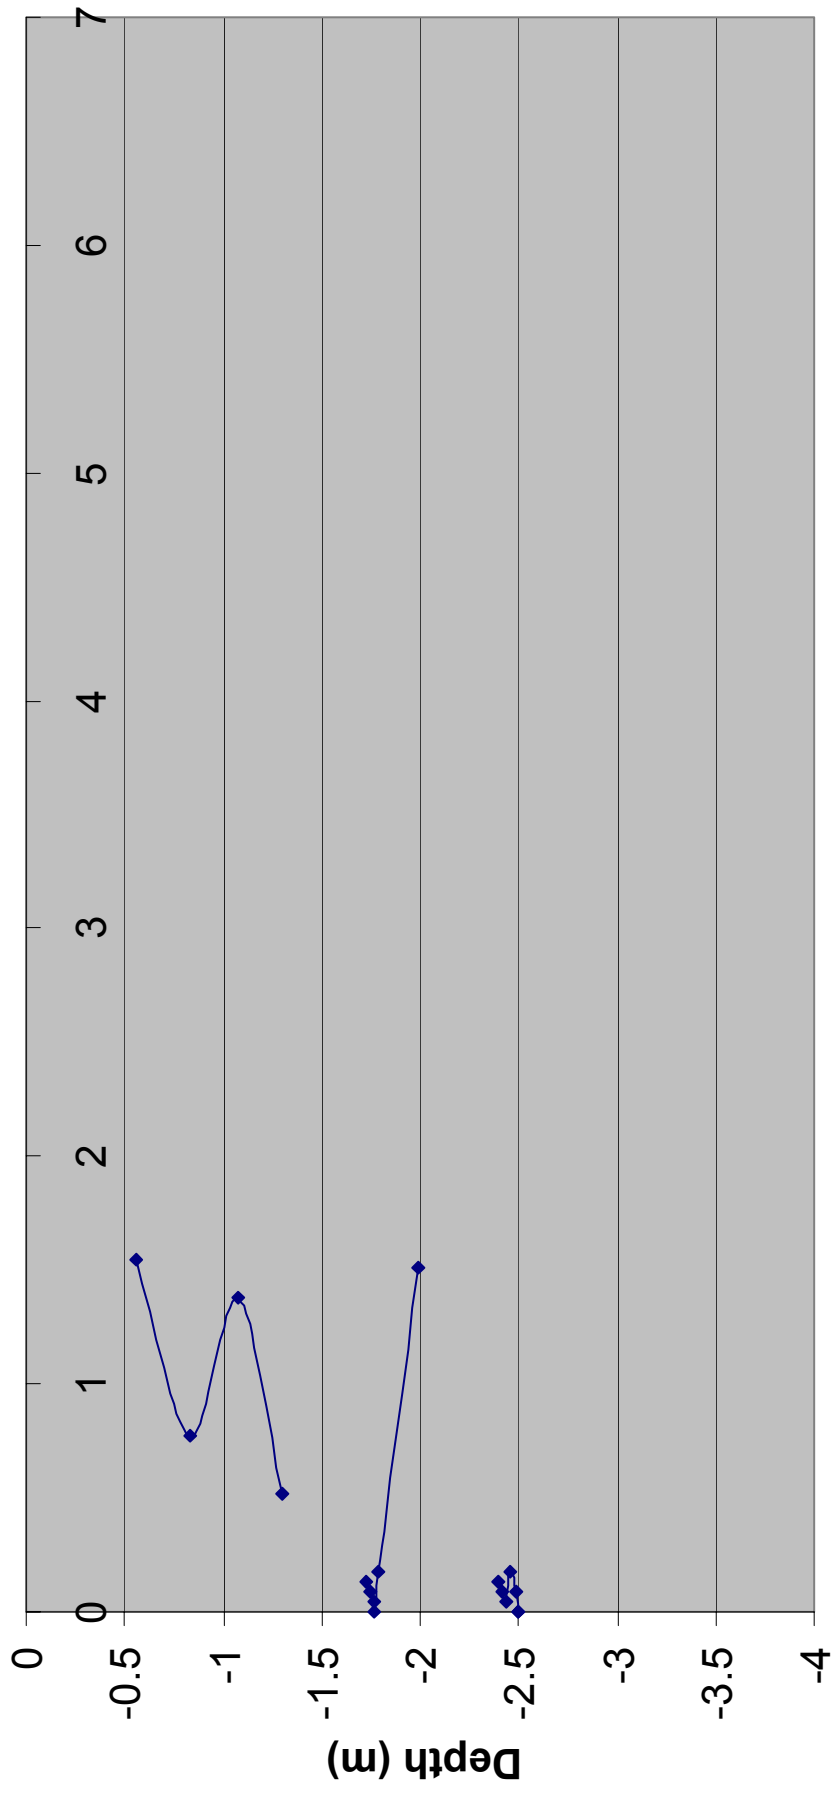
PW 2/11 - Penetration Log

| Penetration Data (all in cm) | Start time | Finish Time | Mean Time (min) | Start Height (cm) | Finish Height (cm) | Mean Depth (m) | Penetration per 100 strokes (cm) | Penetration Rate (m/min) | Penetration Rate (min/m) | Penetration Rate (m/h) |

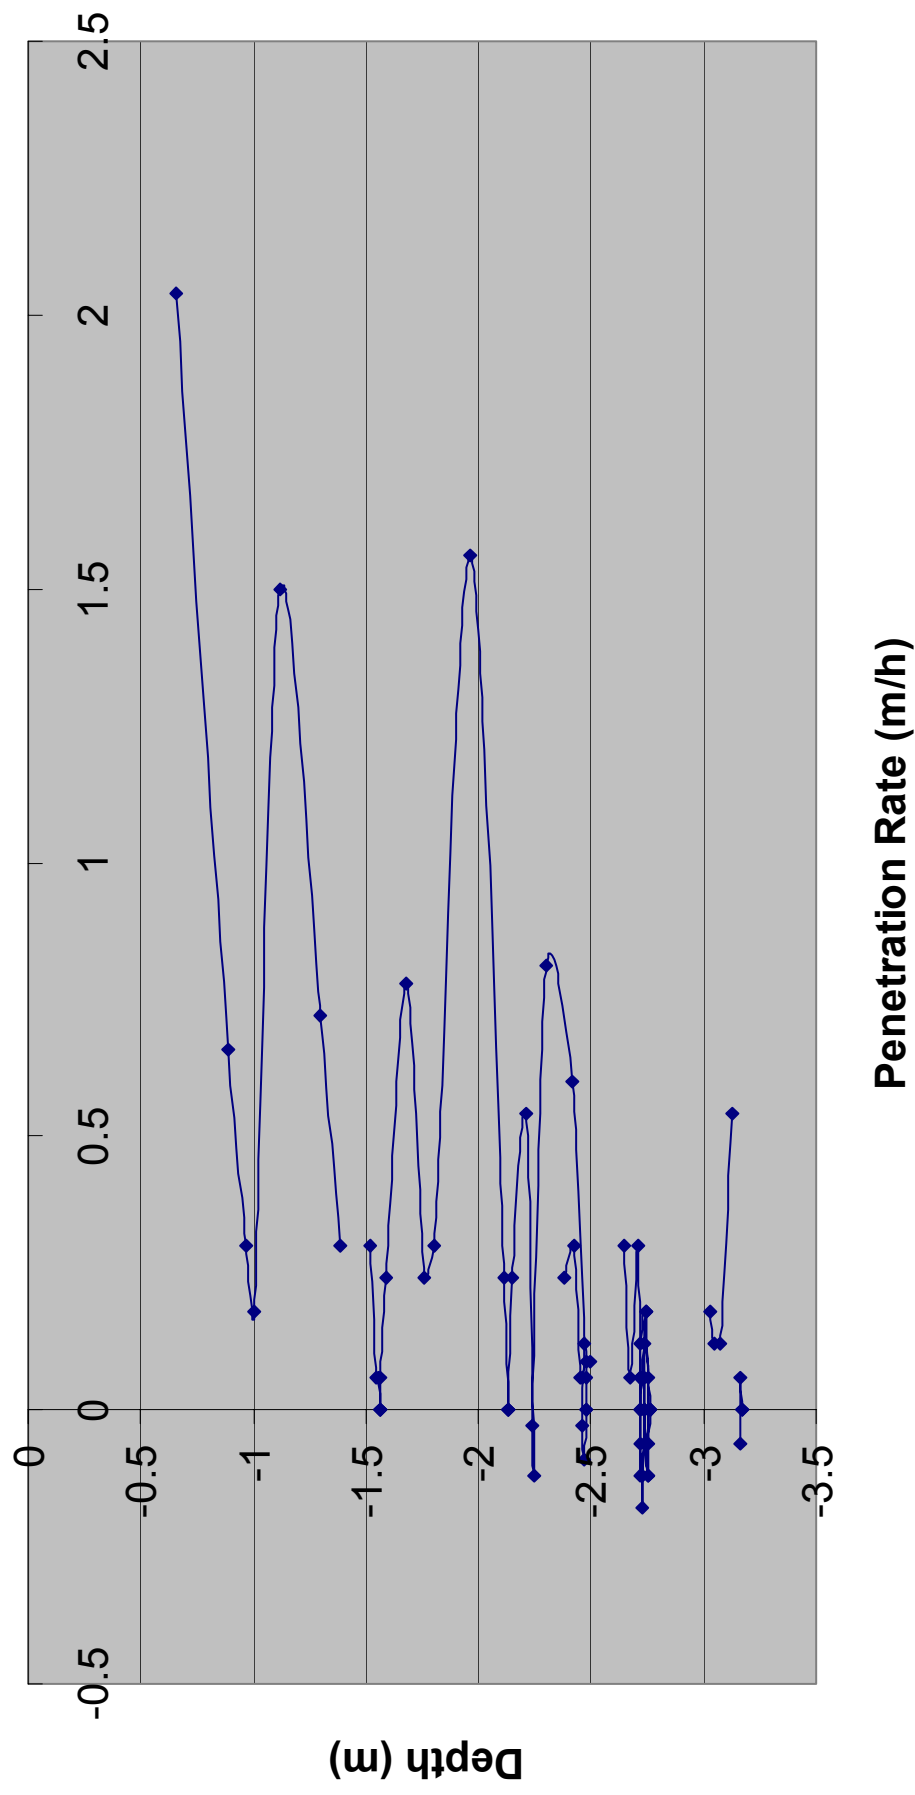
P/W Hard Rock - Penetration Log

Penetration Data (all in cm)
measure to join distance
