**Performance of Chemically Stabilised Roadbases:  
Results and Recommendations from Studies  
in Southern Africa**

**by C S Gourley and P A K Greening**

**Published Project Report  
PR/OSC/168/99  
Project Record No. R6020**

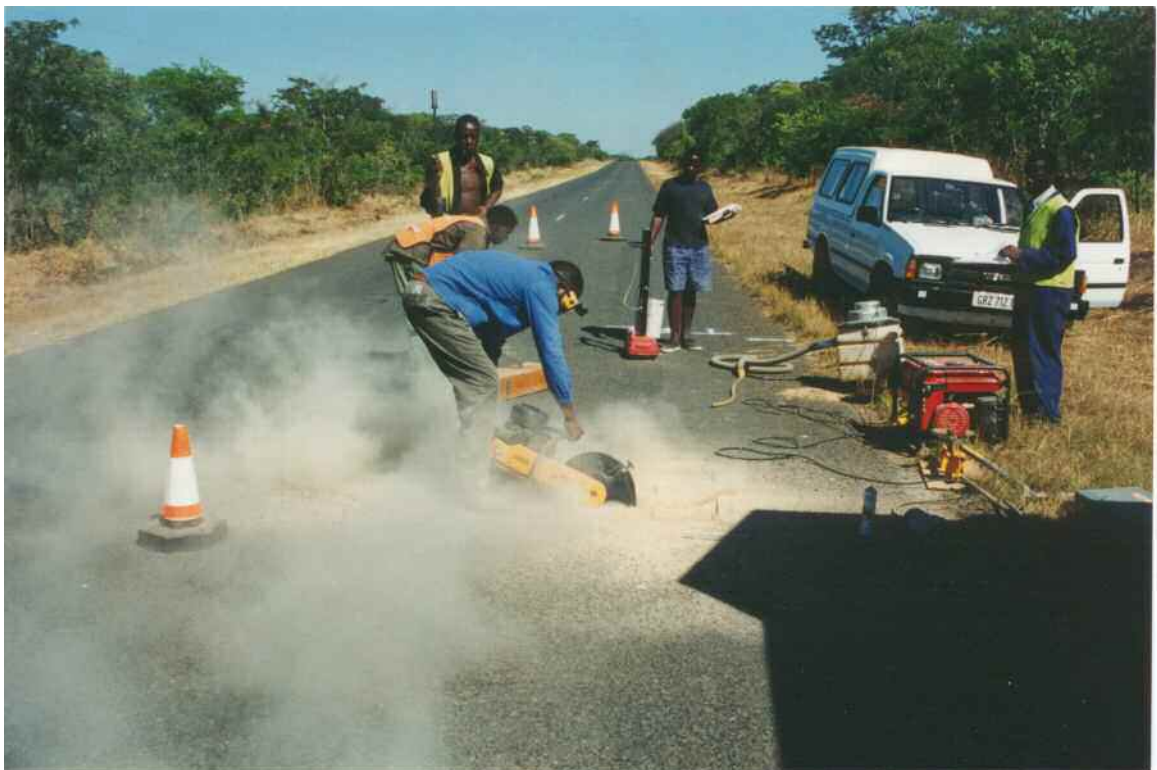
**Plate 4-1 Hand saw used to cut stabilised roadbase**

The condition of the surfacing and its bonding to the underlying roadbase was recorded. Block samples, measuring approximately 300mm x 300mm, were cut out of the roadbase using a power-saw. The top and bottom of the samples were marked, and the samples were waxed and wrapped in plastic film. These samples were transported to the laboratory for UCS testing. The cut faces of the sample holes and off-cuts from smaller blocks were brushed, cleaned and tested for carbonation using phenolphthalein, phenol red, and universal indicators. The non-calcareous materials were also tested for carbonate using dilute hydrochloric acid. The reactions observed were recorded. Additional off-cuts were retrieved for point load testing and further samples of roadbase, sub-base and subgrade materials were taken for laboratory classification and testing for cement content.

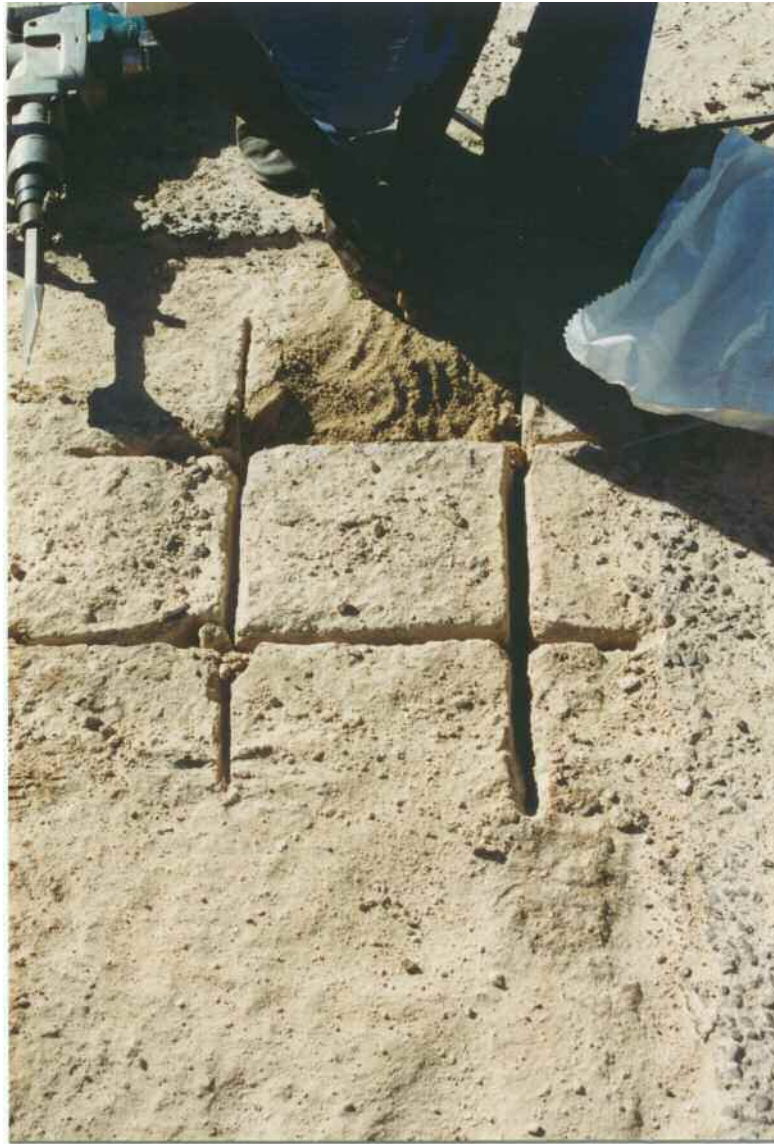
**Plate 4-2 Blocks of roadbase lifted from road for laboratory testing**

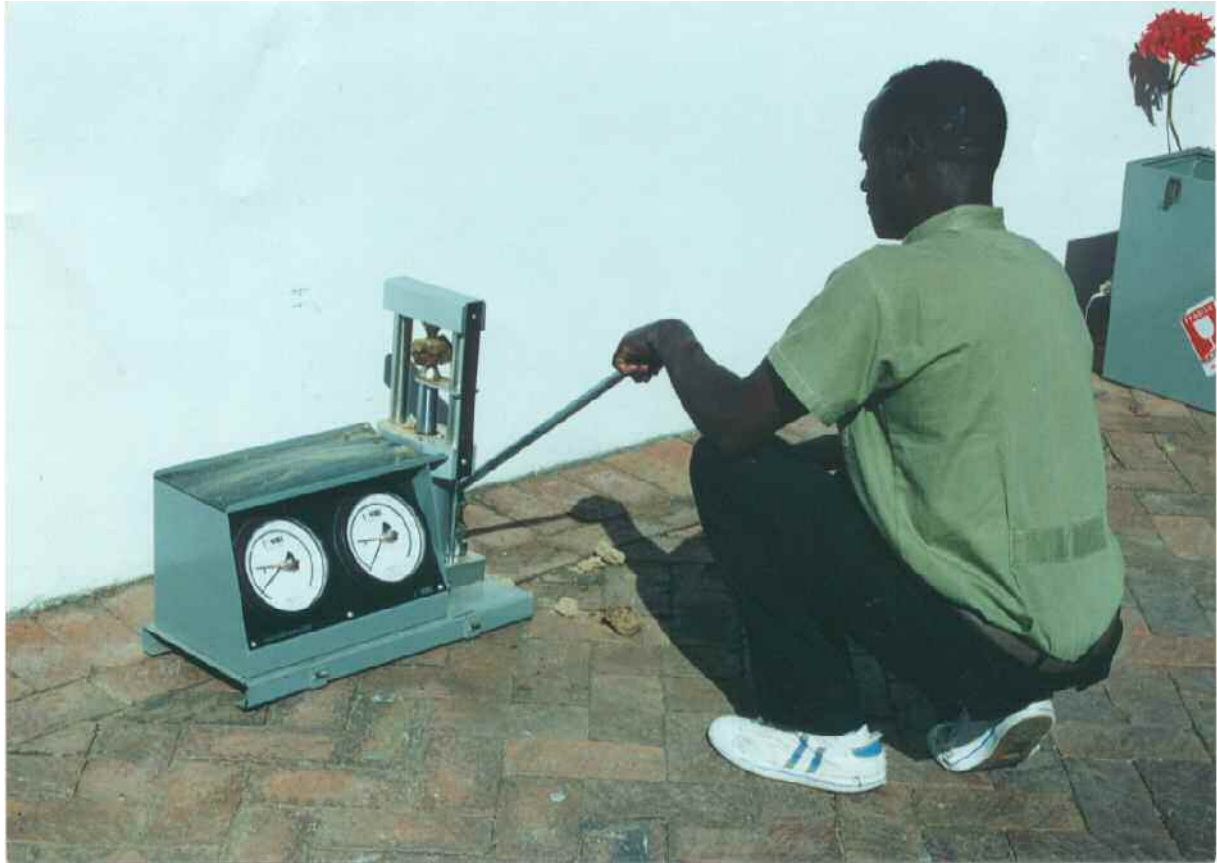
**Plate 4-3 Point load testing of stabilised roadbase**

This test is used to measure the point load strength index on cut blocks, cores and irregular offcuts. Blocks or irregular lumps of size in the 15mm to 85mm range were recovered for testing *in situ* and in the laboratory. Where specimens of this size and shape were not available, they were prepared by chiselling or trimming. The target number of tests was 20 for any particular sample. The test was originally developed as an index strength test for rock materials. It is quick and simple and uses the easily portable equipment (see Plate 4-3 and Plate 4-4). It can be carried out in the laboratory or field. The results can be correlated with other test results, such as uniaxial tensile strength and compressive strength, and the point load test can then be used as a proxy for these tests.

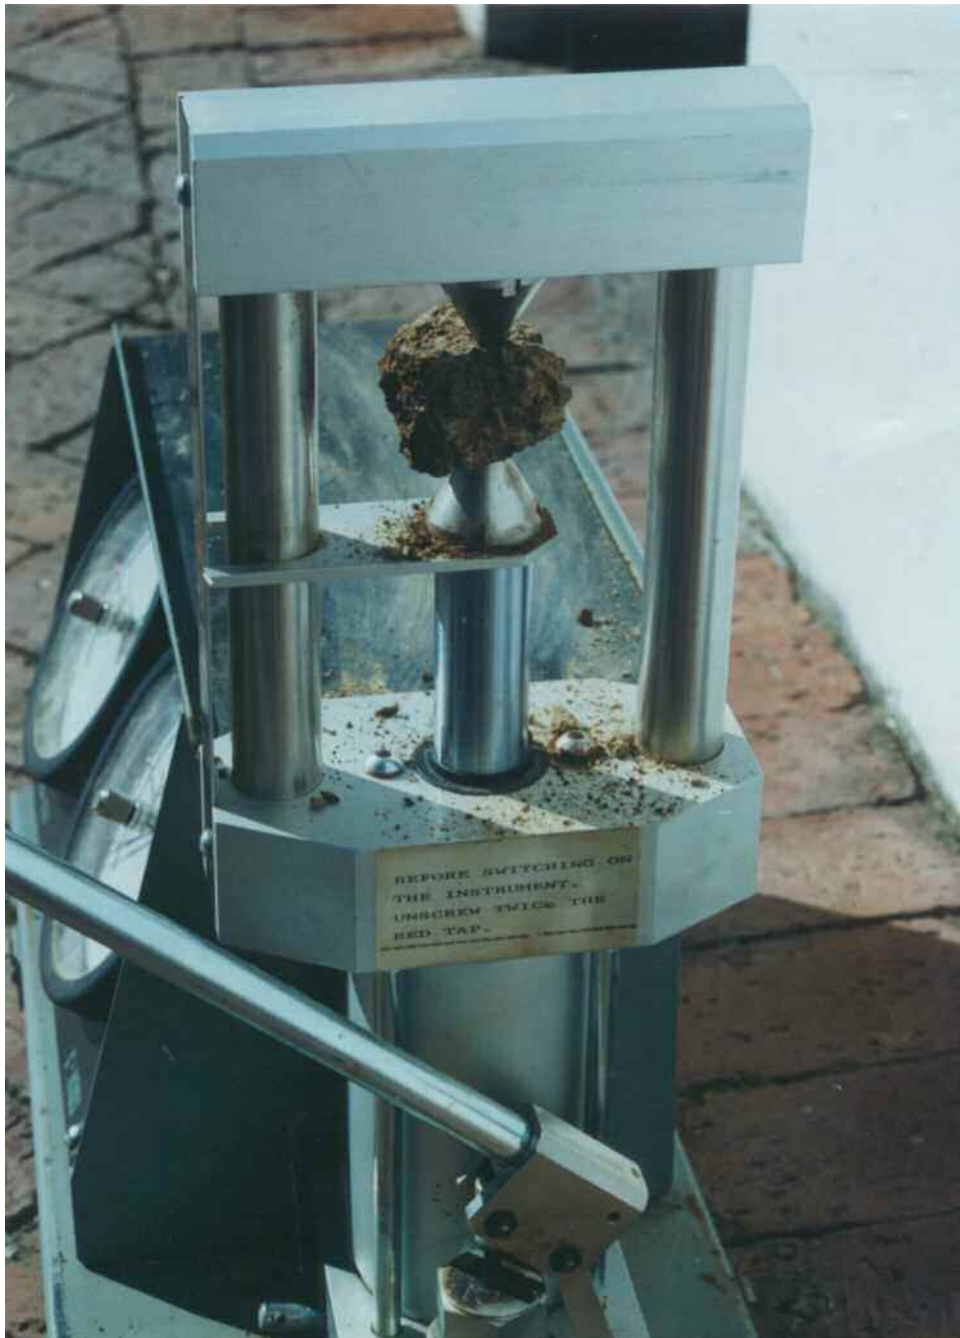
**Plate 4-4 Point load testing of stabilised roadbase**

Further point load testing was carried out in the laboratory on the off-cuts from the block samples at their field moisture condition and again after soaking for 7 days.

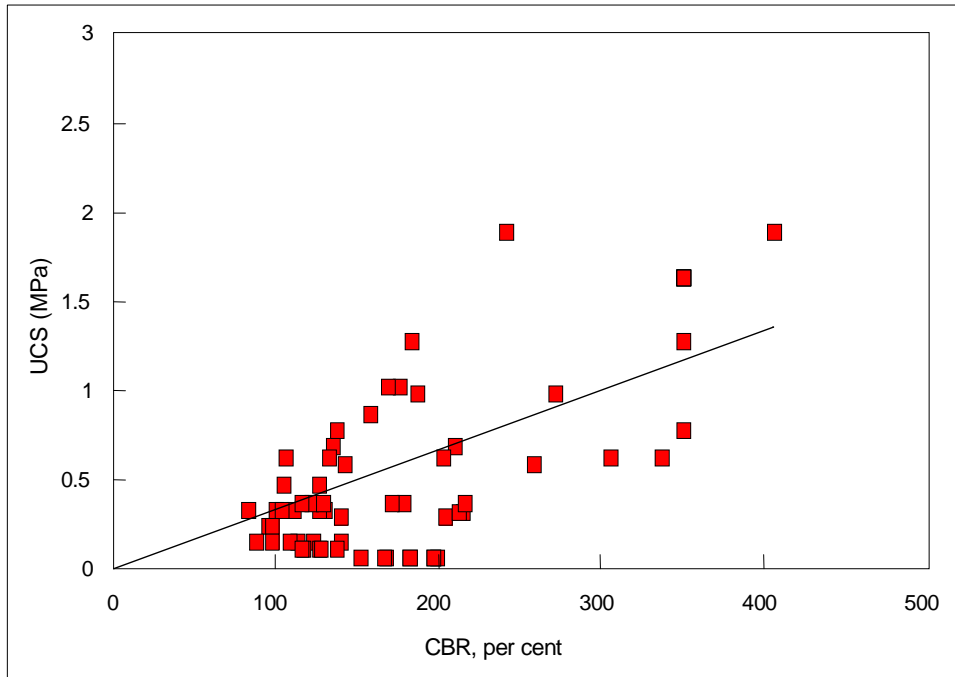
**Figure 6-1 Unconfined compressive strength versus California bearing ratio**

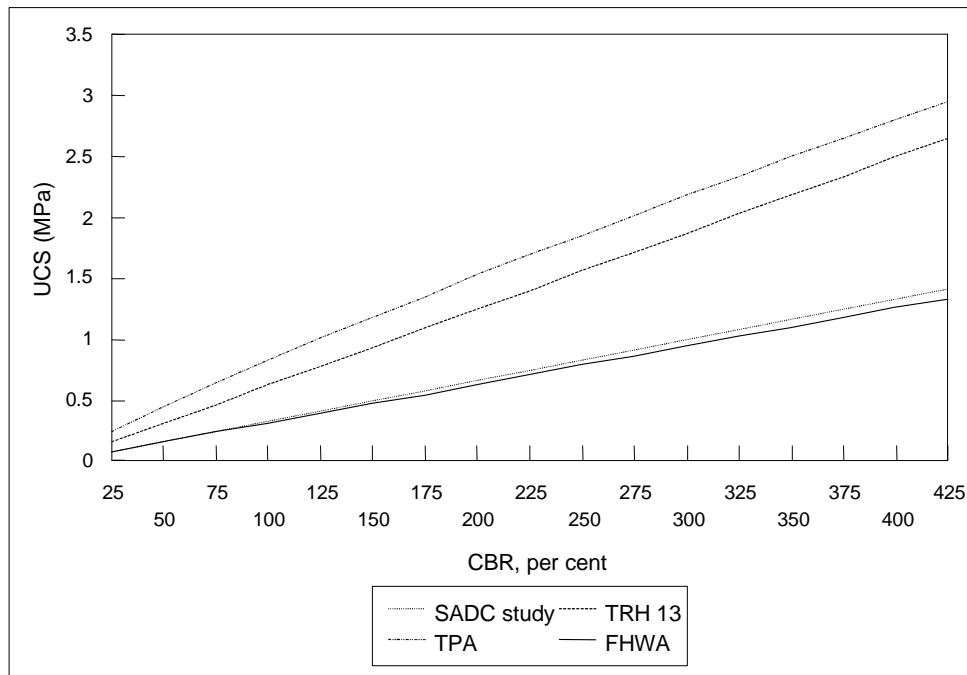
**Figure 6-2 Comparison of relationship derived for UCS and CBR (Equation 6-4) with other published data (FHWA and SADC are for granular soils)**

The relationship derived from this project is very similar to that developed by the Federal Highways Administration (1979) (for granular materials similar to those used in the roadbases in this project), as illustrated in Figure 6-2.

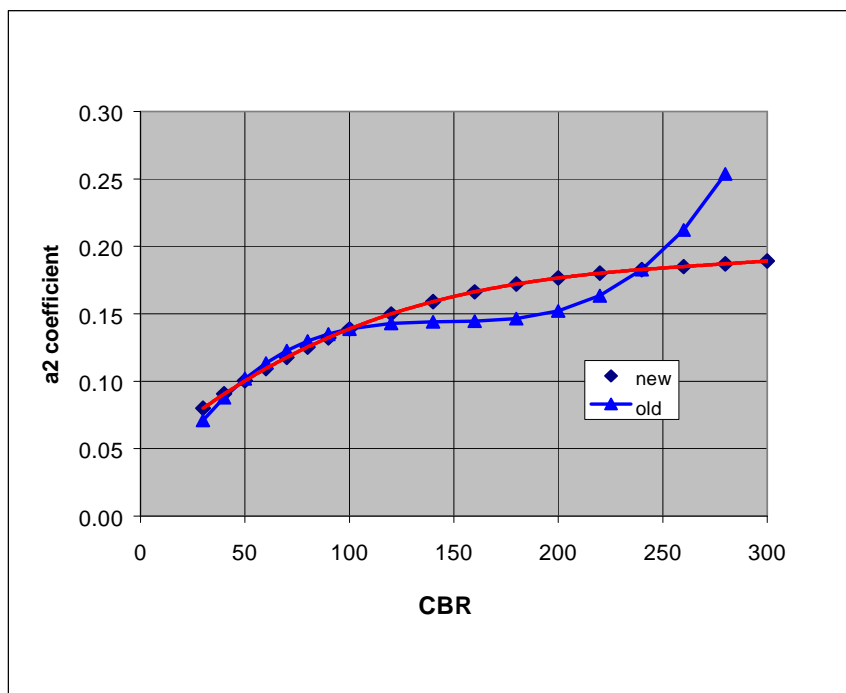
**Figure 6-3 Revised coefficients for granular material**

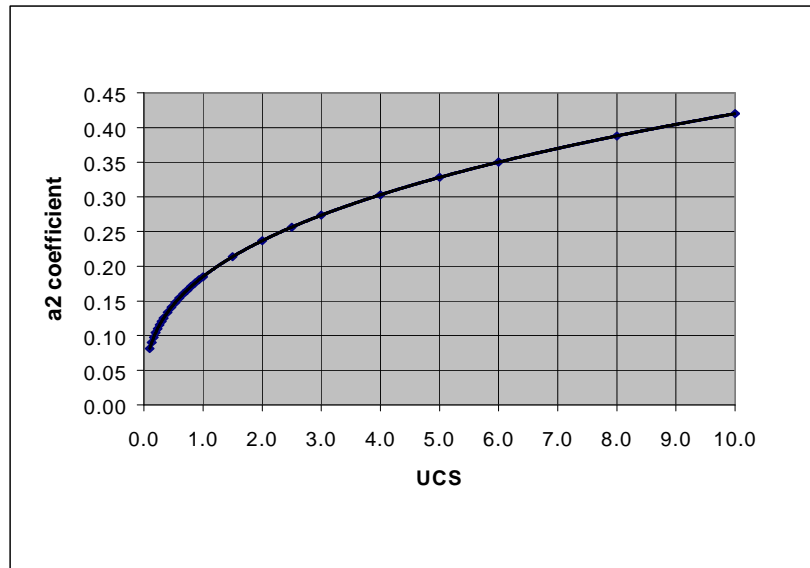
**Figure 6-4 Revised coefficients for cemented materials**

$$a_2 = 0.167 \times \text{UCS}^{0.33} \quad \text{Equation 6-5}$$

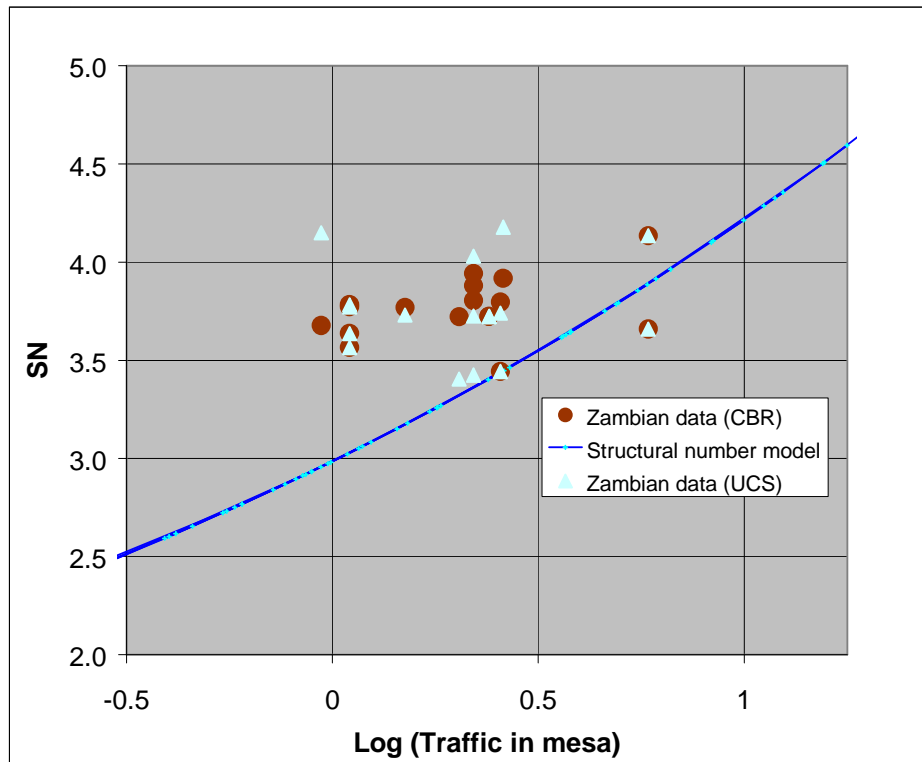
Figure 6-5 Structural number versus traffic for stabilised bases

SN/Traffic relationship obtained from *ORN 31*. The results are shown in Figure 6.5 where it can be seen that the structural numbers calculated using either CBR or UCS are now broadly compatible with each other. The Figure also illustrates that some of the roads have carried more traffic than anticipated, confirming the good performance discussed above.

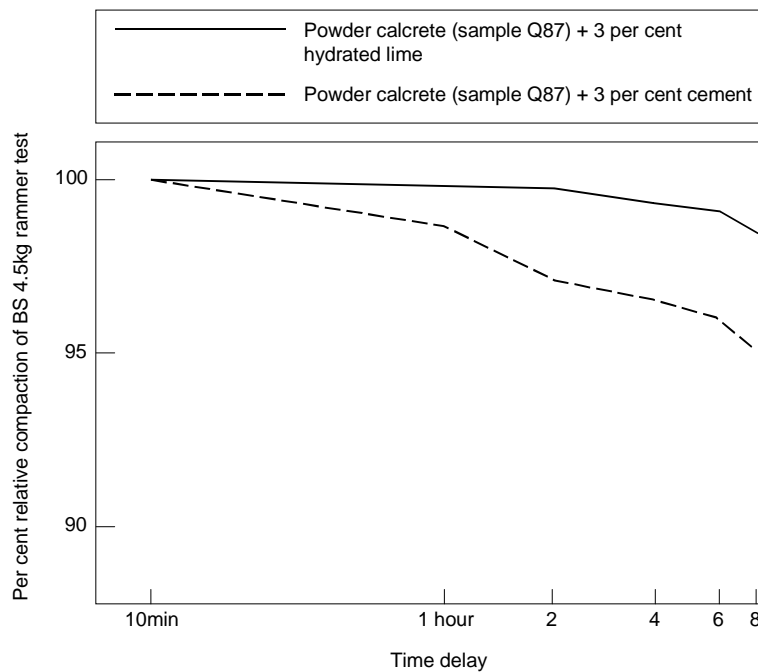
**Figure 6-6 Relative compaction after different time delays following stabilisation (from Lionjanga et al, 1987b)**

The poor performance was attributed entirely to accelerated carbonation of the base due to poor curing. However, there may well be other factors, not yet substantiated, such as the speed of the reaction process with some calcretes which could be equally important. Other factors, including low moisture content, low density, poor construction practice and ineffective priming, may also have contributed to the subsequent poor performance. The difficulties of compacting cement stabilised materials after long time delays are well known (Netterberg 1971). It has been suggested that the reaction times may be particularly rapid with calcretes due to the presence of non-plastic pozzolans in the form of reactive silica. This could have a significant effect on both the production of the cemented products and on compaction. The effect on density of delays between mixing and compaction is shown in Figure 6-6. Corresponding cured strengths are shown in Figure 6-7.

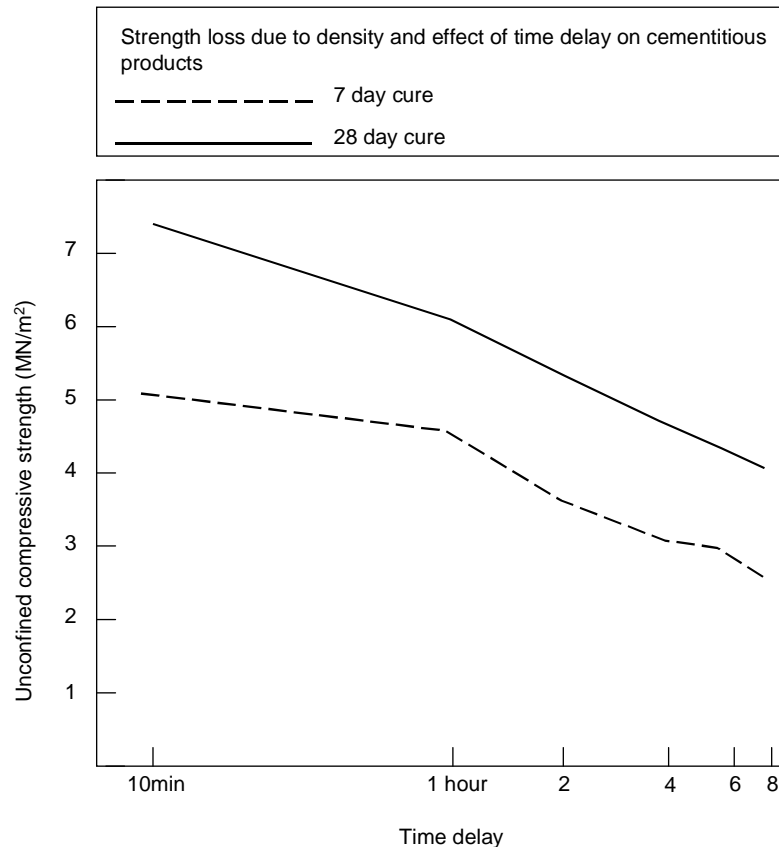
**Figure 6-7 Effect of time delays on the strength of cement stabilised calcrete (from Lionjanga et al, 1987b)**
