COLLABORATIVE RESEARCH PROGRAMME ON HIGHWAY ENGINEERING MATERIALS IN THE SADC REGION

*Environmental Damage from
Extraction
Of Road Building Materials:
Results and Recommendations from
Studies in Southern Africa*

by C S Gourley and P A K Greening

**Published Project Report
PR/OSC/169/99
Project Record No. R6021**

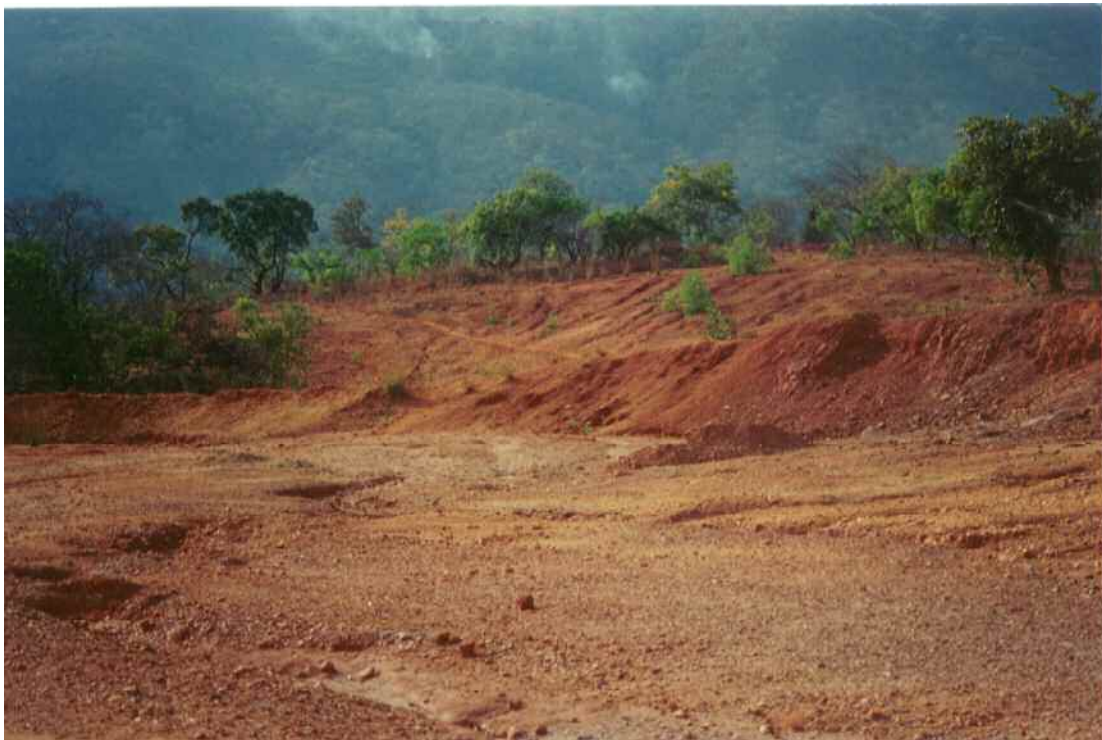
Plate 2-1 Typical condition of an un-reinstated borrow pit

This shows gravelly layer at the surface and little re-growth of vegetation

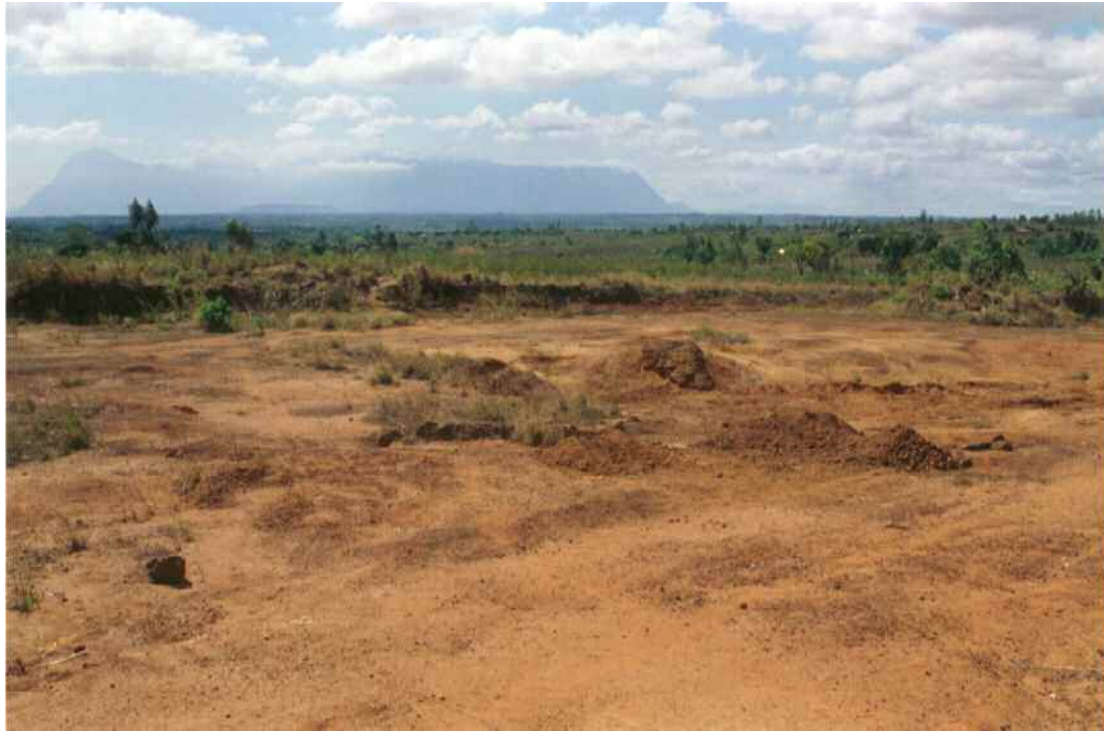
Plate 2-2 15 year old lateritic gravel borrow pit in Malawi
This shows little re-growth of vegetation

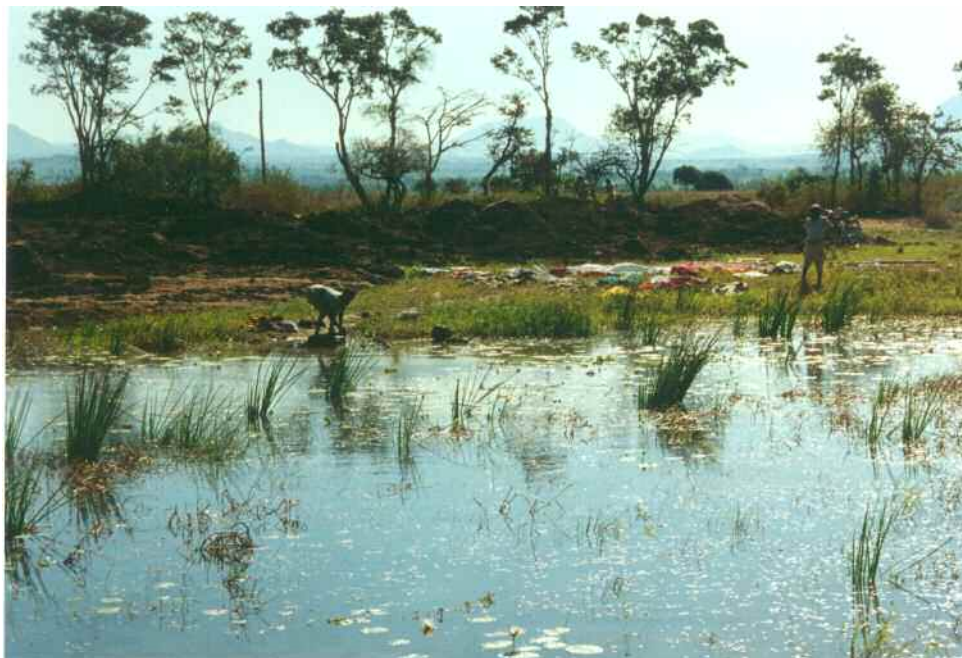
Plate 2-3 Borrow area providing local washing facilities
Continued use is degrading the quality of water available and increasing the health risk to humans and animals

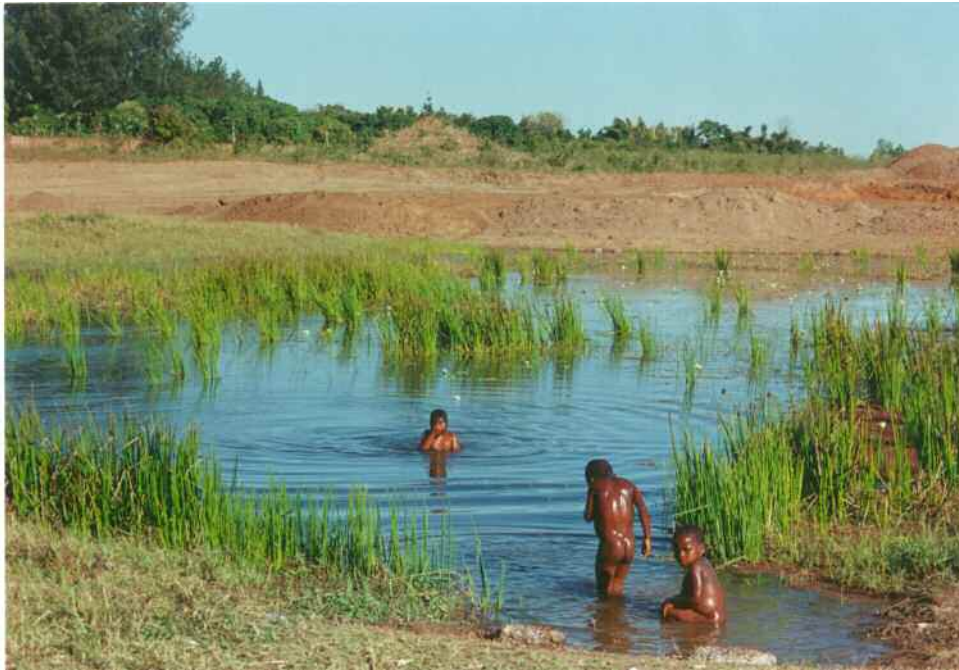
Plate 2-4 Children exposed to risk of drowning and poor quality water
Ponding increases the level of mosquito-borne disease

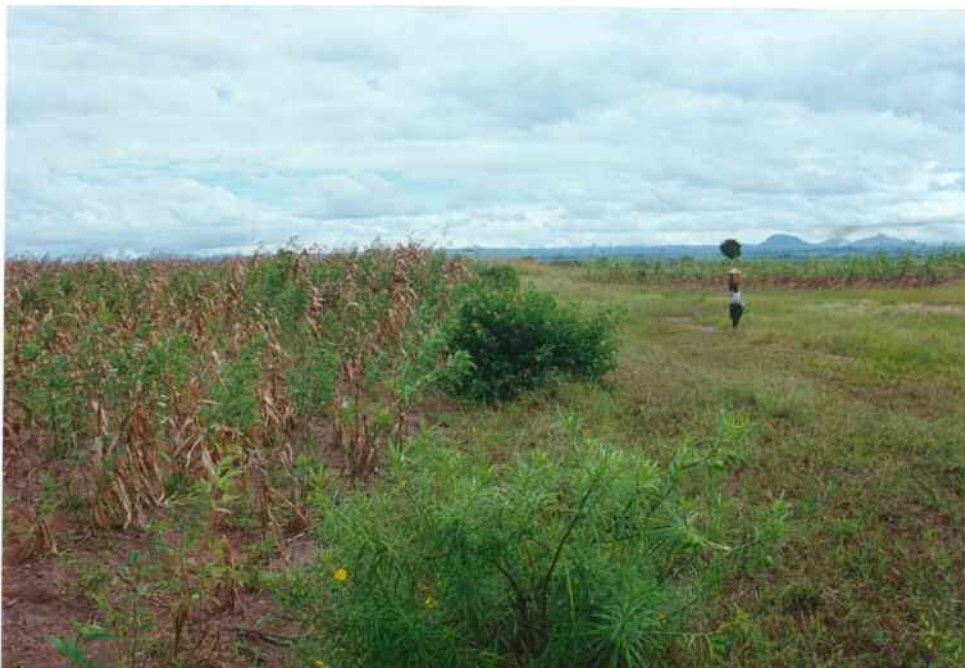
Plate 2-5 Loss of productive agricultural land for subsistence farming
The undisturbed land to the left is still productive whilst that of the borrow on the right has been sterile for 12 years

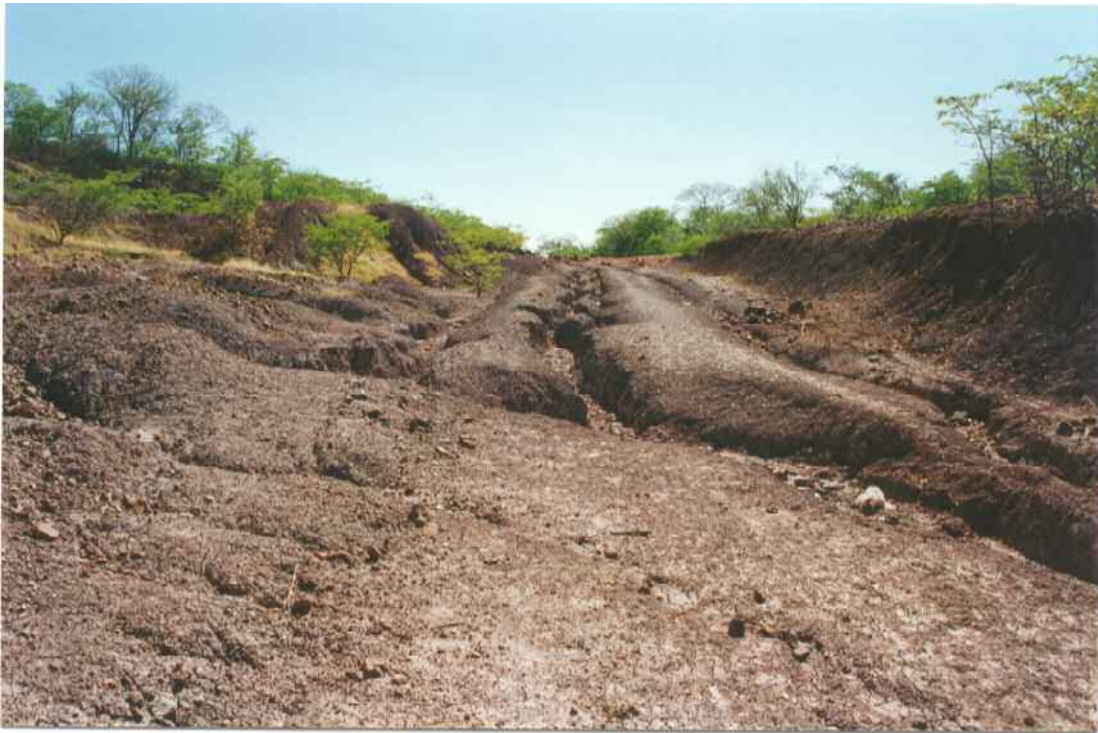
Plate 2-6 Eroded sub-soils on borrow floor

Susceptibility to erosion leads to siltation problems in water courses

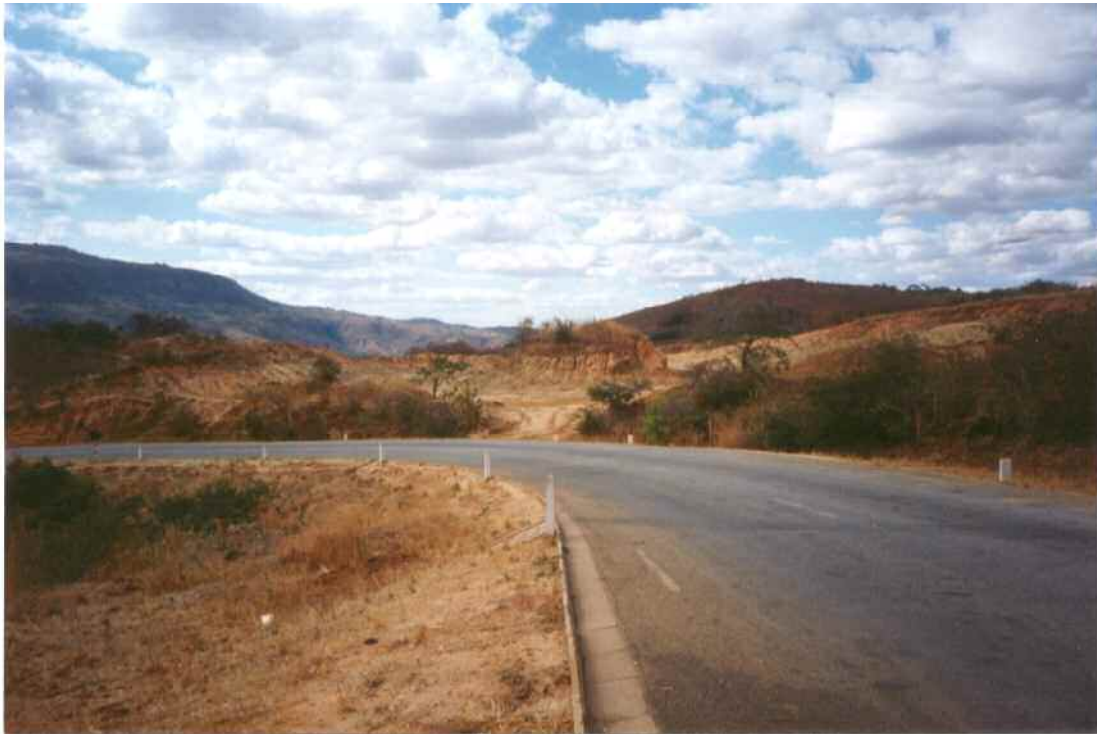
Plate 4-1 Un-reinstated borrow area in an area of natural beauty; Zimbabwe

A visual survey method was developed to assess the level of compliance with the guidance given in existing manuals. The survey sheets incorporated in this method are included in Appendix A. A range of borrow areas was selected from project records or the available materials inventories, and the sites visited by project staff. Typical sites are shown in Plate 4-1 and Plate 4-2.

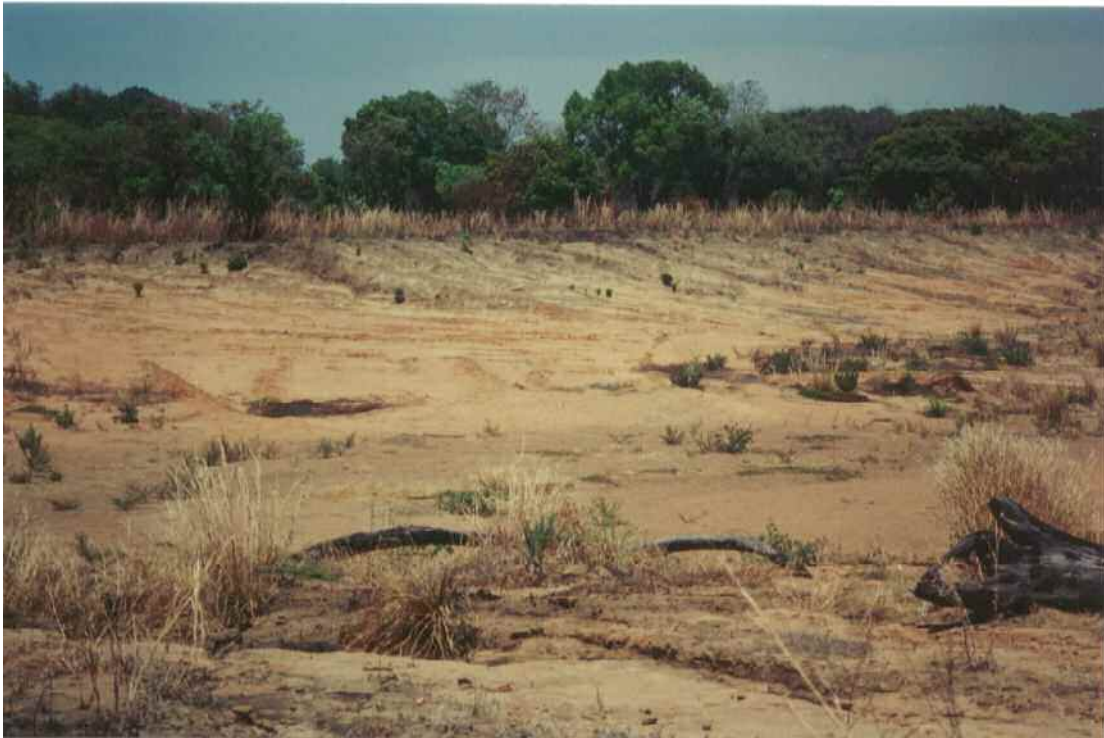
Plate 4-2 Un-reinstated borrow area in northern Botswana
Typical of many borrow pits in the region

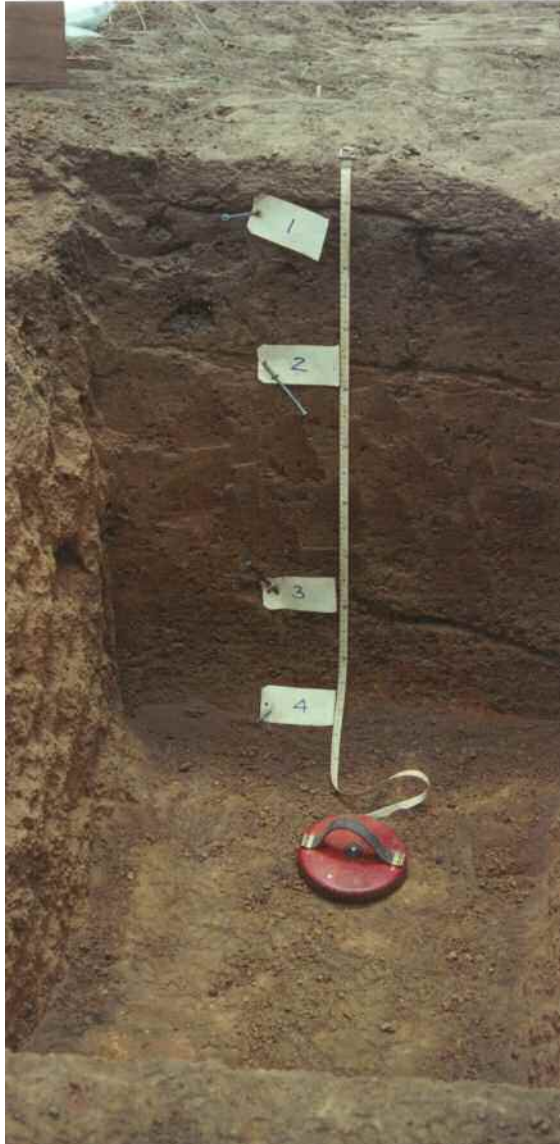
Plate 6.1 Trial pit dug through dense borrow area showing soil profile

1 is top-soil
2 and 3 are sub-soils
4 is laterite gravel seam

Typically six soil pits were excavated at each site to expose the layered profile of a soil, as shown in Plate 6-1. These pits were normally at least 1.5 metres deep or were dug to a limiting layer which was usually the gravel. The horizons of each profile, as shown in Plate 6-2, were then described according to the Food and Agriculture Organisation (FAO) guidelines (FAO 1977). Among the main morphological properties examined were horizon thickness, soil colour (see Plate 6-3), soil structure, soil consistency and gravel content. The pH of the soil was also recorded as illustrated in Plate 6-4.

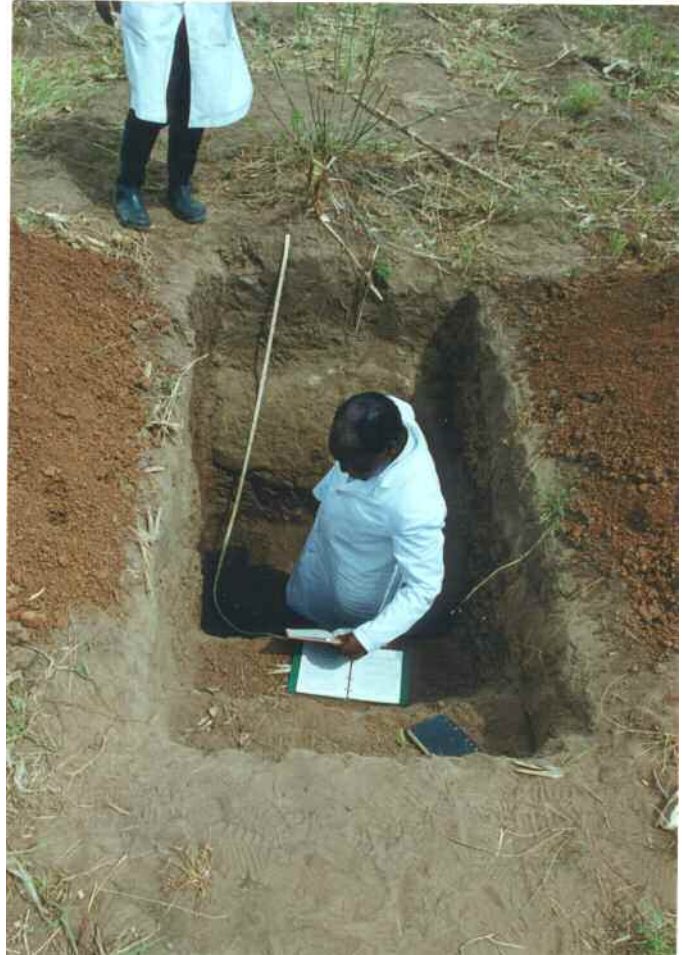
Plate 6.2 Soil description procedure

Soil samples were taken from profiles, using recognised methods, for chemical analysis by the soil laboratories at the Chitedze Agricultural Research Station (Plate 6-2). The basic analyses carried out were for pH, organic matter, nitrogen, phosphorous and exchangeable cations. The soil bulk densities, both unheated and heated at 105°C, were determined from small undisturbed cores, as in Plate 6-5. These soil-science based tests were carried out at the Bvumbwe Agricultural Research Station.

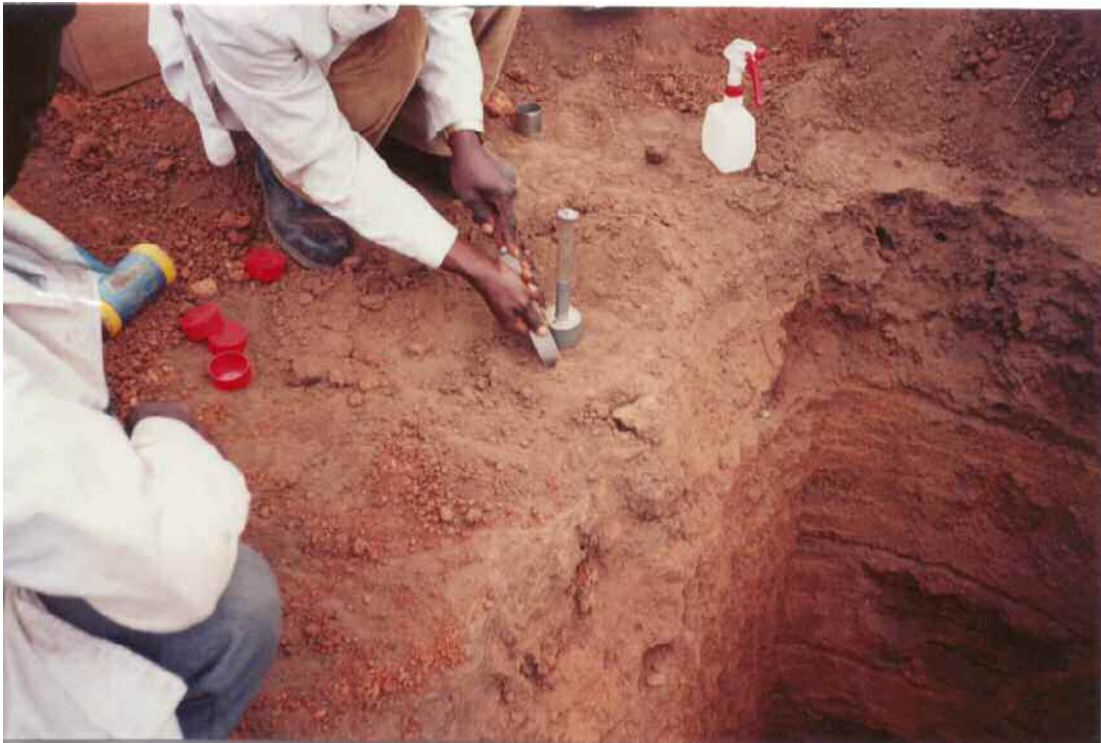
Plate 6-5 Extraction of undisturbed soil cores for in situ soil density testing

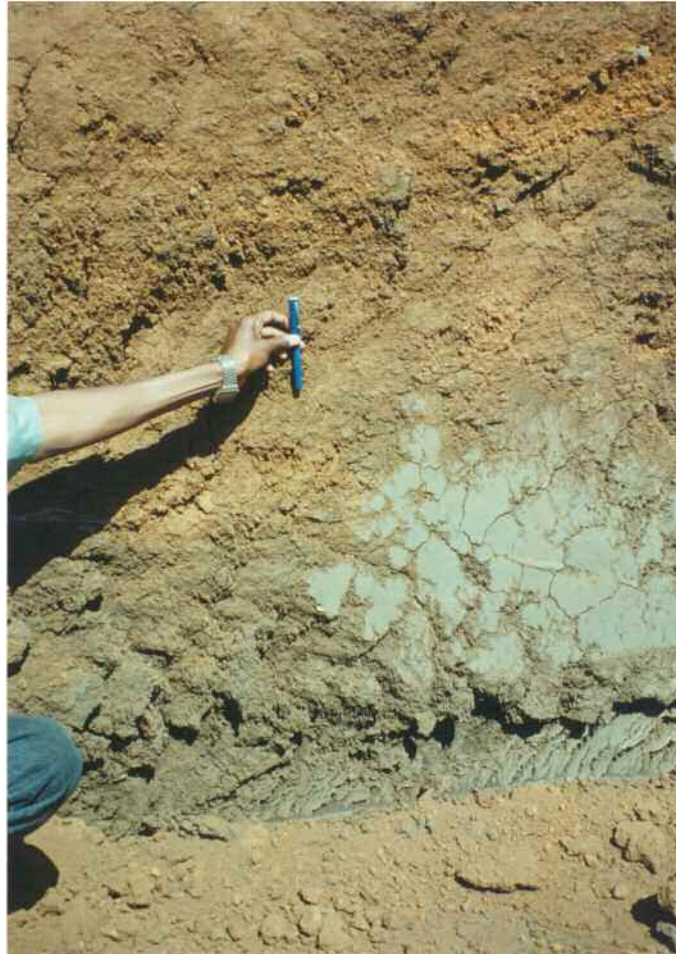
Plate 6-6 Disturbance to soil profile by mixing top-soil and sub-soil during overburden stripping operations

In the Khululira, Muhura and Matutu borrow areas, the top-soil and sub-soil were removed, stockpiled and replaced in an uncontrolled sequence of movements. The general properties of the soil profile and its variation with depth suggest that soil layers have not been reinstated in their original order. The operational processes used at these sites inevitably result in disturbance of the soil profile, and in the mixing of the top-soil and sub-soil layers, as in Plate 6-6. Comparison of the soils before and after restoration indicate that there have been changes in soil colour, soil texture, clay content, organic matter content and nitrogen content. An almost unavoidable result of any borrow area working is that the natural slope, hydrology and normal geomorphological processes are disturbed.

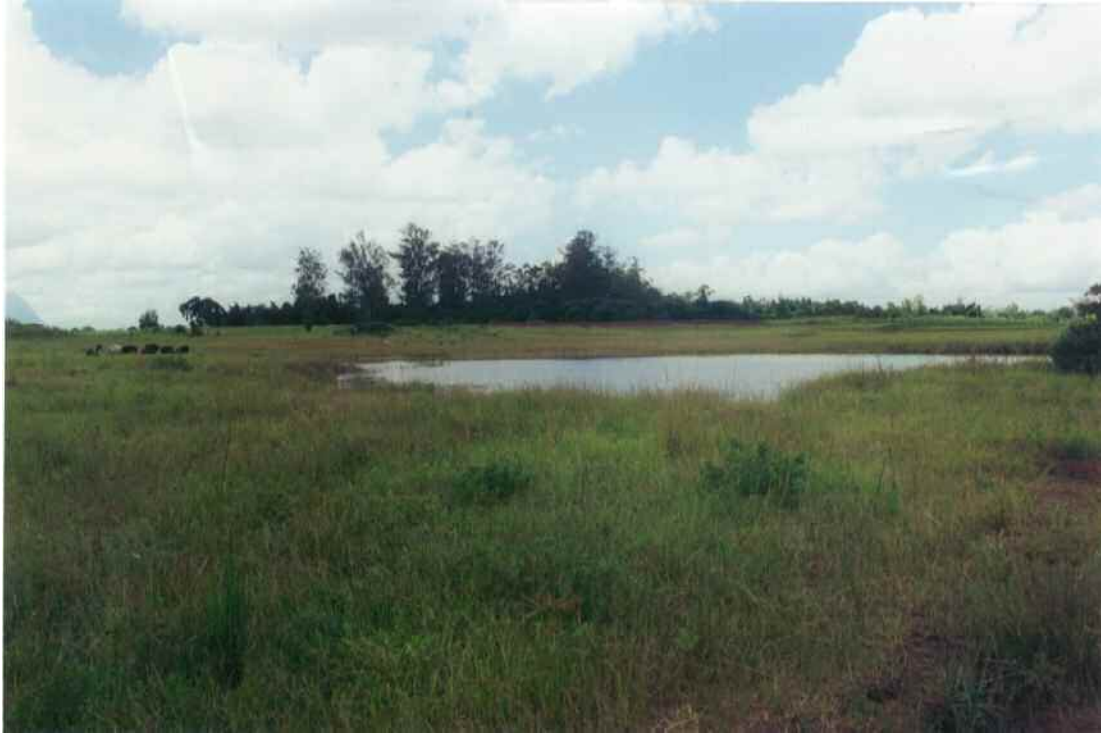
Plate 6-7 Environmental impacts at the Khululira gravel pit March 1999

In the natural state, the land at the Khululira and Muhura gravel pit sites sloped almost imperceptibly towards natural drainage lines beyond the gravel pit sites. After gravel extraction and the subsequent restoration, local basins were created. The land now slopes towards these basins at an increased gradient, and there is now an increased risk of soil erosion, particularly since the soil has been loosened. The land surface is now so uneven at the sites that normal subsistence farming operations, particularly ploughing, will be very difficult. These negative impacts were most pronounced at the Khululira gravel pit site, as shown in Plate 6-7, although in some areas, where top-soils were repositioned correctly, crops were being planted, as shown in Plate 6-8.

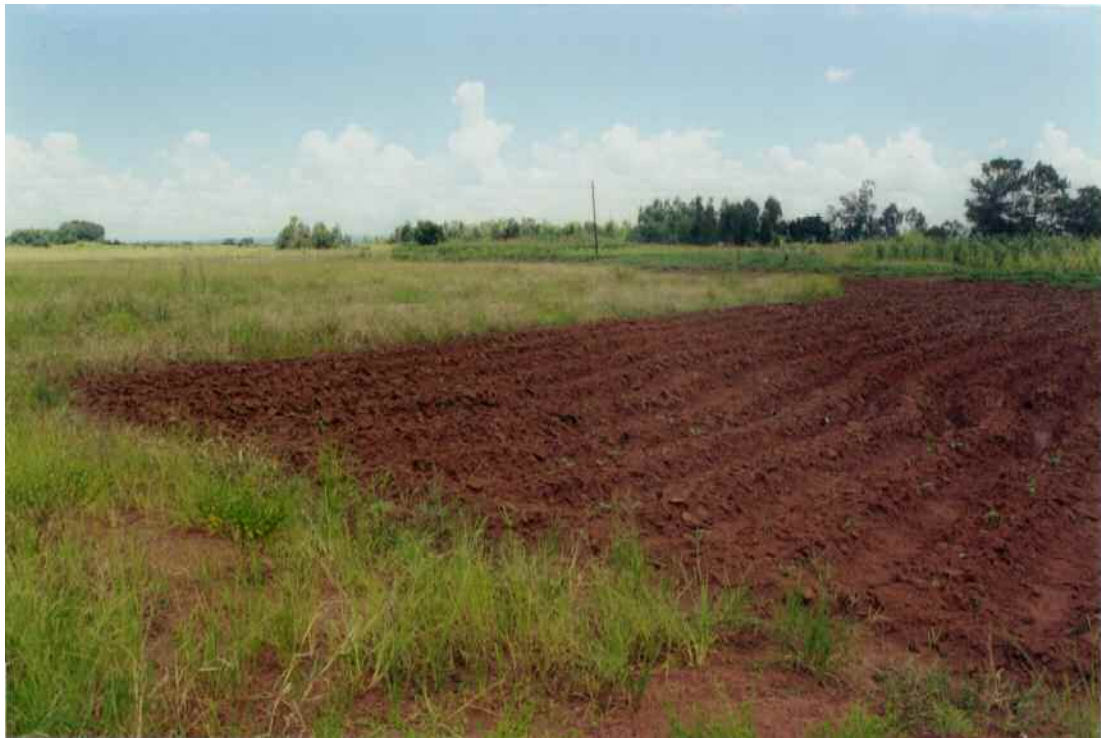
Plate 6-8 Agricultural activity commencing at Khululira gravel pit March 1999

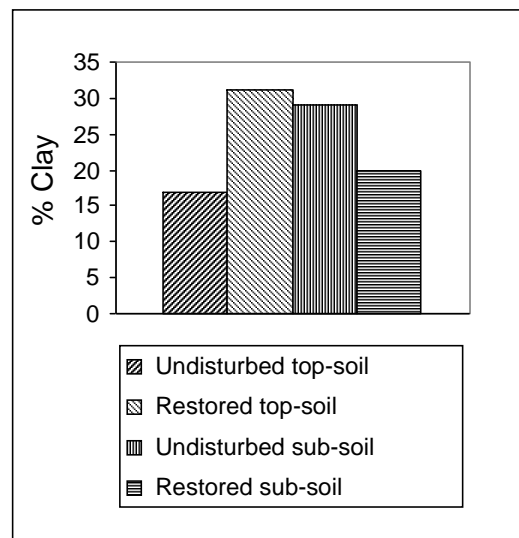
Figure 6-1 Increases in clay content for the Matutu borrow area

These observations are illustrated in Figure 6-1 for the Matutu Borrow area. Here it can be seen that the percentage of clay increases in the top-soil, but reduces in the sub-soil after reinstatement. More importantly, nitrogen in the top-soil has been lost after the soils have been replaced.

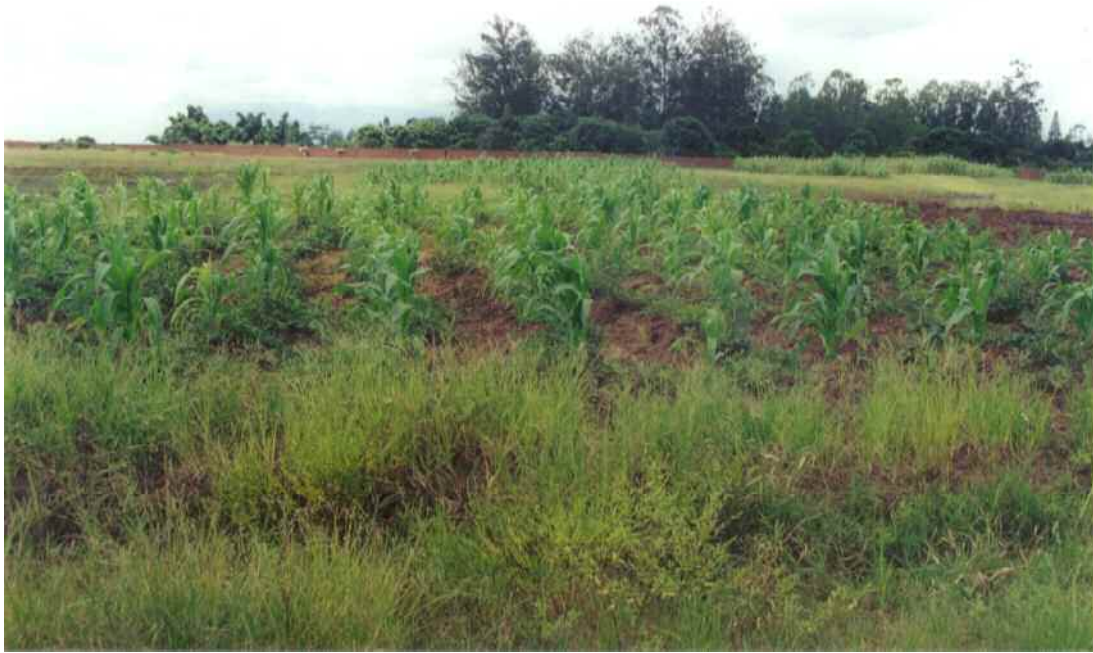
Plate 6-9 Reworking land one year after rehabilitation using new procedures

The revised working procedures appear to offer significant improvements over the normal practice. The land stands a much greater chance of recovering at an earlier stage than any of the other sites. By March 1999, the reinstated area at Ncholonjo was producing maize and, even with the heavy rains in the area, no ponding had occurred at the borrow pit (see Plate 6-9).
