**KARONGA TOWN:  
GROWTH AND RISK PROFILE  
Working paper # 9**

**Mtafu Manda, Dominic Kamlomo, Chrispin Mphande,  
Elija Wanda, Orton Msiska, Jean Kaunda and James Kushe**

**Mzuzu University  
May 2016**

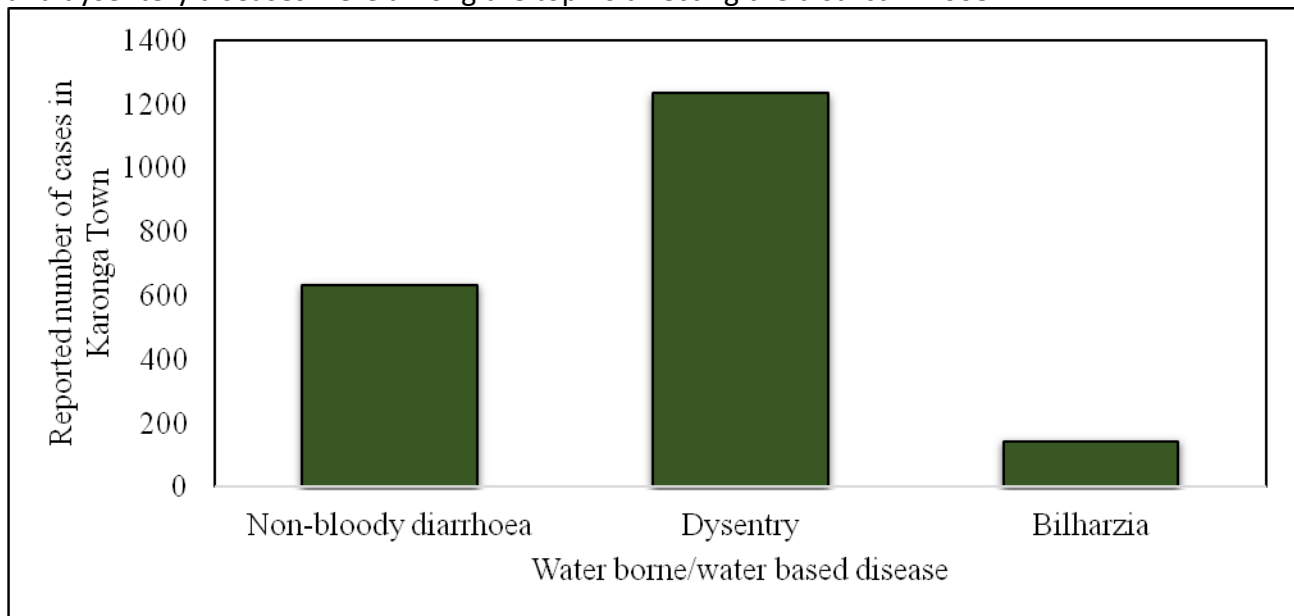
**Figure 1:** Reported cases of water borne and water based diseases in Karonga Town following the 2009 earthquake.

In view of prevailing hazards such as flooding and earthquakes, WASH related diseases are relatively high in the Town. For example, following the 2009 earthquake and floods, Karonga District Hospital recorded a remarkably increased number of water borne and water based diseases The reported cases were: 634 non-bloody diarrhoea, 1234 dysentery and 145 bilharzias (Figure 1). It was further revealed that even prior to the 2009 earthquake, diarrhoea and dysentery diseases were among the top 10 affecting the district in 2008.

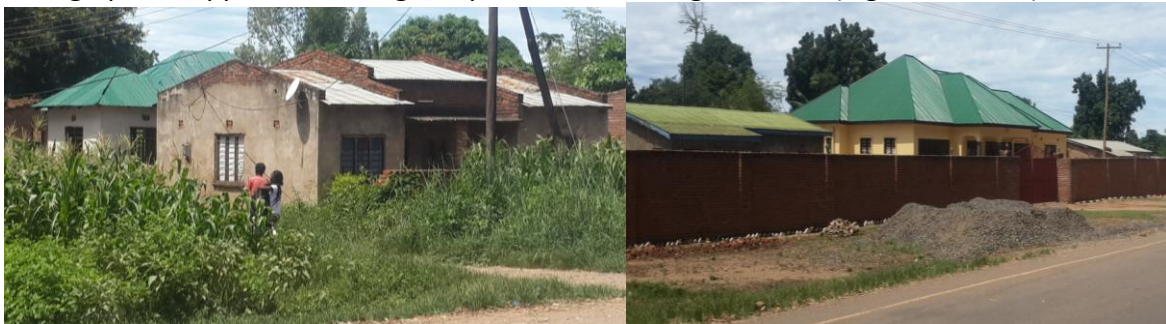
*Figure 2: developers adopt hipped roof house design, Karonga Town ©Mtafu Manda, 2016*

Housing takes up approximately 60% of total land in the town. Housing areas are categorized as low density for high income earners, medium density for middle income earners, high density permanent and traditional housing (THAs). The THAs, which are Malawi jargon for site and services, are largely informal in nature and have attained slum status due to overcrowding of multiple housing units on individual plots and a lack of basic infrastructure and services. The high density permanent housing areas comprise houses largely owned by MHC, while medium density housing is a mix of private and institutional houses within the town. Housing is also categorized according to quality determined by the type of material used for construction: permanent, semi permanent and traditional houses. Nearly one half of the houses can be categorized as poor quality. Using the criteria of the National Statistical Office, 49% of the houses are permanent, 36% are semi permanent and 15% are traditional (NSO, 2010). Traditional houses are built of grass thatch, mud floors and sun dried bricks. The poor design of many of the houses has resulted in them being highly vulnerable and unable to withstand the tremors in the 2009 earth quakes. A guidebook was developed by government to promote safe house construction (GoM, 2010). Though adoption is slow, there is evidence of local people taking up the hipped roof design as promoted in the guidebook (Figure 2 refers).

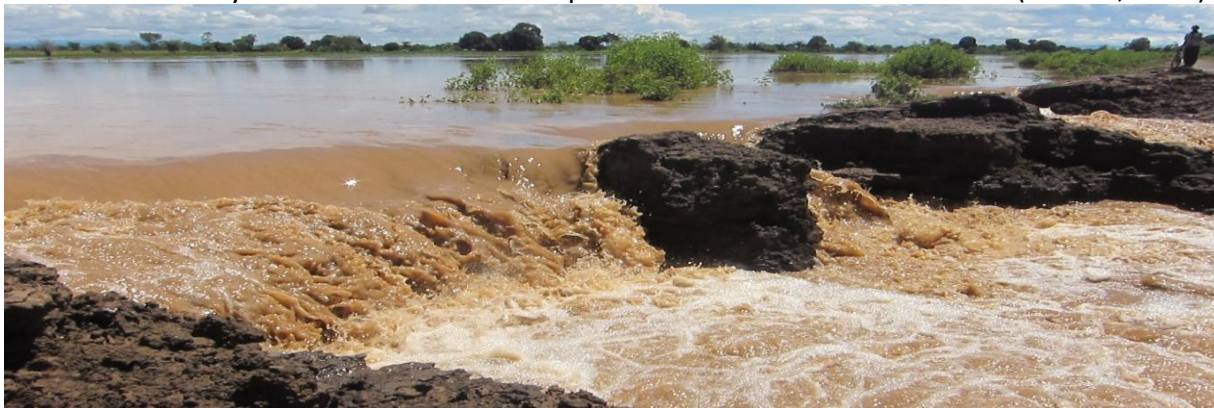
Figure 4: Earthquake Damage leads to flooding, © Department of Disaster Management Affairs (2011 cited in Manda (2014))

Vulnerability to earthquakes therefore dates back from the times of the Town’s historical development (Macheyeki et al., 2014) essentially because of its location within the East African Rift Valley. Specifically, Karonga Town lies on a fault line parallel to the Livingstone fault which forms Lake Malawi Biggs et al., 2010; Macheyeki et al., 2014). The 2009 earthquake report indicates that the 6<sup>th</sup> December waves read 7.2 on Richter scale and damaged several buildings, roads and a flood control dyke along the Rukuru River (Macheyeki et al., 2014). The damage to the flood control dyke rendered the town unprotected from the floods in 2011 (Manda, 2014).

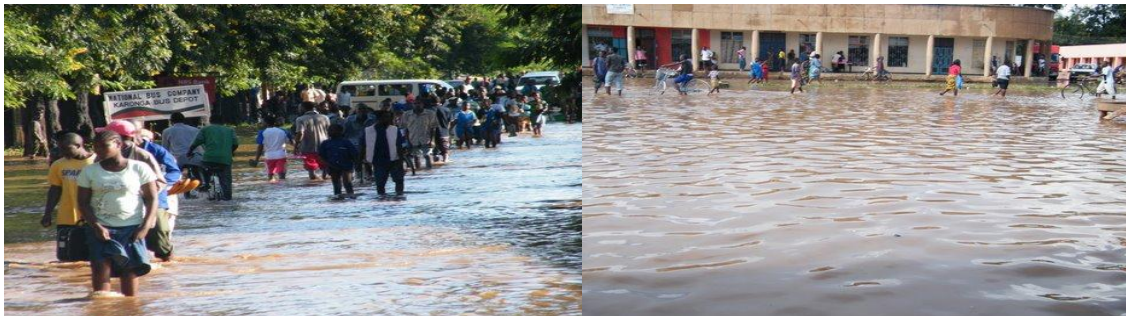
Figure 5: Karonga Town Centre Floods, 2011

Various types of floods occur in Karonga Town including flash floods, out bank floods mainly from the North Rukuru River and Lake Malawi and urban floods due to poor drainage systems. However, records regarding floods only started being seriously recorded since 1981 following the 1979/80 floods after a feasibility study conducted by Gitec Consult. The study showed that Karonga Town was at risk mainly due to out bank flooding of North Rukuru River. The floods occurred in 1979/80 because the water level in Lake Malawi rose from 471m above Karonga reference level in 1915 to 477.8m in 1980 (Macheyeki et al., 2014). The lake level rise induced flooding damaged most of the old town and led to the relocation of the commercial centre to the current site 1987. The location of the new town centre was regarded as a much safer location from mainly Lake Level rise related floods and out bank river floods. However, flooding has continued with varying degrees of impact. In 2010/11, severe flooding after the damage to the dyke affected the whole new commercial area (Figure 5). In 2016 floods once again affected the central town and residential areas in part due to poor or blocked drainage.
