International Organisation for Migration

Flood Resilient Shelter in Pakistan

Phase 2: Evidence-Based Research

October 2017

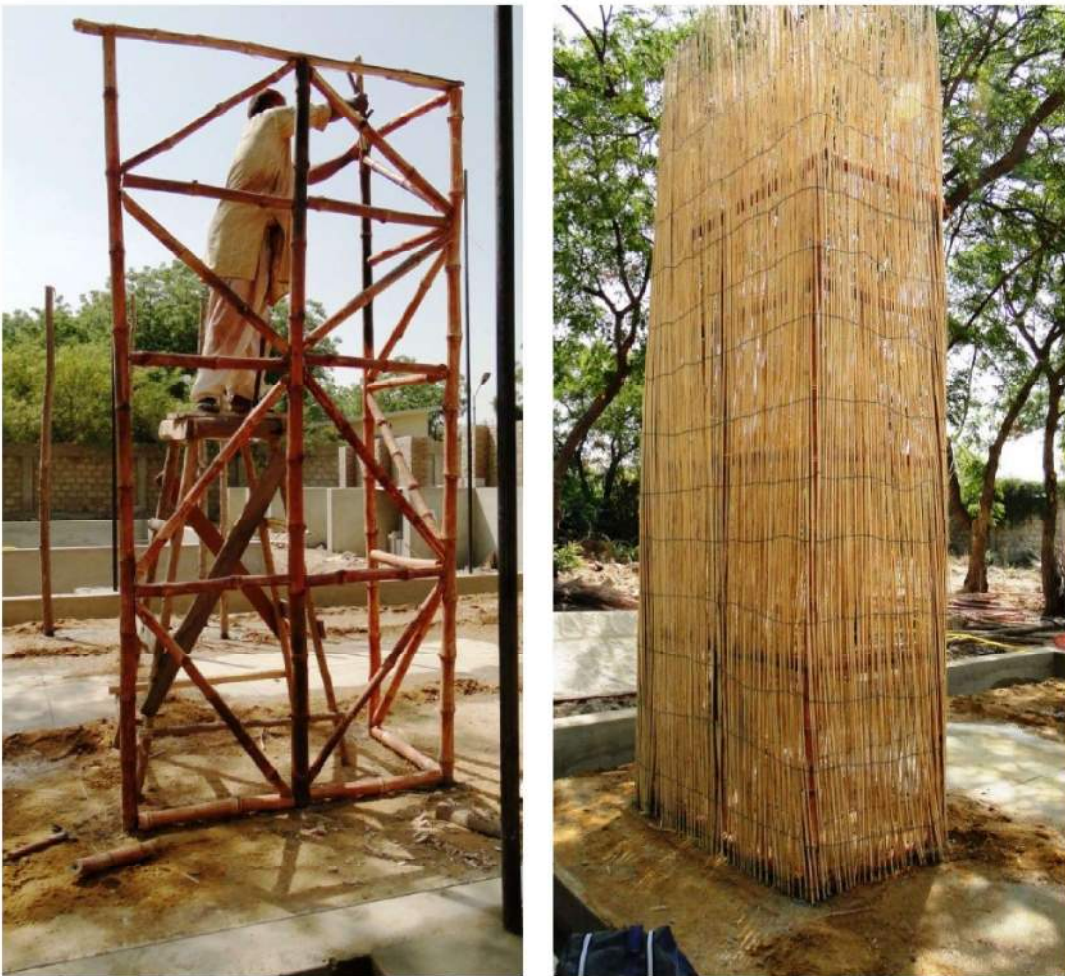
Figure 4 Loh-kat panel at testing facility made from bamboo frame and chicks matting. The next step is to apply plaster to the chicks matting. Note that the bamboo frame requires lots of diagonal bracing in order to make it stable. With many loh-kat shelters recorded as visibly leaning over it is most likely due to insufficient bracing.

Traditional Loh-kat construction consists of a lattice of interwoven timber strips or branches plastered either side with similar variations in existence all over the world. By contrast some Loh-kat shelters built in the response consisted of a bamboo frame with verticals at increased spacing and a reed matting known as ‘chicks’ fixed to one side. Key informant interviews suggest that this was a response to material depletion, a factor which could help to explain the relatively poor performance of this wall typology under certain criteria.

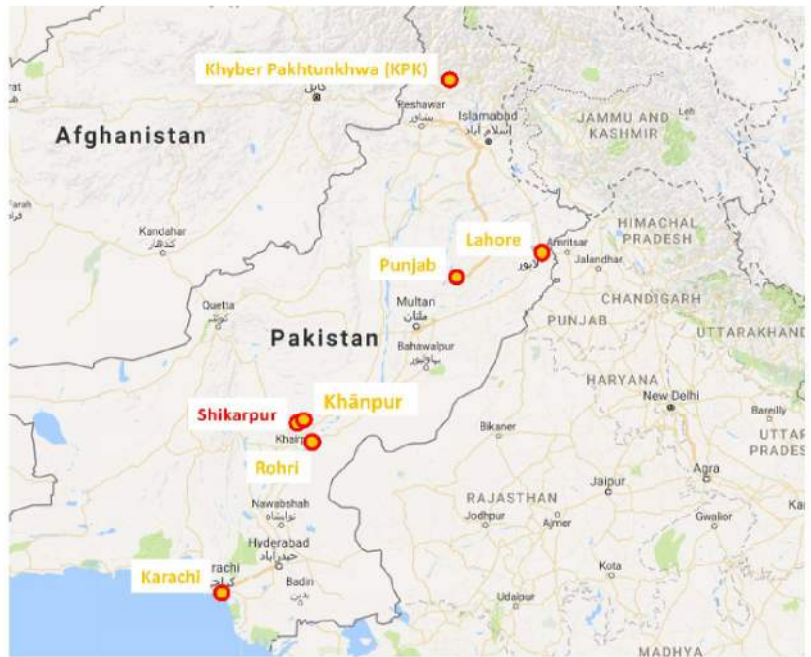
Figure 11 - Material transportation assumptions

Transport factors were developed based on the mode of transport and distance travelled for two journey legs. The first leg covered point of origin, such as a factory in Karachi or a forest in Punjab, to a merchant or warehouse, which for this study was assumed to be located in Shikarpur. The second leg consisted of a shorter journey from the merchant to a village, most likely via a different mode of transport. Distances and modes of transport for the first leg were estimated based on research into the most likely locations for sourcing a given material. Transport modes for the second leg of the journey were developed based on homeowner surveys. For distance a worst case (90th percentile) of 20km was assumed. Values for vehicle emissions were extracted from data sources in table 16 below.

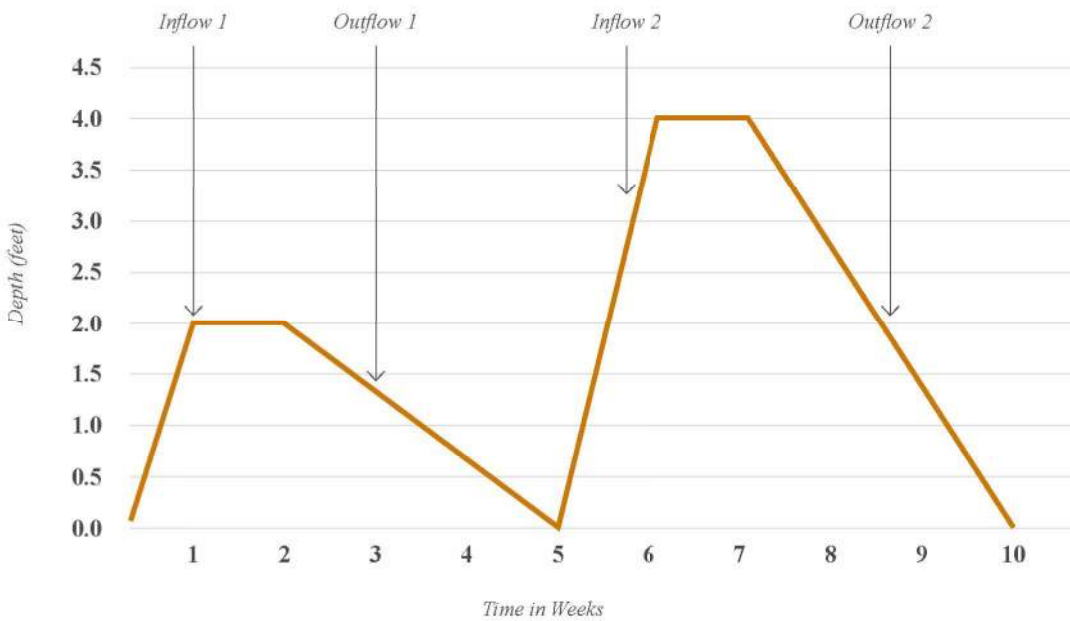
Inflow 1	Outflow 1	Inflow 2	Outflow 2
0.286 feet per day	0.095 feet per day	0.571 feet per day	0.190 feet per day

Figure 13 - Flood testing profile – water depth over time and flow

shelter agencies supported by research papers that water levels rose quickly and then took a number of weeks to drain away. It was thought that the effectiveness of raised floors and toes would require the water level to be below their high point whilst this flood profile would quickly inundate them, limiting the data which would be collected on their value. This led to a two stage flood profile, with the water level rising to 2' and then to 4' later on, all within the 10 week testing period (See Figure 13). Water was pumped into the tank and drained at the rates provided below in a way that prevented the panels being subject to flowing water.

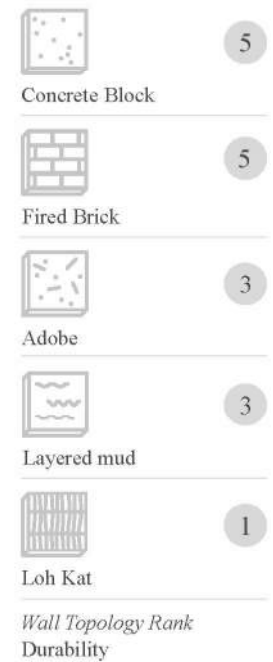
Table 20 - Shelter design life (years)

Wall typology	From Key informant interview	Engineering judgement	
		Lower	Upper
Loh-kat	1 to 7	1	15
Layered mud	2 to 8	5	50
Adobe	2 to 8	5	50
Fired brick	7 to 15	10	50
Concrete block	No data	10	50

Key informant interviews asked shelter agencies the anticipated life spans of different shelters with a range of values given. This illustrates the difficulty of predicting life spans, whilst the data also indicates low expectations across the typologies with adobe and layered mud in some cases given a similarly very low prognosis to loh-kat. The engineering judgement column is based upon an upper and lower bound of what should be possible to achieve based on the inherent characteristics of the materials. The upper bound represents a shelter that is well designed, detailed, constructed and maintained, the lower bound represents the opposite. It is possible for earth construction to be as durable as engineered materials such as fired brick if its limitations are understood and mitigated, refer to section 6.3 Water Resilience for more detail.

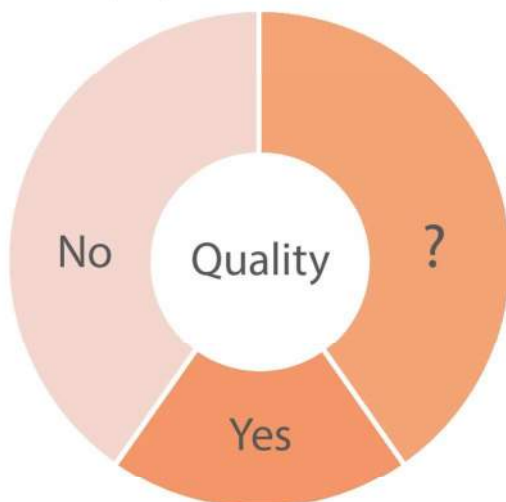
Materials that people had concerns about quality

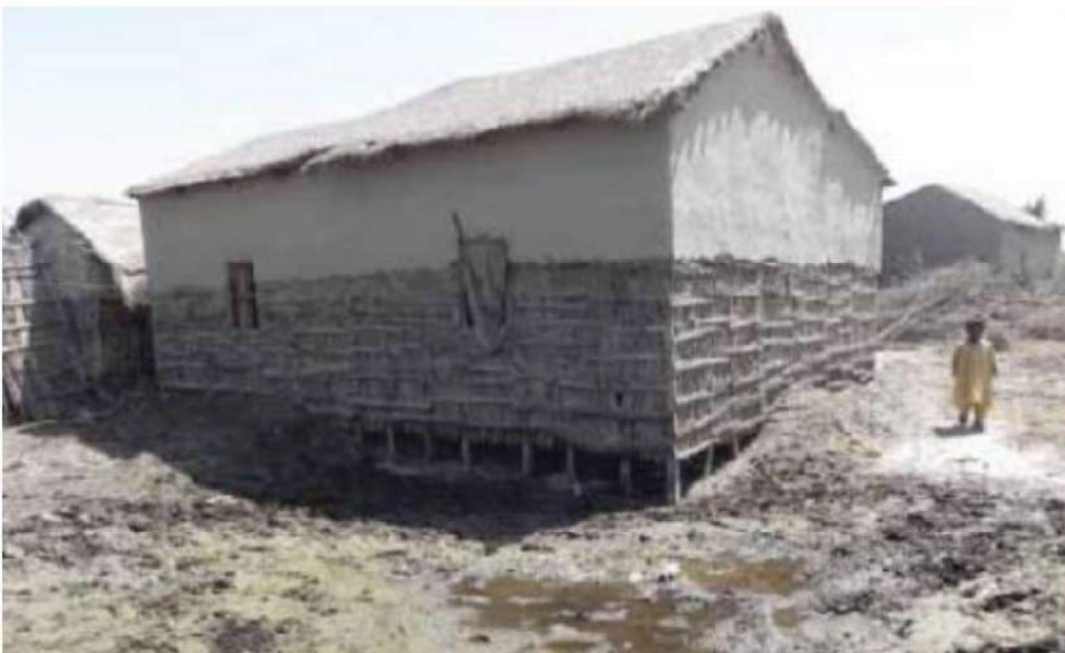
Figure 16 - Loh-kat shelter after flooding (UN-HABITAT 2010)

Whilst loh-kat was not included in the flood testing it has the potential to resist standing water, relying upon its timber frame to maintain structural integrity and support the roof whilst the plaster matrix is washed away (See figure 16). Where rapidly constructed loh-kat shelters were performing poorly in terms of structural integrity and stability, this resilience to standing water is likely to be reduced, however this hypothesis is untested by this research (refer to section 9 – Recommendations for further work). In addition loh-kat that is made from softwood or bamboo are liable to rot if left immersed in water for too long.

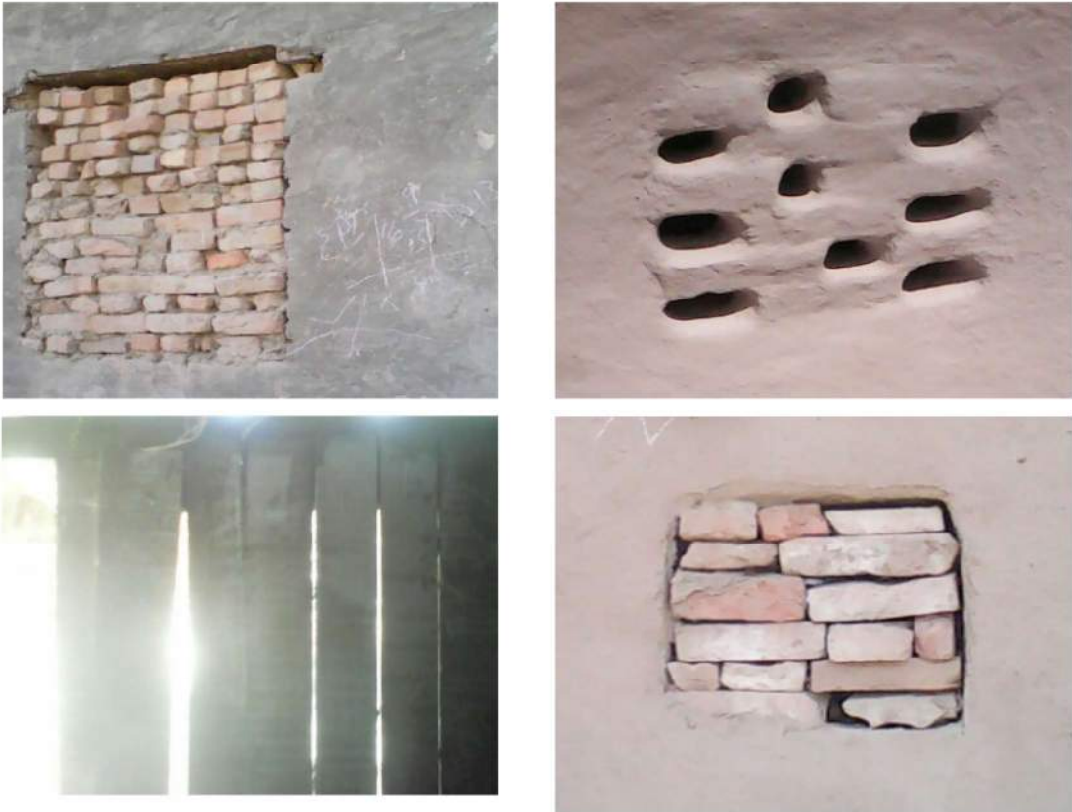
Figure 19 - Modifications made to windows by homeowners seeking to address concerns over privacy and

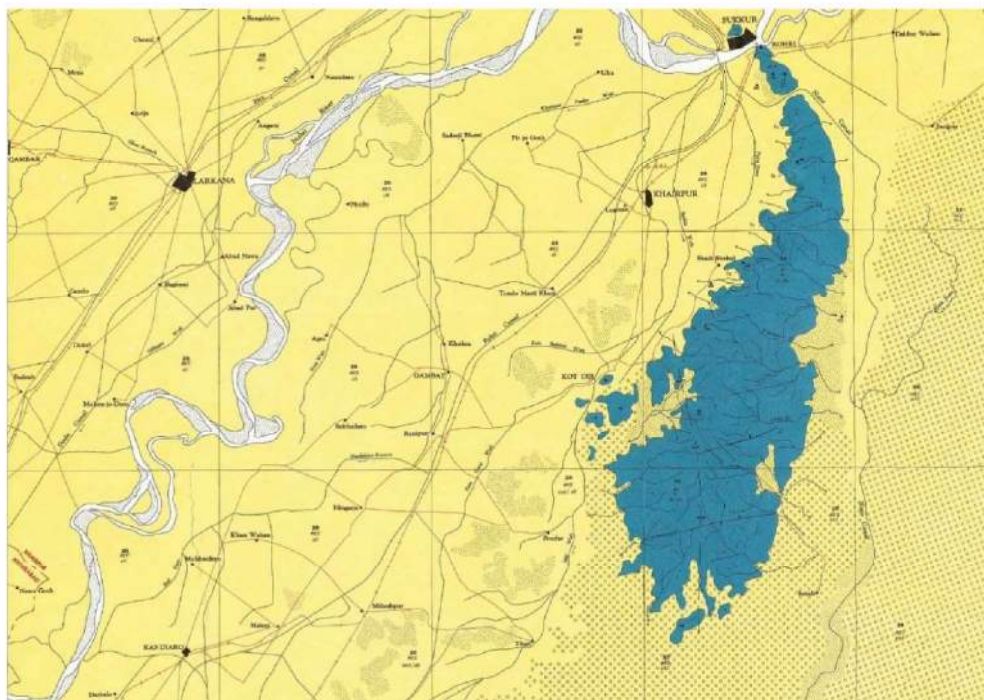
Figure 2 - Extract from 1:250,000 scale geological map Sheet 16

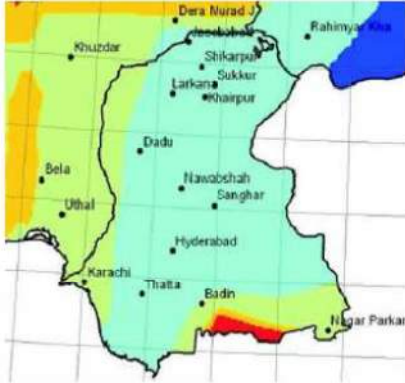
Source	Hazard (Peak ground acceleration)	
Pakistan Building Code	<p>Typical study area PGA = 0.16g Maximum PGA = 0.3g</p>

<p>Seismic Zones</p> <ul style="list-style-type: none"> Zone 1 Zone 2A Zone 2B Zone 3 Zone 4
EMME study	<p>Typical study area PGA = 0.2g Maximum PGA = 0.3g</p>
