## Materials

## Understanding flood damage to shelter

The following findings are extracted from a Rapid Technical Damage Assessment<sup>1</sup> conducted by UN Habitat following the 2010 floods.

The objective of this study is to assess the flood or inundation resilience of structures made up of clay as the primary constituent. Walls with conventional clay mix design and engineered clay mix design (experimental) along with other constituent and fibres are tested. Effect of wall geometry on its resilience is also assessed.

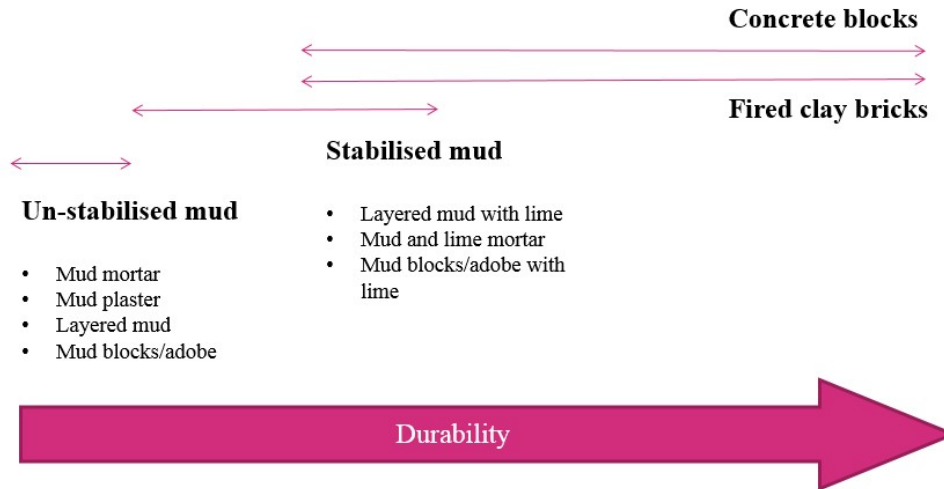
**Figure 4** – Durability of materials when immersed in water or subject to rainfall erosion

The diagram provides a general assessment of the durability of materials when subject to immersion or erosion from water with durability increasing from left to right. The smaller arrows indicate that within a given material there can be wide variation in their performance associated with quality of materials and workmanship.

The relative performance of materials when immersed in water or subject to erosion from rainfall is well established. We know that an un-stabilised mud brick shelter with no DRR features will perform poorly. We know that a fired clay brick with cement mortar shelter will perform well.

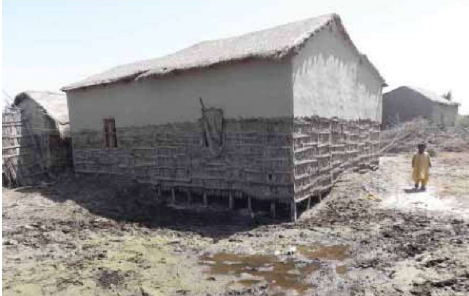
Typology and Hazard	<ul style="list-style-type: none"> <li>Key observations and <u>Potential areas to investigate through testing</u></li> </ul>
<p><b>Loh Kat – Standing water</b></p>

<ul style="list-style-type: none"> <li>Foundations eroded</li> <li>Mud plaster is washed away</li> <li>Importantly the bamboo/timber frame remains in place meaning that the roof remains intact</li> <li>Walls can be repaired once water has receded</li> </ul> <p style="text-align: right;"><u>Foundation design</u></p> <p style="text-align: center;"><u>Redundancy of walls for improved roof support</u></p> <p style="text-align: right;"><u>Lime stabilised plaster</u></p> <p style="text-align: right;"><u>Raised floors and plinth protection</u></p>
<p><b>Fired Clay – Standing water</b></p>

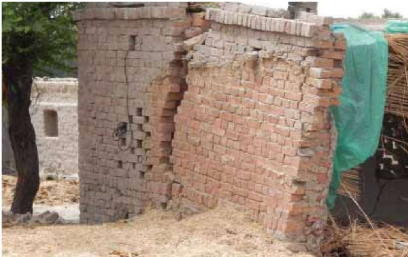
<ul style="list-style-type: none"> <li>Bricks are largely water resistant and remain intact</li> <li>Where used with mud mortar the mud is washed away, the wall no longer has cohesion and collapse follows</li> <li>Water-logged shallow foundations are subject to settlement, resulting in cracking and collapse of walls.</li> </ul> <p style="text-align: right;"><u>Foundation depth</u></p> <p style="text-align: right;"><u>Upper and Lower ring-beam</u></p>

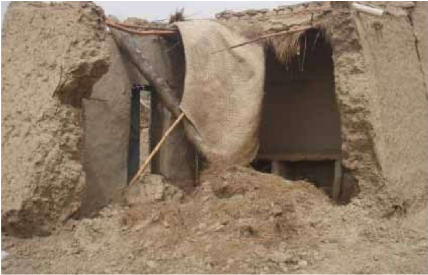
<p><b>Adobe/Mud brick – Standing water</b></p>

<ul style="list-style-type: none"> <li>Walls dissolve and collapse</li> <li>With no redundancy in the structure the roof also collapses</li> <li>Water-logged shallow foundations are subject to settlement, resulting in cracking and collapse of walls.</li> </ul> <p style="text-align: right;"><u>Lime stabilisation</u></p> <p style="text-align: right;"><u>Wall tie-ing and redundancy (buttresses etc)</u></p>

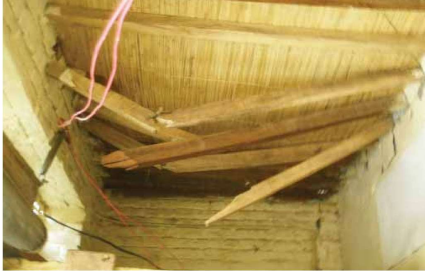
### Mud roofs – Rainfall

- Mud roofs become saturated with rainfall causing failure of roof covering and or the roof structure.

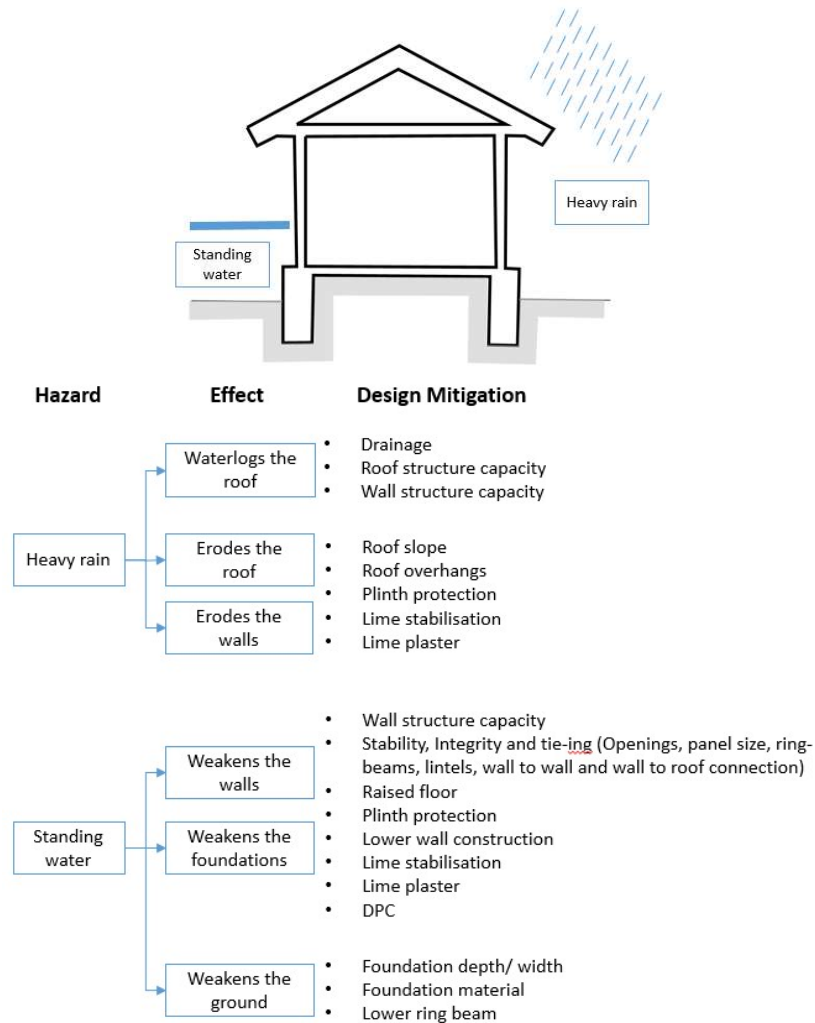
The diagram below illustrates how heavy rain and standing water might be mitigated by shelter design features. This helps to identify the design features that physical testing should explore. The impact of additional loading from waterlogging of roof on the roof structure can be explored through structural analysis. The impact of ring beams and other forms of structural tie-ing may not be possible unless tests are conducted on full scale shelter.

**Figure 5** – Possible design mitigation for standing water and heavy rain

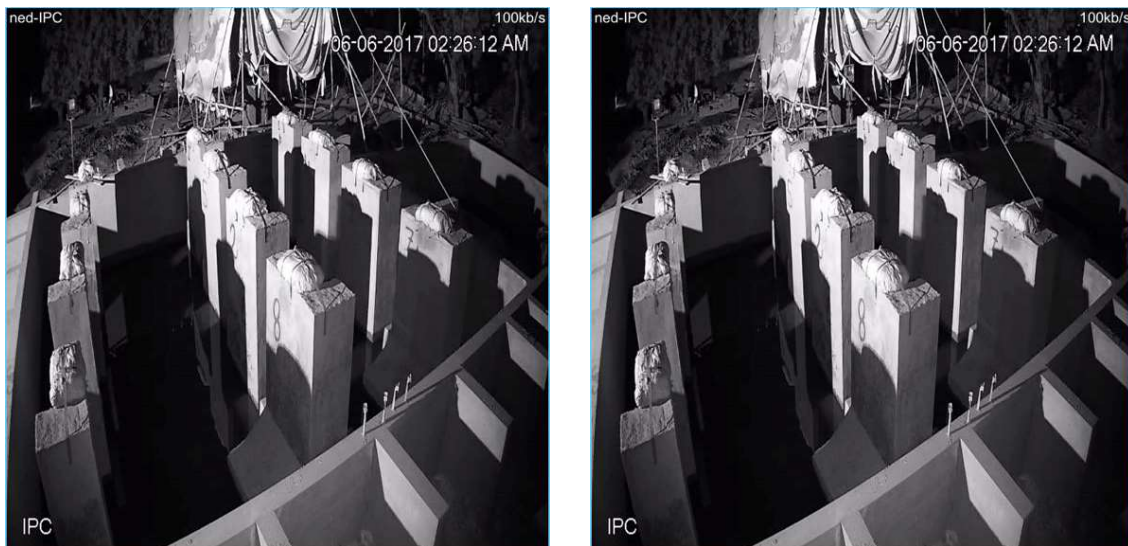
The flood simulator consists of two large tanks. One of the tanks is named as flood tank and the other is the reservoir to hold the water to be fed into the flood tank. These tanks are connected to each other with pipes and pumps to transfer water from one tank to the other. The inlets in the flood tank are placed in such a way that the clay structures constructed within it are not affected by turbulence of inflow. Figure 1 shows the view of flood tank from two different points. It can be seen that wall panels are constructed inside the flood tank which. The constructed walls are also provided with some loading conditions as seen in Figure 1, discussed in succeeding sections of the report.

Figure 1 View of flood tank from two different angles

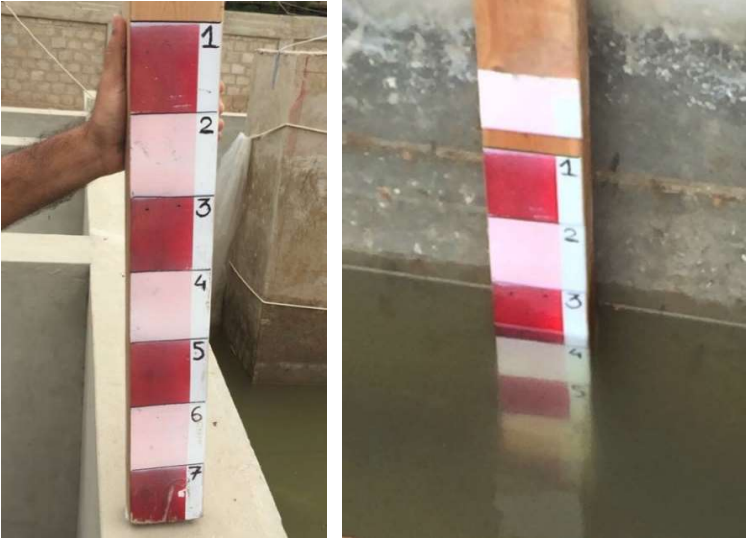
The flood tank was filled with water with constant supply to a depth of 600 mm at a rate of 122 mm per day such that the water reaches 600 mm after 5 days. A staff gauge for measurement with custom calibrations was installed in the flood tank as show in Figure 4.

**Figure 2 Staff gauge for measurement of water depth in flood tank**

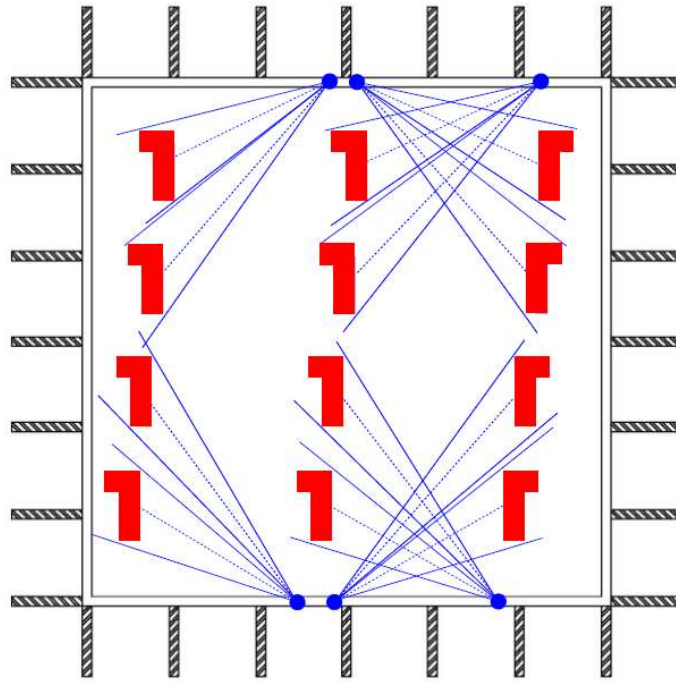
The still camera set up consists of a number of good quality cameras being moved around the 12 different locations as shown in Figure 5, and placed onto a fixed mount, which has been set up according to trials to ensure that it captures the entire height of the wall in the frame.

Figure 5 Camera location for still photography

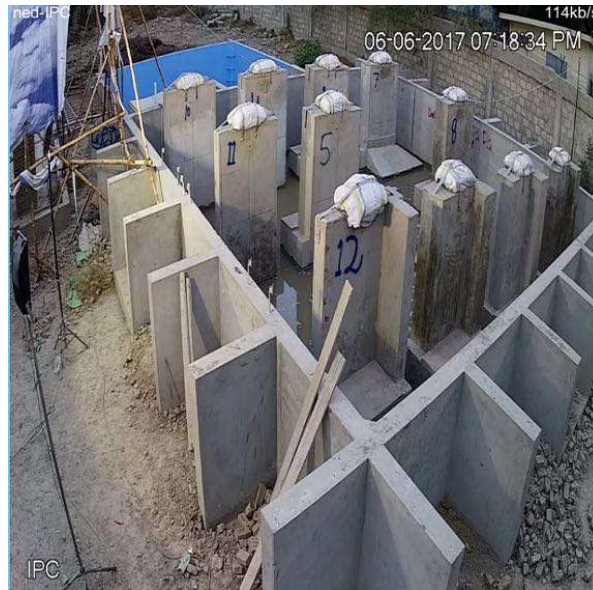
A live video feed is set up to allow streaming of the site online. For monitoring (in case collapse is not captured otherwise) and publicity (via a website or app), these two cameras are set up to view all of the panels. These were installed on a pole near the site, high enough to get a good view. Figure 7 shows the view from mounted camera.

Figure 7 A view from camera installed for video recording

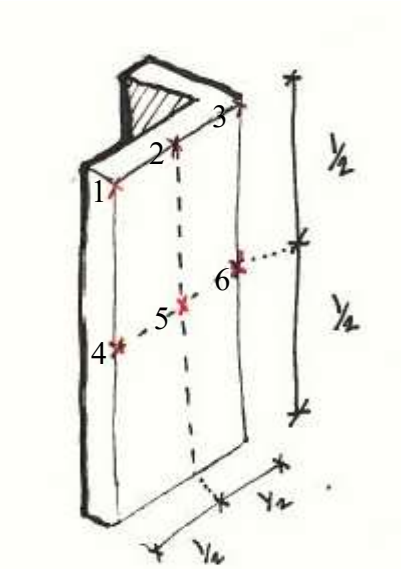
The total stations were used to take measurements of 6 points on each of the twelve wall panels as presented in Figure 8. The positions of these readings are marked on the wall so that readings are from the same places each time. It is not possible to record damage to the panels under water. Measurements are; therefore, restricted to above the water level. Following parameters are measured:

It was possible to process the 6 point observation on each wall by bench marking the distance of these 6 observations from fixed points near the flood tank. Linear distances are observed

between the bench mark and the point on walls. The difference in these distances from bench mark depicts the movement of wall panels for sink, drift and tilt.

Figure 8 Observation points on wall panels

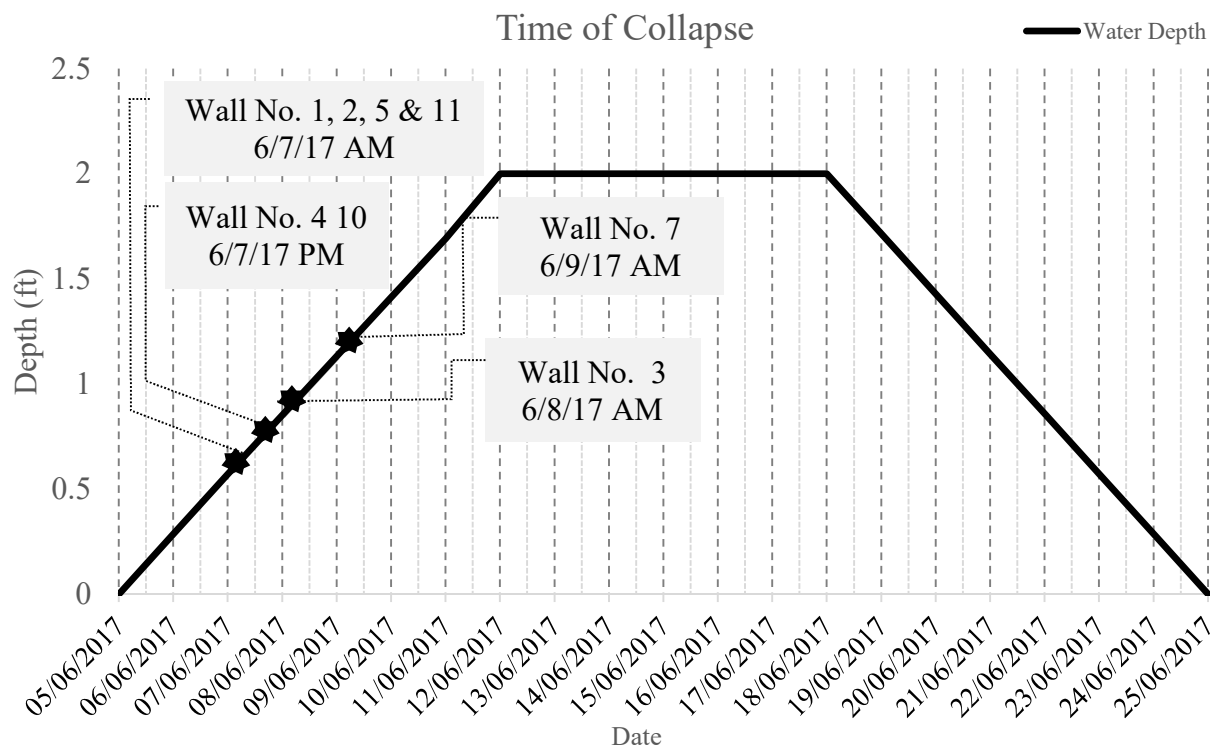
Flood wave as discussed in previous chapters was 600 mm high. Figure 9 shows the depth of water in flood water in the flood tank with points highlighting the time of collapse of respective wall panels.

Figure 9 Time graph of collapsing wall panels in phase 1 of flood wave

Wall panel numbers 1, 2, 5 & 11 were the first to collapse from the effect of incoming flood wave. They were not able to sustain inundation depth of 185 mm. Wall No. 4 & 10 collapsed at

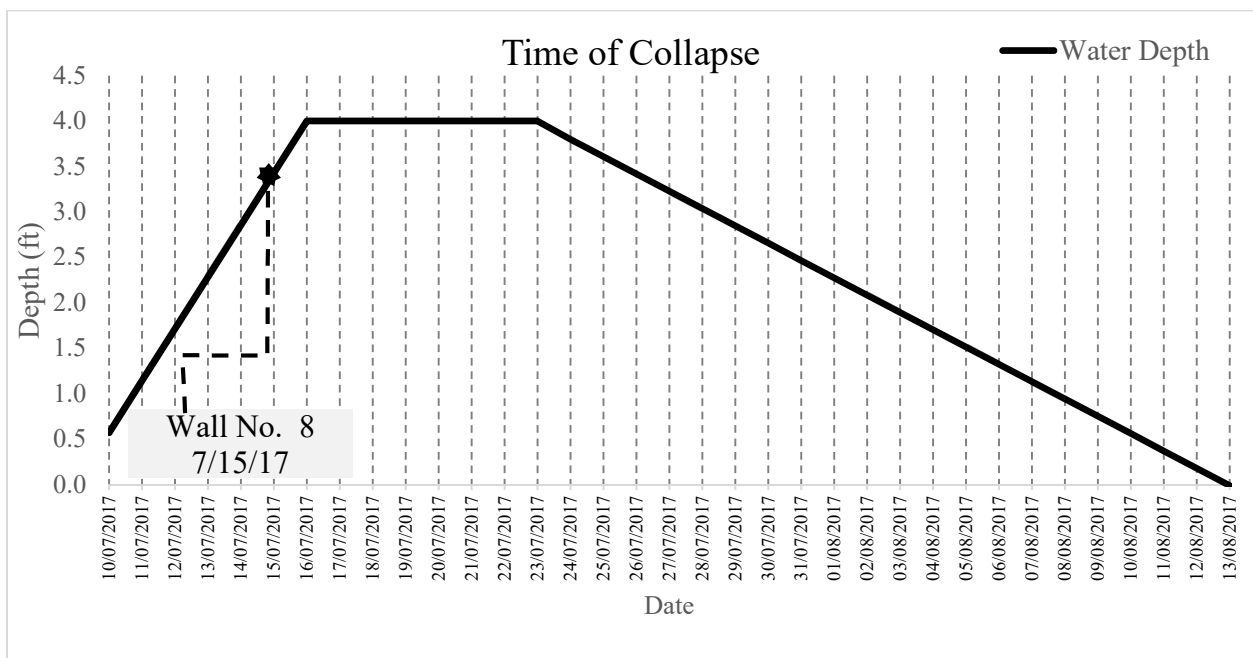
Wall panels sustaining the first phase on 600 mm inundation depth were again put to test for a depth of 1.2 m. The second phase consisted of flood wave of 1.2 m in the first week, maintaining this depth for the next week and taking off the water in three weeks at constant rate. The observations of the wall collapse in this second phase are summarized in Figure 10.

Figure 10 Time graph of collapsing wall panels in phase 2 of flood wave

Wall Panel No. 8 collapsed on 15 July 2017 after sustaining inundation depth up to 990 mm. The left over wall panel number 6, 9, and 12 sustained the second phase of inundation and are still standing in the flood tank.

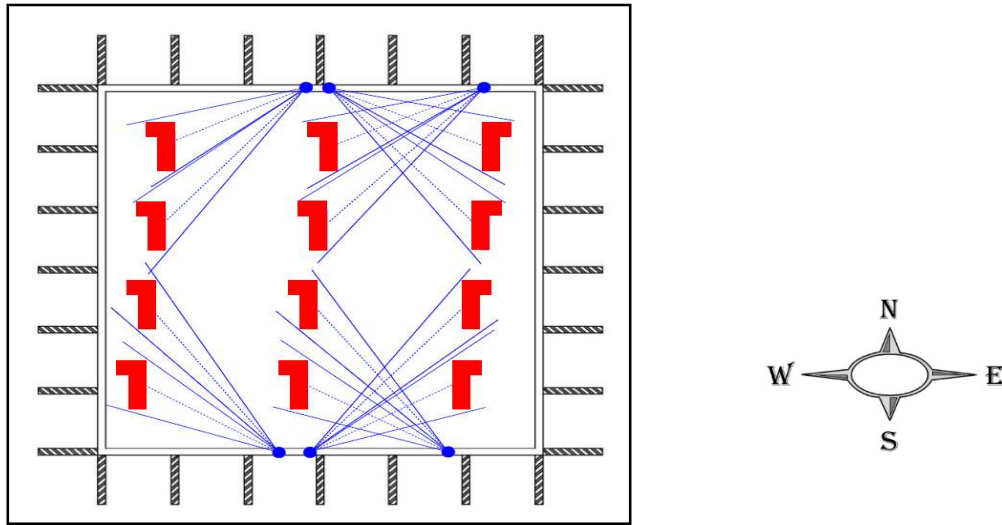
Positive (+) signs of maximum lateral movement depict that wall is moving in westward direction while negative shows the opposite meaning. The reference meridian for direction is shown in Figure 11. However, direction of collapse of panel is the function of the observation taken before the panel fails not the maximum value during the observation period.

Figure 11 Reference for Direction of collapse

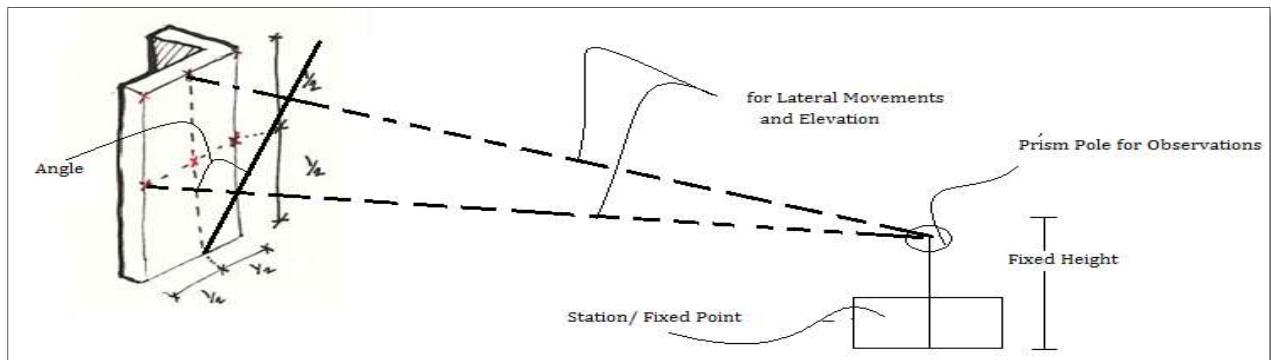
Maximum lateral movement is reported on point 01 to 06 for each of the panel face. Angles were calculated on the basis of the lateral movement and height of the panel. All values of angle reported in radians. Elevation variation was calculated on the basis of the elevation data with reference to a bench mark setup as shown in Figure 12.

Figure 12 Explanations of Different Measurements

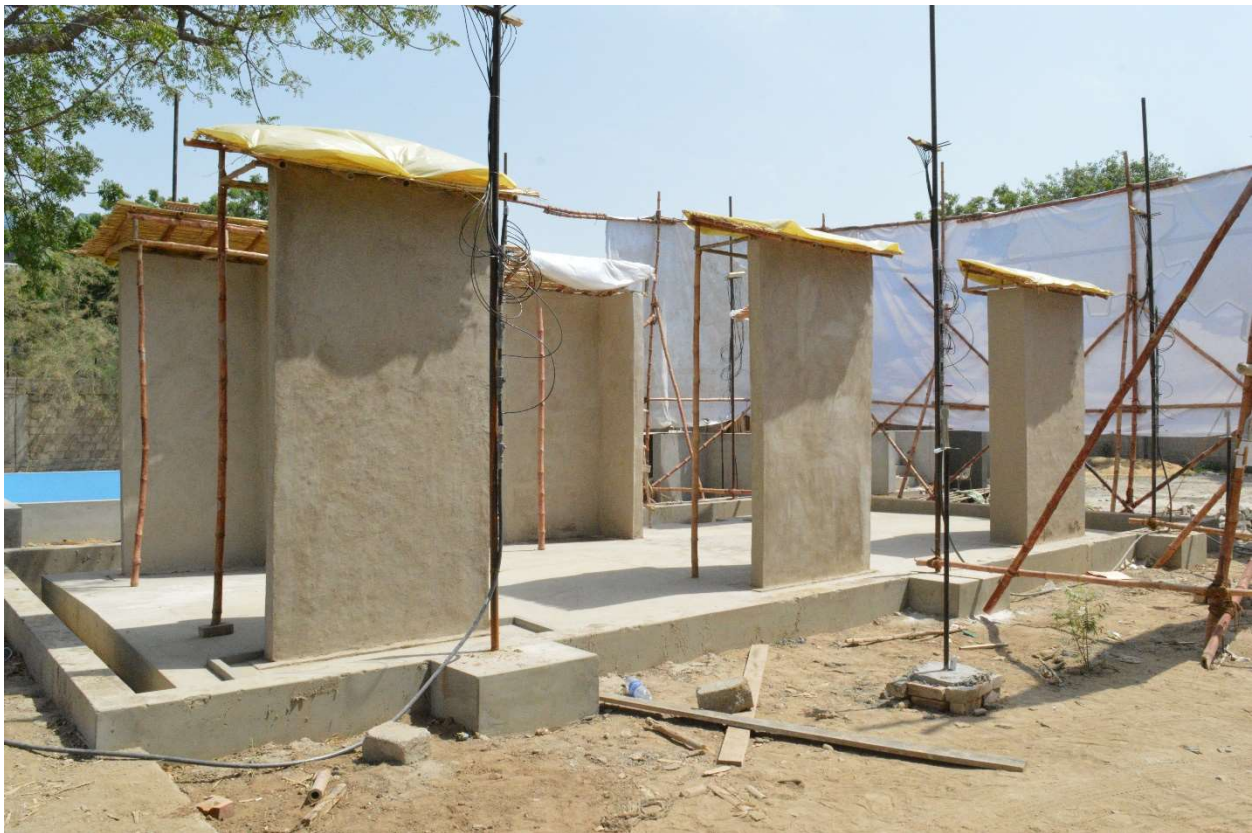
In order to achieve the desired objectives, a rainfall simulator is constructed at NED University of Engineering and Technology. The rainfall simulator has a concrete cement flatbed of  $20 \times 9$  m with sprinklers mounted on elevated poles along its periphery as shown in Figure 1.

Figure 1. Rainfall Experiment Setup

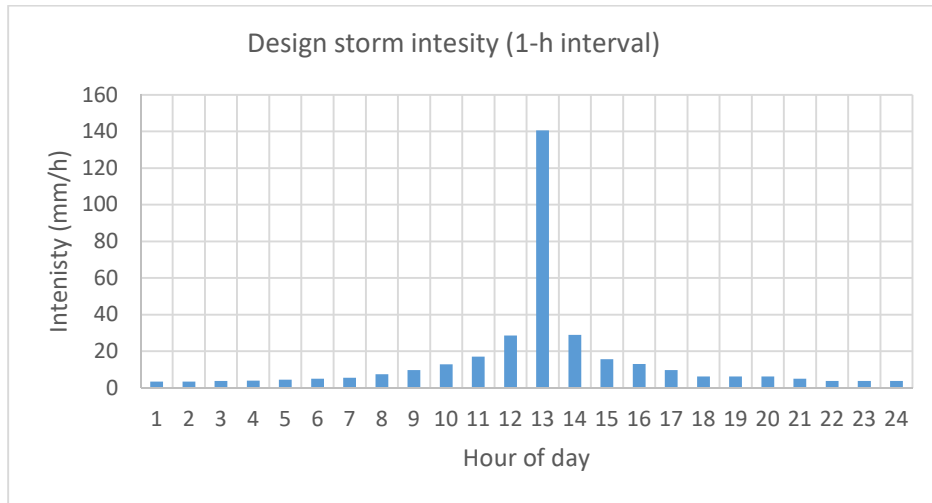
module PC-Storm Water Management Model (PC-SWMM, CHI, Canada) is used to convert the 24 hour values over smaller time interval. For an arid region, SCS type III design storm is used. This design storm gives the highest rainfall intensity for an hour - 140.5 mm/hour.

Figure 3. 24-hr distributions for 347.98 mm rainfall

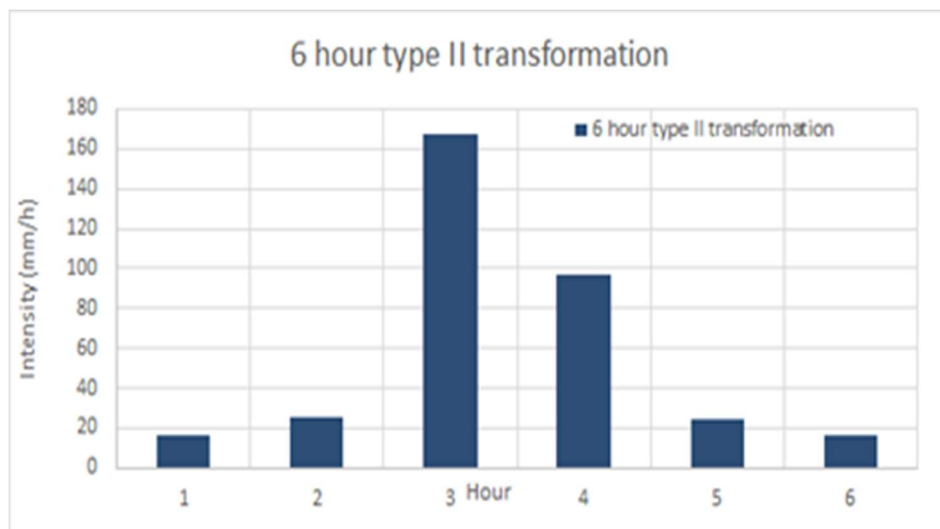
The 24-hour rainfall is transformed into 6-hour rainfall, to help the logistics of testing, by changing the intensity and keeping the total amount of rainfall and probability distribution of the rainfall intensity constant. Figure 4 shows the distribution after transforming 24-hour rainfall into 6-hour rainfall using type II design storm.

Figure 4. 6-hour distribution of 347.98 mm rainfall

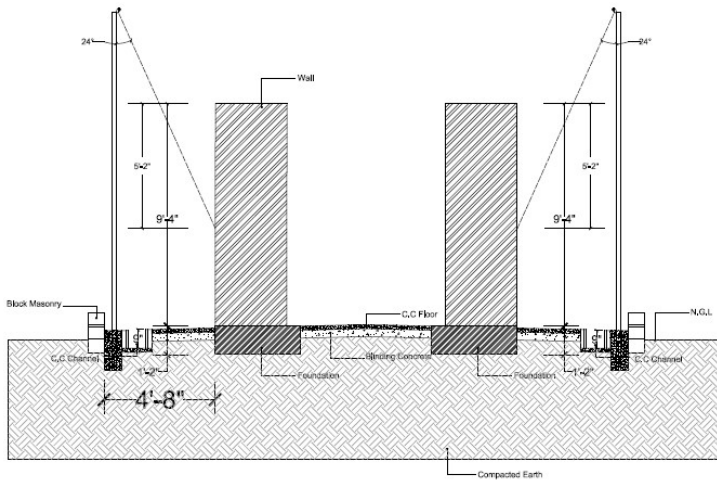
Sprinklers are mounted on elevated poles along the periphery of the plot to provide equal simulation conditions for each wall panel. Sprinklers are orientated to cover full wall height with the middle of the sprinkler shower hitting the middle of the wall panel as shown in Figure 5. **Error! Reference source not found.** The extent of the sprinkler includes the base of the wall and the floor just in front of the wall, to ensure that the effect of rain at the toe of the wall is simulated accordingly. Figure 6 shows a wall panel on the rainfall experiment setup. Drainage is also provided ensuring that the water runoff will not flood the base of the panel and for drained water sampling as shown in Figure 6.

Figure 5. Cross section of the rainfall simulator

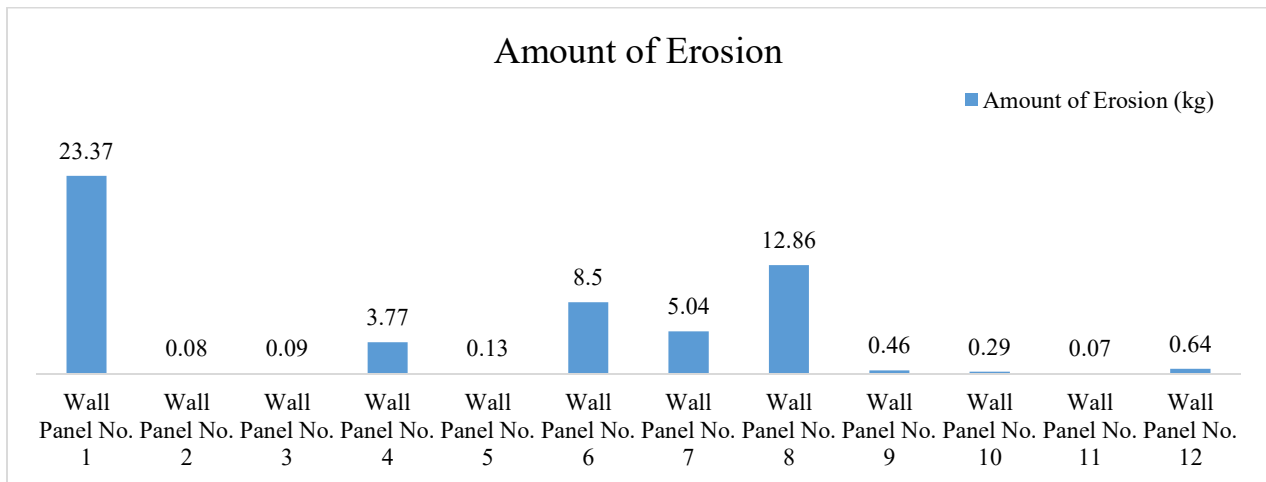
It is evident from the analysis for all the walls that the highest amount of erosion is observed in the 3<sup>rd</sup> and 4<sup>th</sup> hours during which the intensities were the highest and the second highest, respectively. Figure 9 shows the total erosion plotted against respective wall numbers.

Figure 9. Total erosion in Kgs for all wall panels

The analysis show that wall panel no. 1 suffered the maximum loss due to erosion and wall no. 10 sustained erosion with minimum amount of 0.07 Kg of erosion.

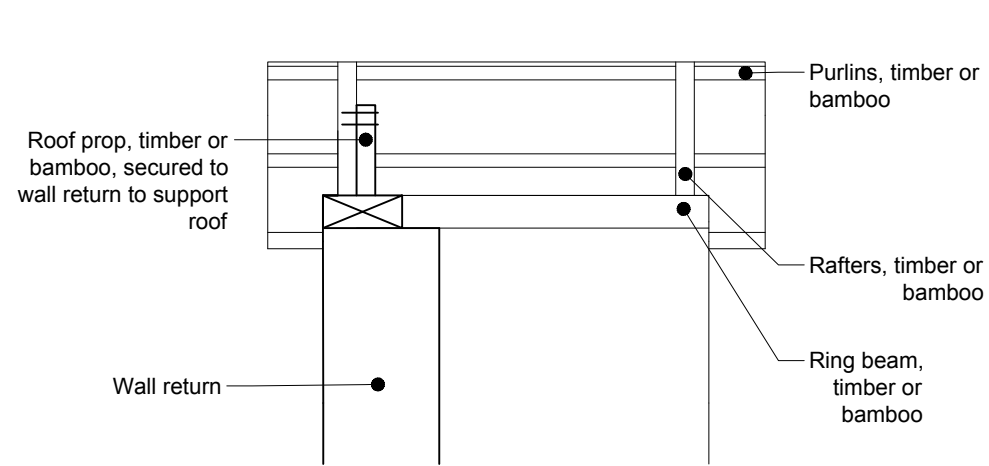
Abode roof construction elevation

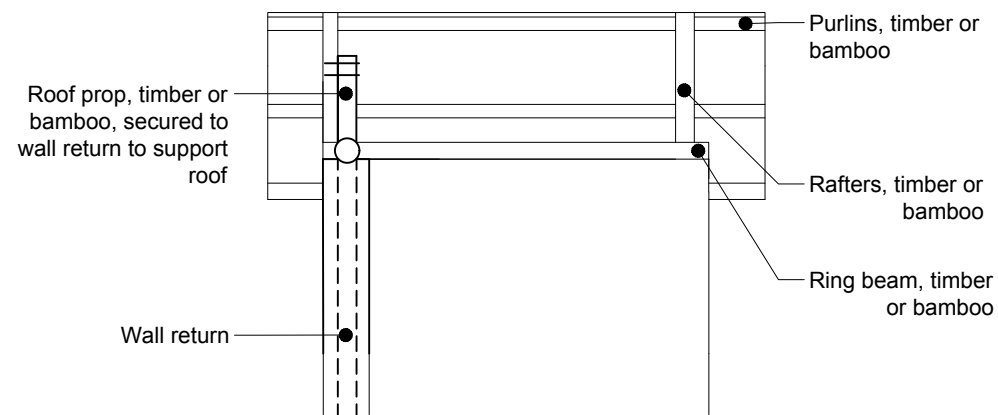
Loh-kat roof construction elevation

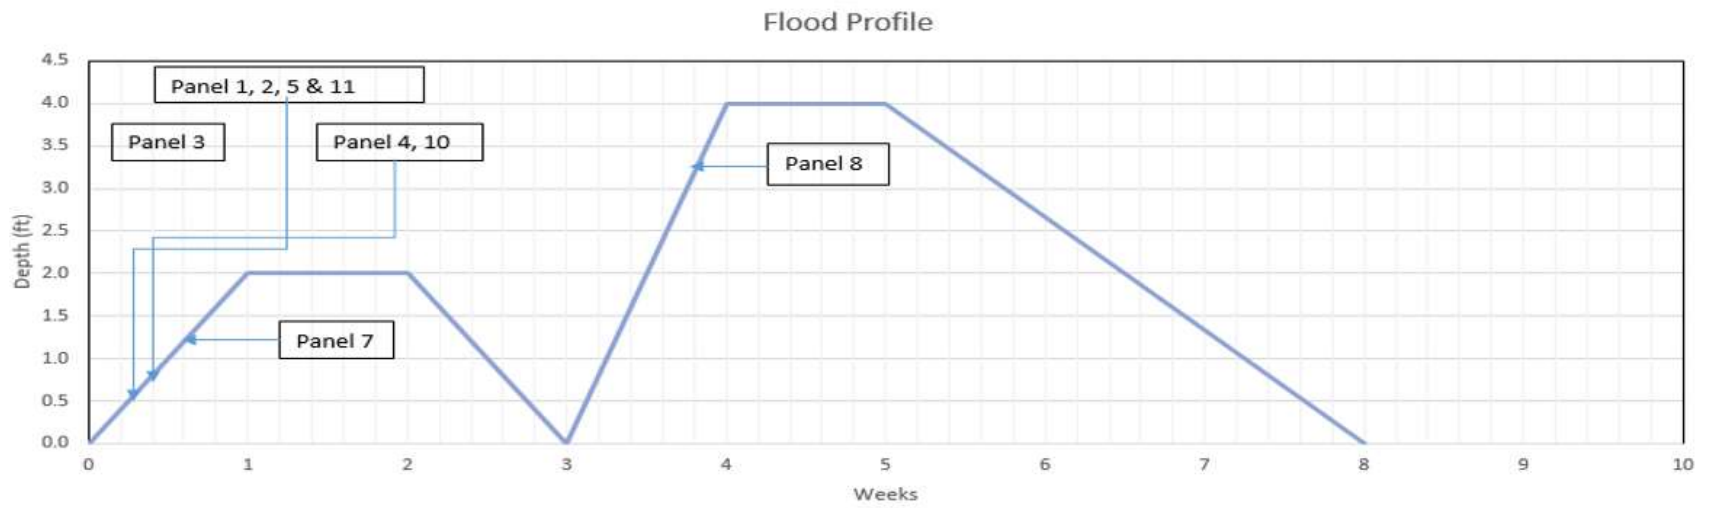
**Figure 1** – Flood profile indicating time and depth of collapse of different panels

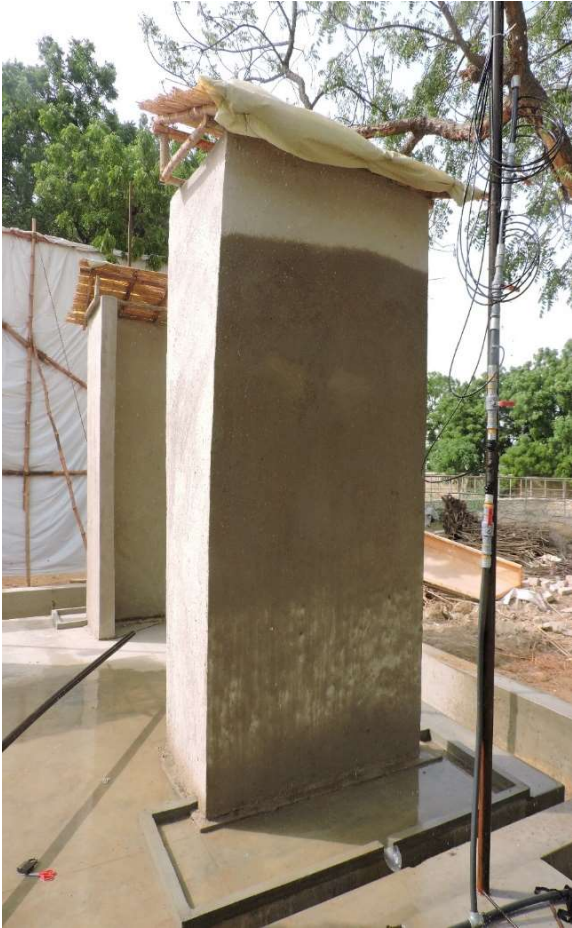
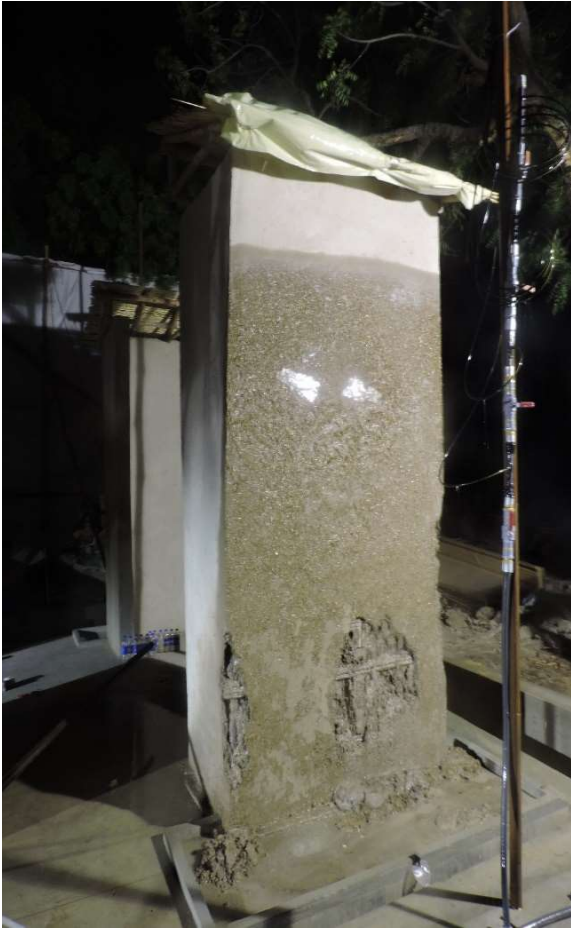
Panel 1: Traditional Loh-kat with clay soil, sand & straw render

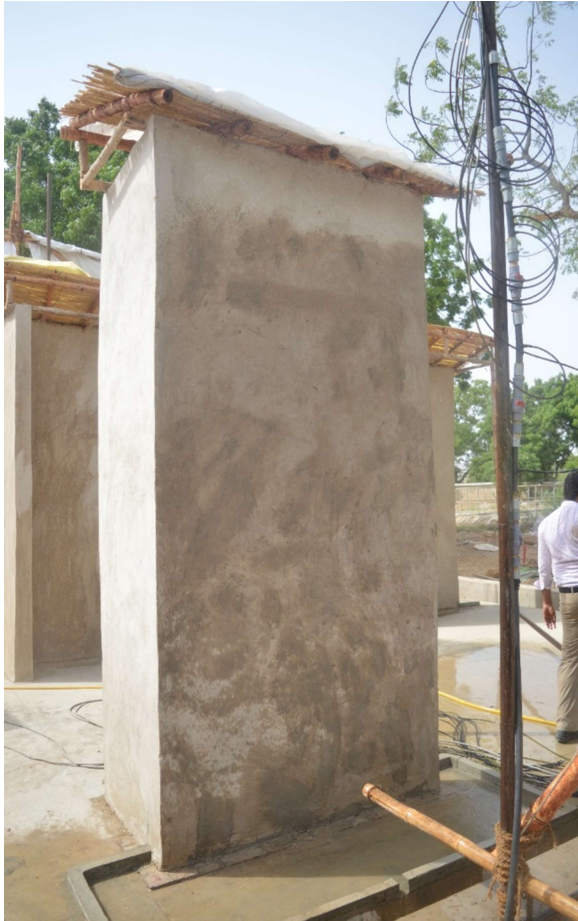
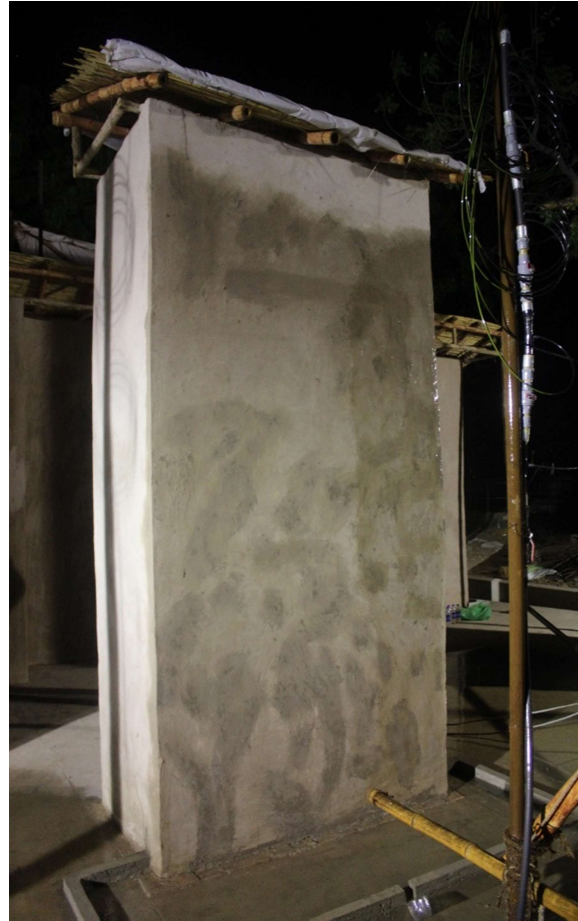
Panel 2: Traditional Loh-kat with lime putty, clay soil, sand & wheat straw render

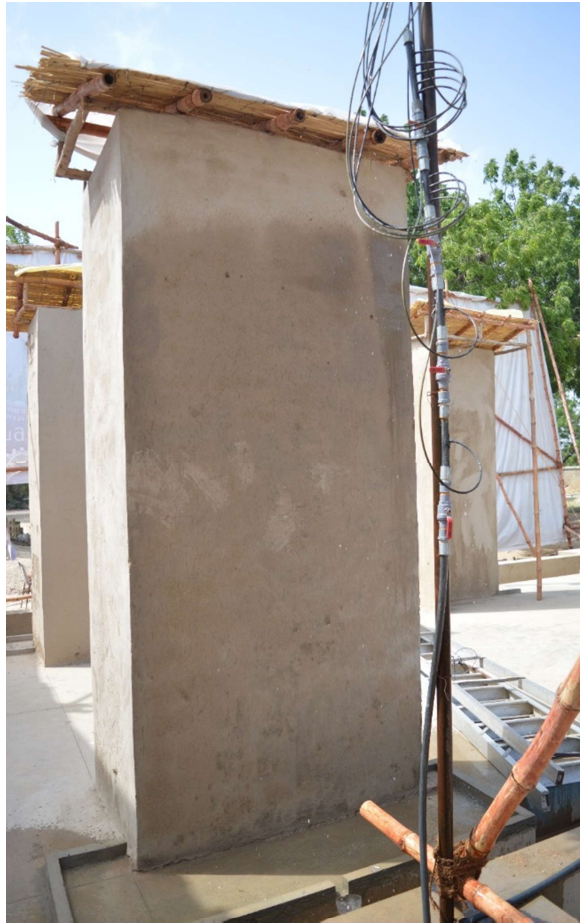
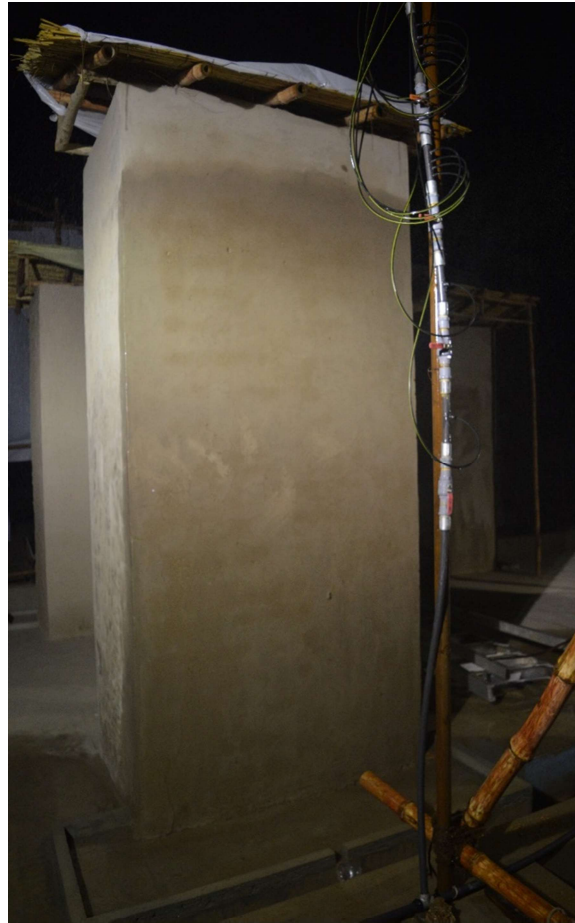
### Panel 3: Adobe block walls with soil-cement render

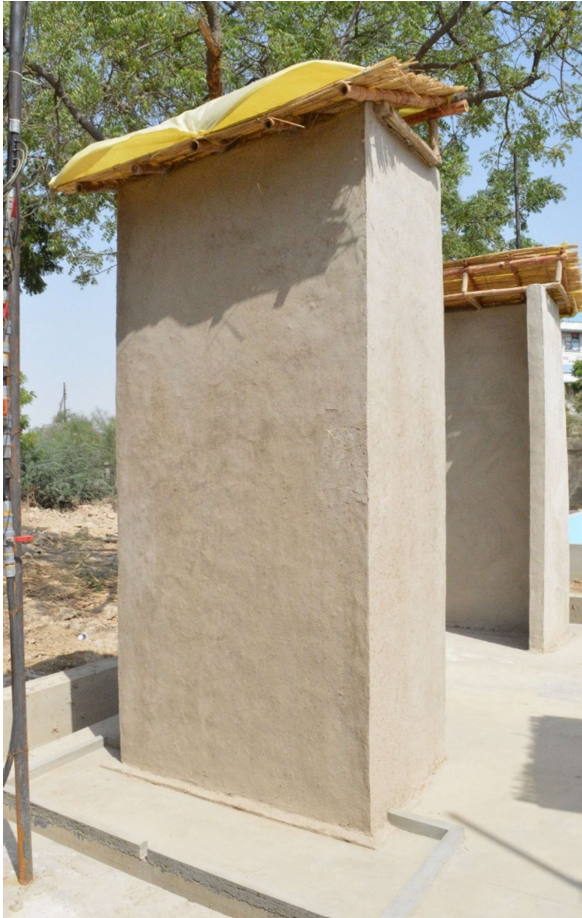
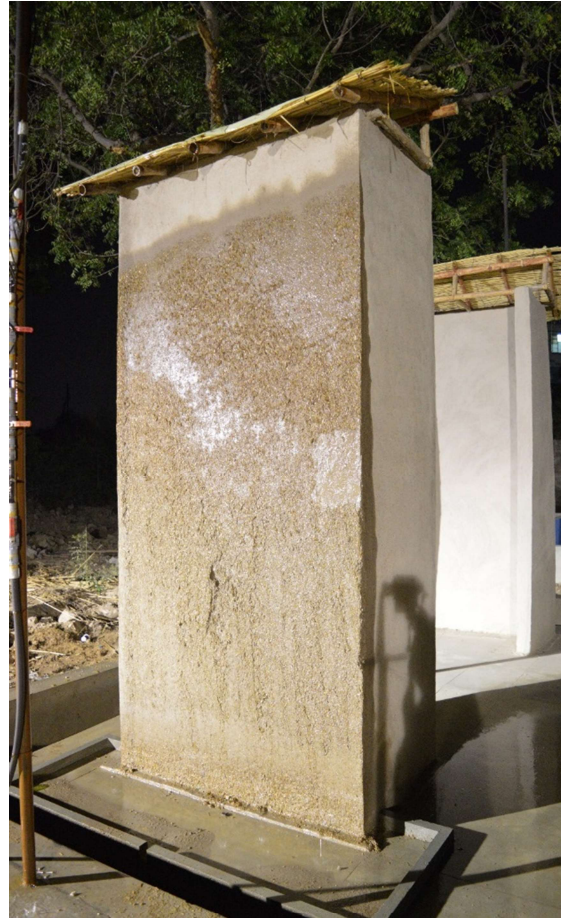
Panel 4: Bamboo and chicks matting Loh-kat with clay soil, sand & straw render

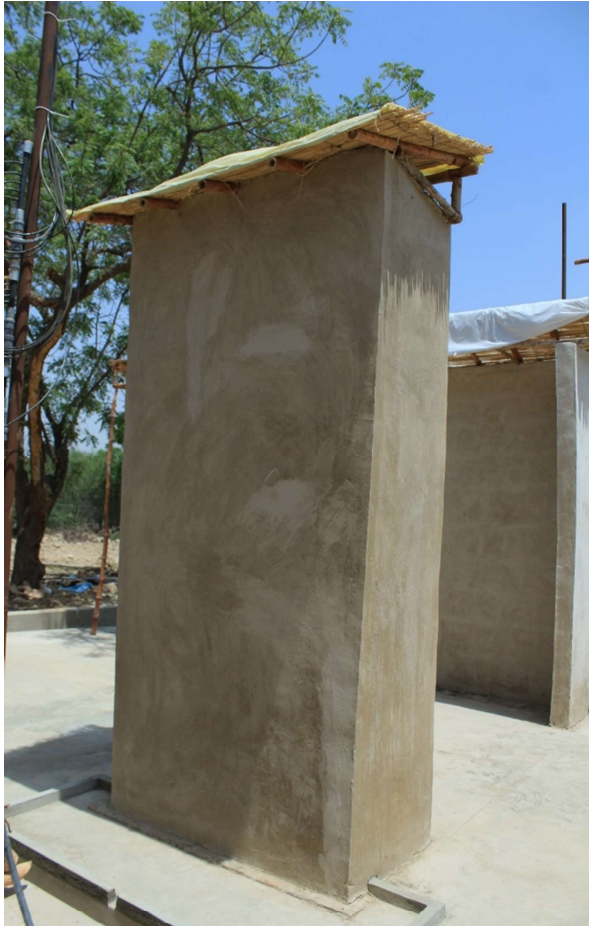
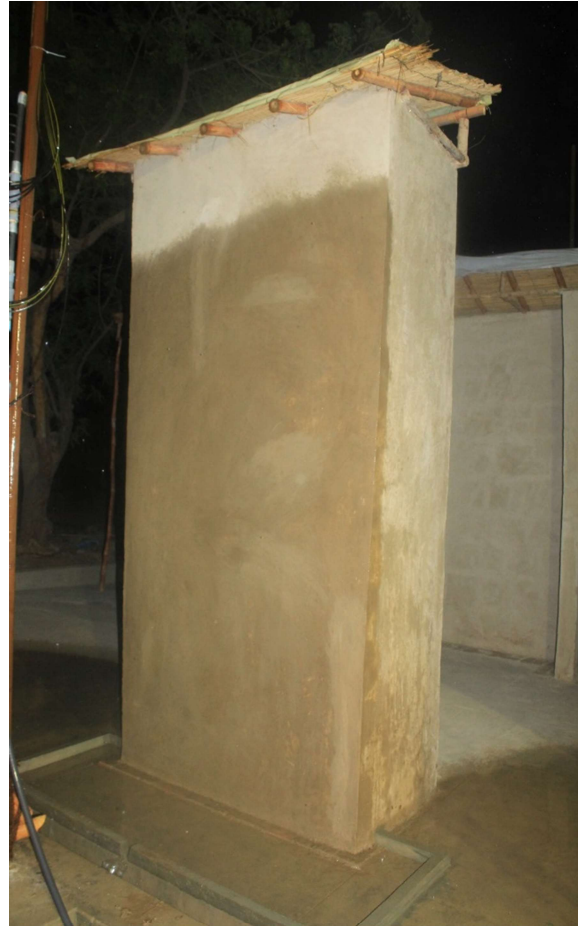
Panel 5: Bamboo and chicks matting Loh-kat with lime putty, clay soil, sand & wheat straw render

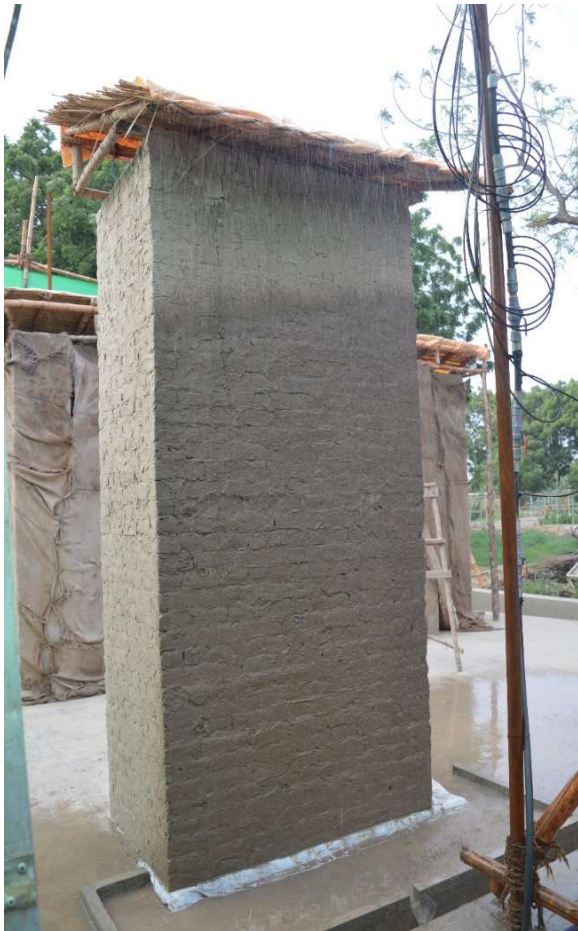
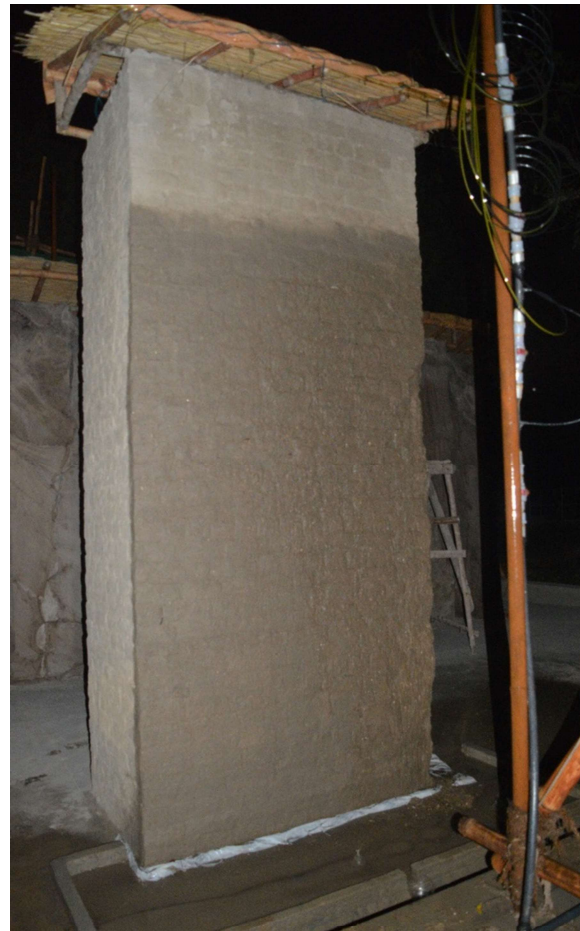
Panel 6: Adobe soil block walls with no render

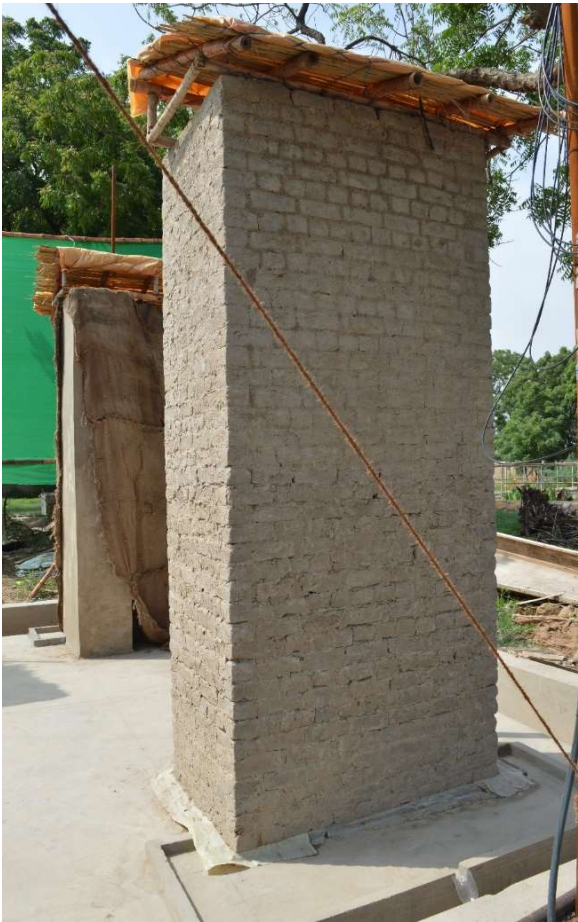
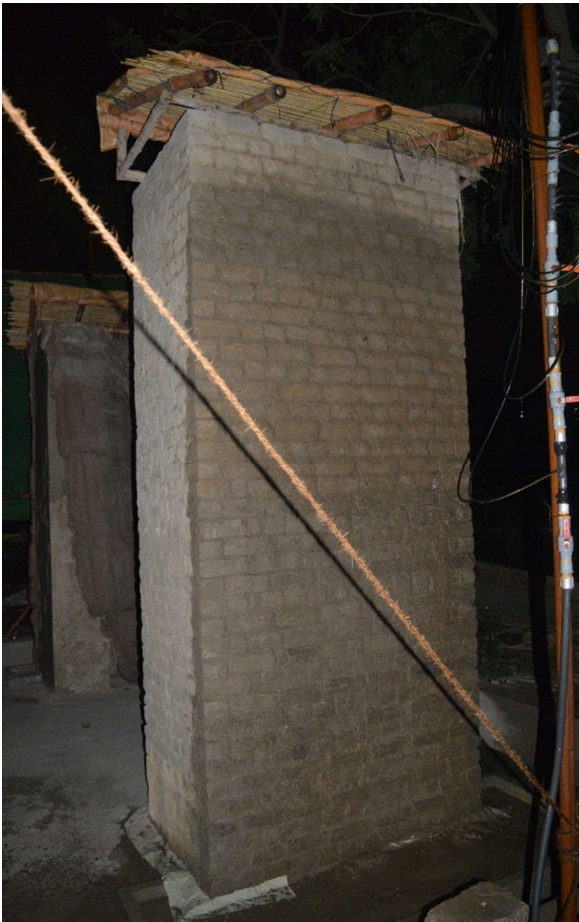
Panel 7: Adobe lime soil block walls with no render

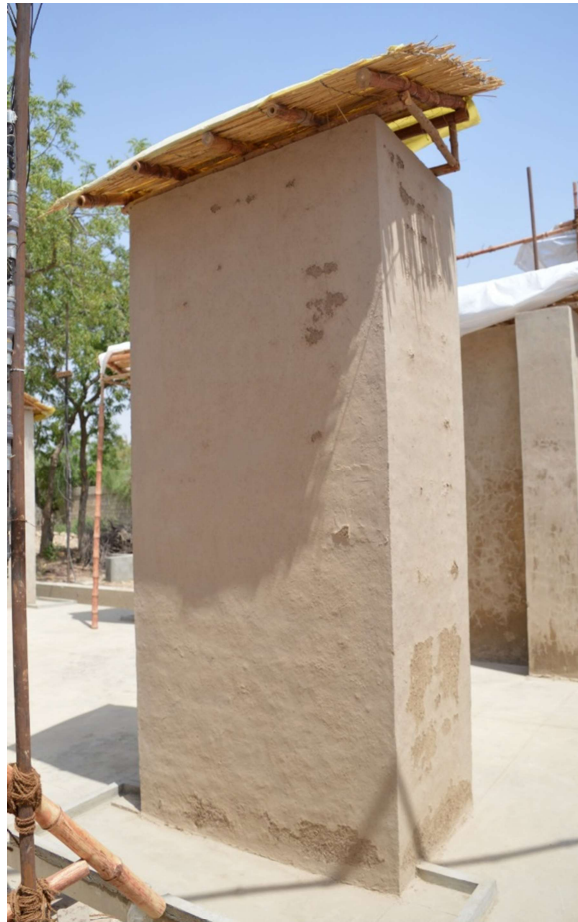
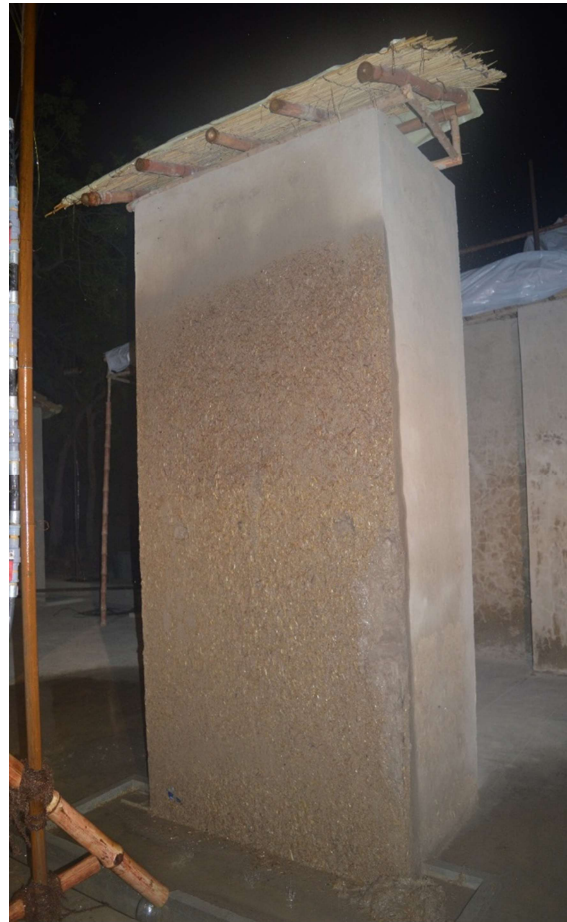
Panel 8: Adobe soil block walls with clay soil, sand & straw render
