## Materials

## Understanding flood damage to shelter

The following findings are extracted from a Rapid Technical Damage Assessment<sup>1</sup> conducted by UN Habitat following the 2010 floods.

The objective of this study is to assess the flood or inundation resilience of structures made up of clay as the primary constituent. Walls with conventional clay mix design and engineered clay mix design (experimental) along with other constituent and fibres are tested. Effect of wall geometry on its resilience is also assessed.

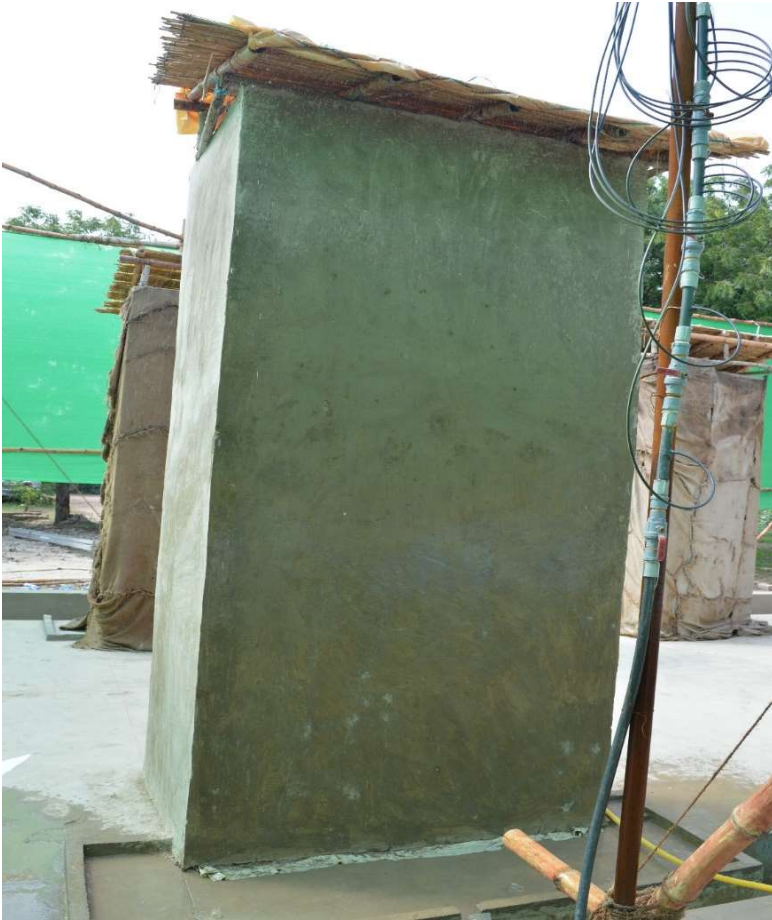
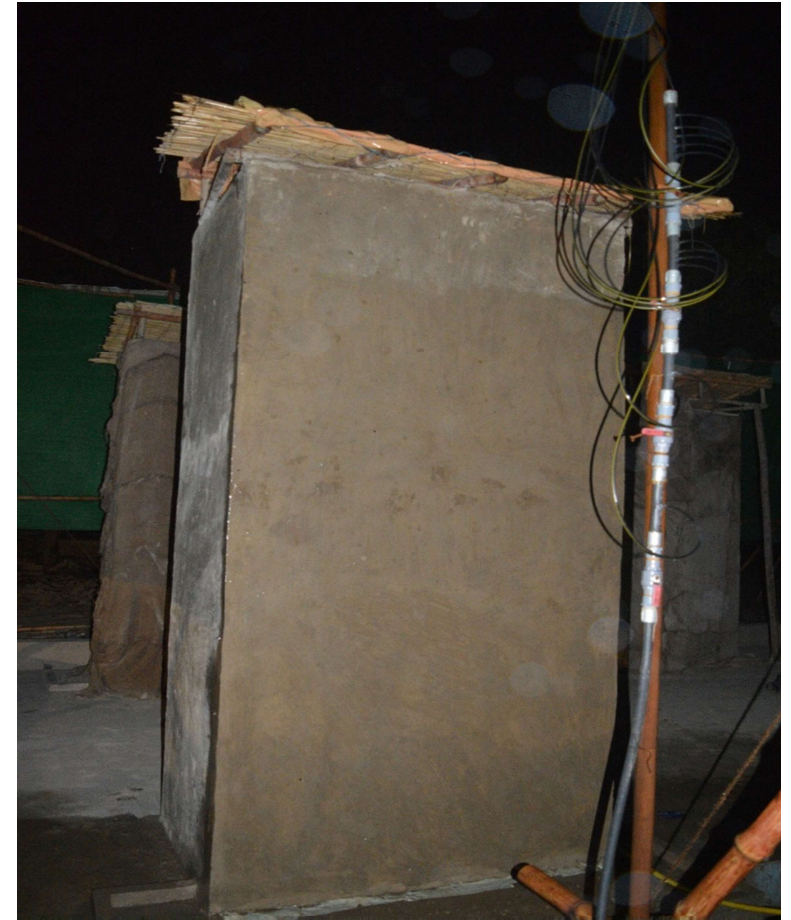
Panel 9: Adobe soil block walls with lime putty, clay soil, sand & wheat straw render

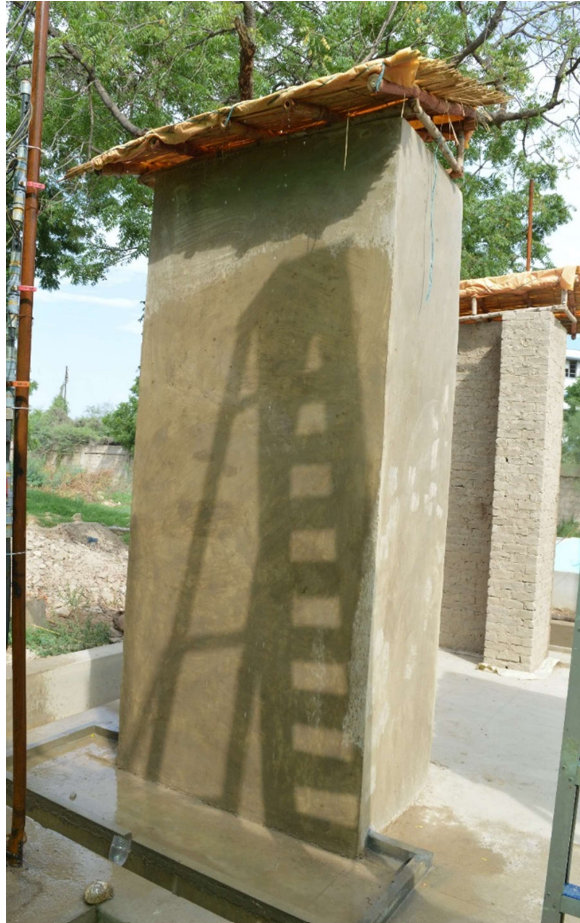
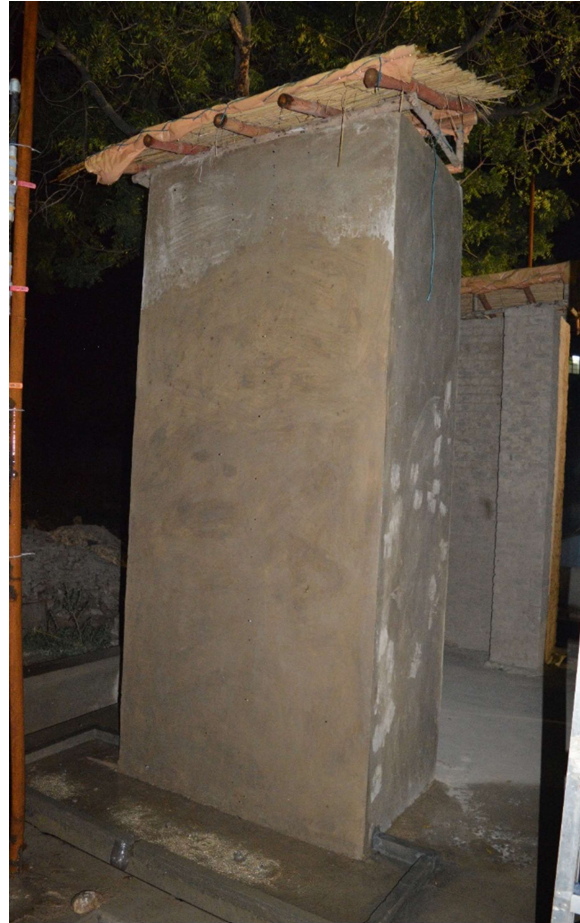
Panel 10: Adobe soil block walls with lime, soil, sand, dung & straw render

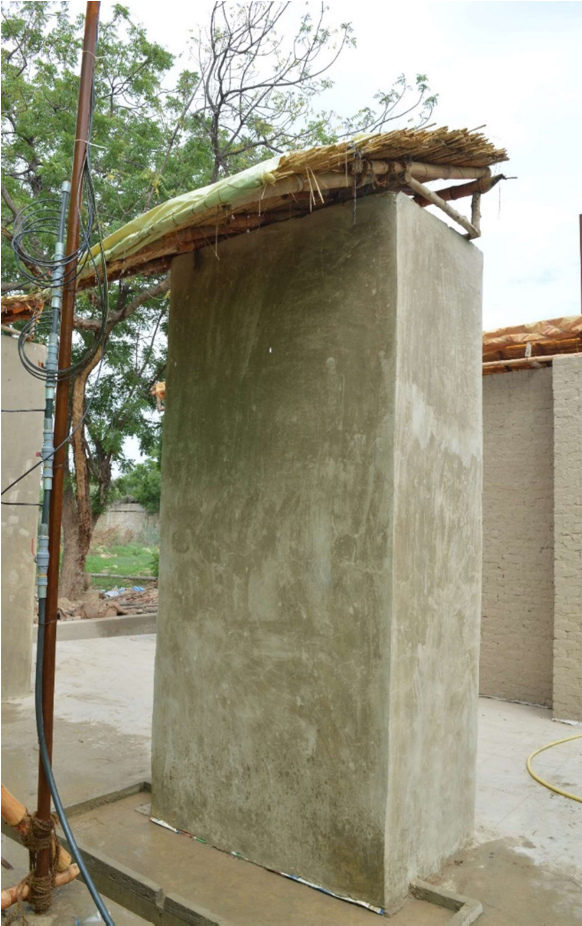
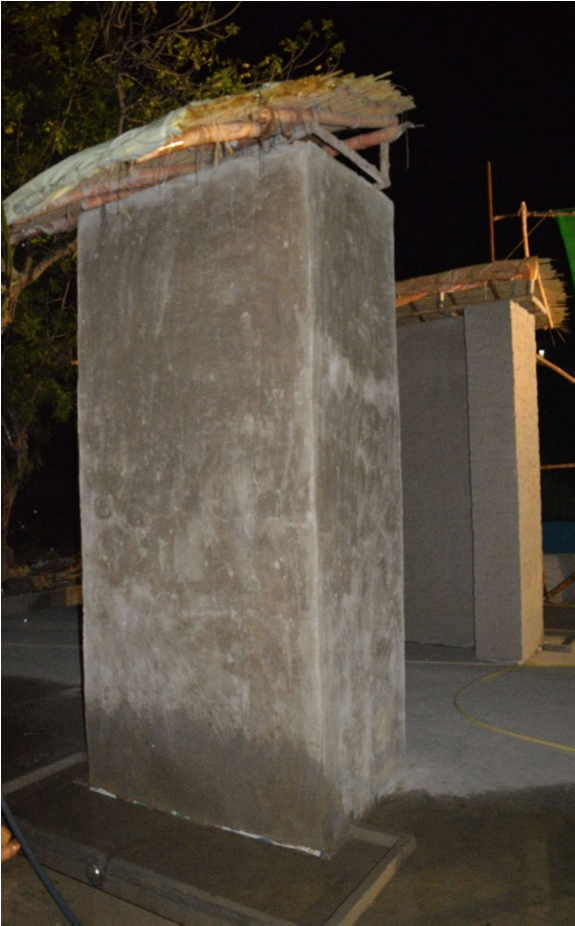
Panel 11: Overhang Adobe soil block walls with lime putty, clay soil, sand & wheat straw render

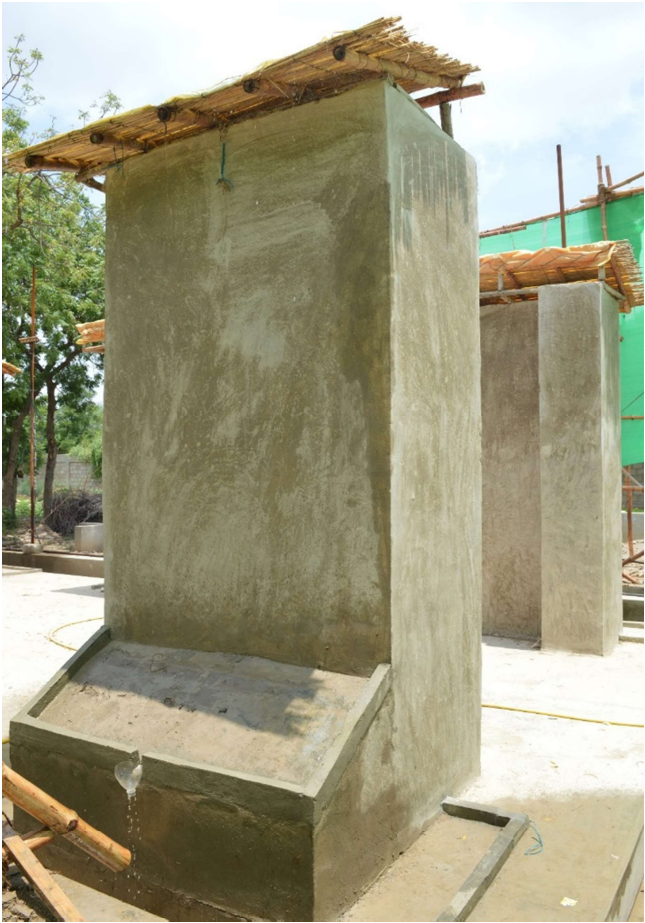
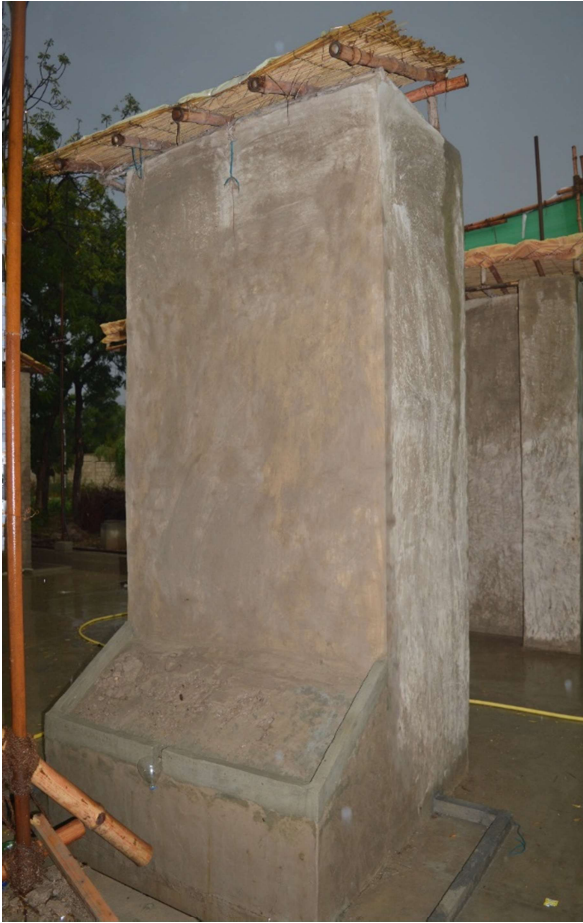
Panel 12: Toe detail Adobe soil block walls with lime putty, clay soil, sand & wheat straw render
