**SERVICE INQUIRY INTO AN ACCIDENT INVOLVING A WATCHKEEPER UNMANNED AERIAL VEHICLE (UAV) WK031 AT WEST WALES AIRPORT (WWA), ABERPORTH ON 16 OCT 14**

## MAA DG/SI/04/14 – CONVENING ORDER FOR SERVICE INQUIRY INTO AIRCRAFT OCCURRENCE INVOLVING WATCHKEEPER WK031 ON 16 OCTOBER 14 AT 1113L

**PART 1.3 – NARRATIVE OF EVENTS**

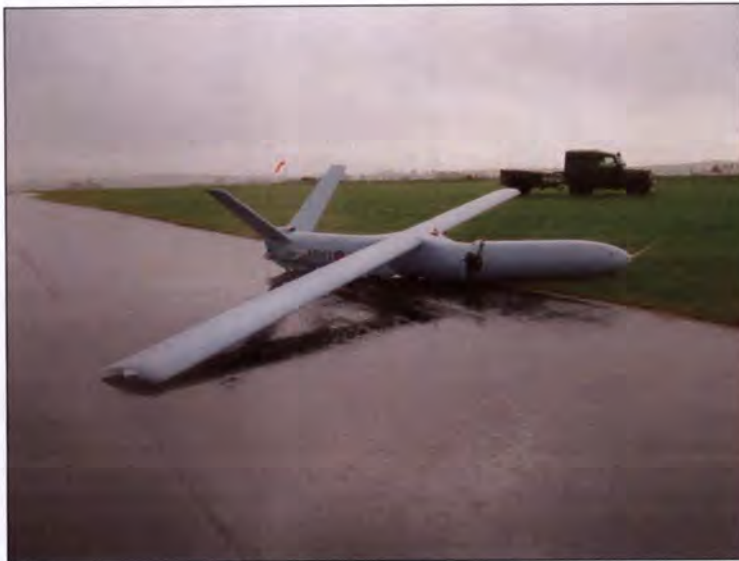
Figure 1 - WK031 on Southern side of Rwy 26

1.3.16. Post the UAV's 'Flare and de-crab' external eyewitnesses observed the UAV pitch rapidly nose down from a height of approximately 10-15ft AGL and impact the runway, causing considerable damage to the fuselage structure. The vehicle continued to slide along the runway with the undercarriage collapsed before coming to rest on the runway's southern side at 1113hrs.

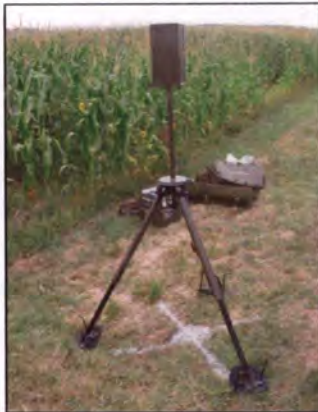
1.4.17. **ATOLS Components.** ATOLS comprises several key components, namely the Ground Beacon Unit (GBU) (Fig 5) which acts as a terrestrial reference point, the Ground Radar Unit (GRU) (Fig 6) and the Airborne Beacon Unit (ABU). The GRU and GBU are located next to the runway at accurately surveyed points and the ABU is located in the nose of the UAV. The GRU tracks the position of the UAV and provides position information to the vehicle via the GCS and datalinks using the GBU as a surveyed reference to enable accurate target positioning. In the event of a failure or malfunction of the ATOLS, the UAV can still perform an automatic landing by reverting to the GTOLS.

Figure 5 - Ground Beacon Unit (GBU)

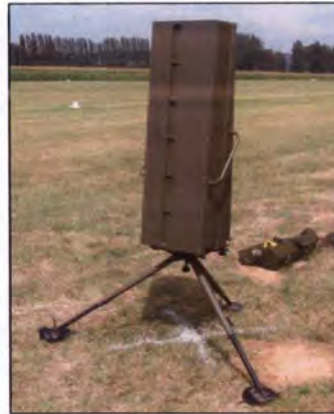
Figure 6 – Ground Radar Unit (GRU)

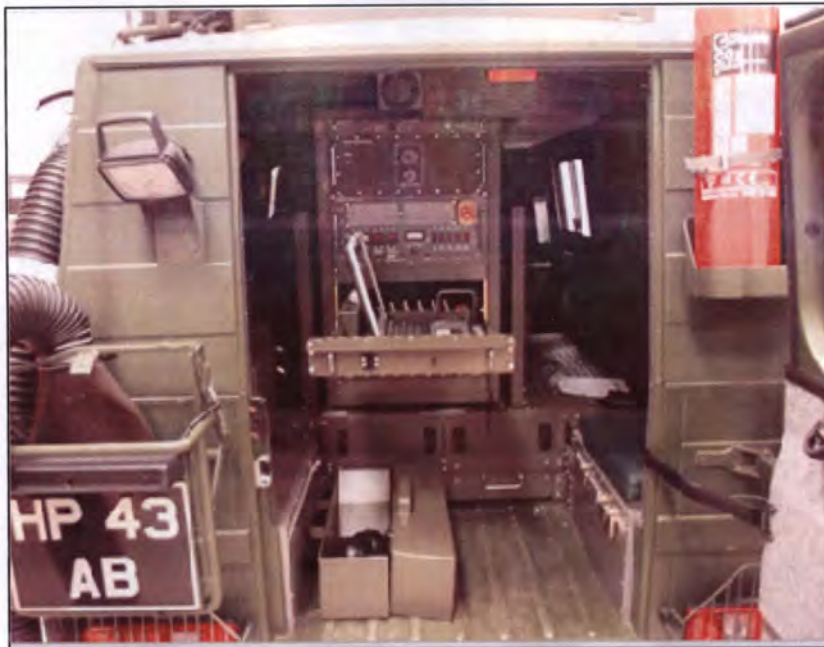
1.4.18. **Portable Aircraft Test Equipment (PATE).** The PATE is normally housed within the Flight Line Section Command Unit (FLSCU), a modified Pinzgauer vehicle (Fig 7) that is also used to tow the UAV during airfield /strip operations. The main functions of the PATE include:

- a. UAV 'Before and After Flight' checks.
- b. UAV functional system tests.
- c. Pre-flight checks.
- d. Engine start.
- e. Data upload/ download.
- f. Supporting fault diagnostics to Line Replaceable Unit (LRU) level including payloads.

Figure 7 - The Portable Air Vehicle Test Equipment (PATE)

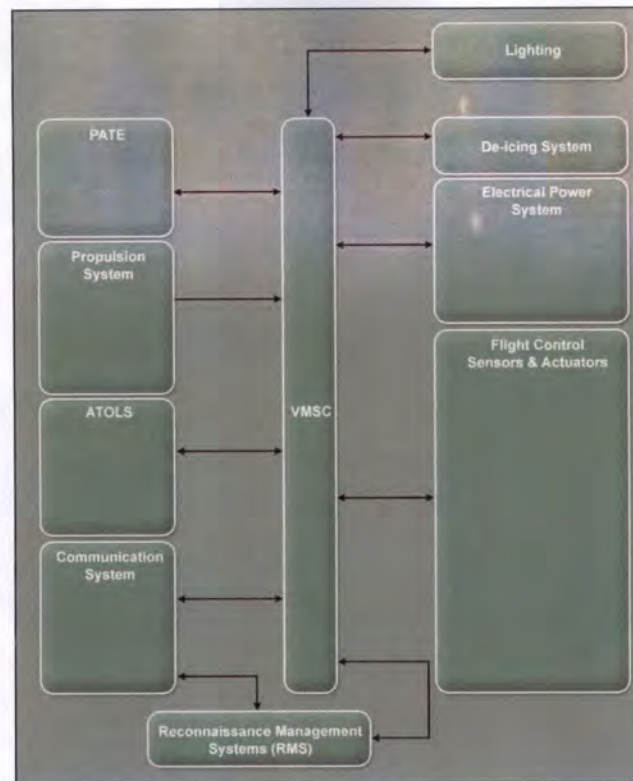
1.4.20. **Vehicle Management System Computer (VMSC).** The VMSC forms the 'brain' of the UAV and is a single physical LRU; it houses dual redundant computers primarily responsible for controlling the VMS (Fig 8). An in-built VMS monitor compares the health status of the two computers (Side A and B) and will decide which computer to utilise. The VMSC is a software based computer system which houses a multitude of hardware interfaces designed to interact in real time with sensors, monitors and controls incorporated within the UAV. It responds to the pre-programmed flight mission plan and reacts dynamically to near real time commands received from the GCS via the data links. It is designed to automate routine tasks normally carried out by the pilot of a conventional aircraft through all phases of flight from Engine Start to Engine cut, including Automated Take Off and Landing.

Figure 8 - Vehicle Management System Computer (VMSC)

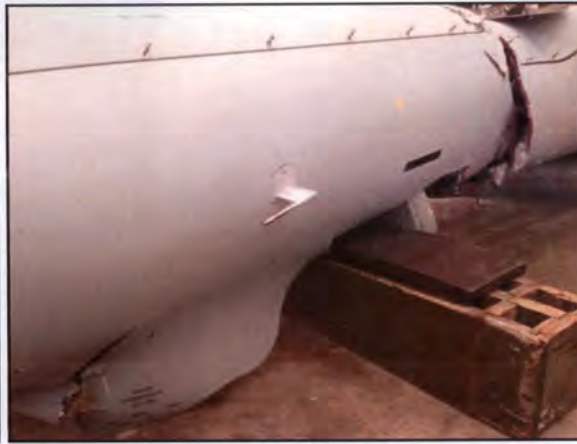
1.4.23. **Pitot Systems.** There are 2 dual redundant pitot systems fitted to the Watchkeeper. Both the Kollsman (Fig 9) and Space Age pitot probes (Fig 10) supply static and total pressure, which feeds dual redundant Air Data Units (ADU) within the Athena units. Static and Total pressure measurements are then differenced to provide dynamic pressure which is used by the VMSC. Angle of Attack (AOA) and Angle of Slip (AOS) are supplied by the Kollsman pitot probe only.

Figure 10 – Space Age Pitot
