Rail Accident Investigation Branch

Rail Accident Report

Fatality at Johnson's footpath crossing near Bishop's Stortford, Hertfordshire 28 January 2012

Report 27/2012
December 2012

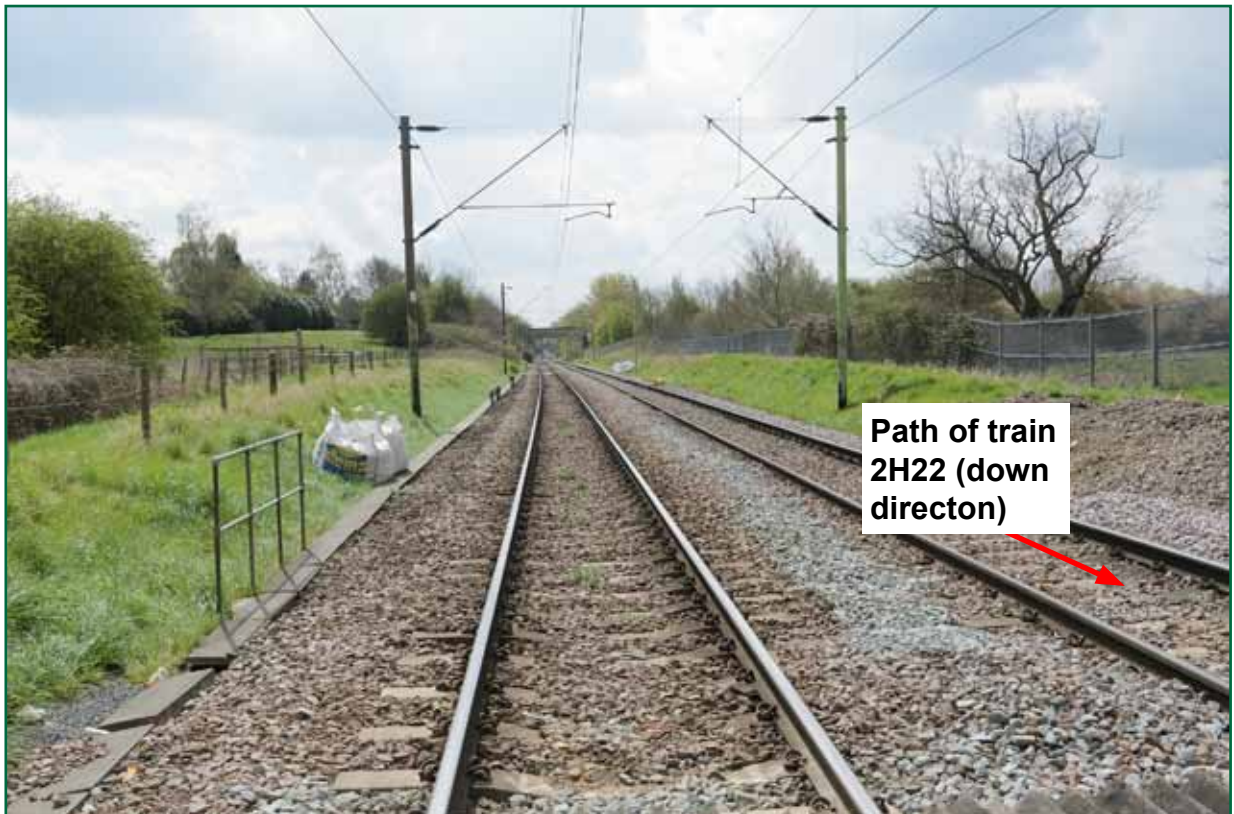
Figure 3: View from Johnson's footpath crossing, looking in the up direction (south) towards Bishop's Stortford

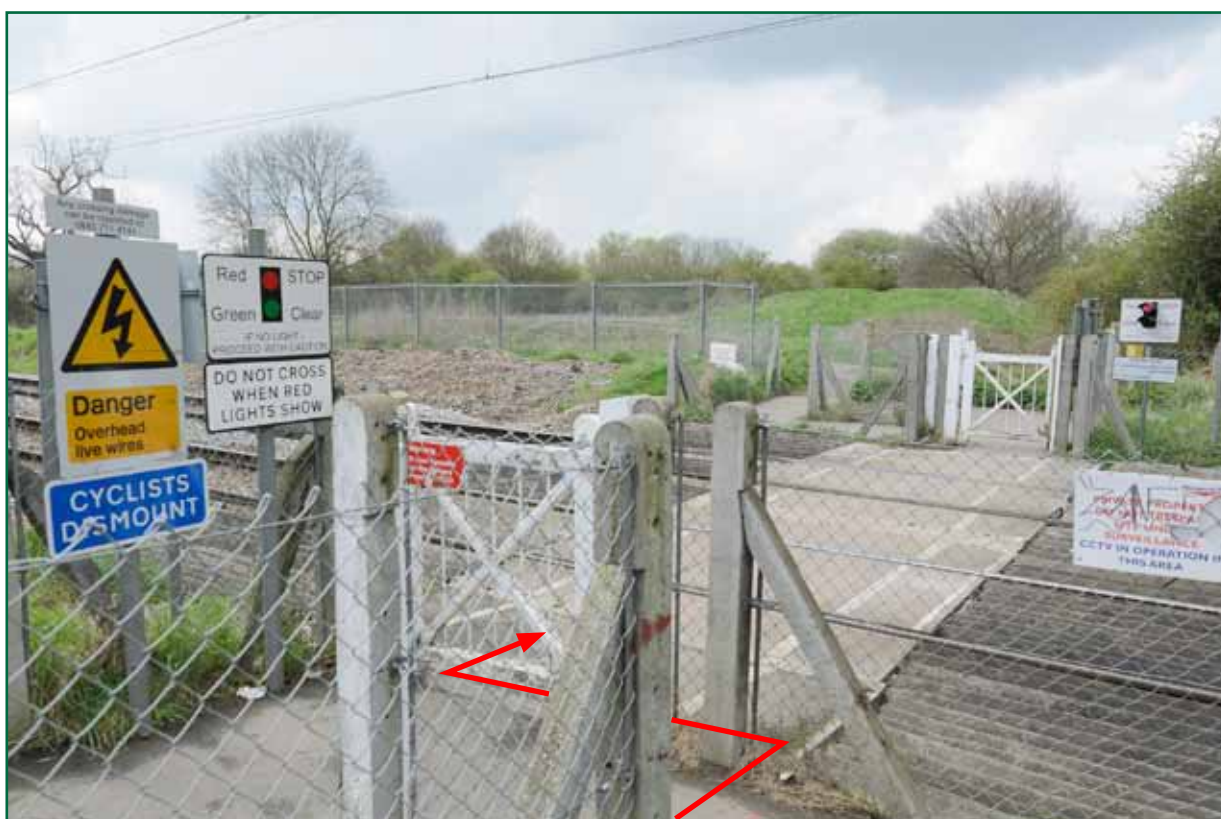
Figure 4: Approach to Johnson's footpath crossing viewed from the east (up) side

- 15 The crossing was equipped with *miniature stop lights* (MSLs)³ (located on the opposite side of the railway from approaching pedestrians), audible alarms, self-closing wooden gates and warning signs. The positioning of the MSLs on the far side of the railway corresponded with the guidance published by Her Majesty's Railway Inspectorate⁴ when they were installed (refer to paragraph 29). The signs also complied with guidance at the time; additional signs reading 'Do not cross when red lights show' were positioned so that they were visible on the near side of the crossing, see figure 4. The immediate approach to the crossing on each side of the railway involved a doglegged path as indicated at figures 4 and 5.

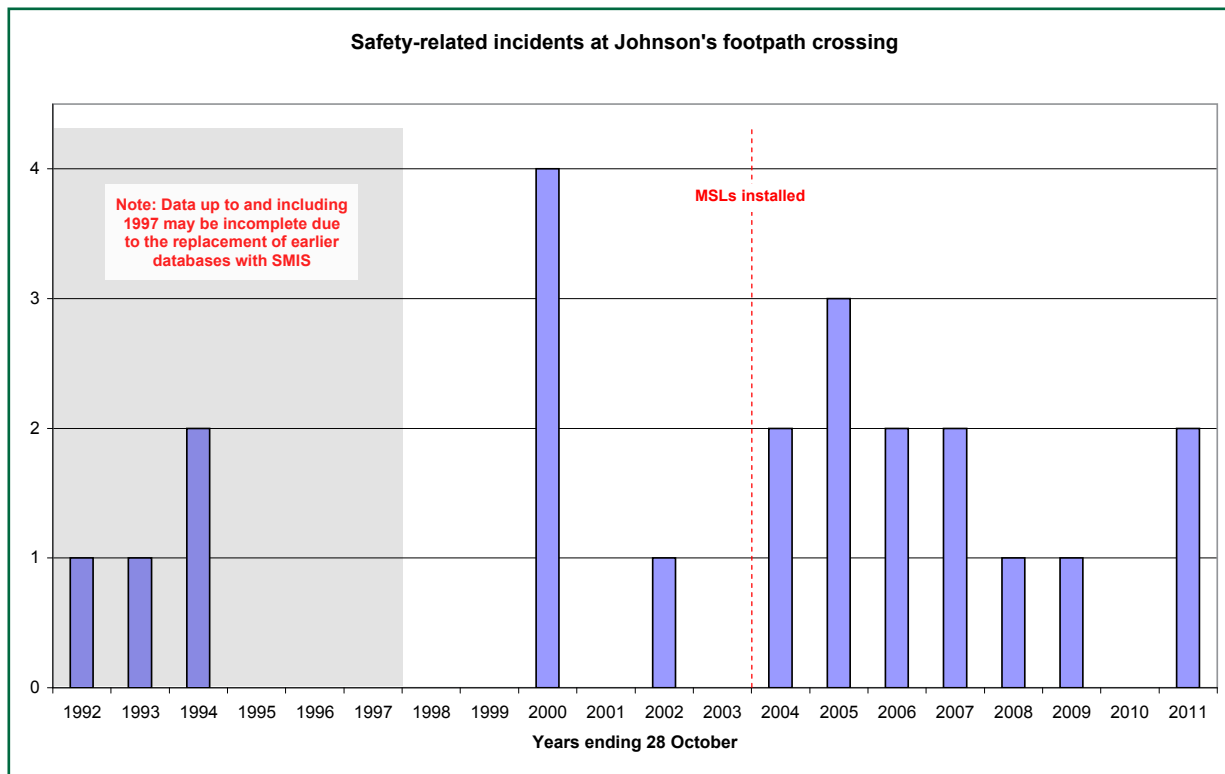
Figure 6: Rate of occurrence of incidents resulting in a near miss or fatality at Johnson's footpath crossing

- 34 The current ALCRM risk scoring of a level crossing (refer to paragraph D5 in appendix D) does not take account of reports of near misses or misuse, although the ORCC is required to consider such factors (paragraph 26; see also paragraph 83). There is documentary evidence that the ORCC considered the history of incidents and near misses at Johnson's footpath crossing, although it is unclear how this was factored into risk assessments for the crossing. In its report on the fatal accident at Halkirk level crossing on 29 September 2009 (RAIB report 16/2010), the RAIB noted that Network Rail's procedures did not give guidance on how the incident history of a level crossing should be used to supplement the information given by the ALCRM, in order to understand the risk and inform decisions on implementing risk reduction measures (refer to paragraph 77).

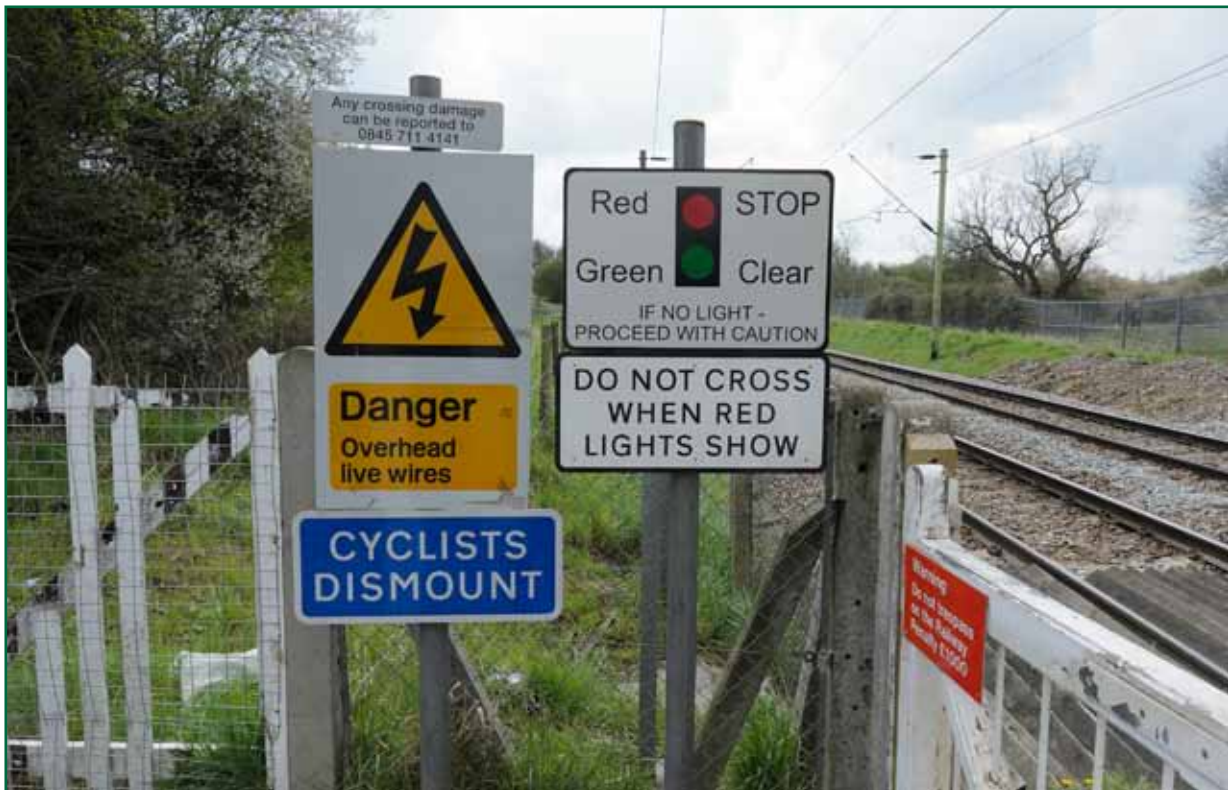
Figure 7: Approach to Johnson's footpath crossing, looking in the up direction (south)

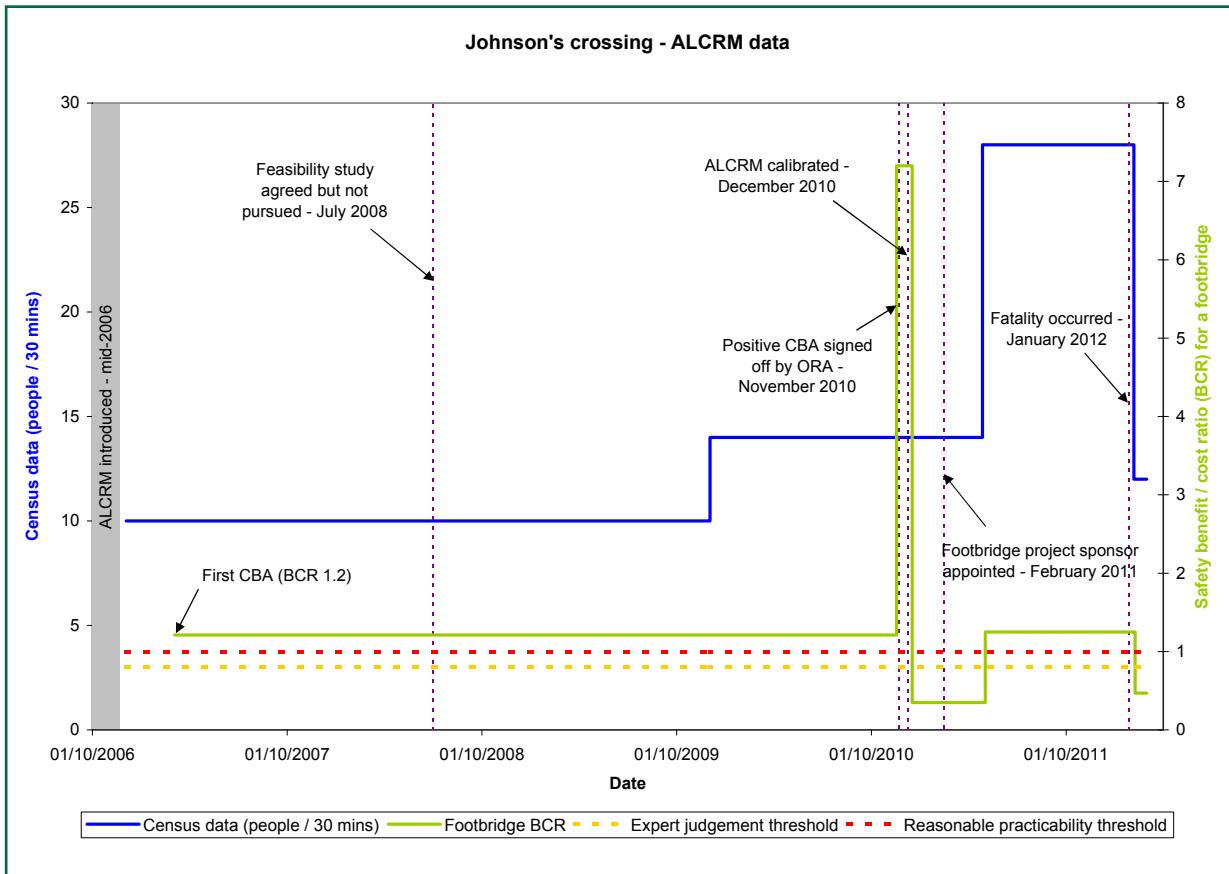
66 Since the re-calibration of the ALCRM in December 2010 (refer to appendix D, paragraph D6), the BCR for a footbridge to replace Johnson’s footpath crossing has varied between 0.35 and 1.25 (table 1 and figure 8), where any figure in excess of 1 represents a positive case for making the investment (paragraph 26). The variations occurred principally because of fluctuations in the census data, although the predicted capital cost of a footbridge was also reduced to reflect Network Rail’s modular footbridge design. The number of crossing users recorded during quick censuses at Johnson’s footpath crossing varied from 7 to 28 users in a 30 minute period (the RAIB counted the number of users of Johnson’s footpath crossing for a total of three and a quarter hours on 12 July 2012; the number observed was equivalent to 16 users per thirty minutes).

Figure 8: Variations in census data and benefit / cost ratio

- 67 The changes in the BCR were sufficient to cause the result of the cost-benefit analysis for building a footbridge to replace Johnson's footpath crossing to fluctuate between 'the benefits outweigh the costs' (BCR > 1) and 'the benefits do not cover the costs' (BCR < 0.8). It is possible that the train frequency recorded in 2007 was an error (for example counting the trains passing over the crossing in one direction only). In addition, despite the variations in pedestrian usage indicated at table 1, it is unlikely that the usage had in fact changed significantly in this period. The RAIB has been unable to identify any underlying changes, such as housing developments in the area, which would explain such variations. The use of the quick census is not always an effective means of gauging pedestrian crossing usage, particularly where a crossing may see increased usage at weekends, or at other times outside of those prescribed by Network Rail²⁷. The RAIB has previously identified issues regarding the effectiveness of Network Rail's level crossing quick census technique in the following investigations²⁸:

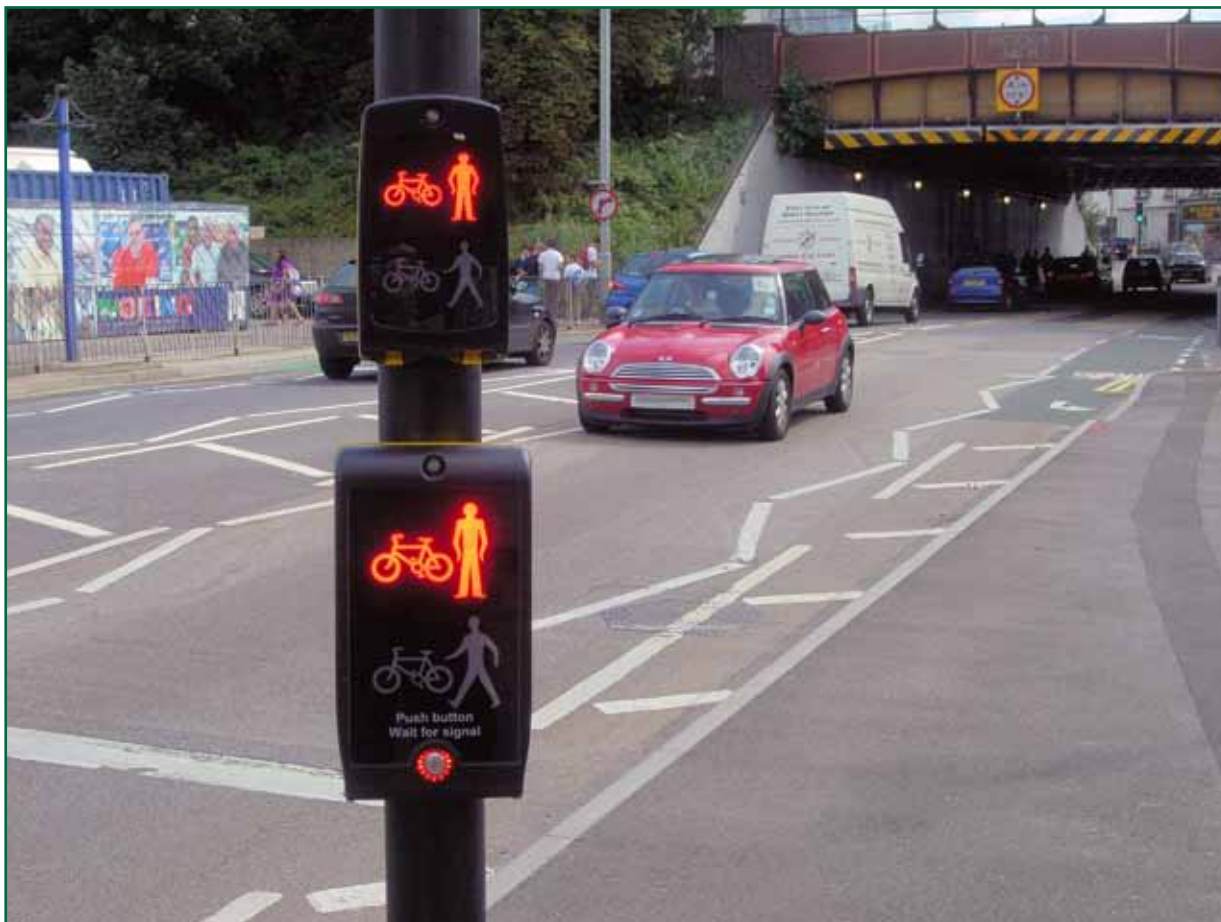
Figure F1: Puffin crossing showing orientation of nearside lights relative to oncoming traffic

<p>Nearside crossing lights (Puffin crossings) are intended to encourage those using the signal demand button to look in the direction of traffic flow.</p>	<p>The ORR has stated that installing MSLs on the nearside of the railway may cause users to be more alert to their surroundings when crossing, not focusing solely on a green lamp ahead. However, the ORR considers that these benefits are probably marginal, and that existing installations in which the MSLs are on the far side of the railway do not need to be modified.</p>
