Revetment Techniques Used on the River Skerne Restoration Project

R&D Technical Report W83

D Murphy and R Vivash

Research Contractor:
The River Restoration Centre

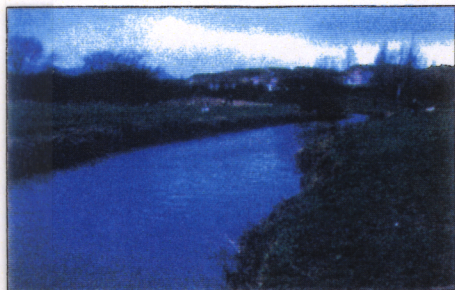
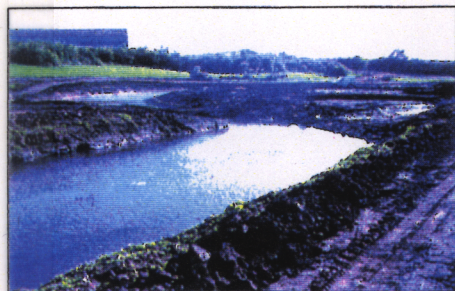
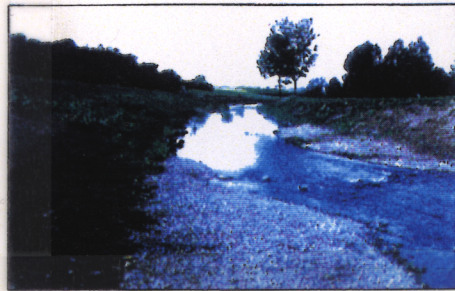
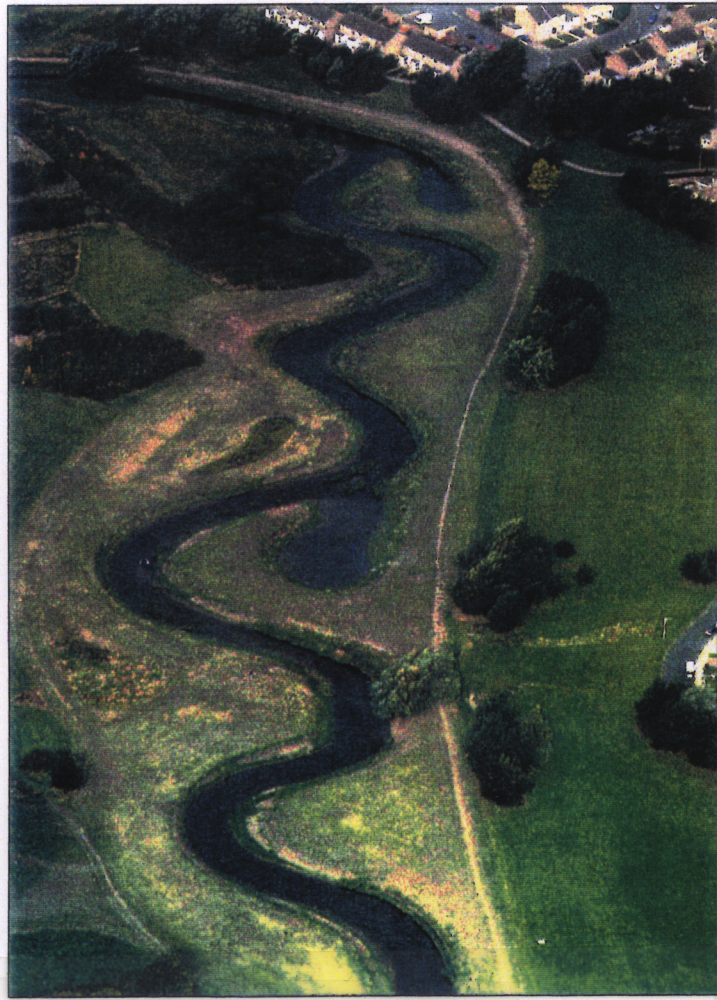
Figure 1.2 Site plan showing scope of works

Before meandering

Meanders being constructed

Riffle with deflectors in background

Aerial view showing meandering completed

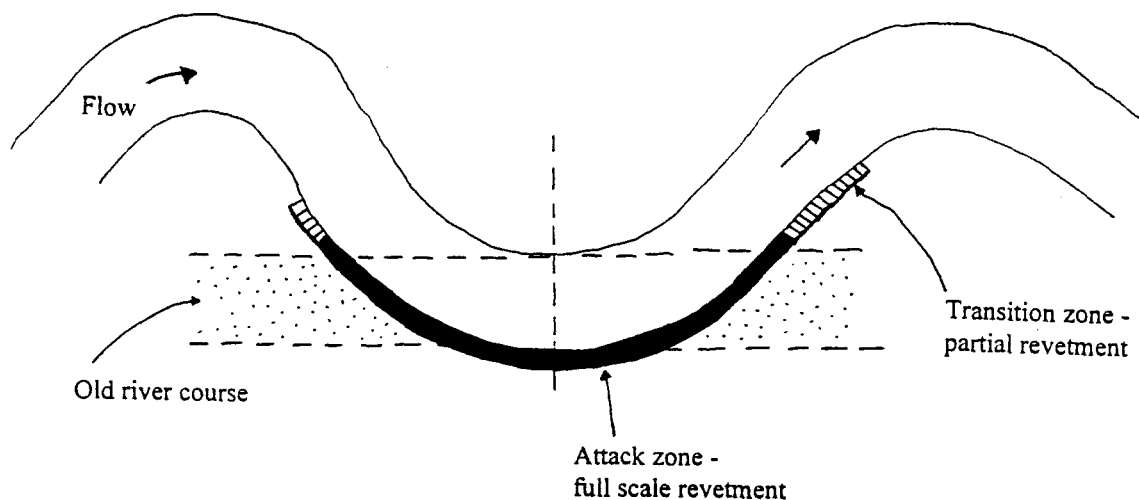
Figure 3.3 Planform of revetment zones

The overriding practical considerations were the need to ensure the security of the gas main running parallel to the old, straight, river course and also to support /protect the backfilling of the old channel on the downstream side of each bend where erosion risks are highest.

This entailed a length of full scale revetment extending across the old river bank as well as along the downstream backfill. The transitions at each end served to avoid a sudden change from unrevetted to fully revetted.

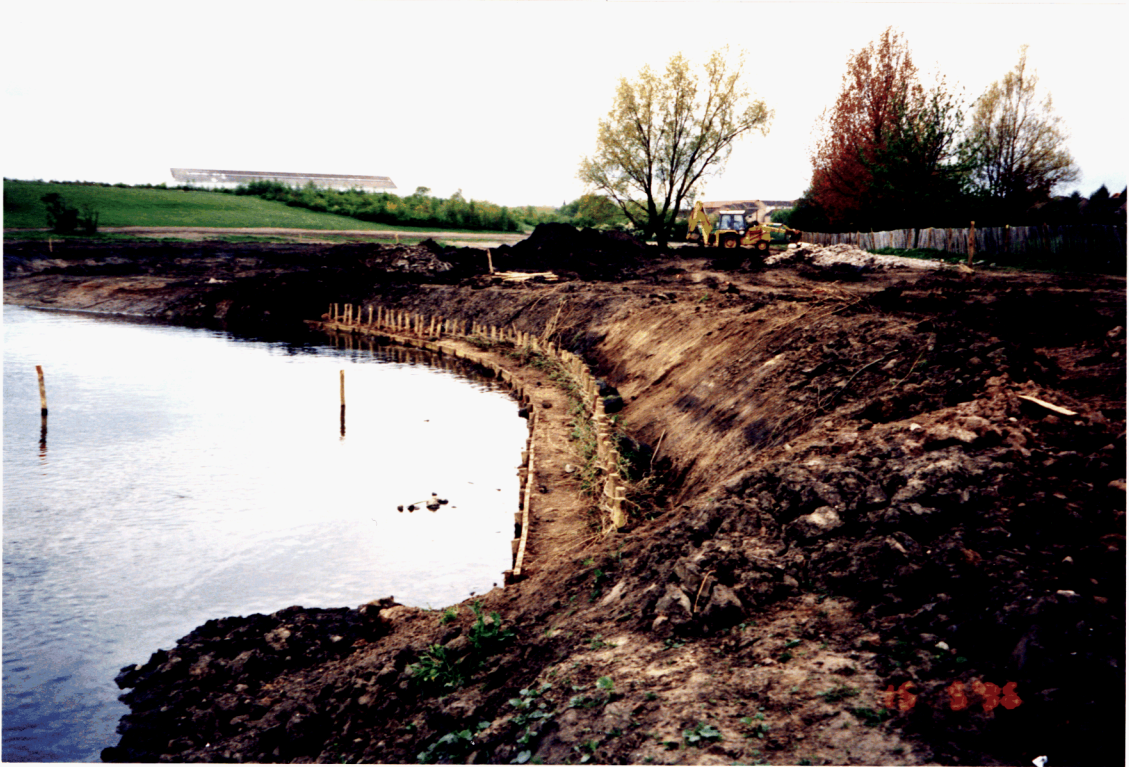
1. Entry spiling - spiling still to complete

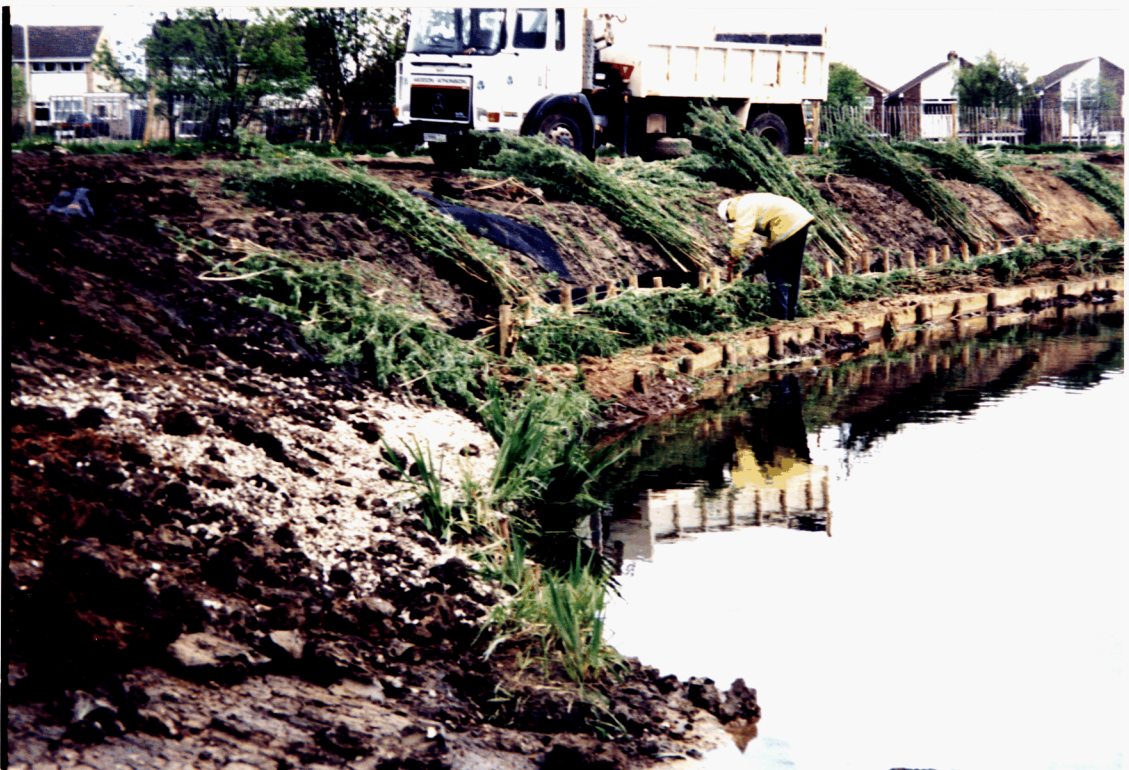
2. Entry spiling - weaving of osier

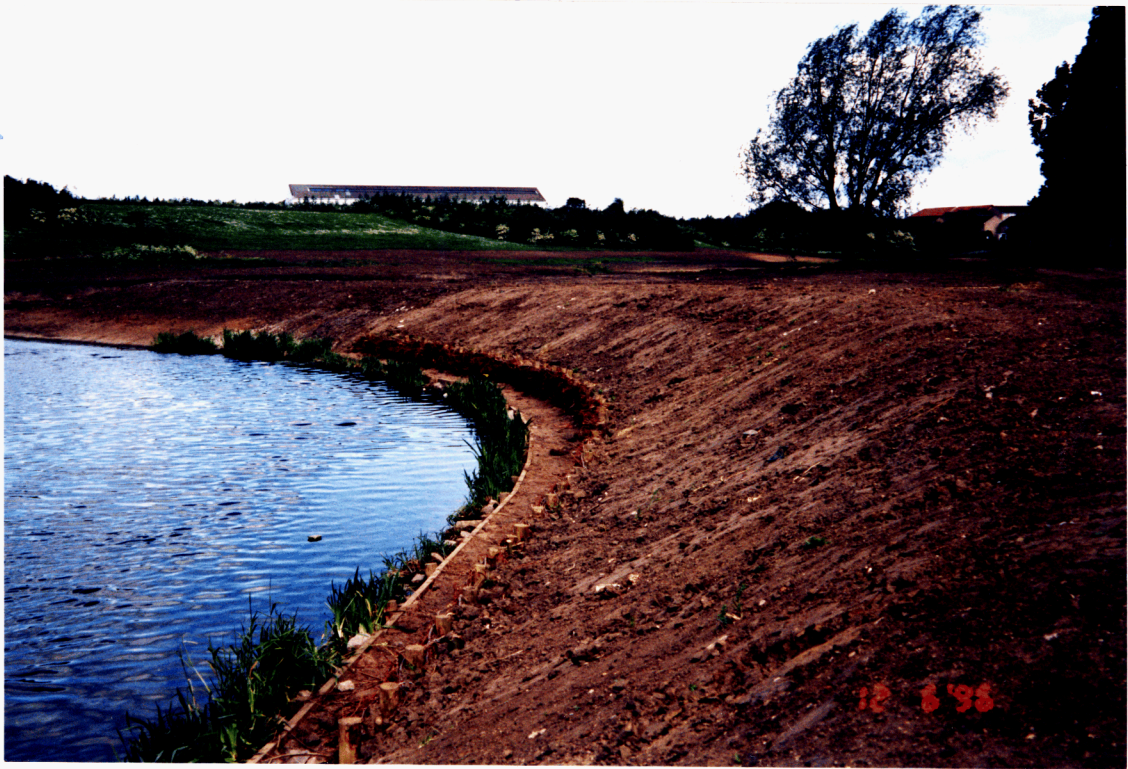
3. Entry spiling complete

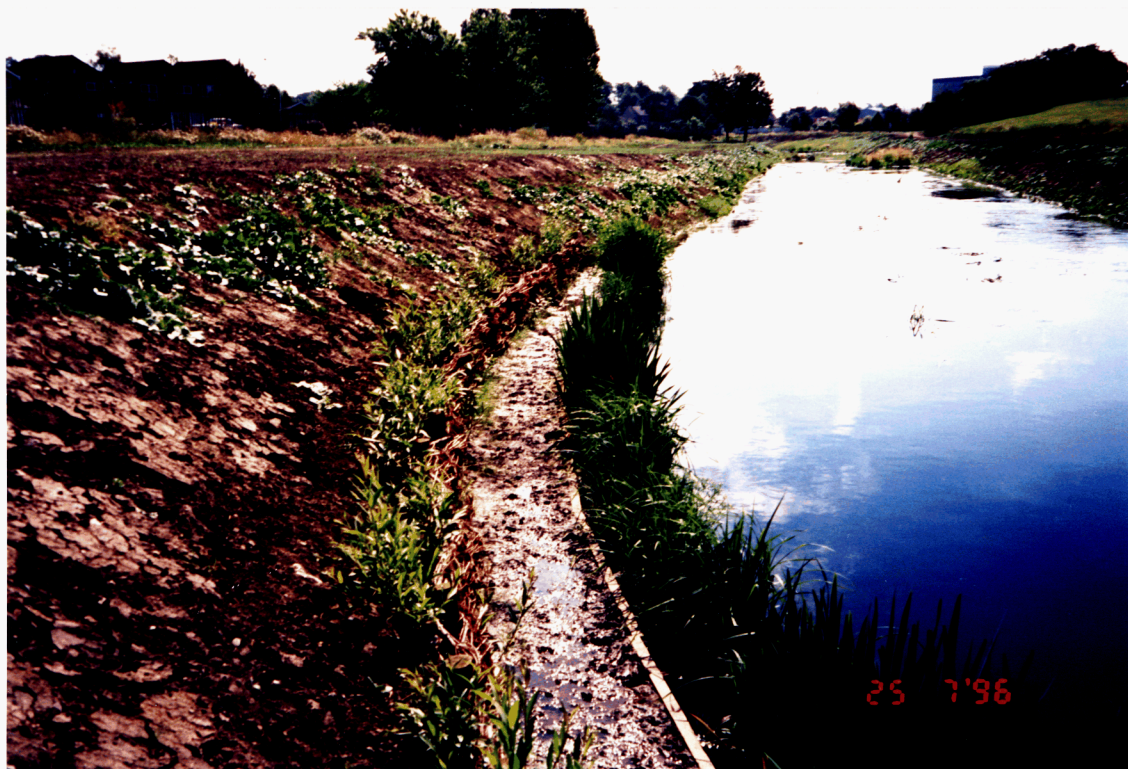
4. Entry spiling two months after installation

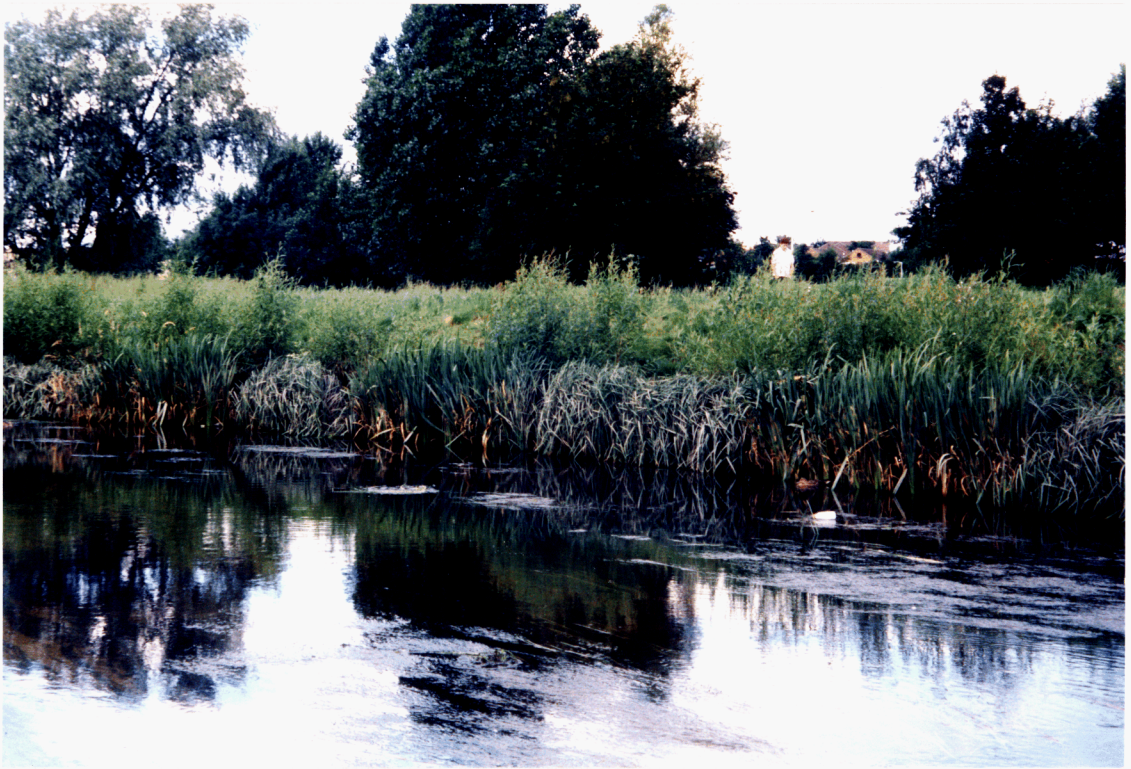
5. Entry spiling after one year

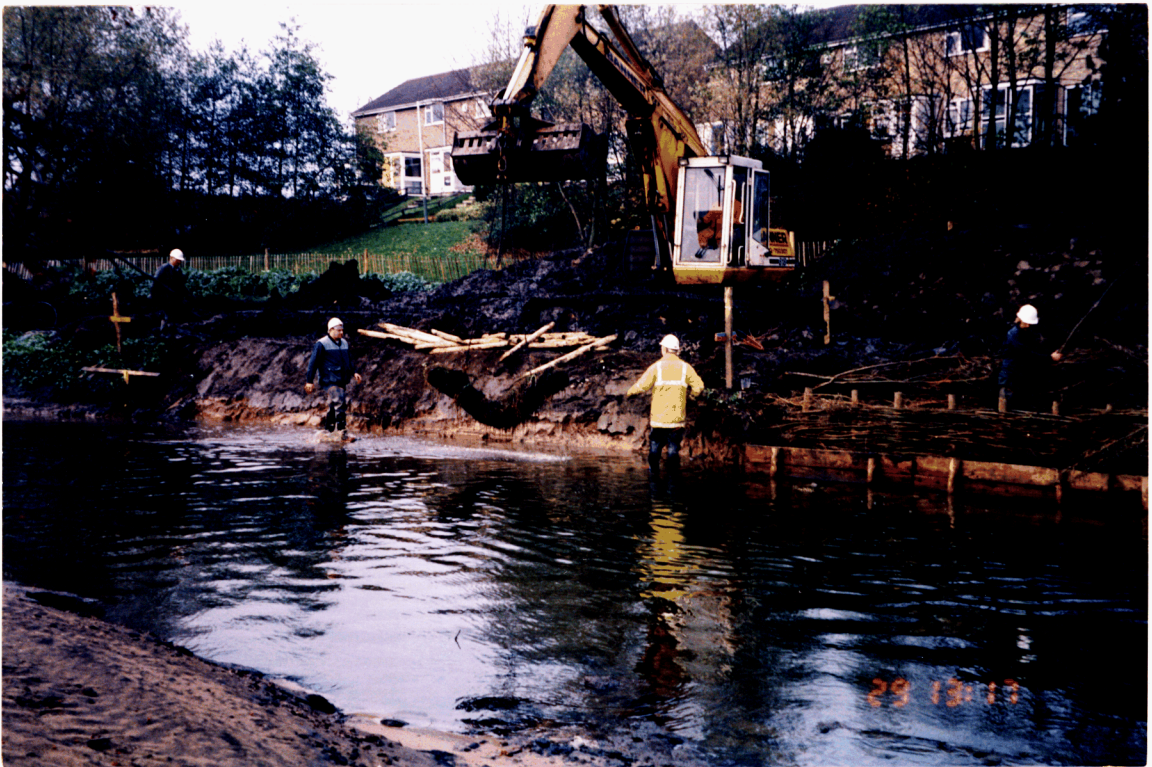
6. Exit spiling - positioning of plant roll

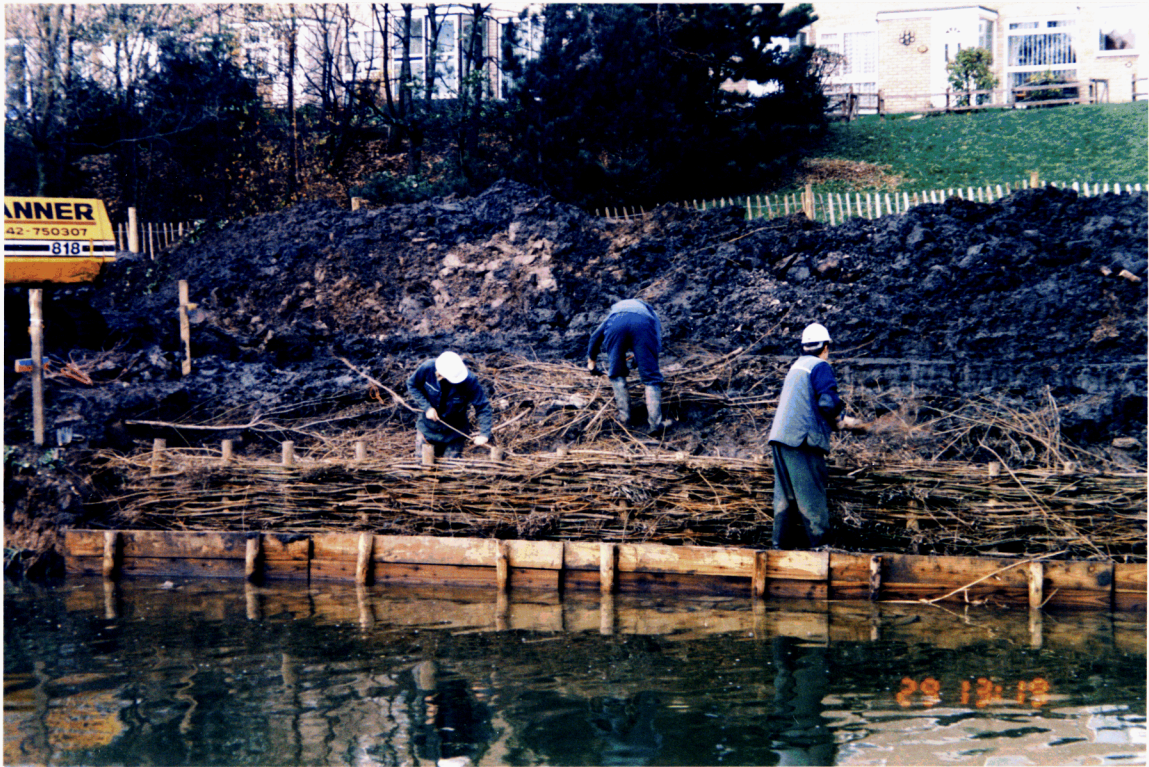
7. Exit spiling - weaving of spiling almost complete

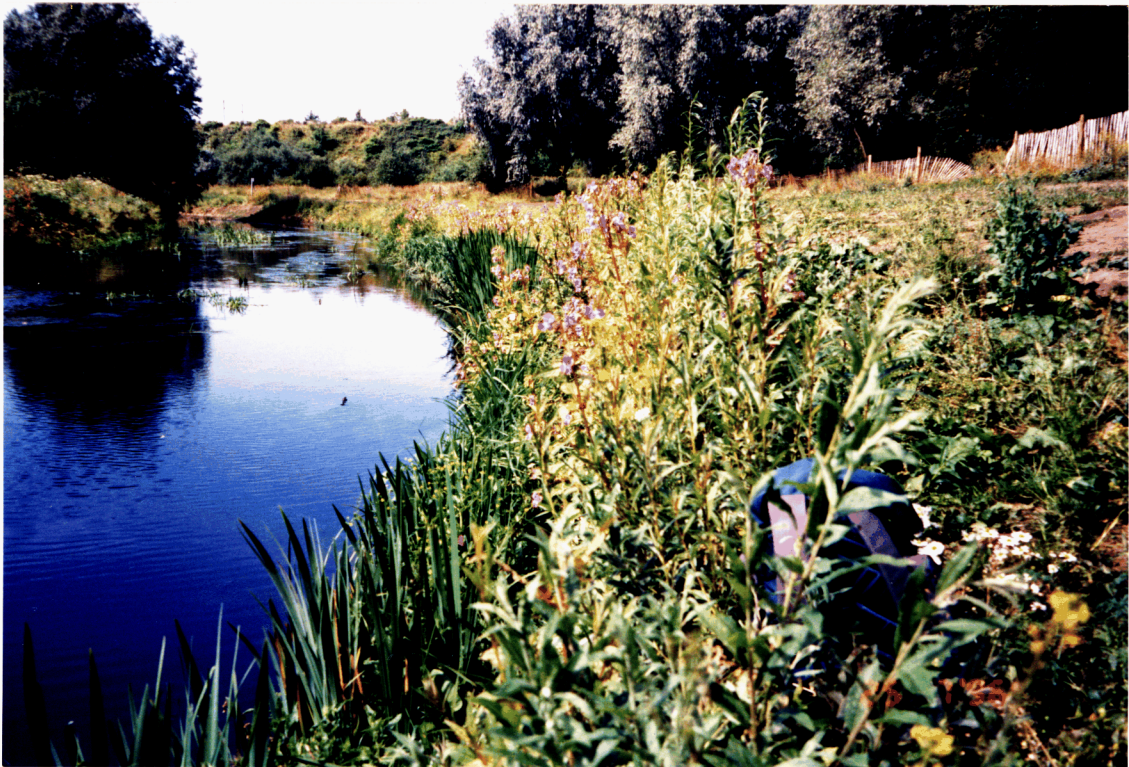
8. Exit spiling eight months after installation

As site conditions do not appear to vary along the revetment, the differences in performance could be attributed to the fact that material for the exit revetment was harvested and stored in water for about six weeks before use. It is feasible that much of the material used at the downstream end of the exit was no longer viable at the time of installation. Only freshly harvested material should be used to ensure successful willow growth.

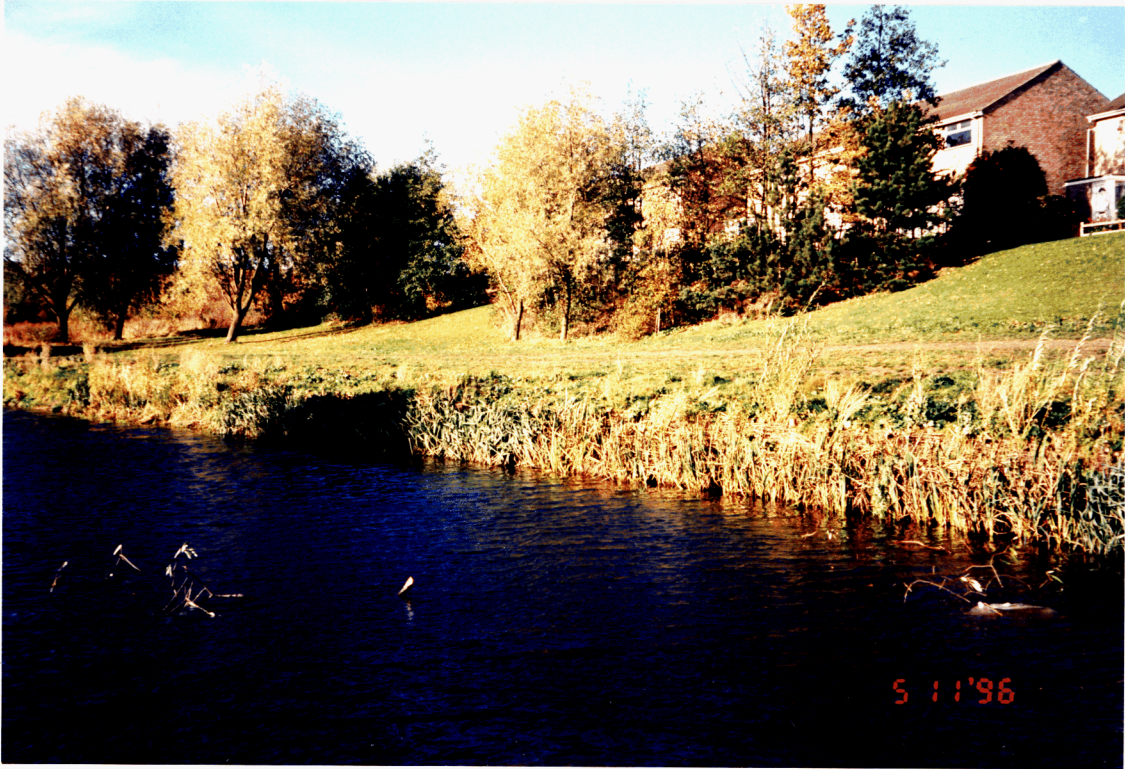
9. Exit after one year - downstream end where few willows have established

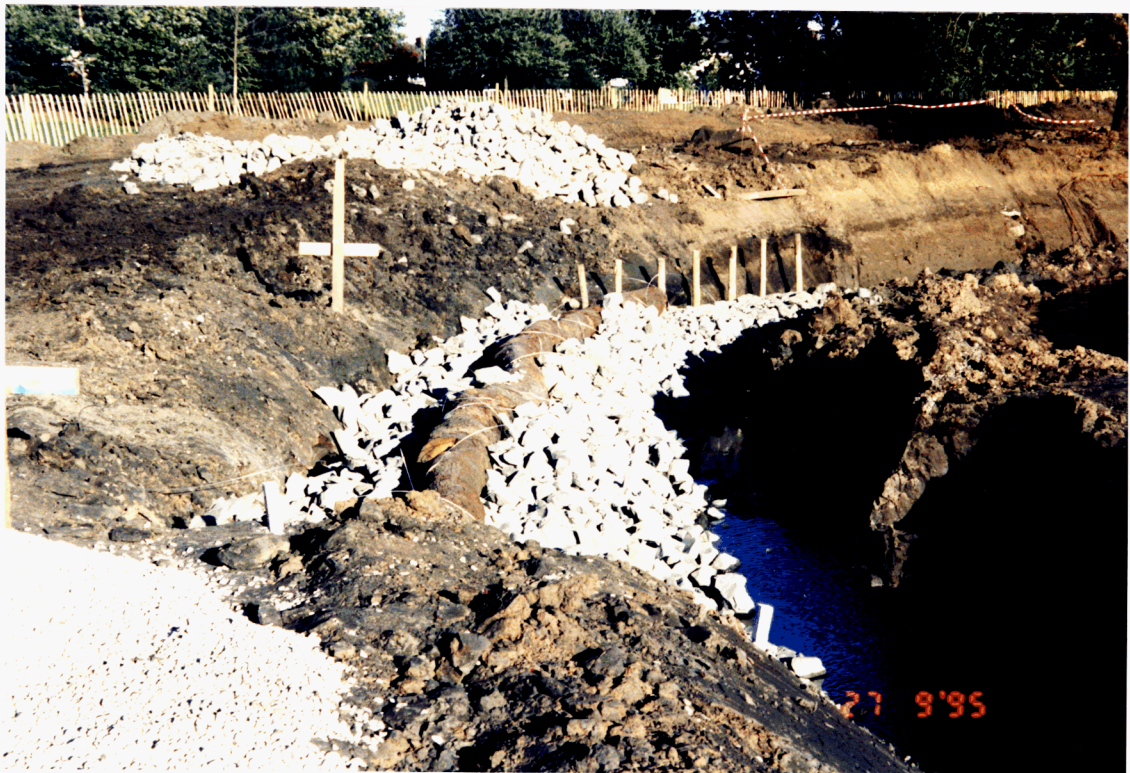
10. Log and geotextile during construction - logs wired over rock

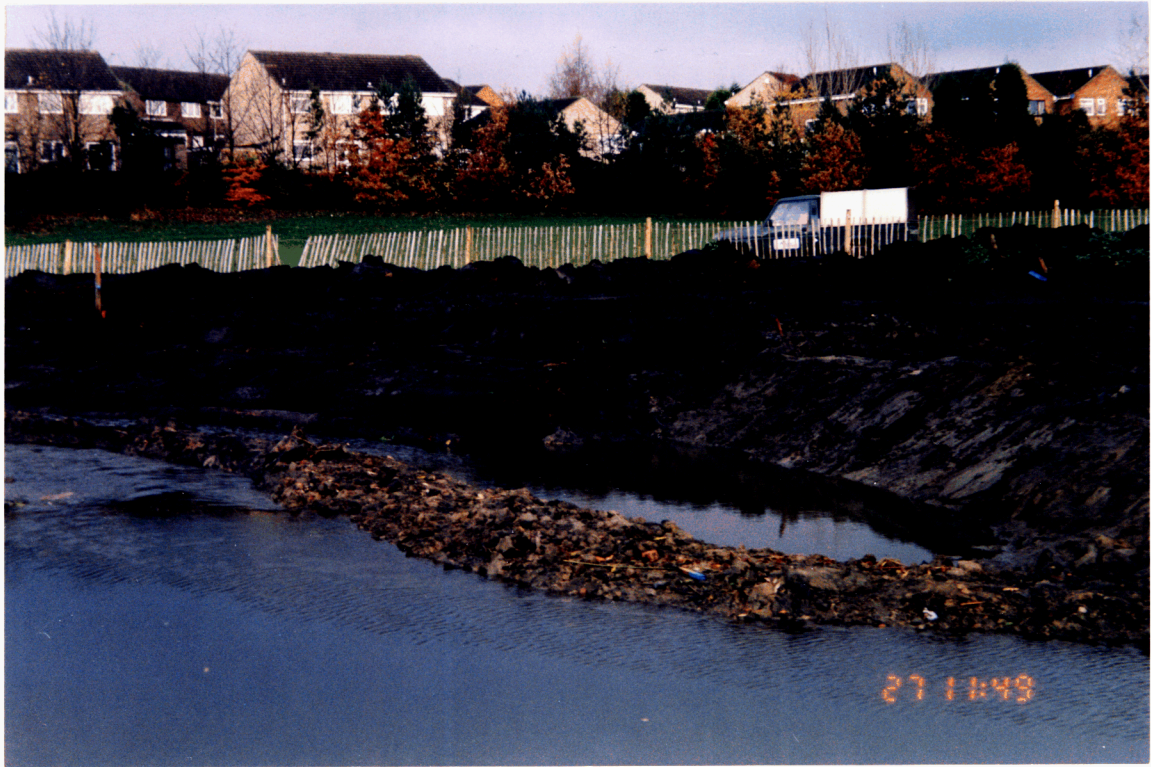
11. Log and geotextile (N3) - geotextile laid behind logs and covered with soil

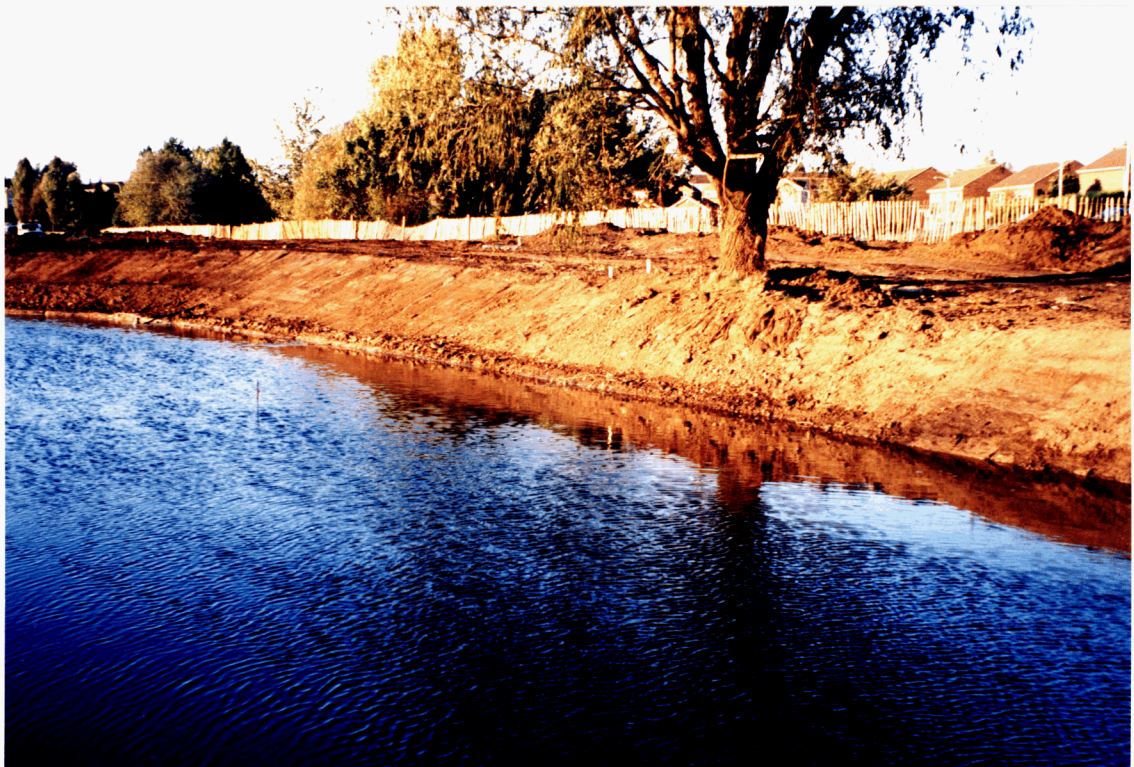
12. Log and geotextile (N1) prior to willow slip planting

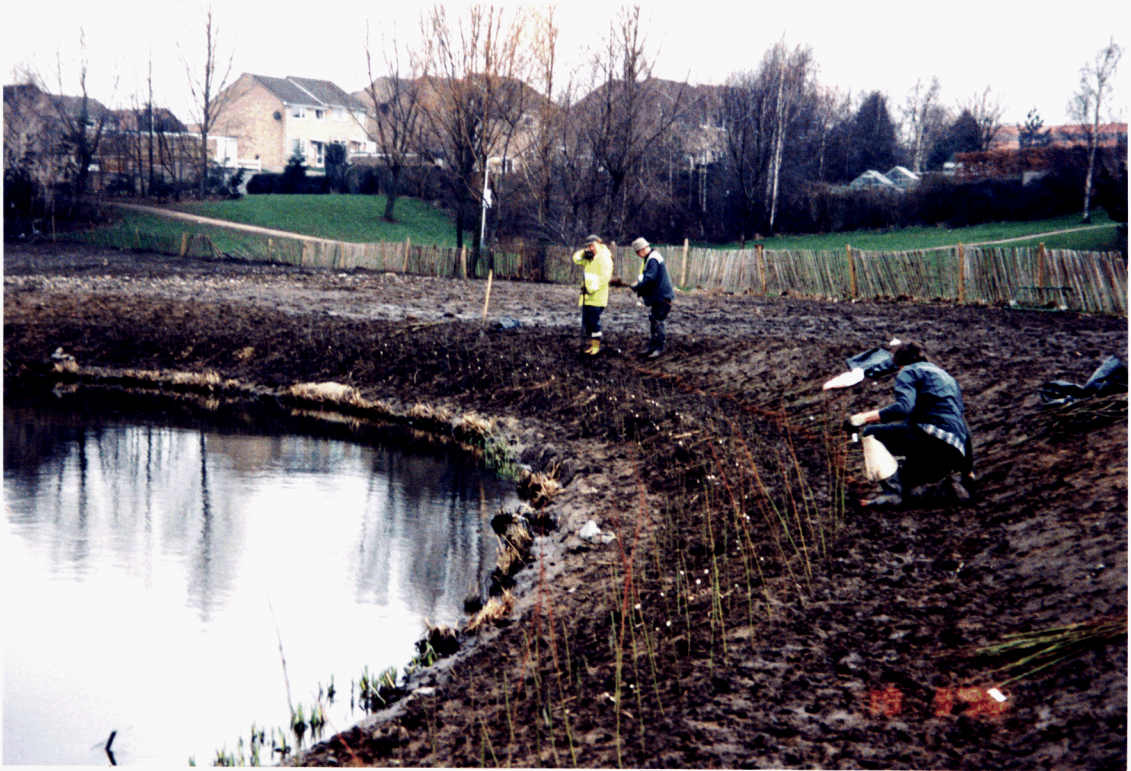
13. Log and geotextile (N3) with willow slips in position

Revetment N3 - The willow slips were planted in March 1996. Rooted goat willow has established in places but the growth rate has been very slow. After the first month some slips were missing particularly at the downstream end. Three months after planting, the rooted goat willow had grown 300 to 600 mm. By the end of the season there was little if any change in growth and the survival rate was only around 10%.

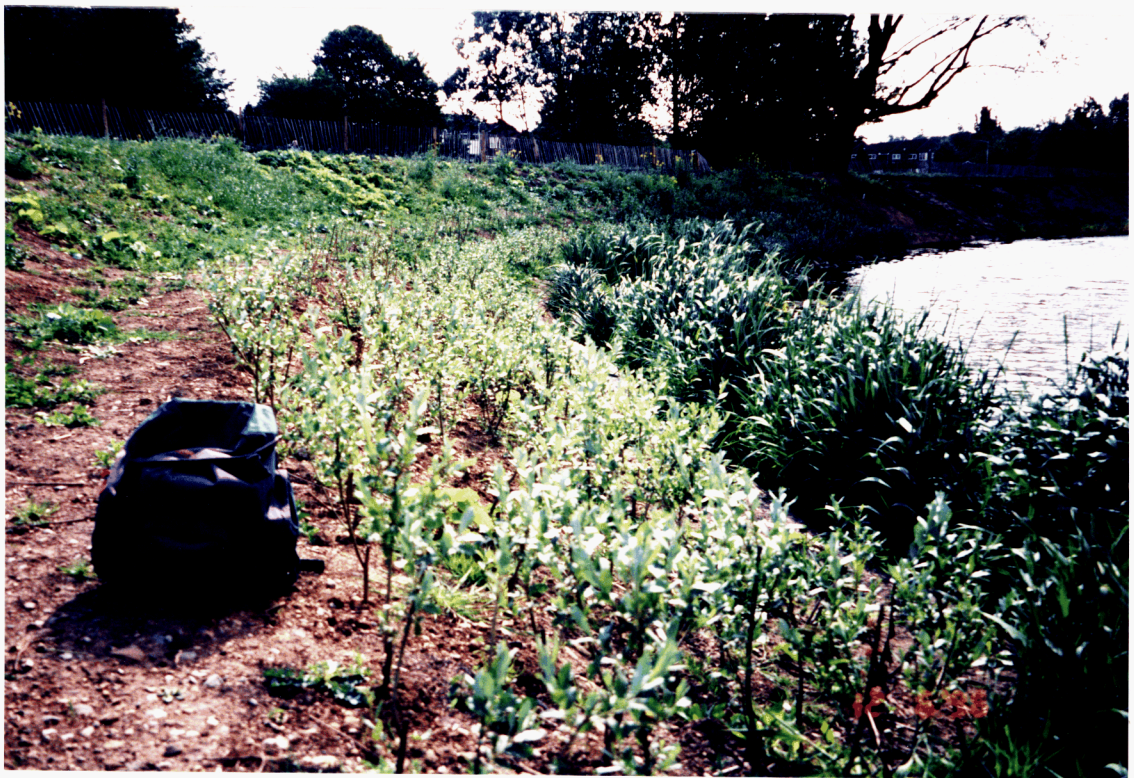
14. Log and geotextile (N1) four months after willows planted

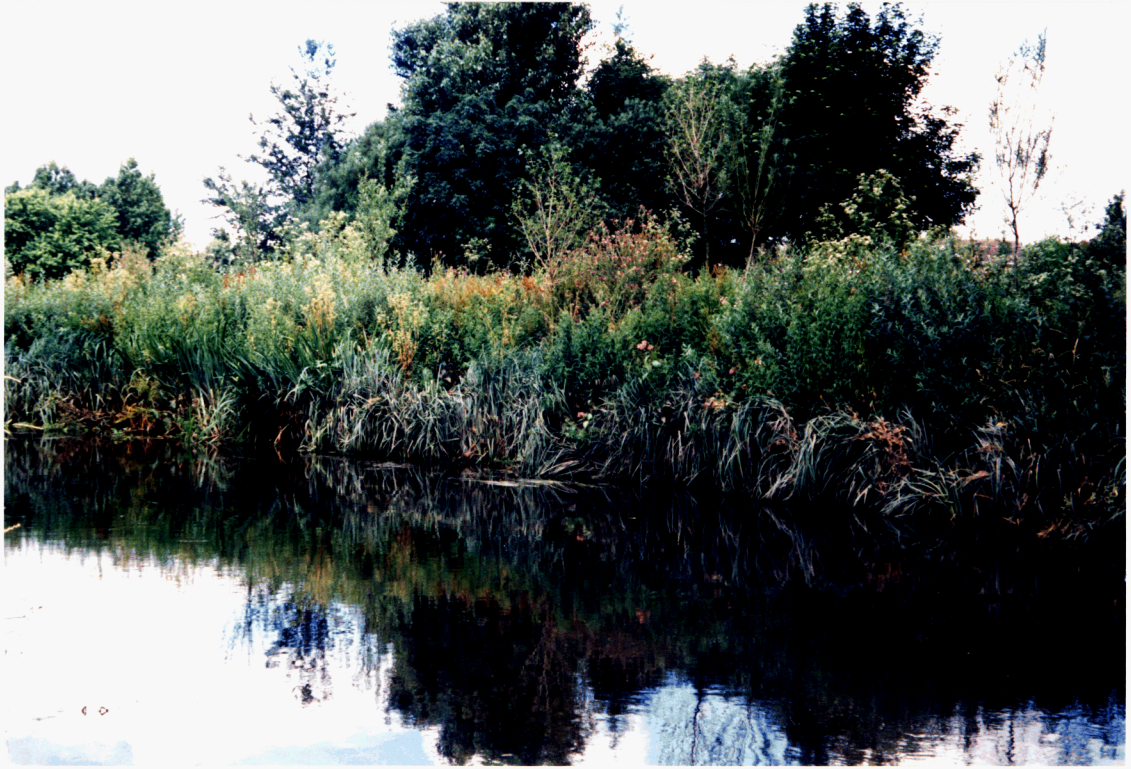
15. Log and geotextile(N1) after one year

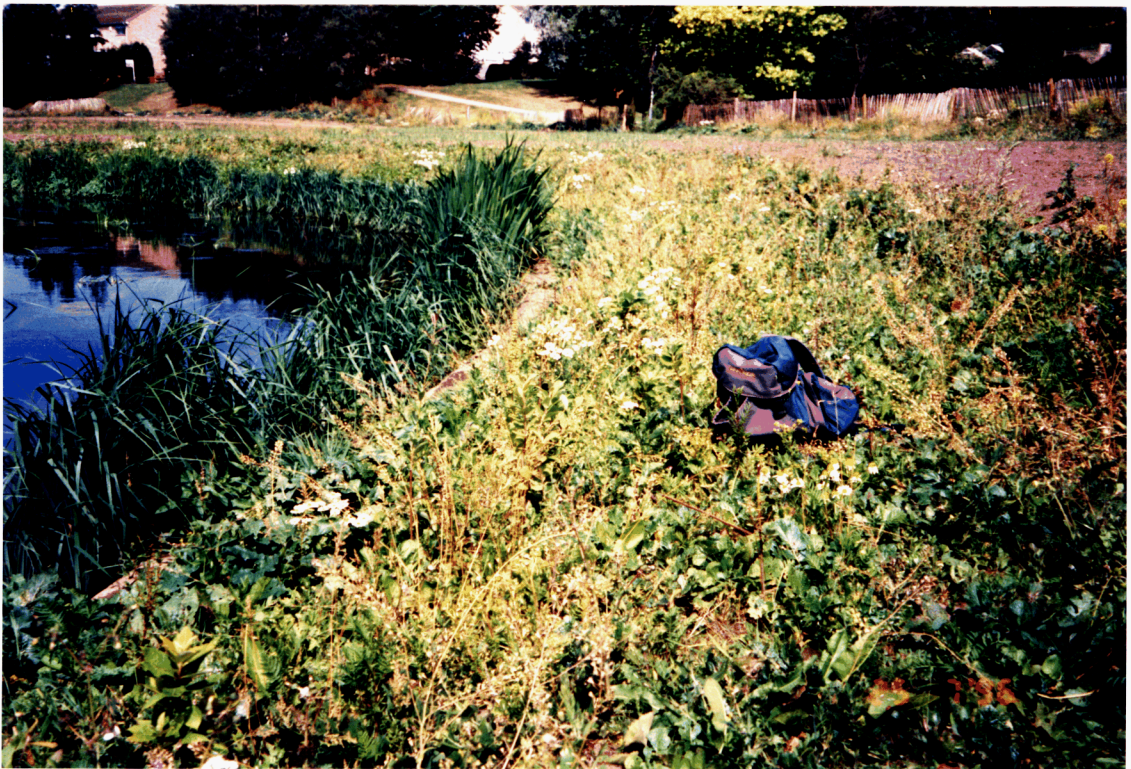
16. Log and geotextile(N3) four months after willows planted

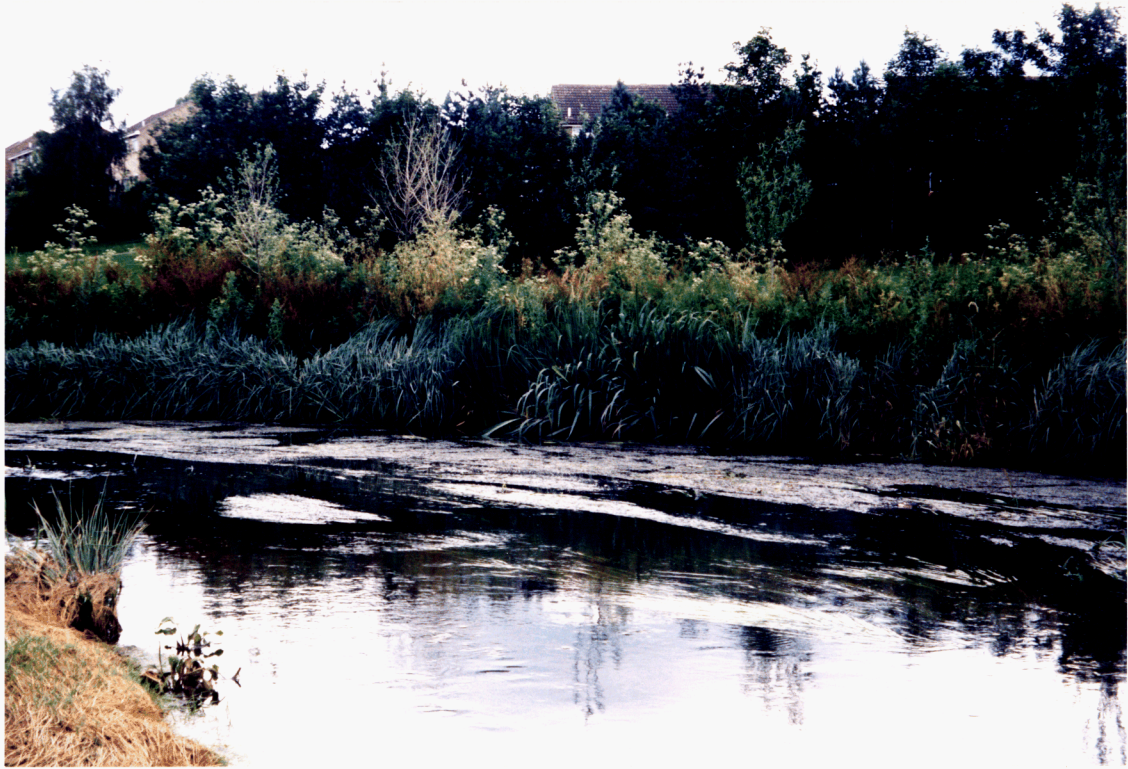
17. Log and geotextile(N3) after one year

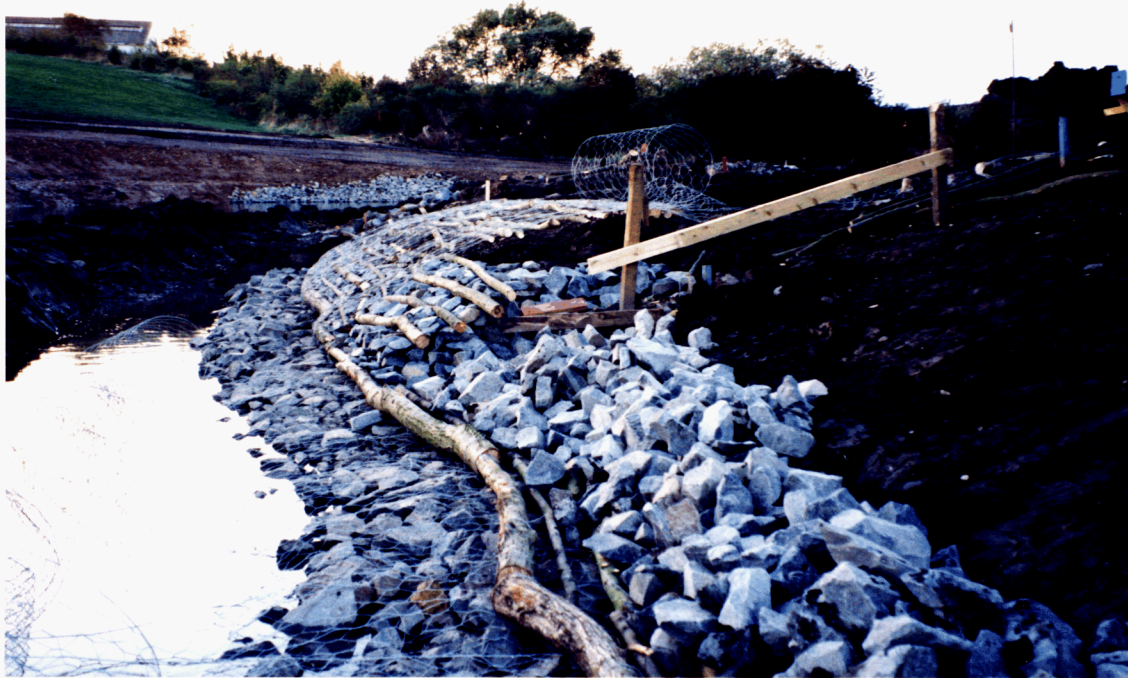
18. Willow mattress - one section under construction

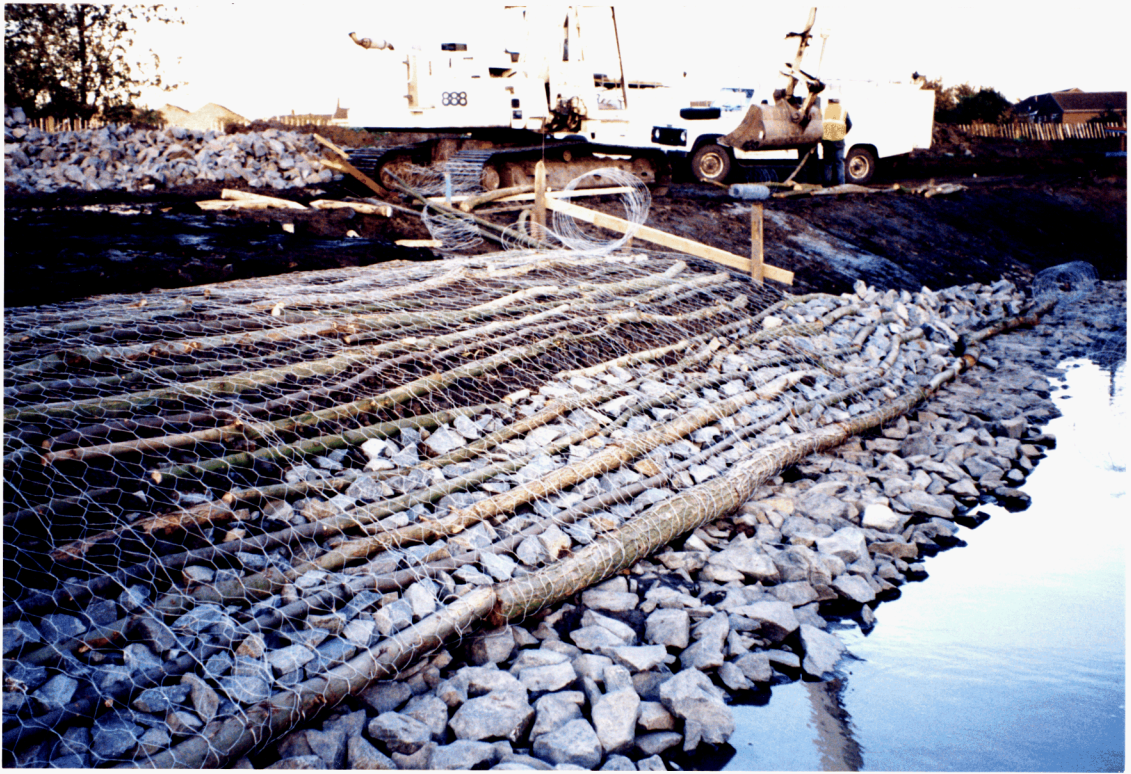
19. Willow mattress in progress

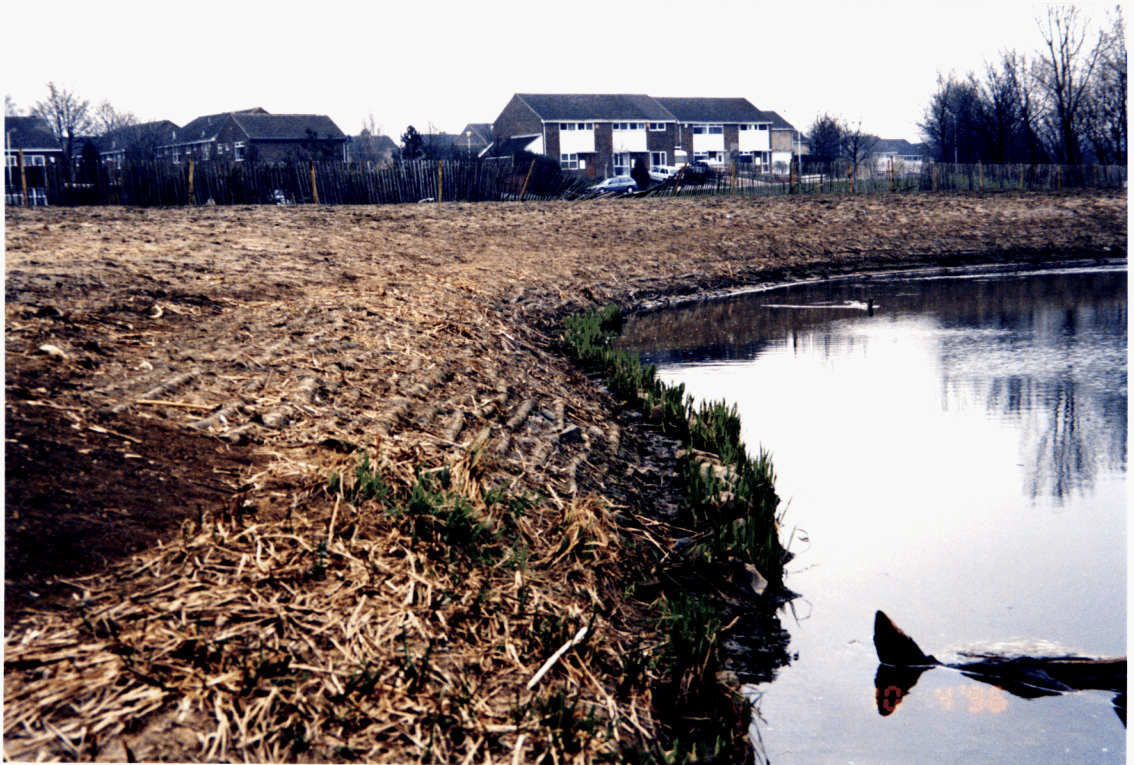
20. Willow mattress after the first winter

Early in the first season, sprouting was most even at the downstream end; later the best growth was at the upstream end. This revetment was made using crack and white willow. The differences in uptake and growth rate may be accredited to this. By the end of the second season, the length with crack willow had grown 1500 to 2000 mm whereas the white willow reached 2500 to 3000 mm. The most vigorous growth was at the water's edge.

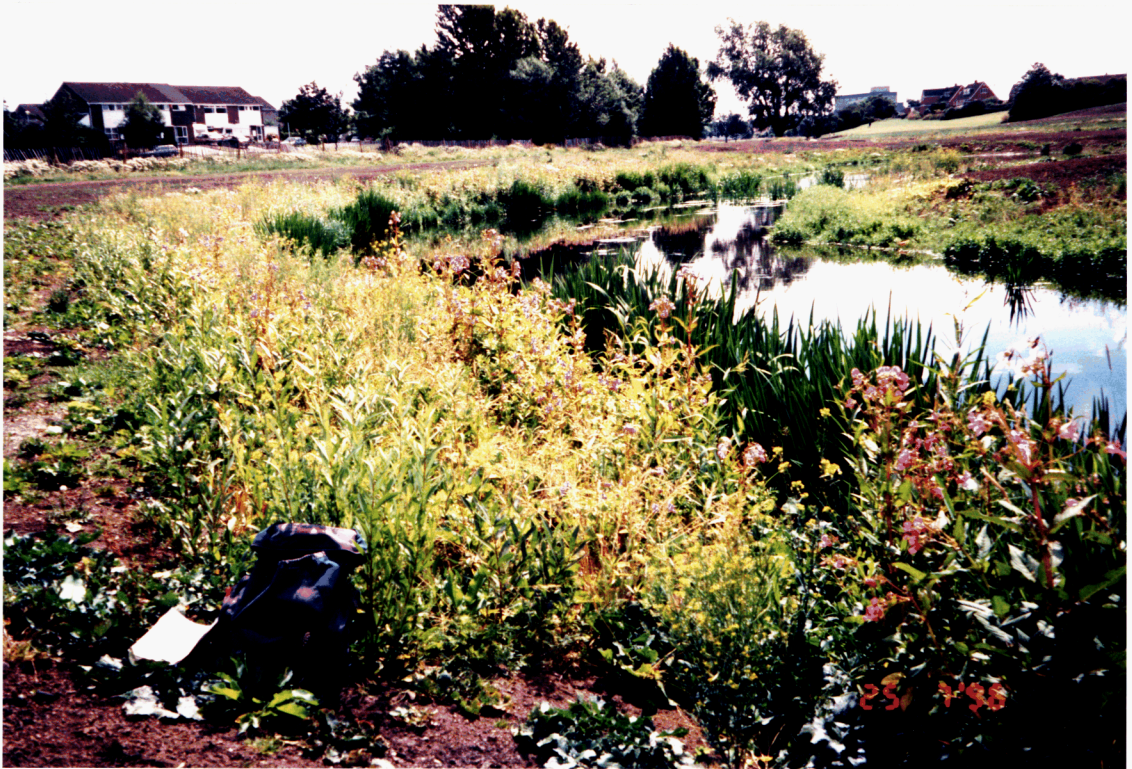
21. Willow mattress eight months after installation

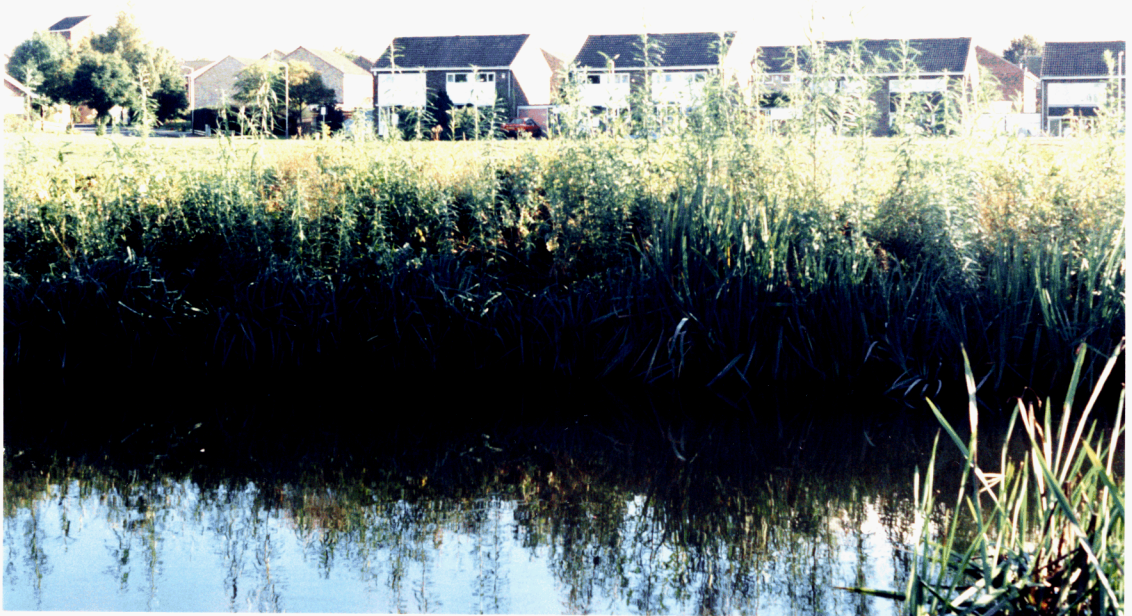
22. Willow mattress during the first summer

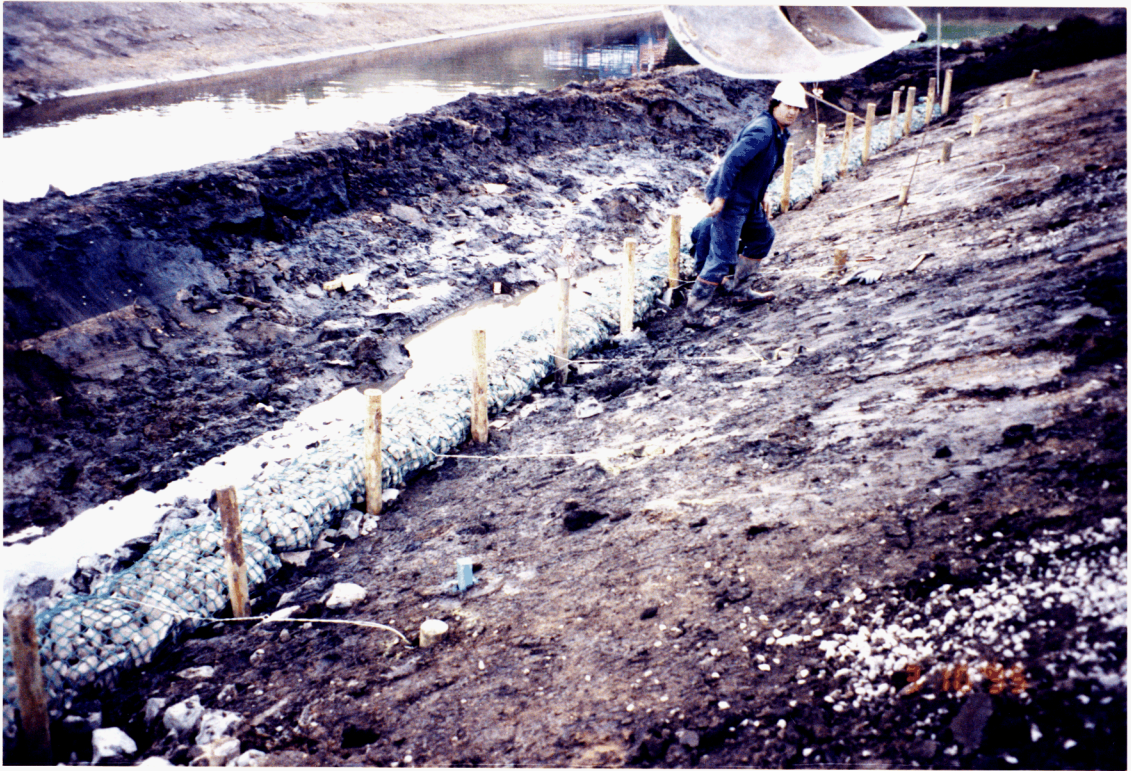
23. Transition rock rolls wired to posts

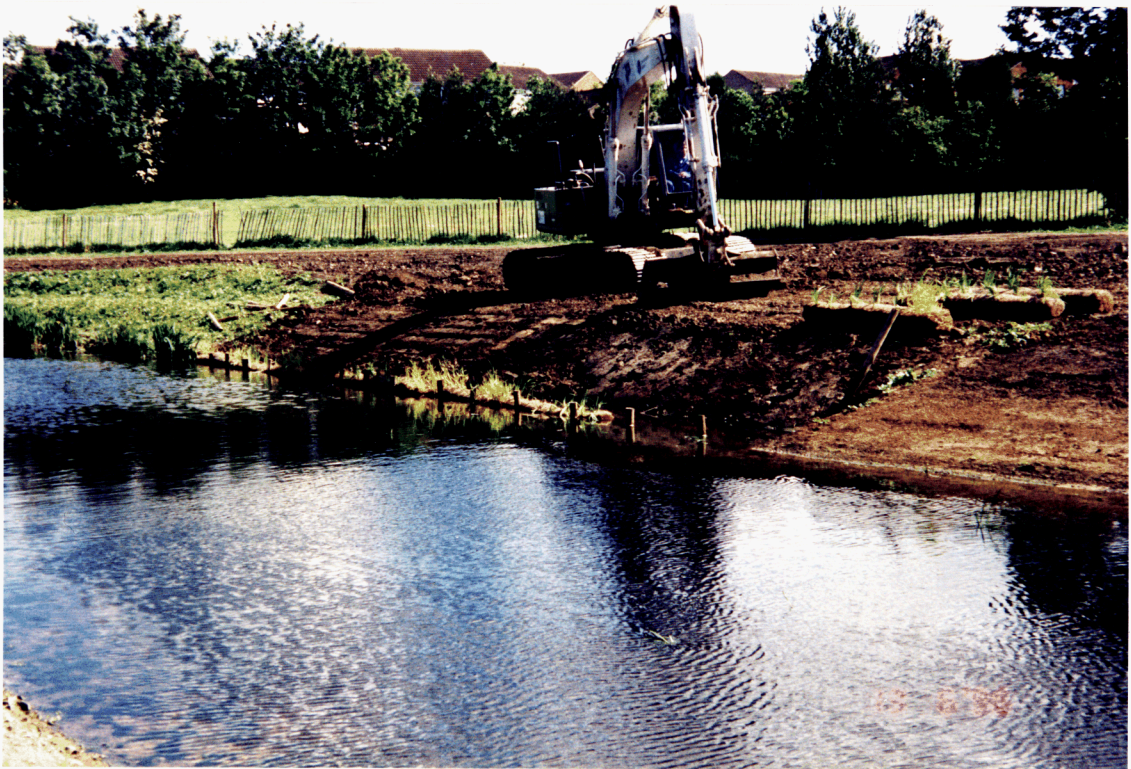
24. Transition plant rolls positioned behind submerged rock rolls
