SAFETY ALERT PART A, B & C

Subject: Havequick Towers – Damaged Antennae

Number: SA 2017/03

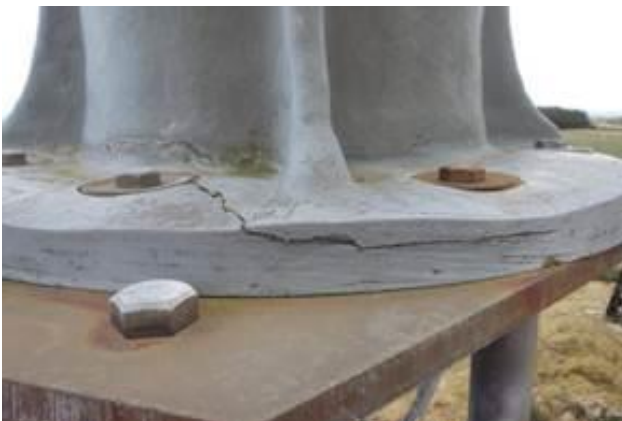
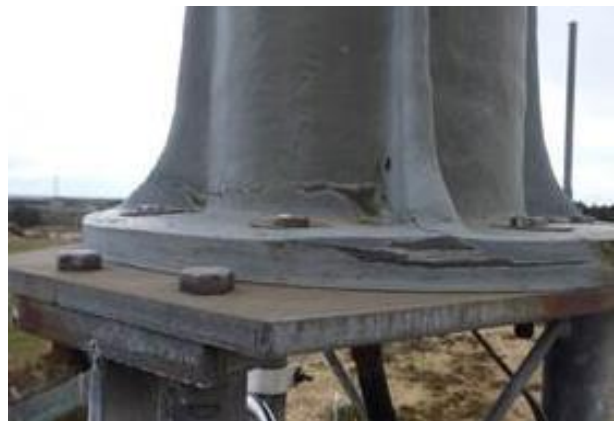
7. Recent Havequick tower inspections have identified some significant cracking in the ageing 7m GRP antenna, which is at risk of propagating to a complete failure, as shown in the photographs below. The total height of the combined structure is 15m, comprising a 7m antenna on an 8m steel lattice tower. At the time of writing, there are no known significant issues with the steel towers.

- (a) Make the antennae safe which may require dismantling. Whilst the structure is lowerable it must only be lowered once a safe system of work (SSOW) is developed supported by a suitable and sufficient risk assessment and method statement. Preparation of these is the responsibility of the antenna owner and should be submitted to the MMO for permit purposes. Although there are obvious hazards to lowering a defective structure, this may be the only practicable means of dismantling for which appropriate precautions are required to ensure a SSOW.
- (b) Keep the MMO informed as to the status of the antenna condition and confirm when it is deemed safe.

17., GRP is prone to an ageing process that may cause deterioration of the material including fatigue cracking and material creep under load. These antennae are also in exposed locations making them subject to repeated cyclical loading and vibration that can accelerate or exacerbate the deterioration process and make ageing antennae potentially susceptible to unexpected failure.
