SAFETY ALERT

Bitumen burns to face

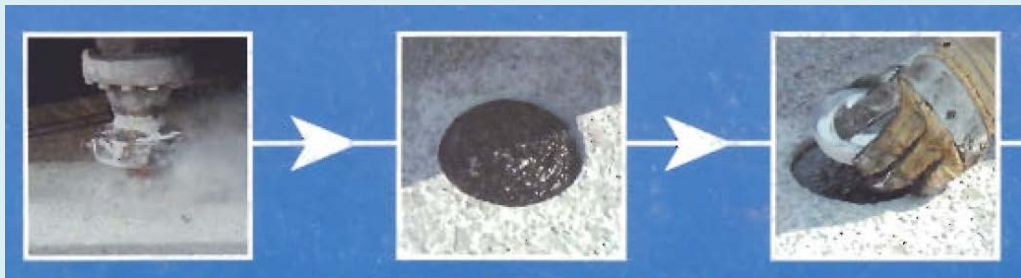
The task being undertaken had three main stages:

1. Mill Hole

2. Insert Bitumen

3. Place Stud

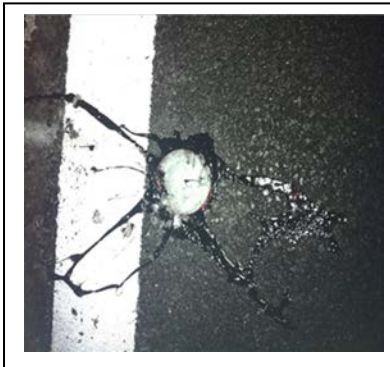
During the placing of a glass road stud into hot bitumen, the stud shattered resulting in the hot bitumen splashing into the operative's face.

1. Bitumen splash

1. Any road studs known to have quality failures are not to be used.
2. RAMS to be reviewed for all operations that use bitumen to consider use of a full face visor in activities where there is a risk of bitumen splashing.
3. Ensure all operations using bitumen have a burns kit and cold water available immediately at the work front.
4. To aid the ongoing investigation, any other known instances of road studs shattering are to be reported to ian.nixon@costain.com

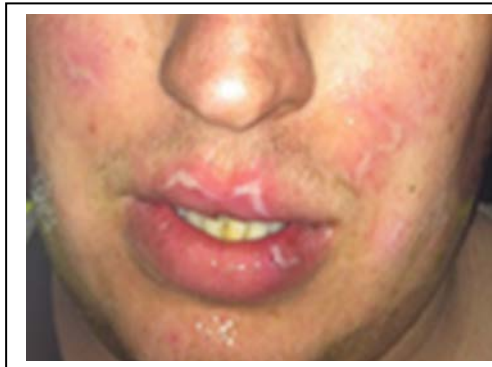
2. Burns to lips and cheek

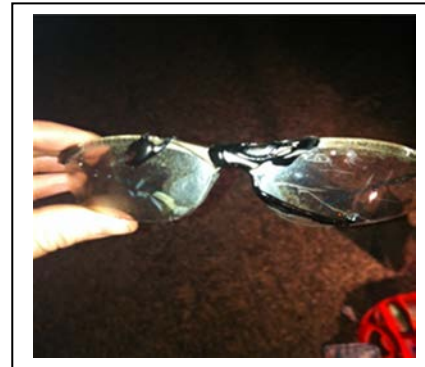
3. Glasses prevented eye injury.
