5.4 **422 Fraserburgh (Original ASHP)**

5.5 ***422 Fraserburgh, Aberdeenshire (Replacement ASHP)***

5.6 **443 Cheshire West**

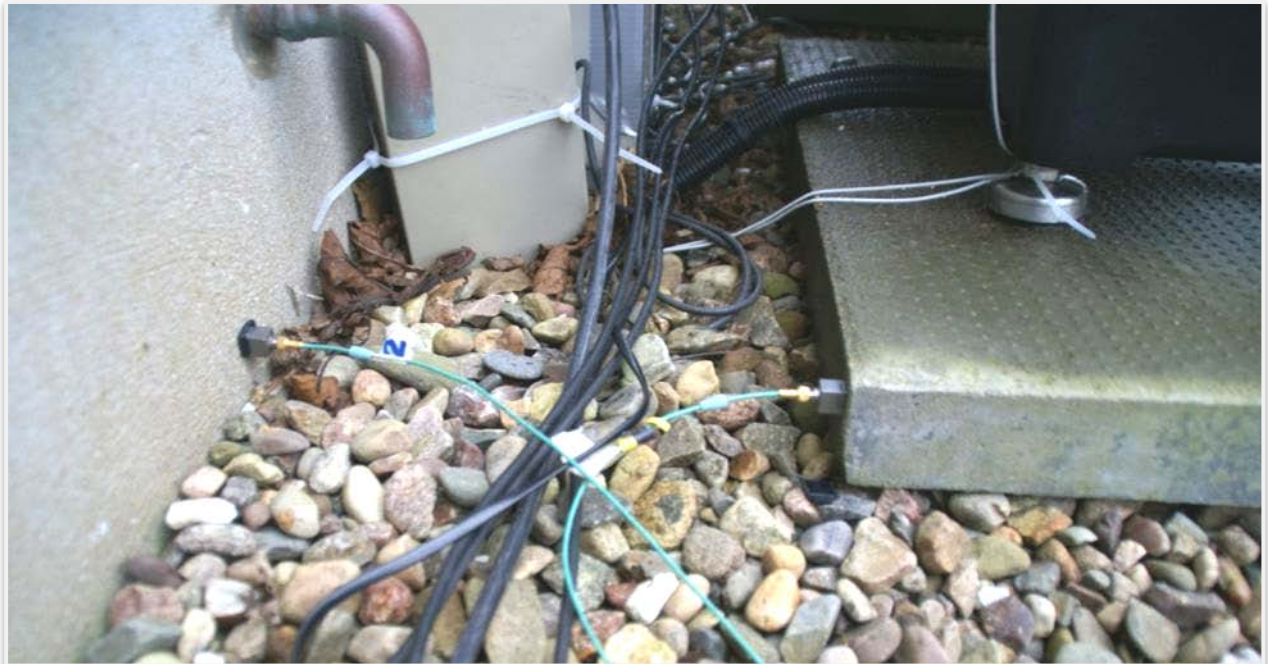
- 5.4.4. The 9 Channel PULSE system was used at this site.
- 5.4.5. The ASHP was located on reflective ground, and in front of a reflective wall.
- 5.4.6. Accelerometers were fixed to the footings and to the wall surface immediately behind the unit, as shown in Picture 5-10. The accelerometers were fixed to the surfaces using cyanoacrylate cement.

Picture 5-10. 422 Fraserburgh (Original), Footing and Wall-mounted Accelerometers

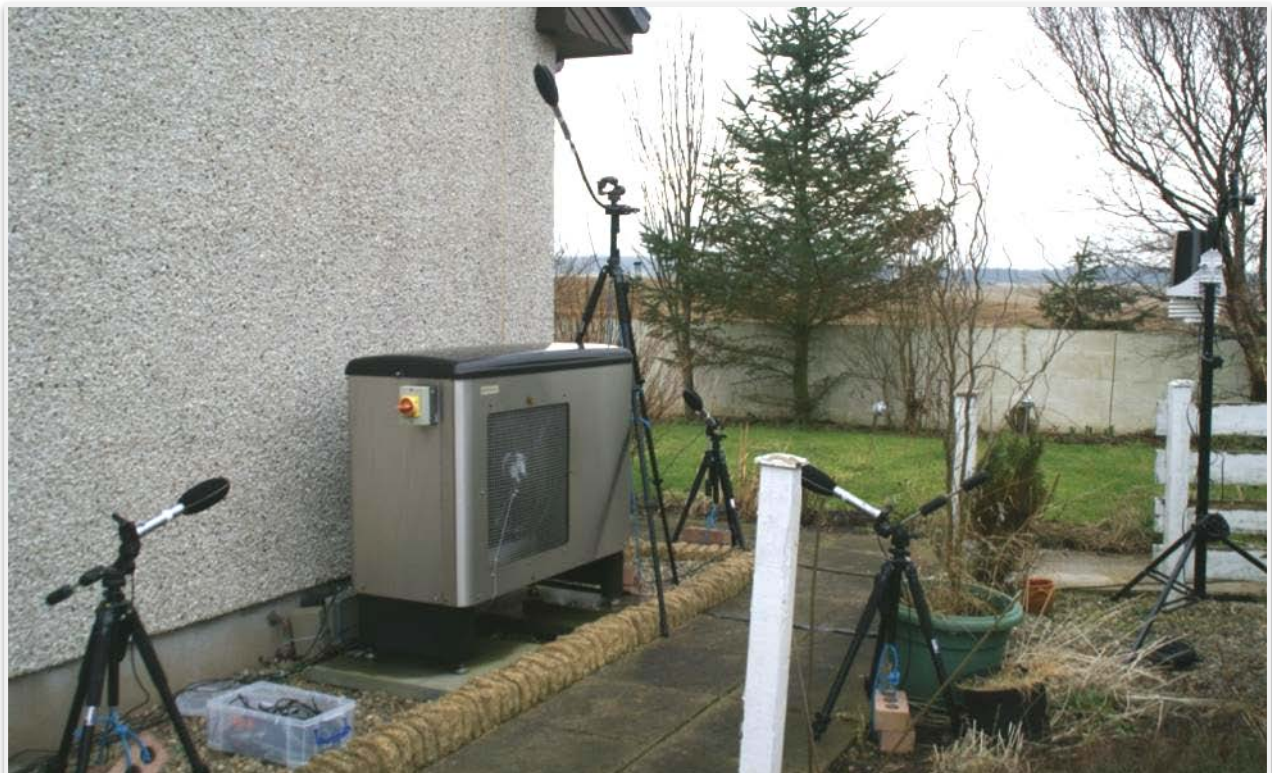
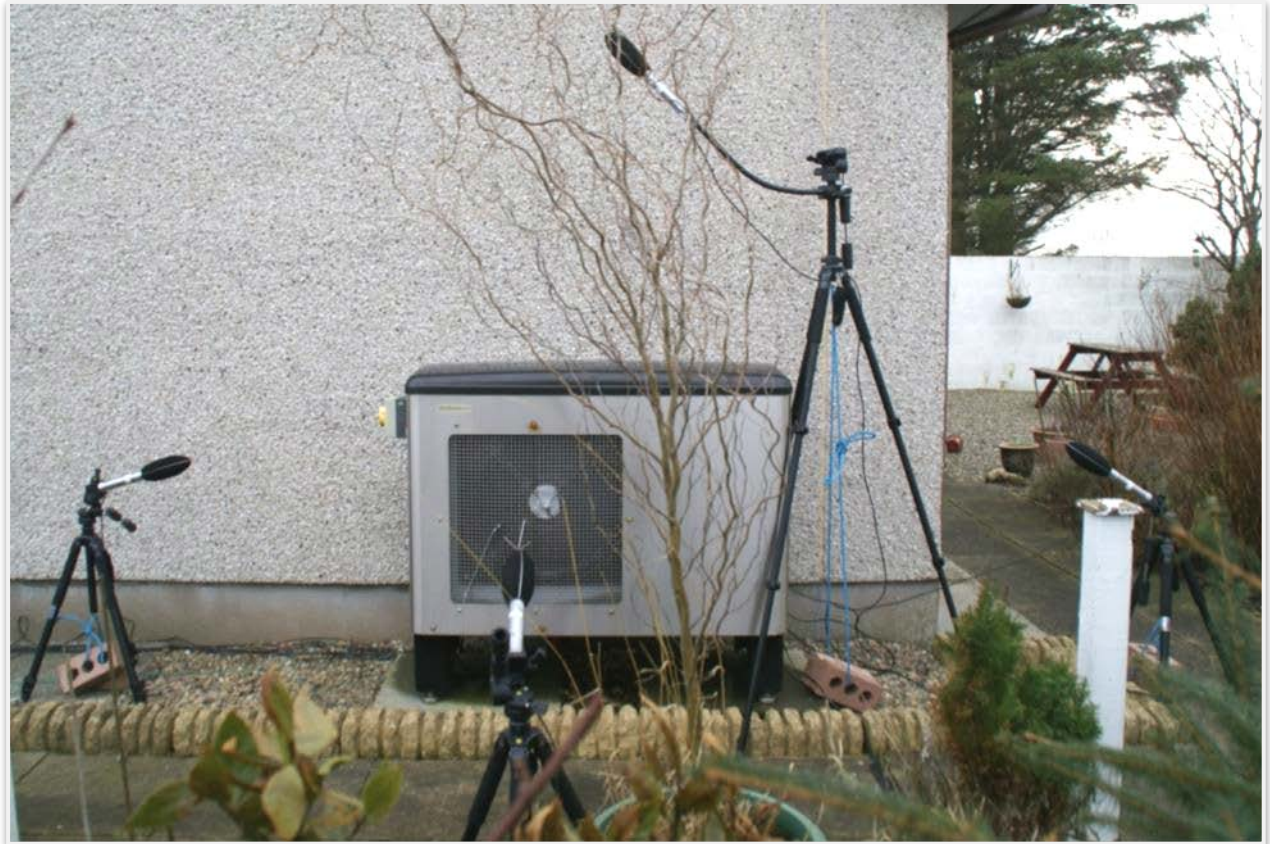
5.4.7. The microphones were mounted on heavy-duty tripods as shown in Picture 5-11 and Picture 5-12. All microphones were positioned 1 m from the ASHP casing.

Picture 5-11. 422 Fraserburgh, Original ASHP and Microphone Arrangement

Picture 5-12. 422 Fraserburgh, Original ASHP and Microphone Arrangement

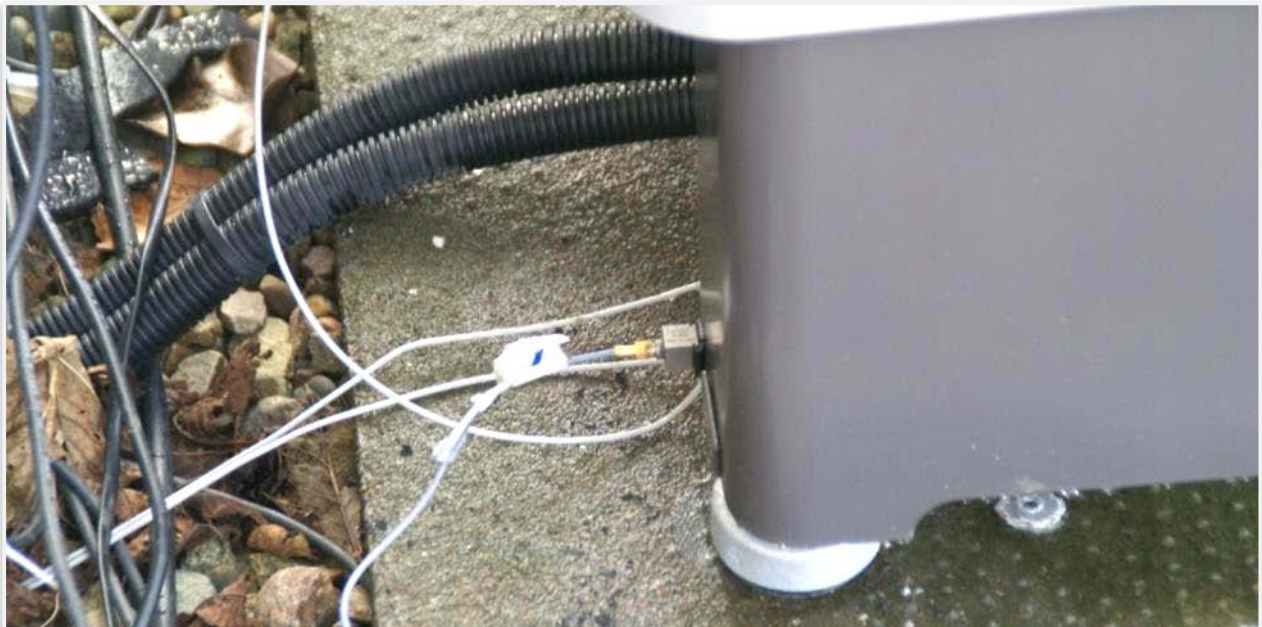
- 5.5.4. The 5 Channel PULSE system was used at this site.
- 5.5.5. The ASHP was located on reflective ground, and in front of a reflective wall.
- 5.5.6. An accelerometer was fixed to the casing of the ASHP, as shown in Picture 5-13. The accelerometer was fixed to the surface using cyanoacrylate cement.

Picture 5-13. 422 Fraserburgh (Replacement), Casing-mounted Accelerometer

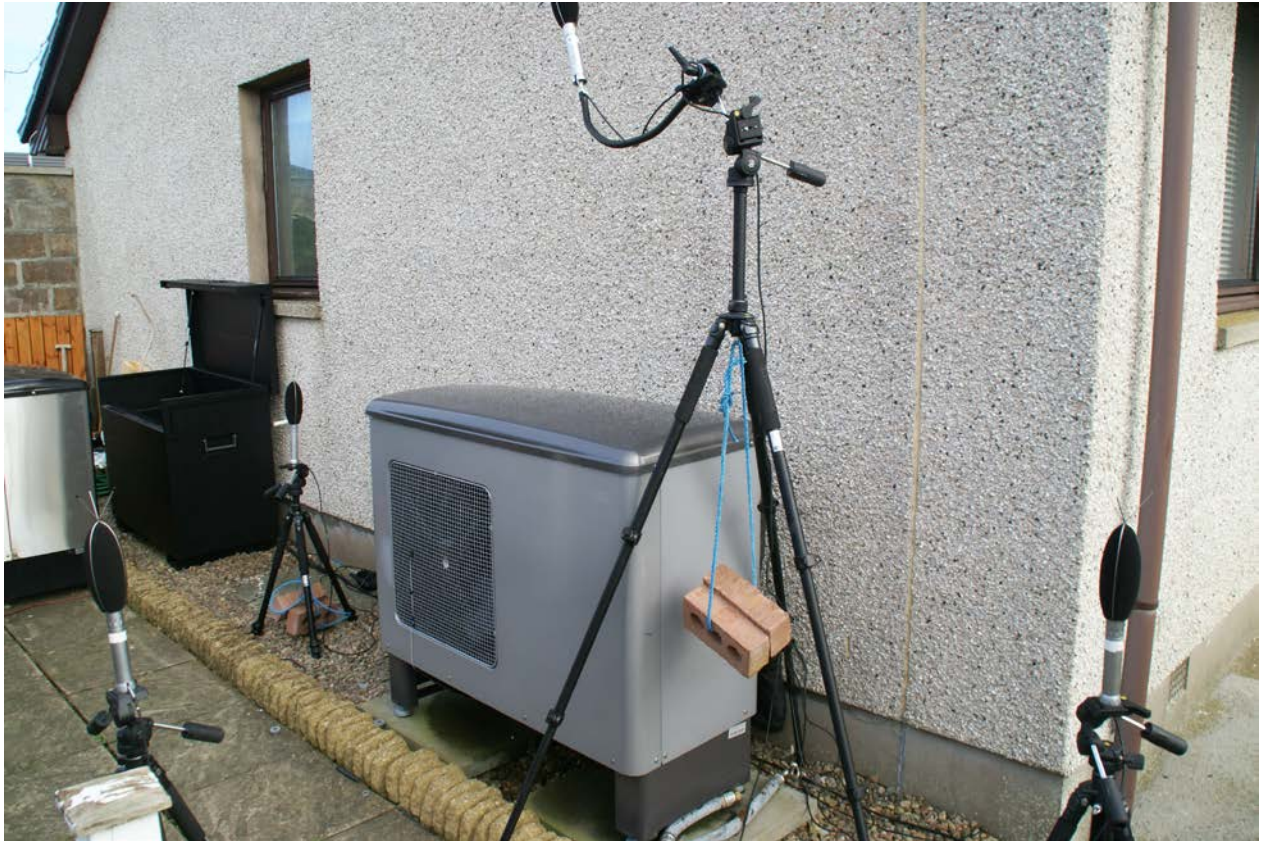
- 5.5.7. The microphones were mounted on heavy-duty tripods as shown in Picture 5-14. All microphones were positioned 1 m from the ASHP casing.

Picture 5-14. 422 Fraserburgh, Replacement ASHP and Microphone Arrangement

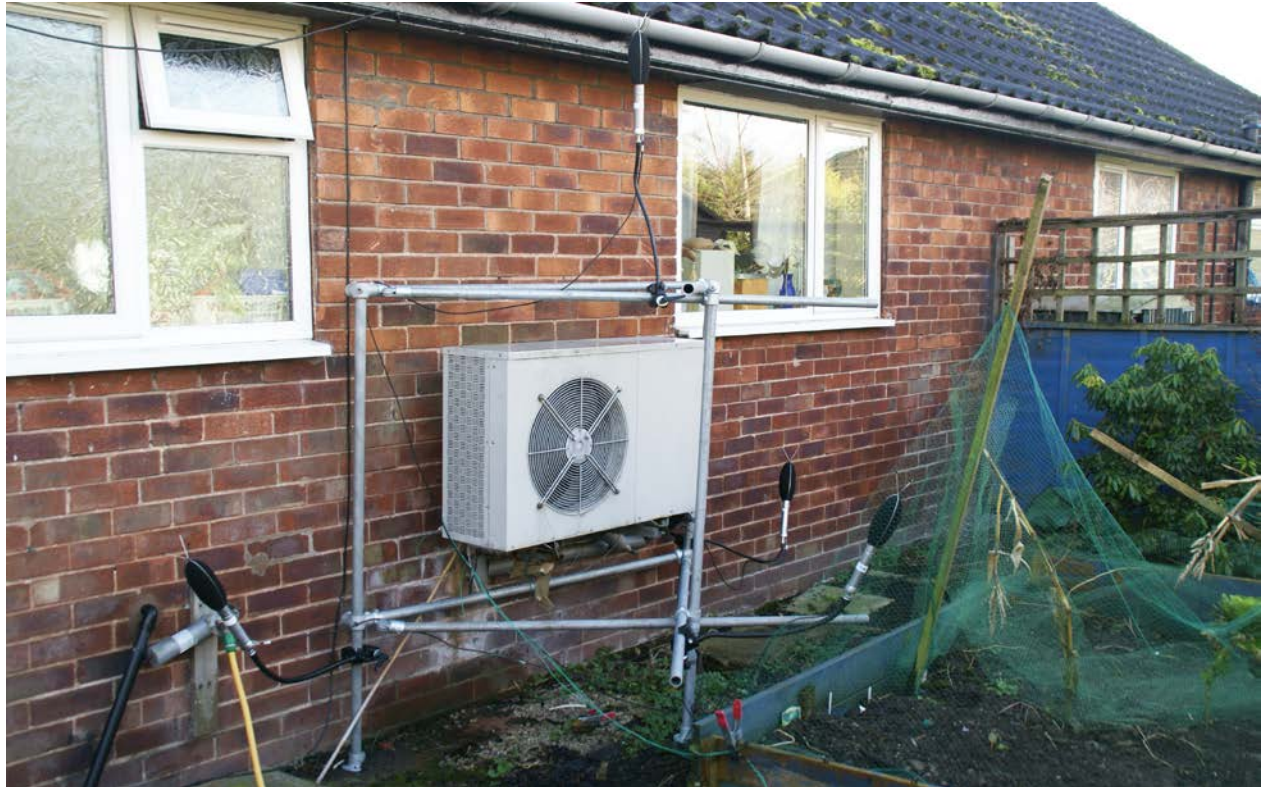
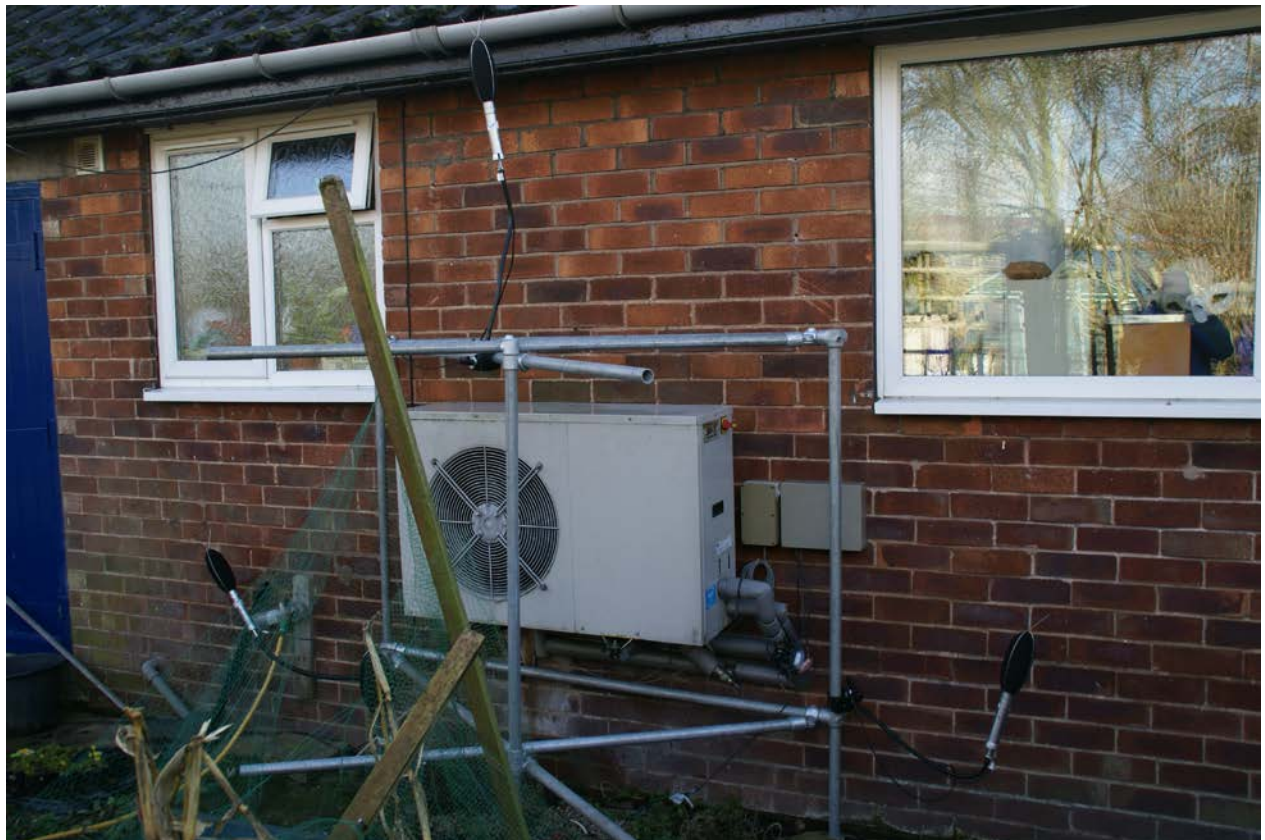
- 5.6.3. The 9 Channel PULSE system was used at this site.
- 5.6.4. The unit was mounted above a mixed ground surface of soil and paving slabs.
- 5.6.5. Accelerometers were fixed to the unit casing and to the wall surface immediately behind the unit. The accelerometers were fixed to the surfaces using cyanoacrylate cement.
- 5.6.6. The microphones were mounted on a temporary scaffolding framework as shown in Picture 5-15 and Picture 5-16. All microphones were positioned 1 m from the ASHP casing.

Picture 5-15. 443 Cheshire West, ASHP and Microphone Arrangement

Picture 5-16. 443 Cheshire West, ASHP and Microphone Arrangement

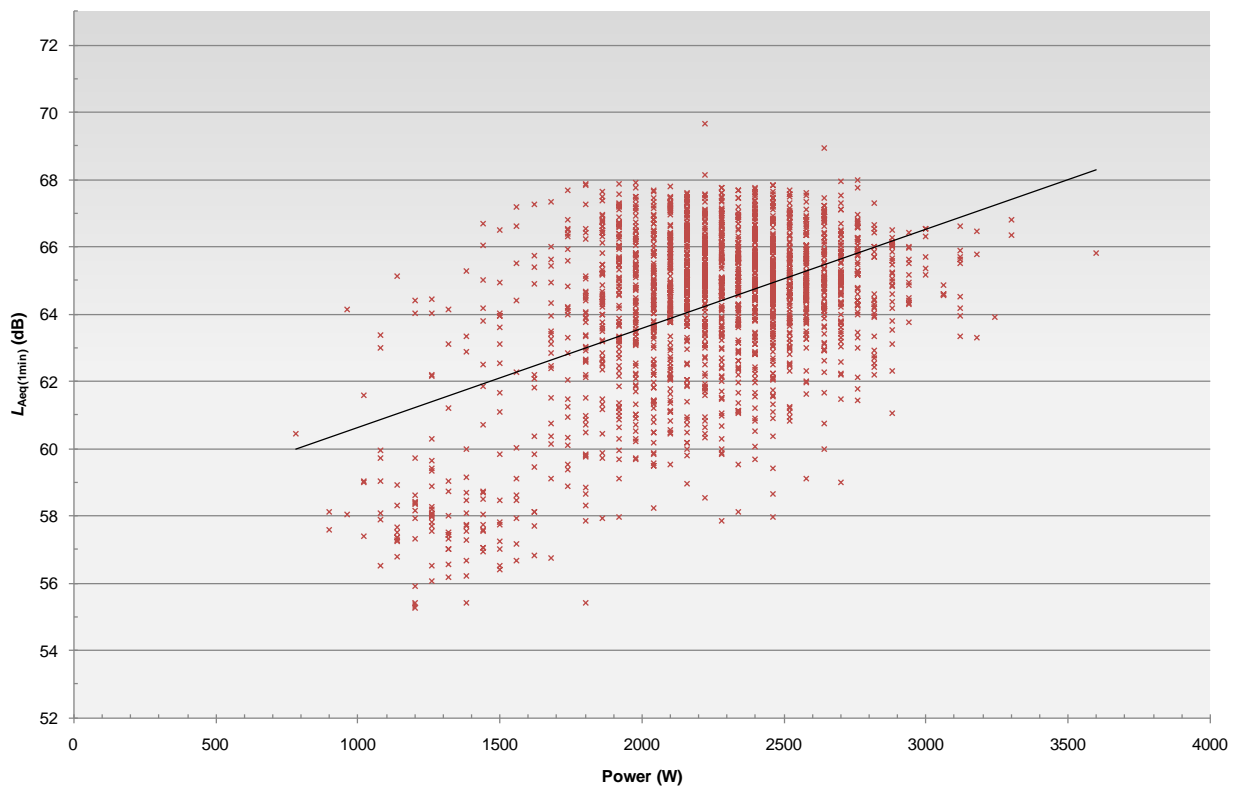
Figure 5-46. 443 Cheshire West, Sound Pressure Level vs Power Consumption

5.6.10. Figure 5-2 presents a scatter diagram showing the noise levels against the power consumption, for the periods when the ASHP was operating. The chart trend line indicates a slight increase in noise level with ASHP power level, although the fit is not conclusive, with a regression coefficient (r^2) of 23%.

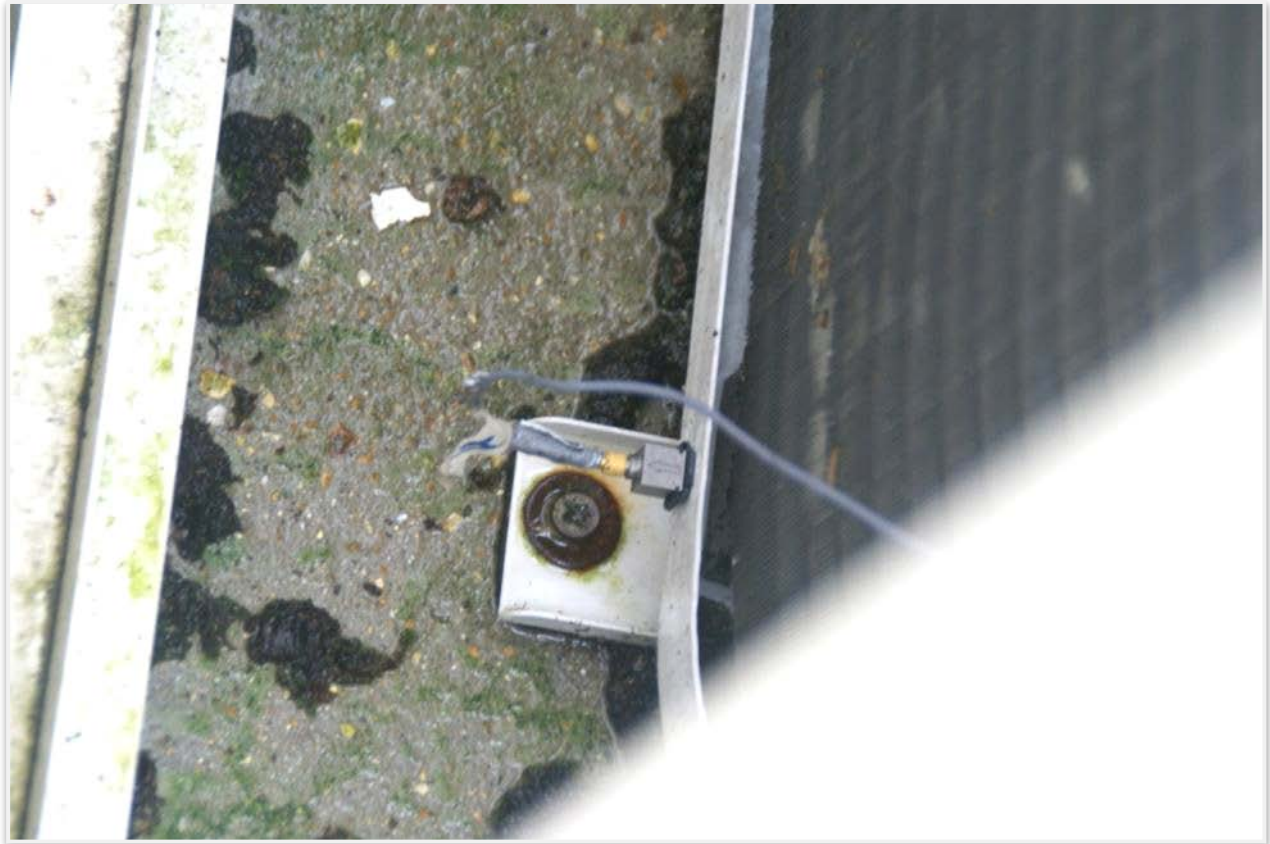
- 5.7.3. The 5 Channel PULSE system was used at this site.
- 5.7.4. The ASHP was located on hard, reflective ground, with a fence panel situated close by, to the right of the unit.
- 5.7.5. An accelerometer was fixed to the unit casing, as shown in Picture 5-17, using cyanoacrylate cement.

Picture 5-17. 474 West Berkshire (Site 1), Casing-mounted Accelerometer

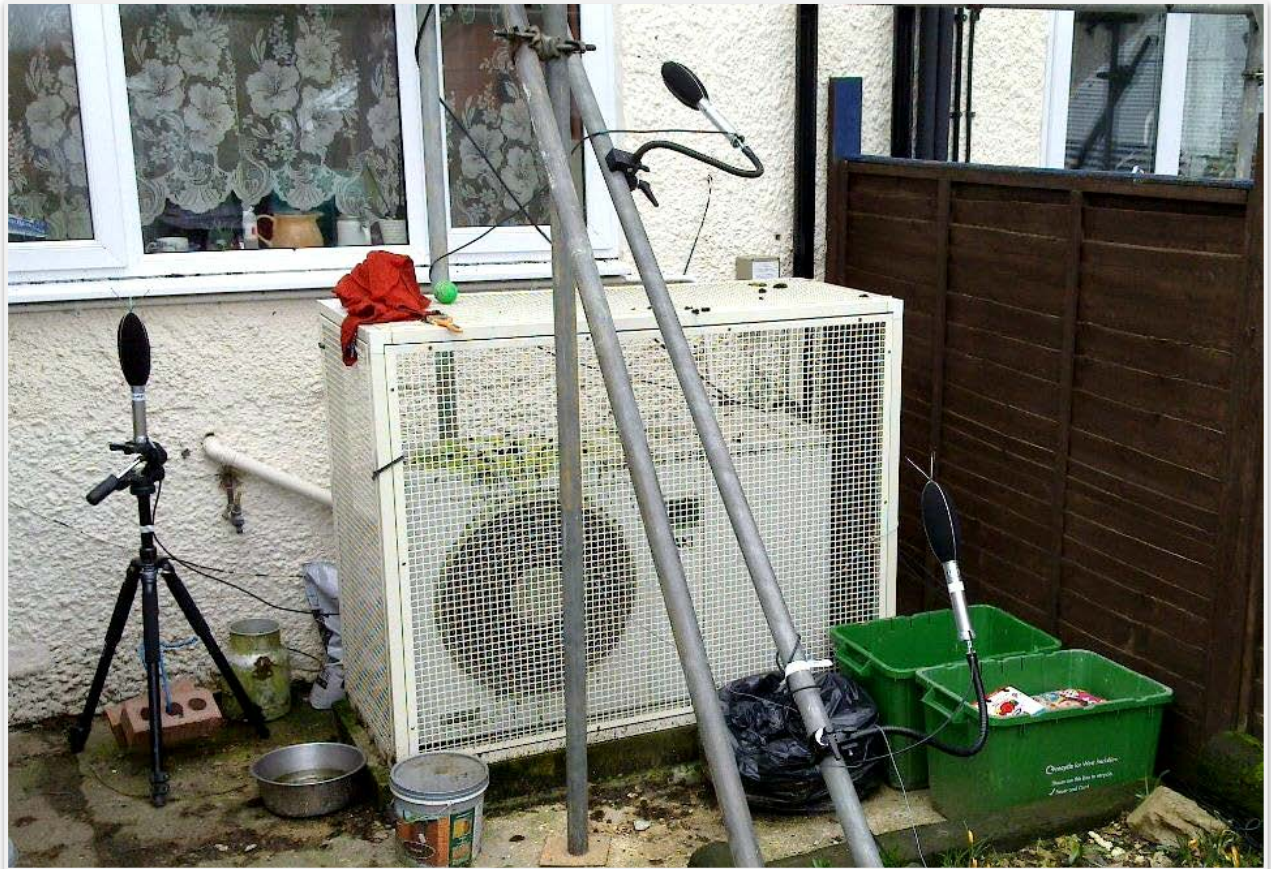
5.7.6. Three microphones were used, two mounted on scaffolding and one mounted on a tripod as shown in Picture 5-18. All microphones were positioned 1 m from the ASHP casing, with the exception of the position to the right of the ASHP, which was situated slightly closer (60 cm) due to the presence of a walkway.

Picture 5-18. 474 West Berkshire (Site 1), ASHP and Microphone Arrangement

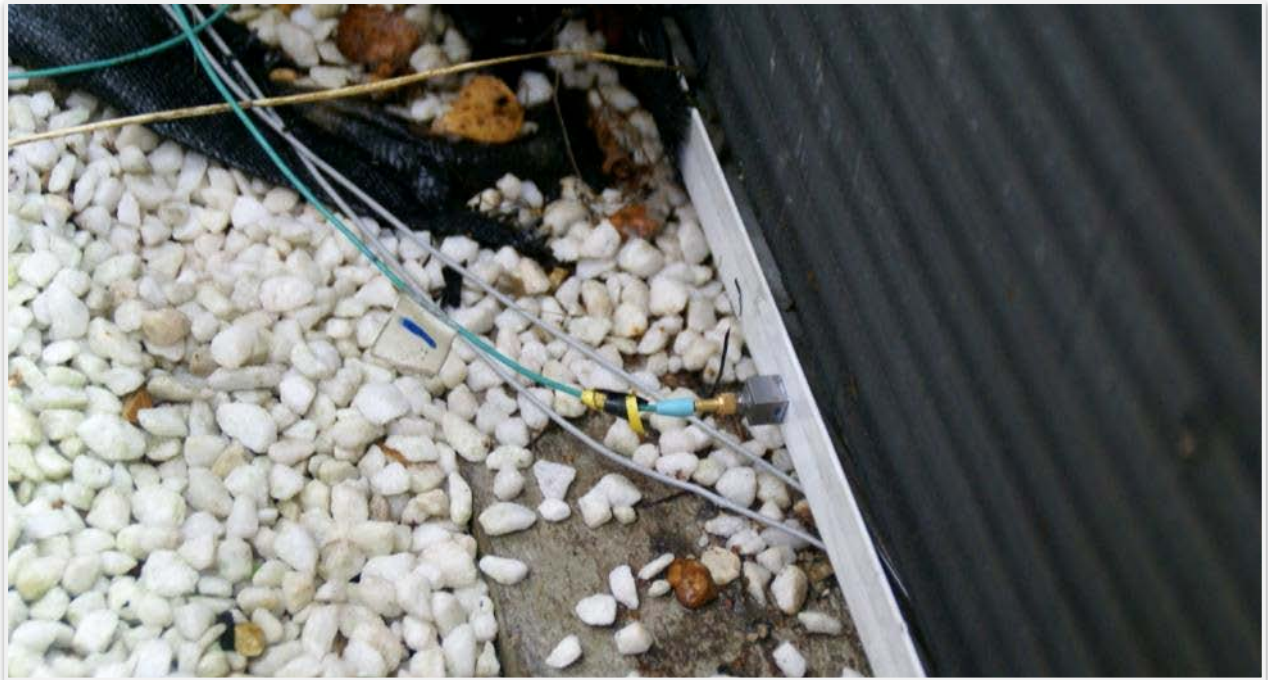
Picture 5-19. 475 West Berkshire (Site 2), Casing-mounted Accelerometer

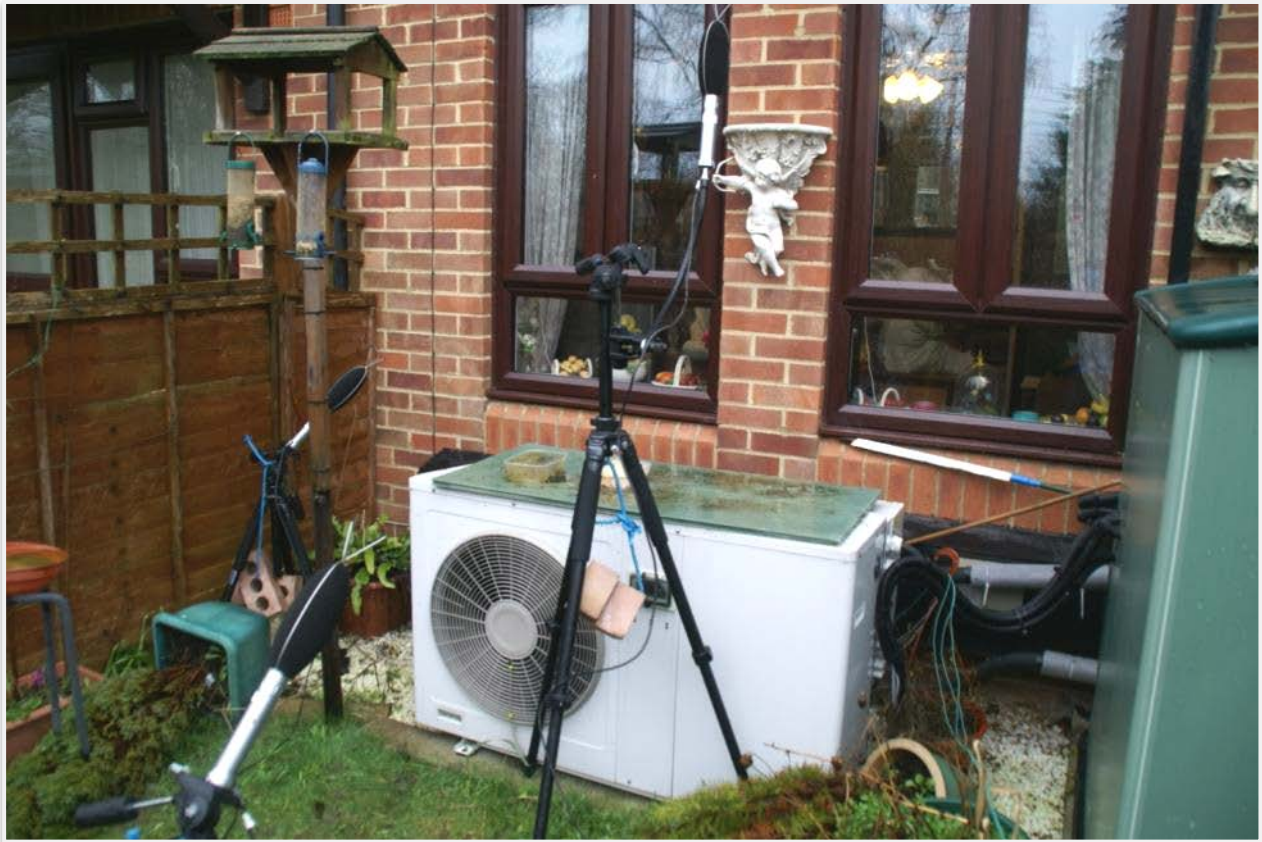
Picture 5-21. 475 West Berkshire (Site 2), ASHP and Microphone Arrangement
