**PART 1.4
FINDINGS**

PART 1.4 – FINDINGS

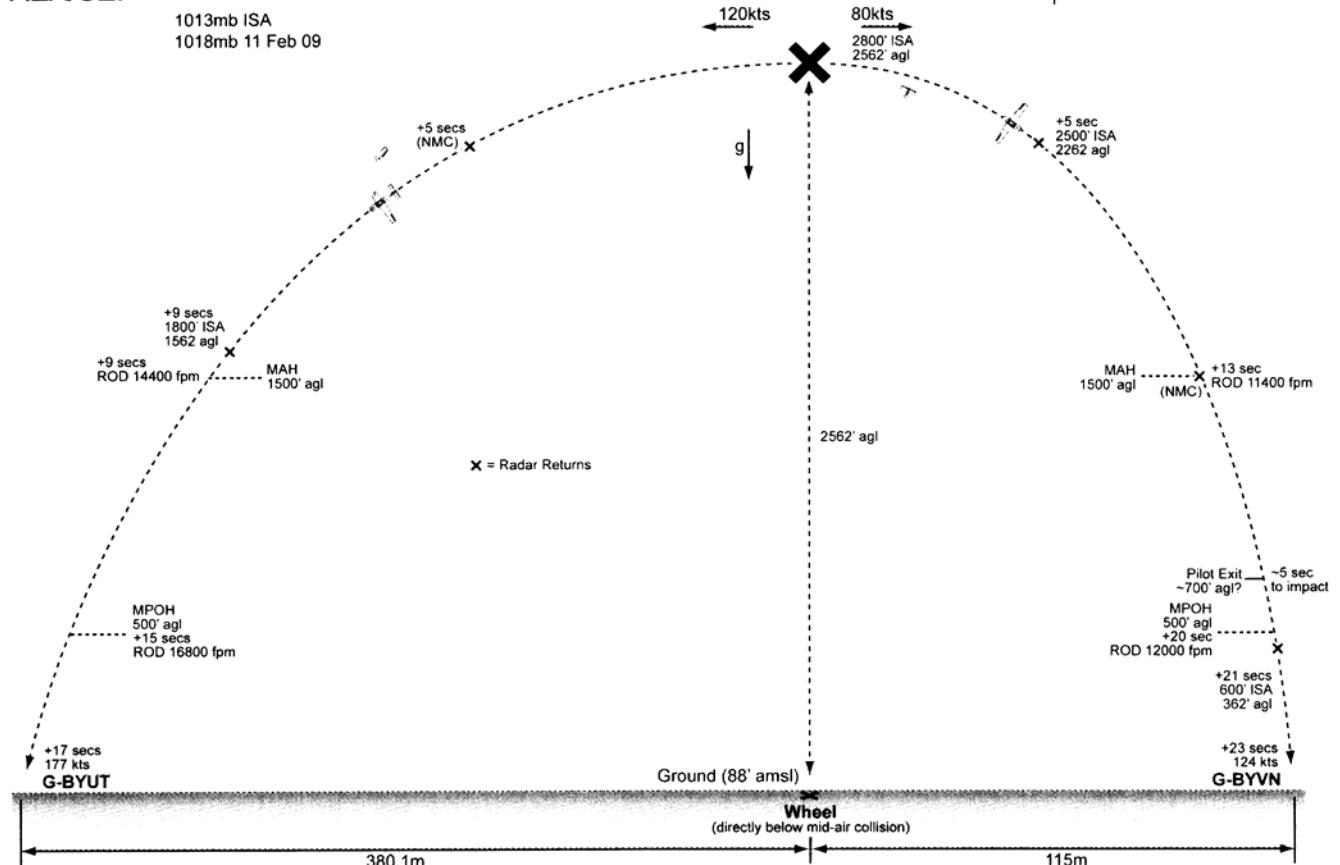
Figure 2. Illustration of radar returns and estimated descent profile post collision.

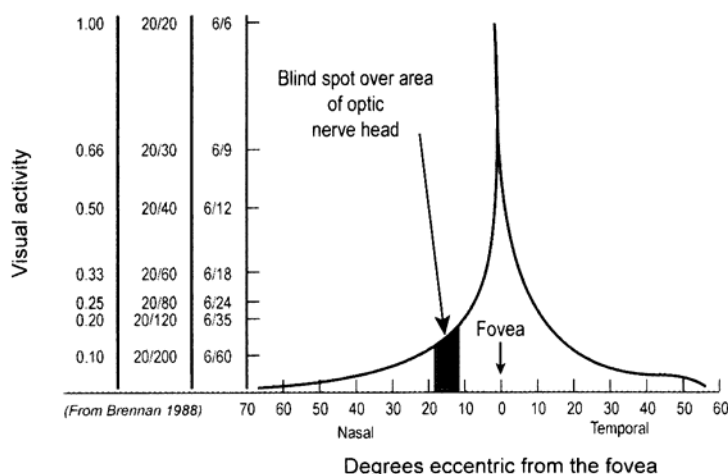
Variation of visual activity

Figure 5. Performance of the human eye – visual acuity.

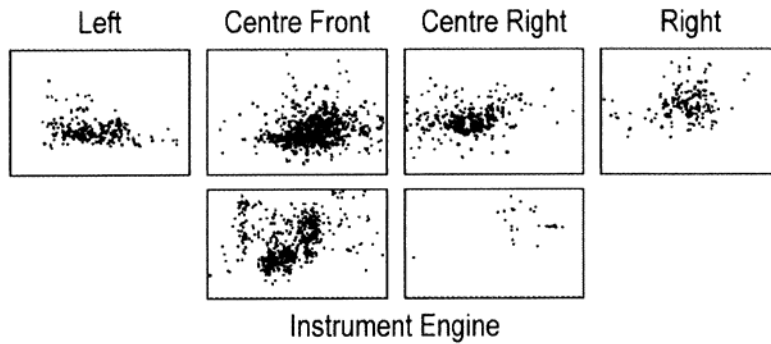
(a) - Best Performer

(b) - Worst Performer

Figure 11. Results from a study of civilian pilots into 'windscreen zoning'; the dots indicate where the study pilots looked in the course of a simulator exercise, as determined by an eye-tracking device.

c. **Windscreen zoning.** The Panel also noted that studies (White 1964)²⁶ have demonstrated that an observer looking for a target is less likely to scan areas of sky near to the edges of windscreens, as compared to areas further away from obstructions (Figure 11). It was not possible to determine if the lookout scans of the pilots of G-BYUT

and B-GYVN extended to the edges of the available FoV; windscreen zoning could not be discounted and was therefore a possible contributory factor.

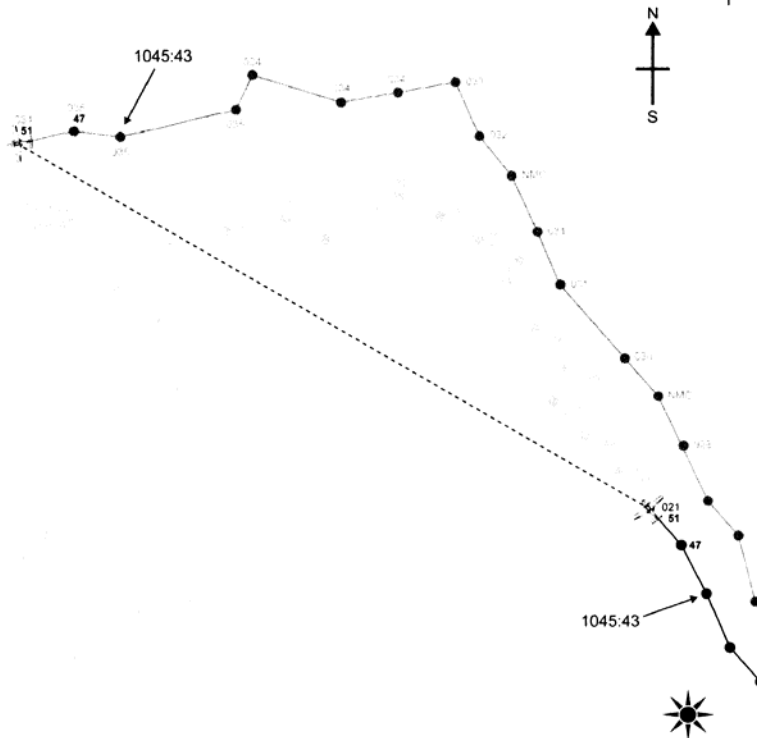
Figure 15. Relative disposition at 1045:51 showing that the pilot of G-BYVN would have been presented with a predominantly tail aspect of G-BYUT.

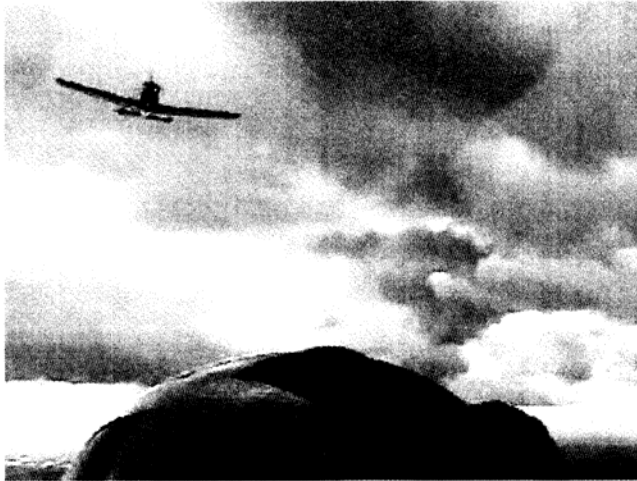
Figure 26. Reconstruction flight: estimated view from G-BYVN of Tutor simulating G-BYUT approximately 1 sec prior to the simulated collision point. Note the elevated camera to achieve an unobstructed view over the adjacent seat occupant. In the reconstruction, height separation was maintained.

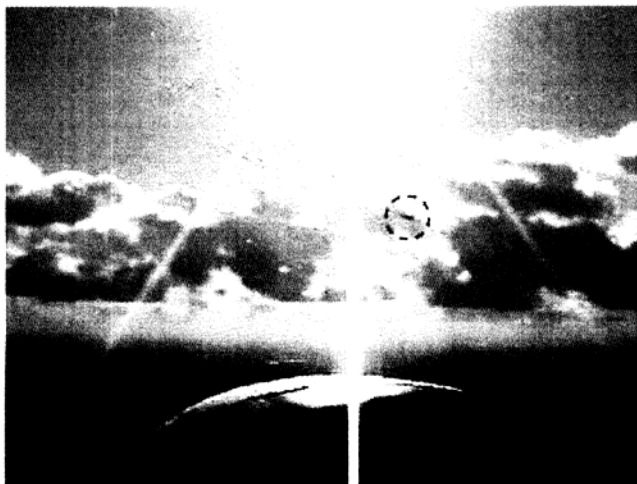
Figure 27. Reconstruction flight: another estimate of the view from G-BYVN of Tutor simulating G-BYUT approximately 1 sec prior to the simulated collision point. Note the alignment of the line of approach with the sun.

viii. The precise orientation of the sun in the final seconds cannot be determined because it is dependant upon aircraft heading, which cannot be known precisely due to the ARP of the radar. Nevertheless, the reconstruction flight was orientated to put the sun in the same general area, based upon the flight path trend recorded, and timed to put the sun at 20.6° above the horizon which accurately replicated the conditions at 1046Z on 11 Feb 09. It was apparent that G-BYUT would have approached G-BYVN from the general direction of the sun (Figure 27) and the Panel concluded that glare would have made visual detection even less likely and was therefore a possible contributory factor.

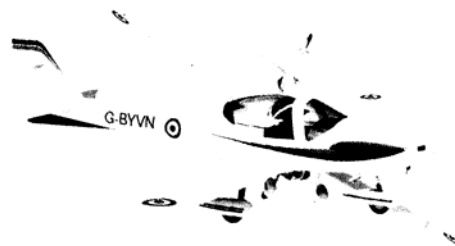
Figure 29. Estimated sightline of G-BYVN.

The Panel determined that the final flight paths leading to collision placed G-BYVN in the low, right windscreen of G-BYUT for at least 20 secs, with a background of bright cloud. If the pilot of G-BYUT was looking into the turn, as could reasonably be expected, then G-BYVN is likely to have been obscured by the frames of his Corrective Flying Spectacles or outside the area of corrected vision. In the final few seconds before collision, when apparent growth would be greatest, G-BYVN is likely to have been obscured by the nose of G-BYUT. The pilot of G-BYVN was likely to have had his view of G-BYUT interrupted by a combination of the left canopy arch and the adjacent cadet, and had to contend with glare from the sun. For both pilots, the opposing aircraft would, if not entirely obscured, have approached from close to a limit to the available FoV; although determined from a survey of civilian pilots conducting a simulator based exercise, the Panel noted the findings of studies that suggest that lookout scans tend to neglect the edges of the available FoV. An appreciation of the final angle of arrival of each aircraft, as seen from the pilots of G-BYUT and G-BYVN, is provided in Figures 28 and 29.

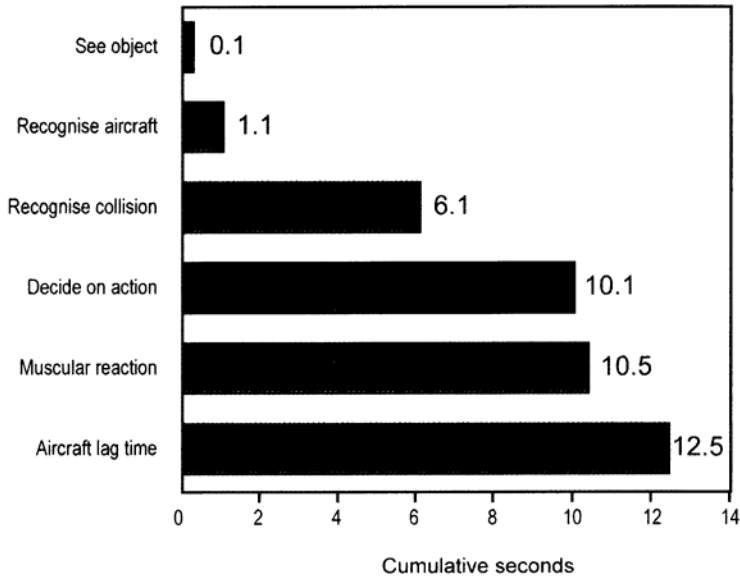
Figure 30. Reaction times to evade a collision threat.

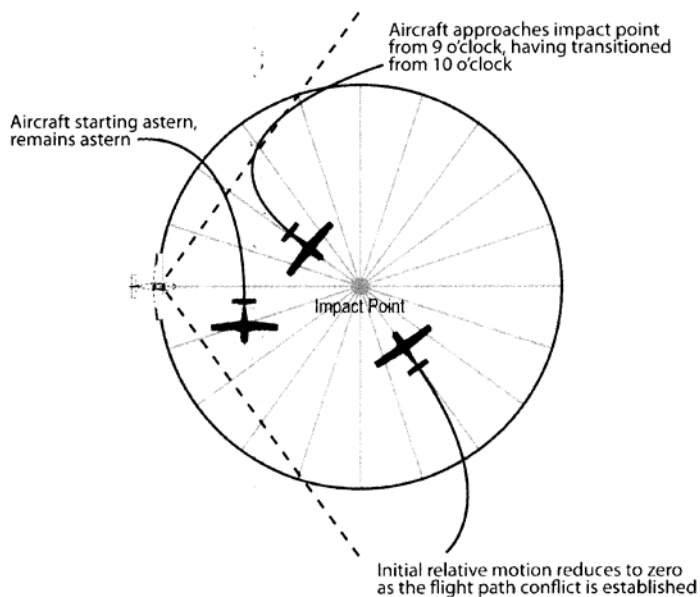
The final closing track of co-speed manoeuvring traffic may be beyond 60° of 12 o'clock but the approaching flight path is likely to transition the forward sector, or the conflict will pass astern.

Figure 34. Relative orientation of manoeuvring aircraft at 100 kts or less.

Aircraft with groundspeeds less than about 100 knots that converge as a result of manoeuvre are also likely to at least pass through the forward sector of the opposing aircraft, although the final angle of arrival can still be from anywhere from the 3/9 line forward, as depicted in Figure 34.
