A Review of River Rehabilitation in the UK, 1990-1996

Research and Development
Technical Report
W175

ENVIRONMENT AGENCY

Nigel T H Holmes

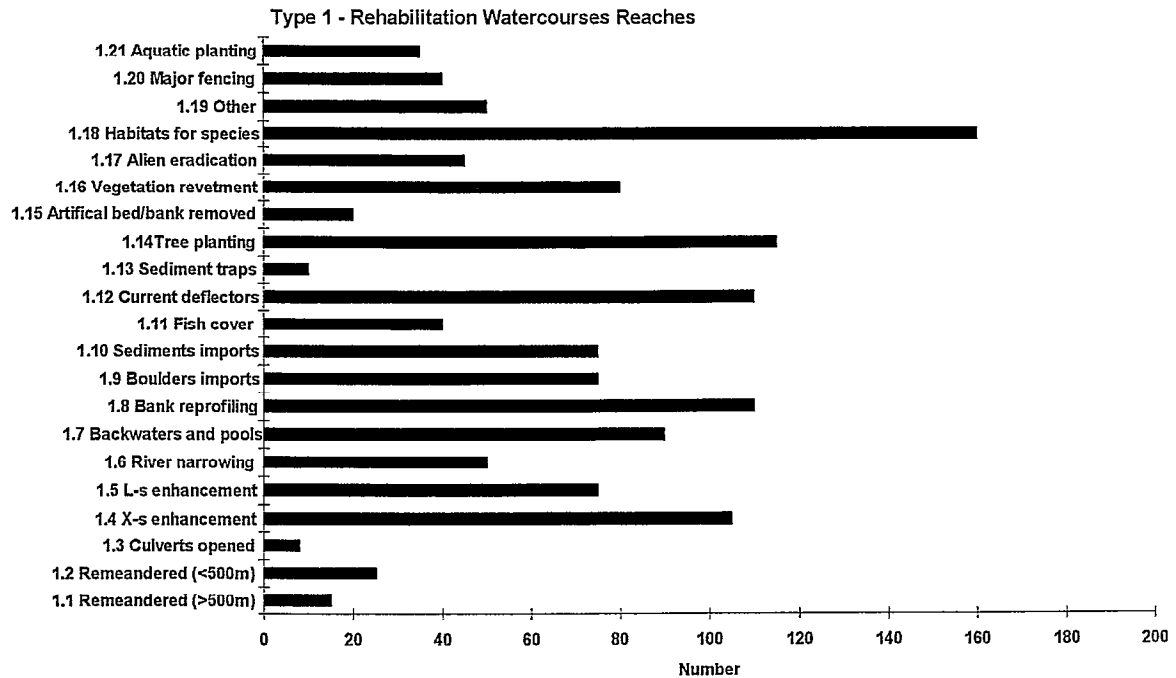
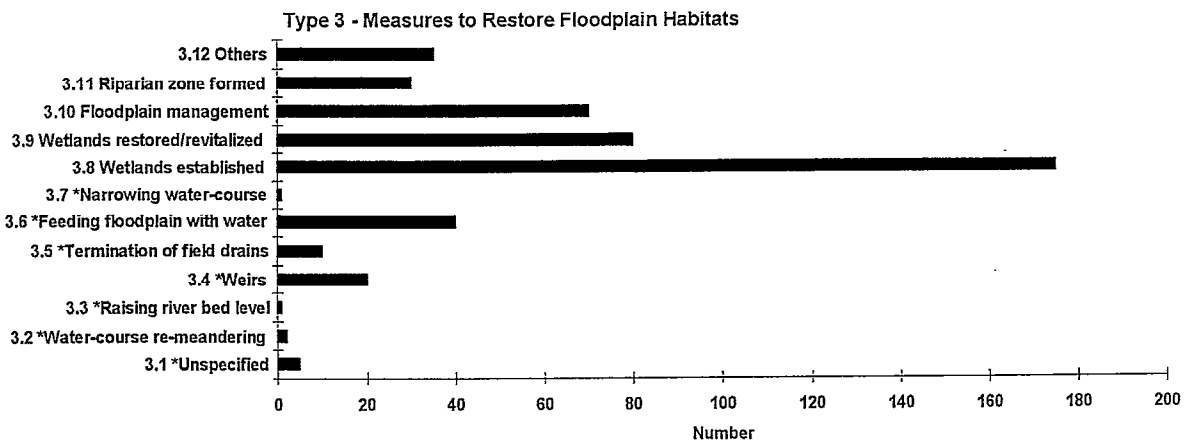
Figure 1. Summary of Rehabilitation Work - Environment Agency

The breakdown of priority activity is broadly as might have been expected. Four of the five categories least often undertaken are all expensive and are more likely to require great confidence in the re-engineering or be only possible where previous standards/risks are reduced. Installation of sediment traps for environmental rehabilitation was only included on the proforma because it is a common action undertaken in Denmark, where most of the engineered rivers are cut through soft sands; but it is one of the two least commonly implemented categories in the UK. The most commonly implemented categories of channel rehabilitation may be achieved relatively cheaply, and often with no conflict with Flood Defence aims and objectives.

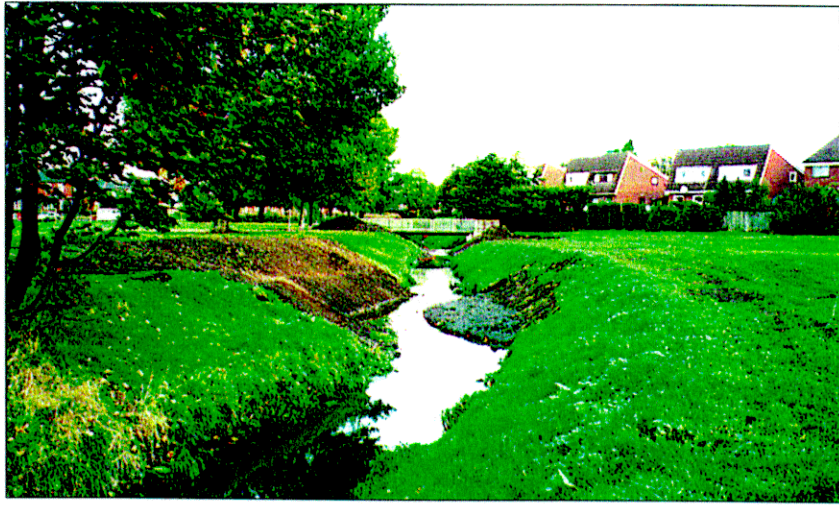
Photo taken at **1** – During work

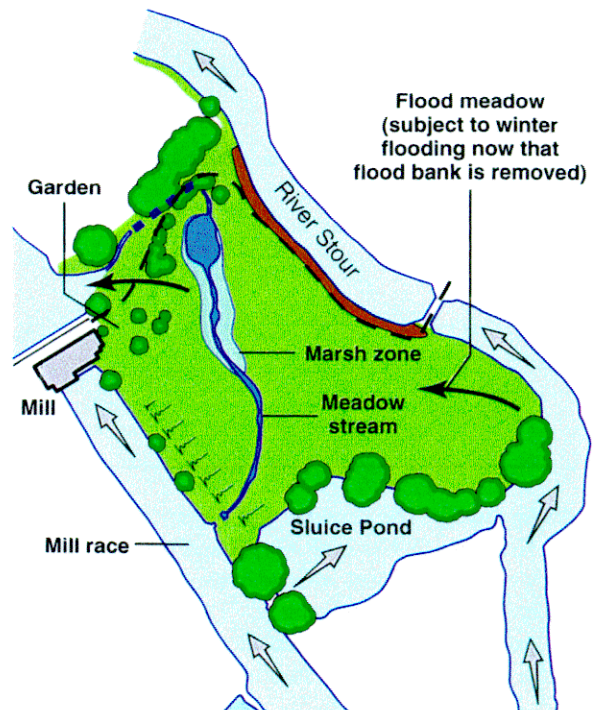
Construction – February 1996

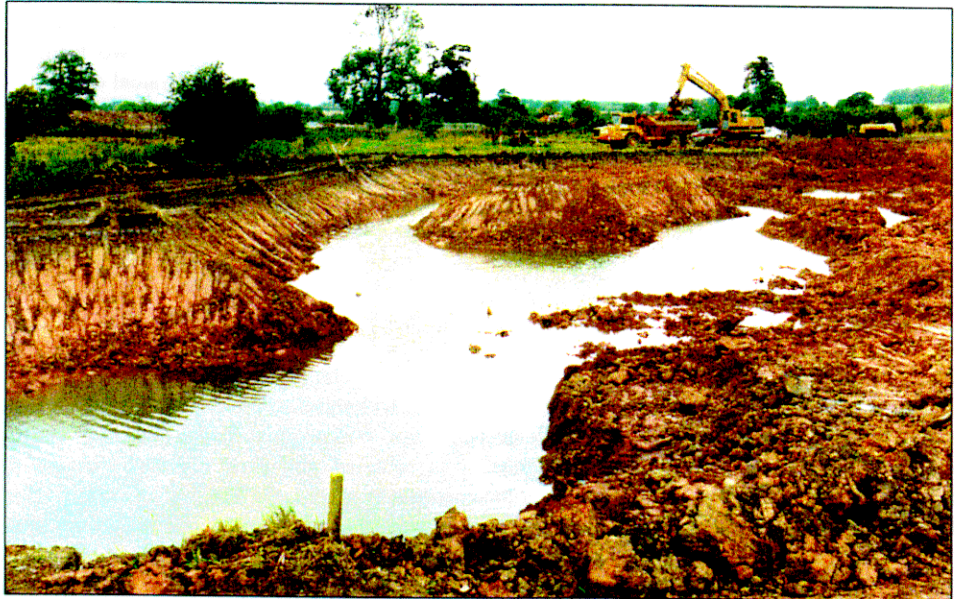
Lake construction showing varied slopes, depths and island

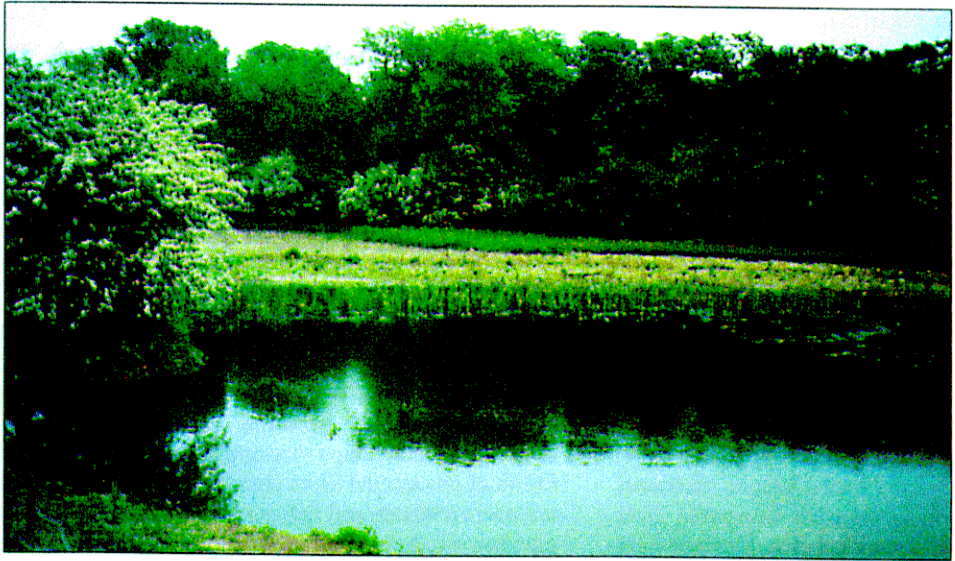
Widened bay and reed bed soon after construction – (May 1991)

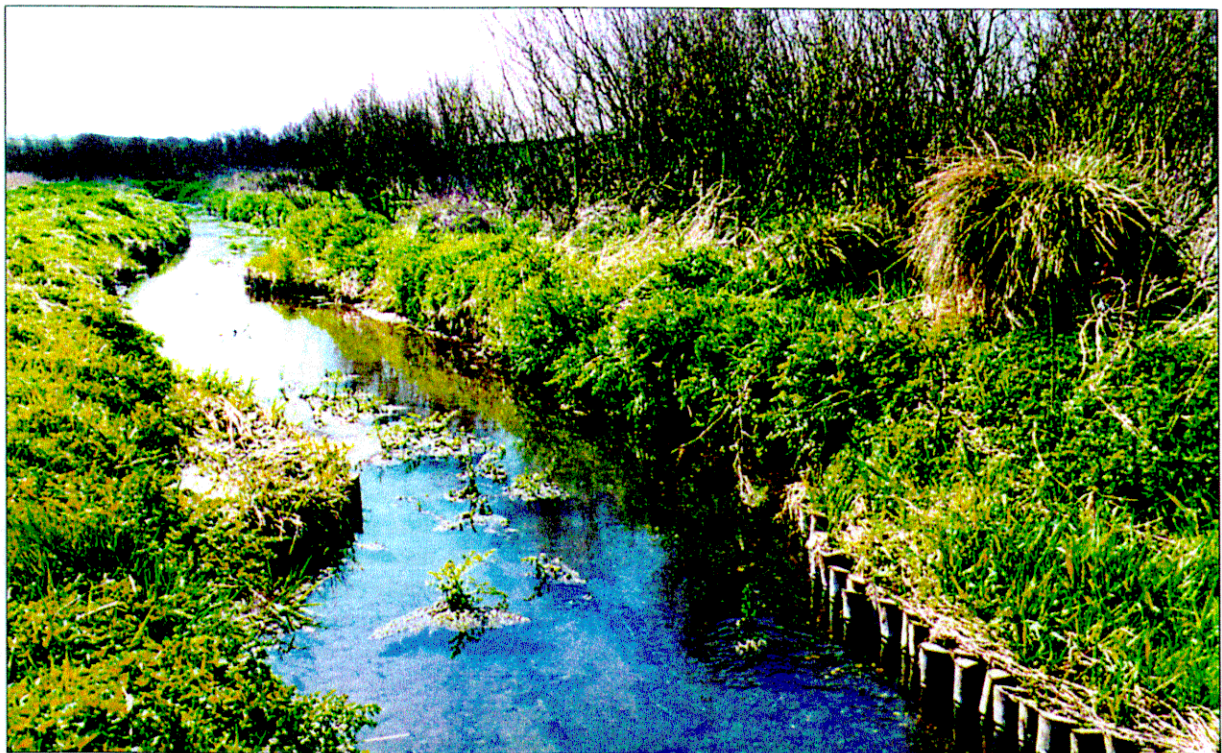
B – 'Meandering' of straight channel using pole revetment and reed infill

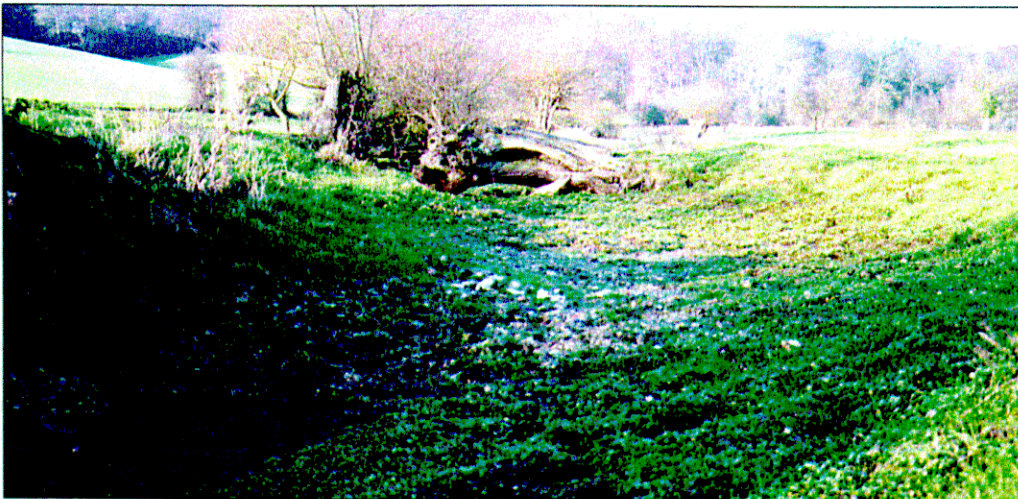
River Pang downstream Hampstead Norreys (Dec 1988)

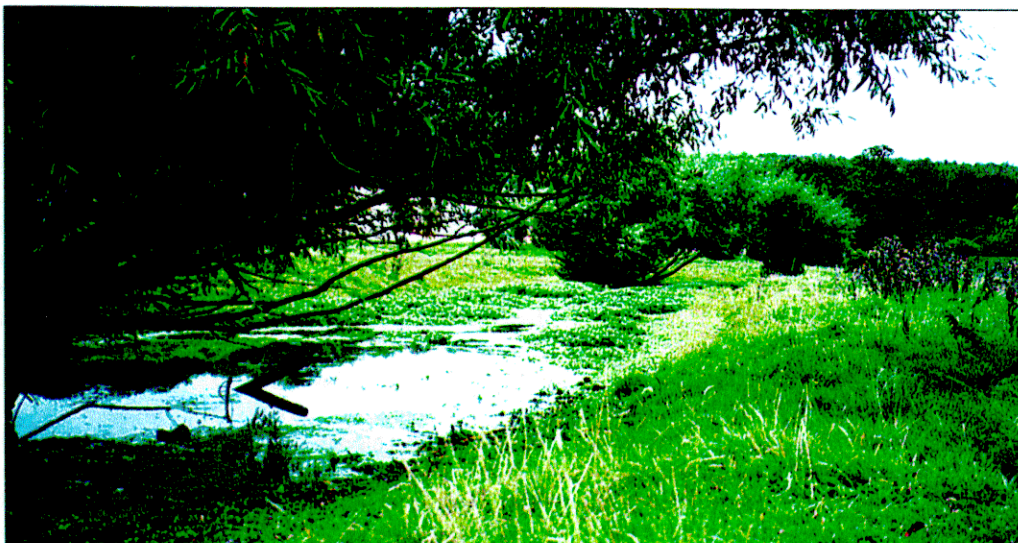
Same location (Oct 1995)

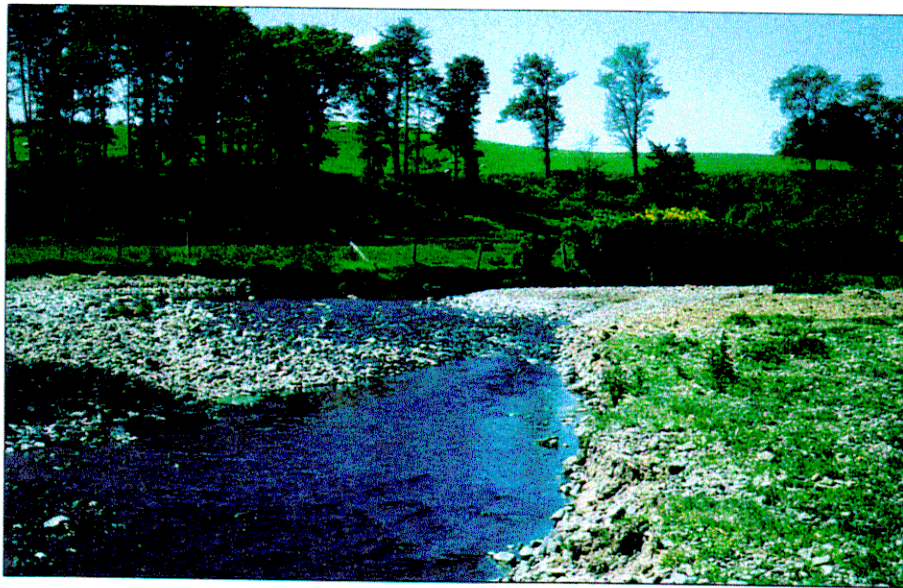
Lilburn 1993 – Before fencing showing effects of over-grazing

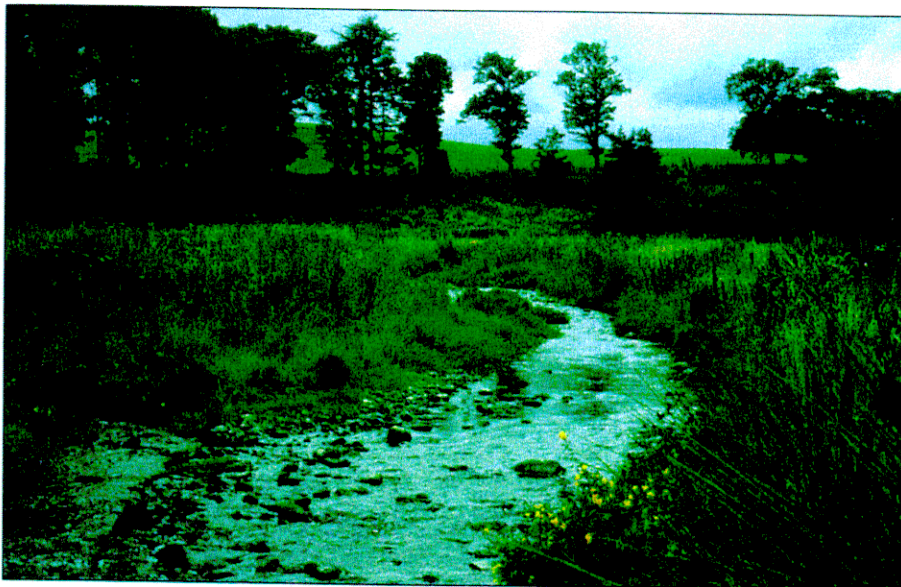
Lilburn 1996 – Three years after fencing showing recovery
