Figure 1. Op. Catchments within the Tees Catchment.

Table 1. Summary of WFD Failing elements within the Tees Subcatchments. 2012 Assessment. (Mitigation Measures Ass. refers to 'heavily modified' Water Bodies requiring a programme of physical works to improve their status.)

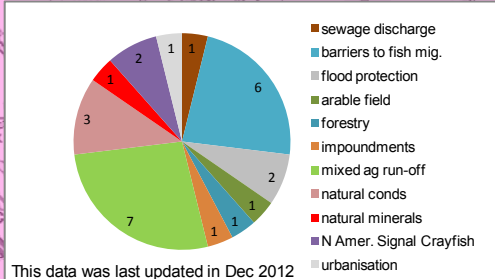
Middle Tees: All Reasons for Failure

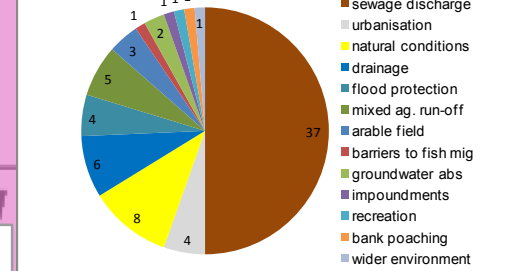
Lwr Tees and Estuary: All Reasons for Failure
