**Porlock Bay:
Geomorphological investigation and monitoring
Gravel barrier breaching and tidal lagoon development**

R&D Technical Report W5B-021/TR

Authors: M.J. Bray and W. Duane
RACER
Department of Geography
University of Portsmouth

August 2001

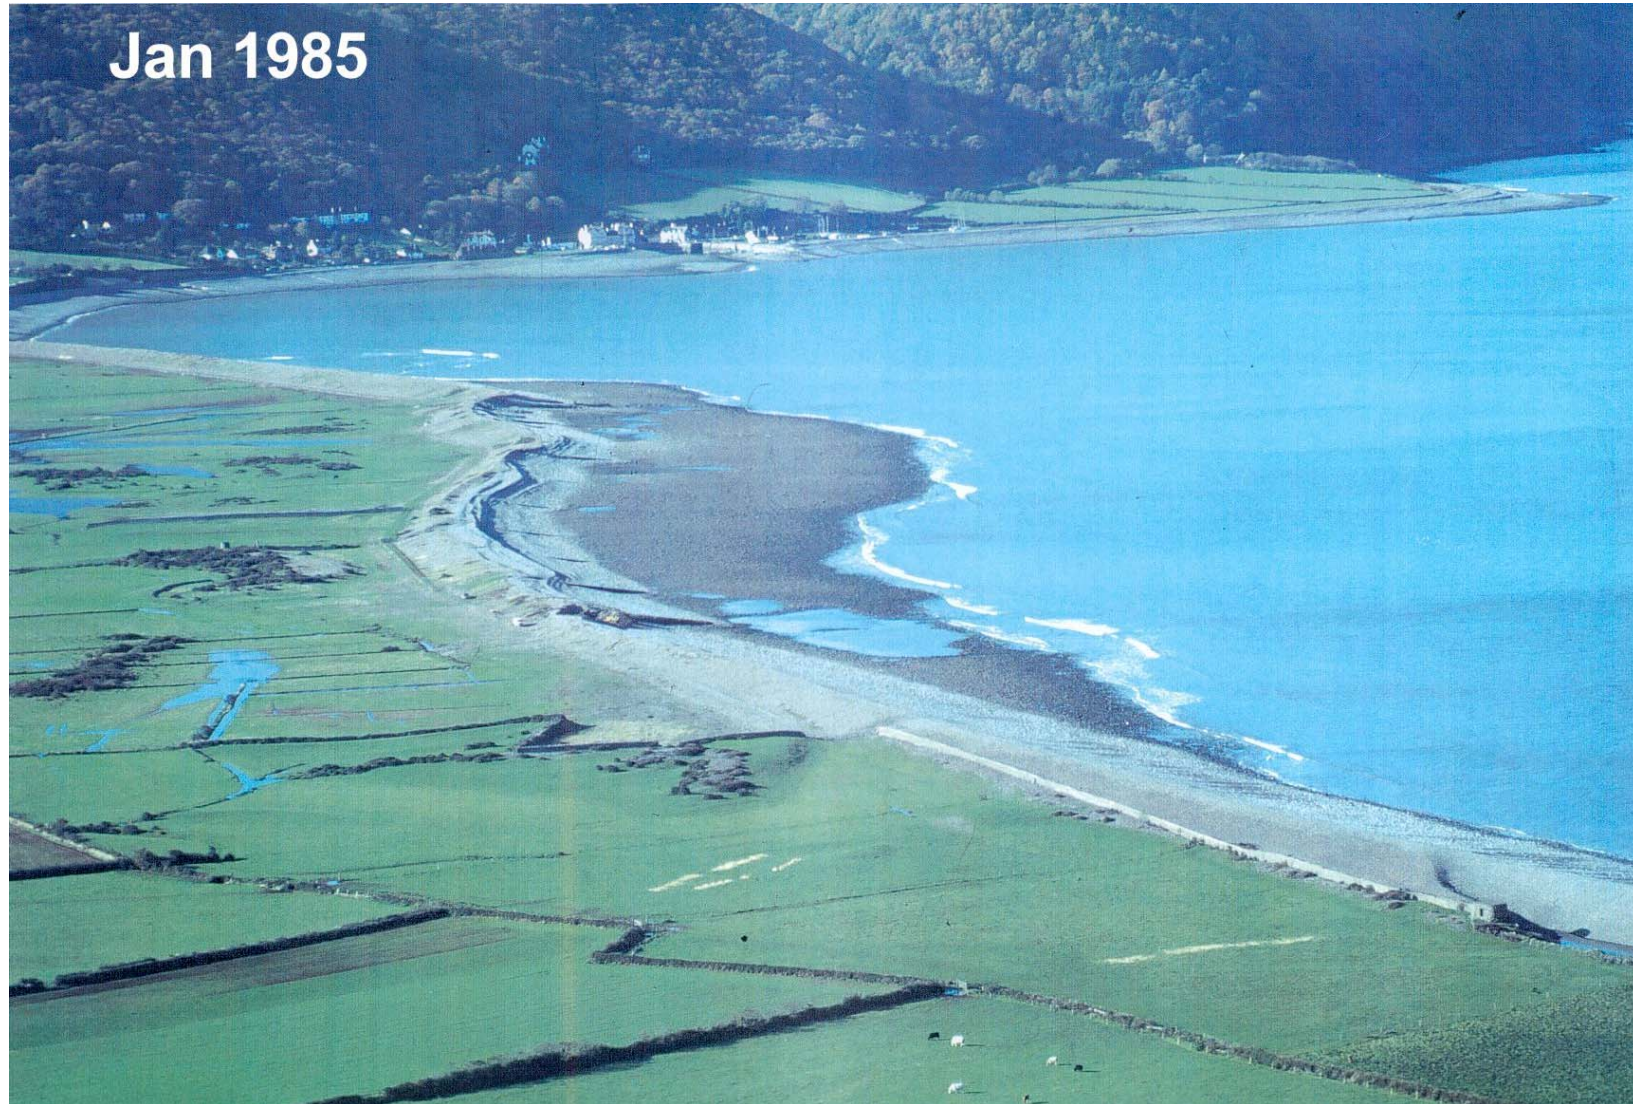
Figure 3 View westwards across Central Parts of Porlock Bay demonstrating the artificially maintained barrier with its steep and high crest. During this time, the back-barrier area was a freshwater grazing marsh drained by the sluice at New Works (mid distance). The exposed foreshore represents land transgressed by the retreating barrier.

Porlock Bay, West Somerset is occupied by a coarse gravel barrier beach extending for some 5km between the Gore Point and Hurlstone Point headlands (Figures 1 and 2). Historically, the barrier has afforded protection to Porlock Weir village and harbour as well as Porlock Marsh an area of low-lying land susceptible to saline and freshwater flooding. Although Horner Water is the only major stream entering Porlock Bay, its small but elevated and steeply sloping catchment is effective in delivering quantities of freshwater to the back barrier marsh. Since at least the mid 1800s, a sluice at New Works has regulated the water levels within a small predominantly freshwater lagoon. Collectively, the marsh environments comprised a diverse and valuable range of habitat types recognised with biological SSSI status in 1990. Historically, the barrier has been susceptible to overwashing and breaching and for many years its stability was maintained by the active management of the Environment Agency (EA) and its predecessors, involving replenishment and scraping to maintain a continuous, high berm crest (Figure 3).

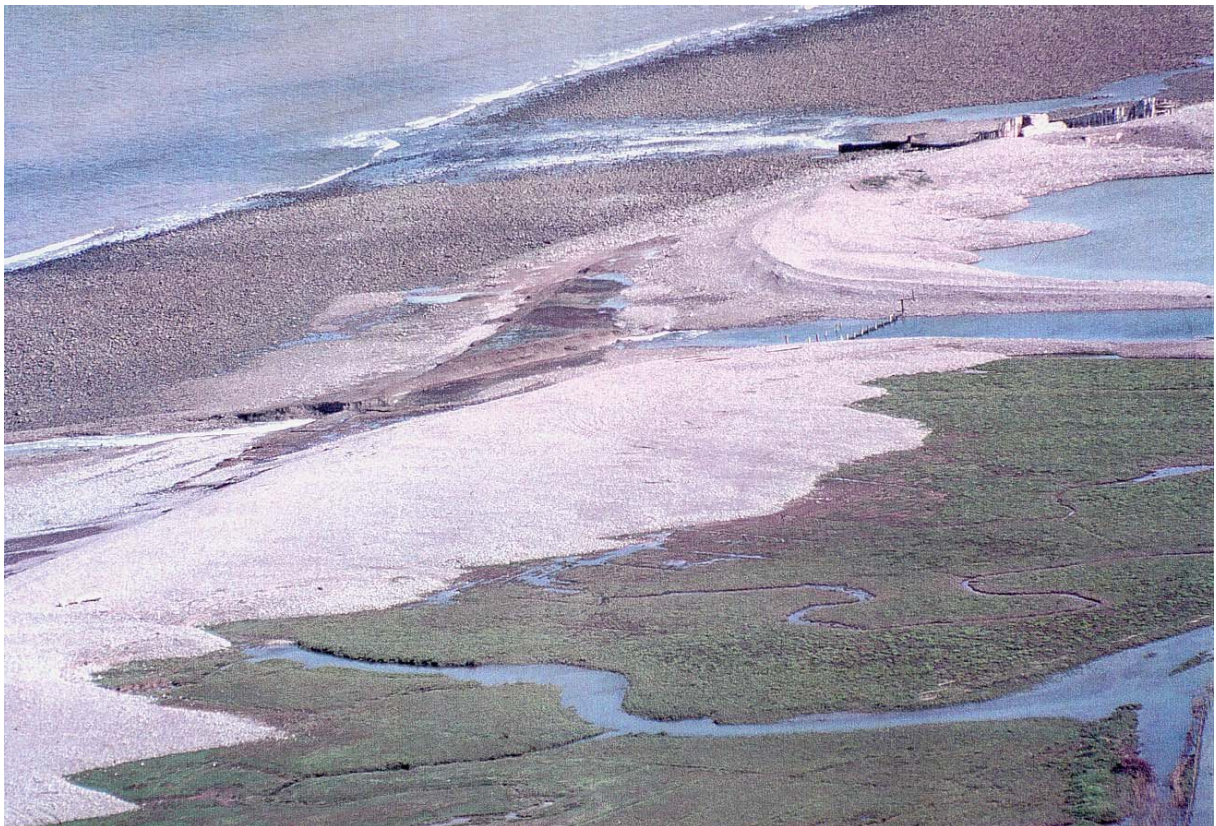
Figure 4 Porlock breach and lagoon revealing extent of flooding during an extremely high tide on 01.03.98.

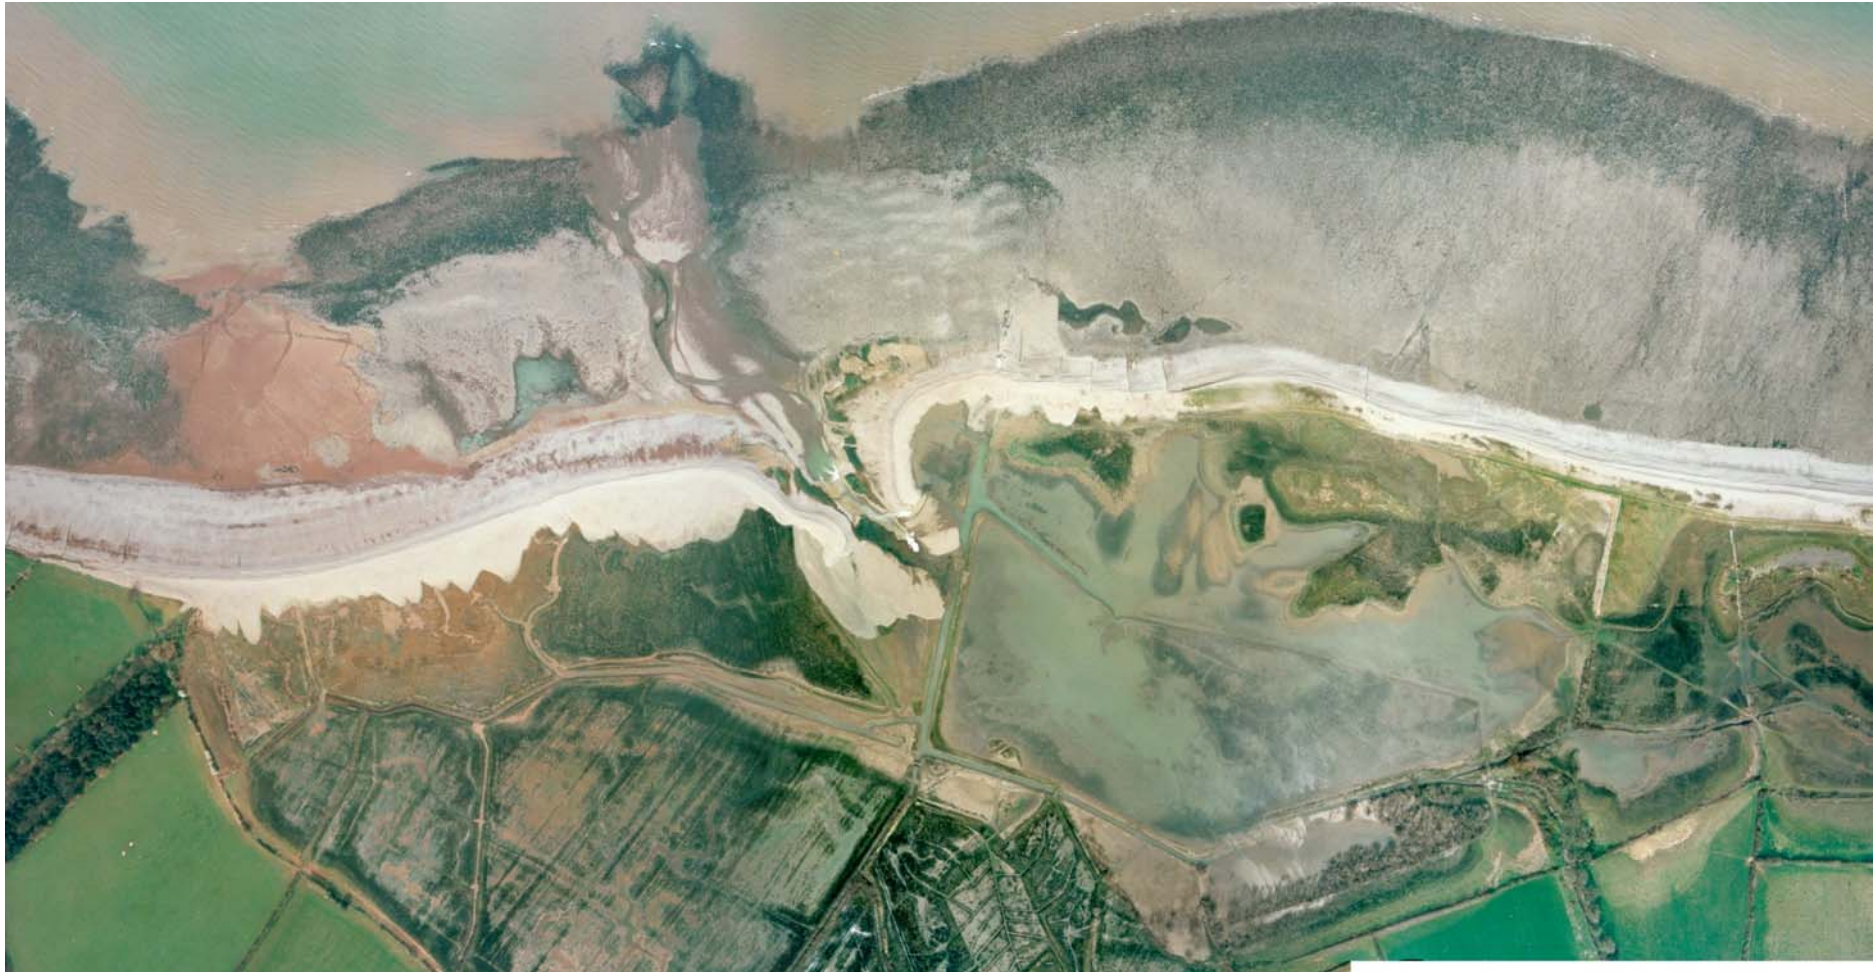
Figure 5 Barrier and breach channel demonstrating landowner's unsuccessful effort to seal the breach with a 'fence' in September 1997. Note the position of the waterfall at the breach some 20m seaward of the fence and also New Works outlet functioning to drain the lagoon. Relic tidal channels in the foreground have been reactivated and are functioning to distribute and drain tidal waters within the developing saltmarsh.

A severe storm on 28-29th October 1996 resulted in overwashing of a section of the barrier, tidal flooding of the marshland and thereafter the formation of a permanent breach channel and intertidal lagoon by the tidal discharge and subsequent exchange (Figures 4, 5 and 6). Rapid erosion of the clay substratum has significantly enlarged the breach such that it is unlikely to seal naturally. Furthermore, the breach is unlikely to be repaired for specific coastal defence purposes as the EA presently pursues a policy of non-intervention so that the barrier and marsh should develop naturally. The landowner has expressed a desire to seal the breach and attempted unsuccessfully to do so in 1997 (Figure 5).

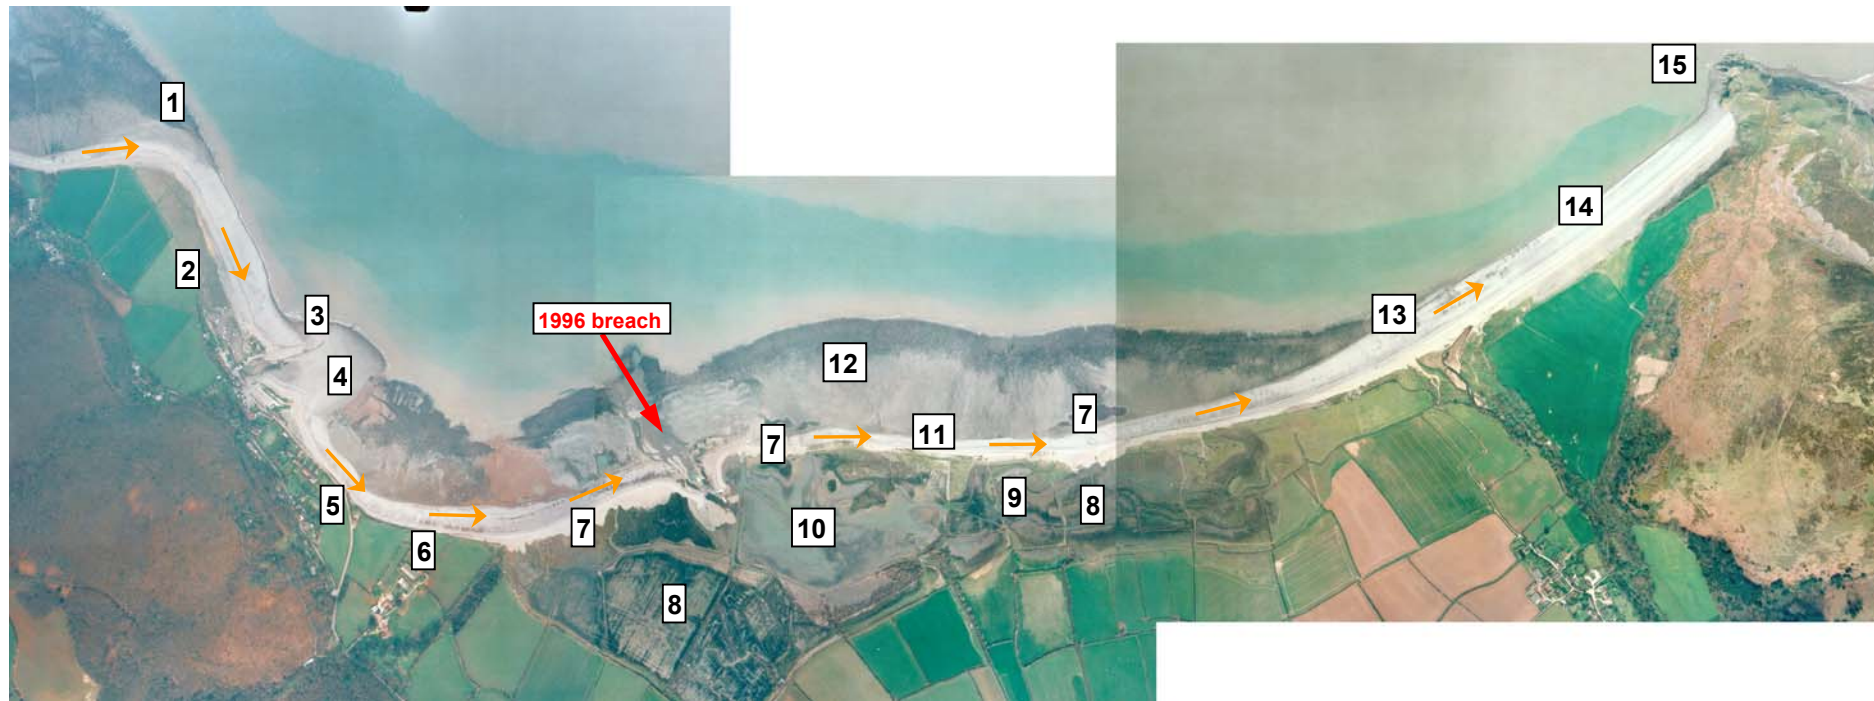
Figure 6 Vertical aerial photograph mosaic of the breach and lagoon at 1216hrs on 1st April 1999. Note that the photos are non-rectified and should not be used for direct measurement of features.

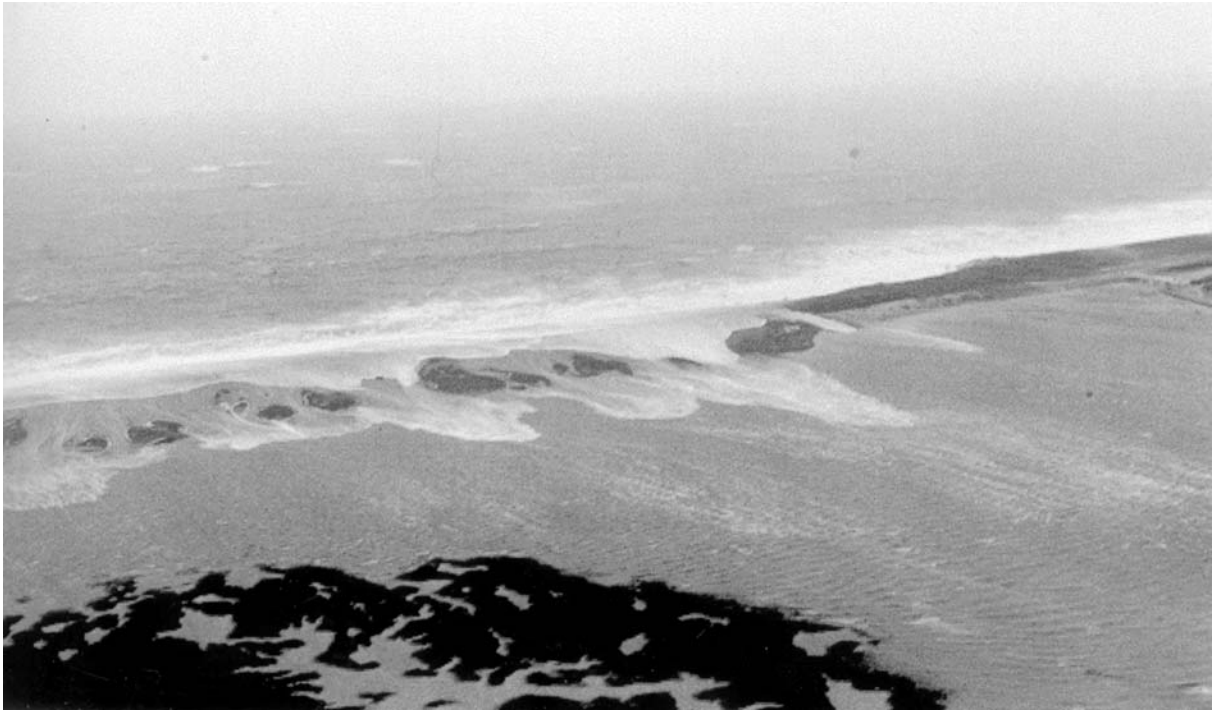
Figure 7. Geomorphology and processes of Porlock Bay, 1st April 1999.

15. Hurlstone Point headland. Hard rock headland thought to form a total barrier to gravel drift, although it fails to retain sand within Porlock Bay.

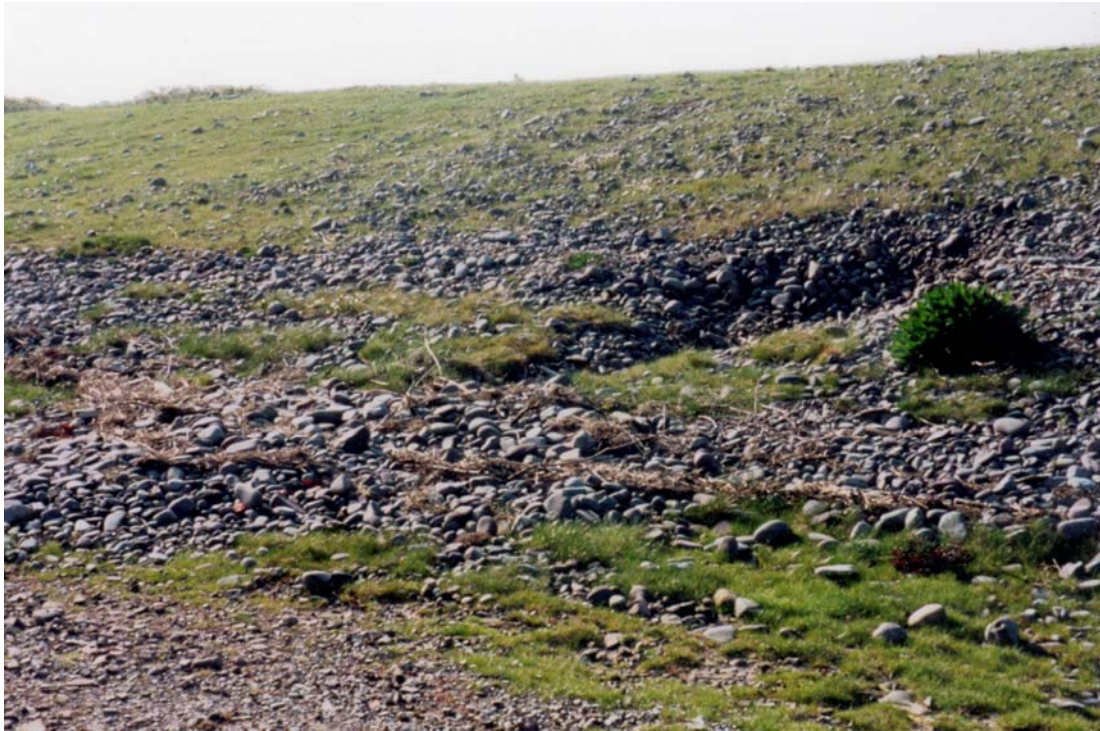
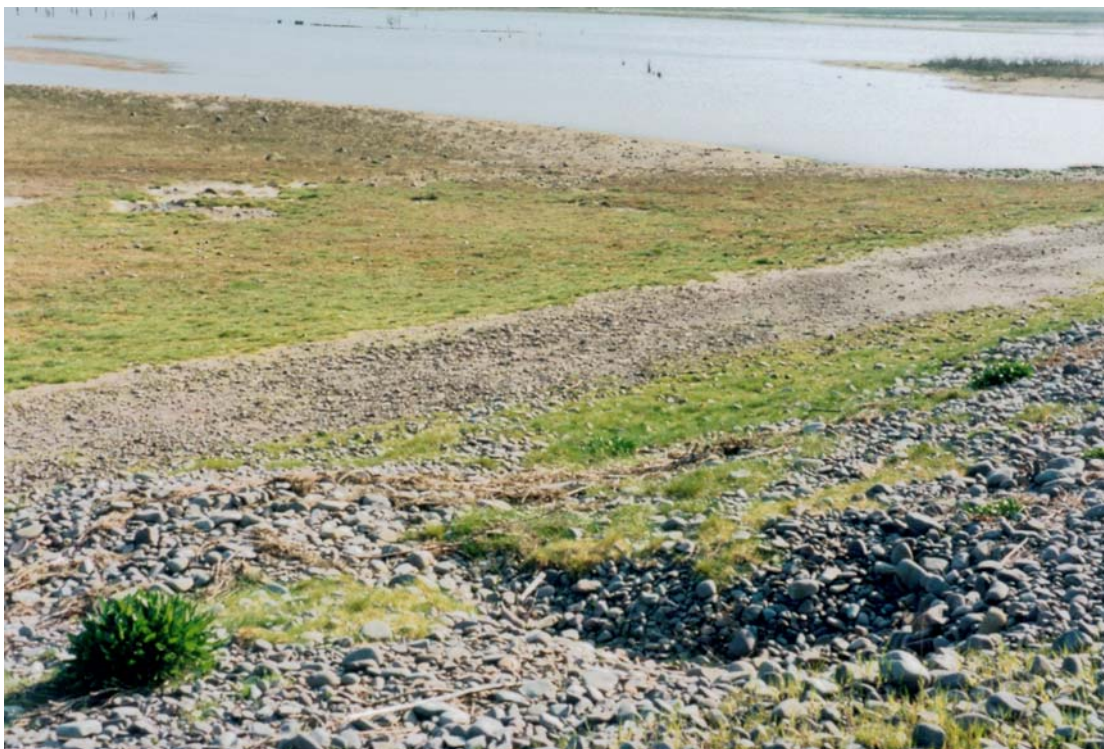
Figure 9 Processes of gravel barrier development. The 1996 breach at Porlock was generated during an episode of overwashing with crest lowering.

- 2) **Barrier processes:** The barrier evolves naturally by berm formation during calm conditions, overtopping in modest storms and overwashing in severe storms (Figures 8 and 9). The latter process results in landward migration or “rollover” causing cliffing and erosion of relict gravel and other sedimentary deposits that become transgressed. Active rollover is indicated by the presence of washover fans comprising gravels that have been driven landward from the crest (Figures 6 and 7). Seepage through the barrier may also occur during storm surges causing formation of characteristic “cans” on the landward face (Figure 10) The pace of migration may depend on the backshore elevation and gradient, the beach volume and the availability of a sediment supply. The degree of oceanographic forcing is also important, especially the wave and storm surge exposure and the rate of sea-level rise. Occasionally, the barrier becomes flattened sufficiently for breaching to occur, as was the case in October 1996. Where breaches are maintained, drift aligned gravel spits tend to grow landward from the barrier along the margins of the breach channel (Figure 6). Fossil recurved spits of this type can be identified landward of the present day barrier indicating the occurrence of past episodes of breaching (Figure 7). The Porlock barrier is unusual in not being managed actively, thus affording rare opportunities to observe the full range of behaviour associated with a depleted, receding barrier.

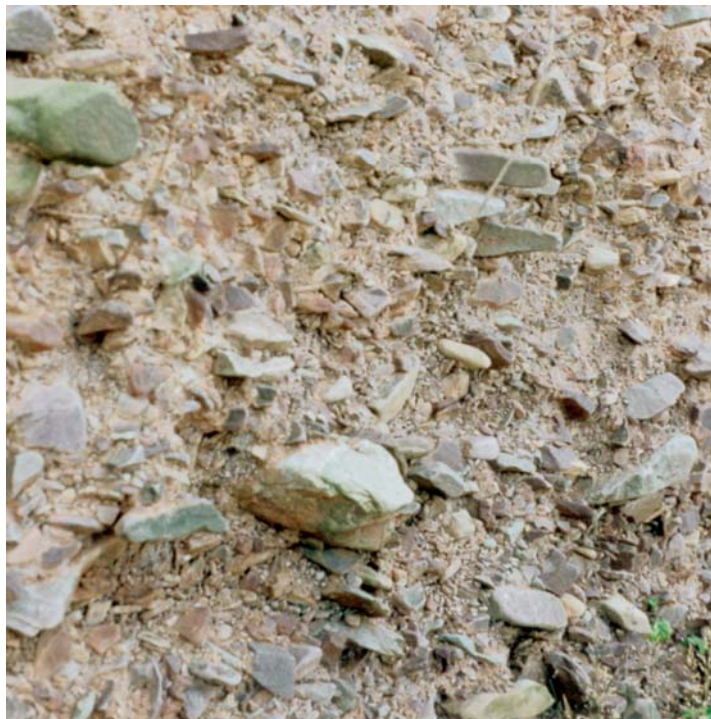
Figure 12. The solifluction deposits of Porlockford Cliffs. They comprise poorly sorted angular sands, grits, gravels and cobbles up to 100mm diameter. The larger clasts are hard sandstones similar in type to those forming the barrier beach so that cliff retreat yields small quantities of beaching forming materials. It is thought that the Porlock barrier was formed from the erosion of previously more extensive deposits of this type in the mid and late-Holocene as sea-levels rose towards their present elevation.

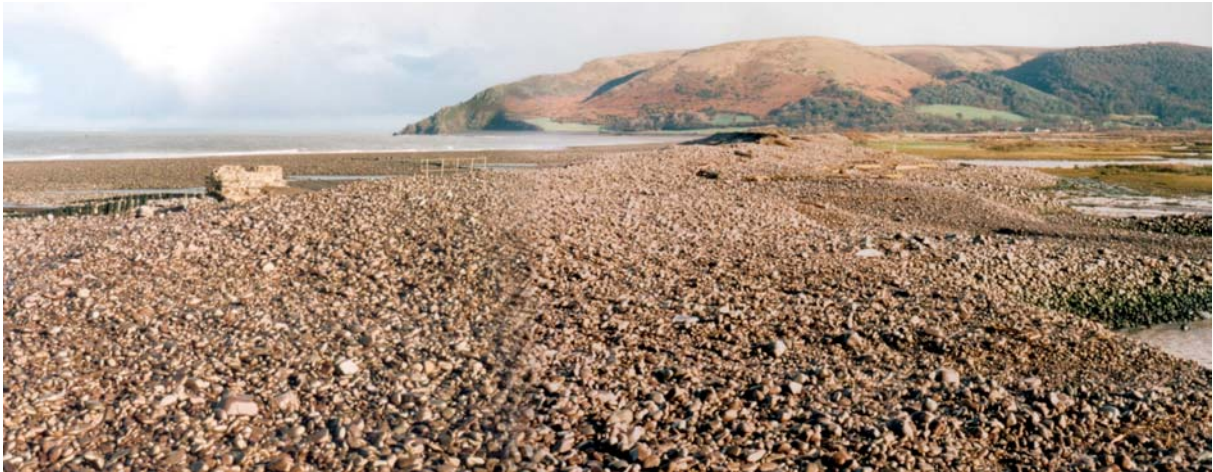
Figure 13. Flattened and overwashed barrier at New Works viewed from profile E03 on 14th Jan 1999. Note that the barrier is lower, but wider than the more static and vegetated sections visible in the mid distance. The wide low-gradient boulder frame is seen comprising the lower foreshore.

The barrier in this cell has exhibited the most complex pattern of changes for it represents the interface between the mobile Porlockford barrier and spits and the relatively stable Eastern Barrier as exemplified by Figures 13 and 14. At profile E10 opposite the War Memorial, the barrier has remained stable and has maintained its 1988 position and form (Type 1 stability). At profiles E06 to E09, the seaward face and portions of the crest of the 1988 barrier have been eroded and it would appear that much of this material has been pushed over the remaining 1988 barrier core to create washover fans. The overall effect has been a widening and flattening of the barrier with a modest recession and slight reduction in crest elevation. These changes are best developed in the west (profile E06) and diminish eastward to profile E09 suggesting that a zone of erosion and natural profile reshaping is migrating eastward (Figure 14). At profiles, E04 and E05 closest to New Works the 1988 barrier has been eroded completely and the material reworked to form a new crest (1m lower and 20m landward) and washover fan extending up to 30m landward.

The two photographs clearly illustrate the differences between the high, narrow, steep and static artificial barrier form (e.g. Figure 14), as opposed to the flatter dynamic landward migrating natural barrier that has become established in many parts as the management practices were relaxed (Figure 13). The latter state is likely to become increasingly prevalent in the future.

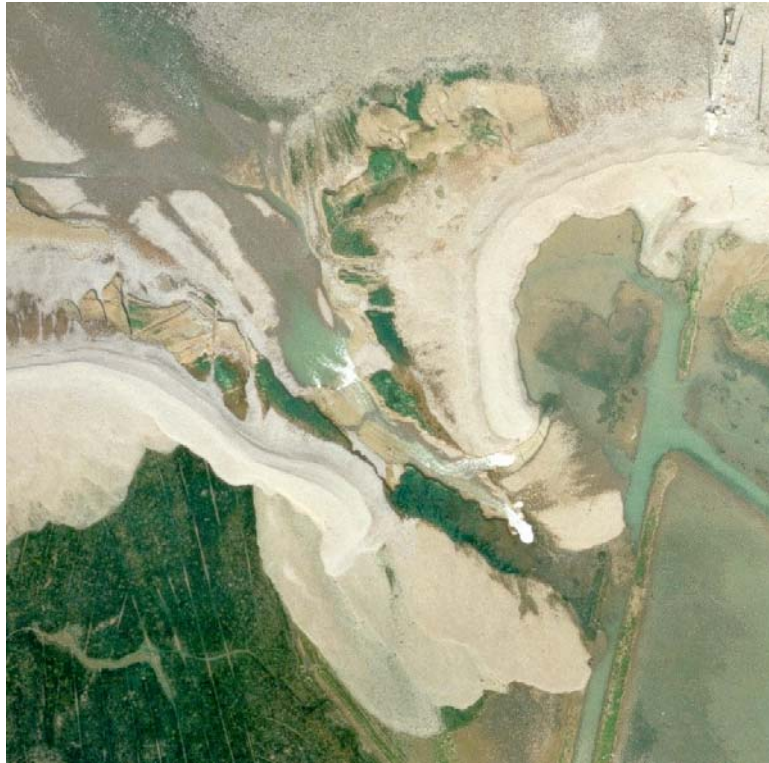
Figure 15. Close view of breach approaching low water at 1216hrs on 1st April 1999. Lagoon waters are draining out of the breach channel forming distinct waterfalls over the retreating clay cliffs that define the incised channel. The recurved spits and spreads of overwash gravels rest upon the clay platform. The western spit is migrating towards the incised channel such that its gravel spills into it becoming entrained by currents and transported seaward forming banks in the outer channel.

Comparisons of the September 1999 photography with that of April 1999 reveals some modest changes occurring around the breach over this short period (Figures 15 and 16). The Digital colour near-infrared imagery is especially effective for study of vegetation. Algae on the clay platform show up bright red and saltmarsh is darker (Figure 16). Waters around the breach are clearly seen to be turbid due to wave erosion of the clay cliffs.

Headward recession within these channels then slowed significantly involving loss of 7m between July 1999 and March 2000 (0.9m month⁻¹) and 10m between March 2000 and December 2000 (1.1m month⁻¹). The northern channel bifurcated around July 1999 (compare Figures 15 and 16), but the overall rates of headward recession of the northern and southern channels were otherwise similar. The reduction of headward recession suggests the channel is moving closer in its configuration to an eventual stable equilibrium form.

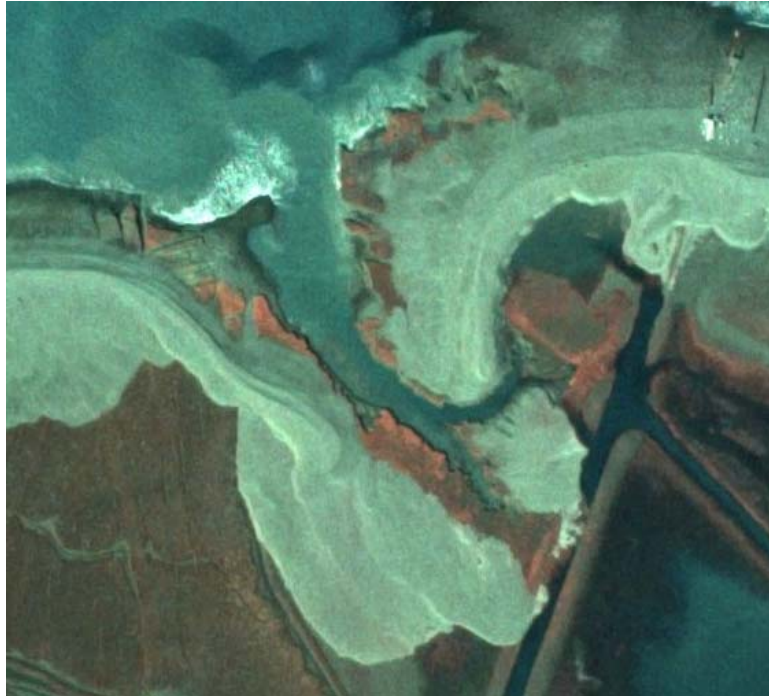
Figure 16. Near-infrared digital image of the breach approaching high tide at 1345hrs (GMT) on 4th September 1999. Note that the tide has yet to rise above the clay cliffs and platform and that the two “waterfalls” have retreated closer towards the main artificial drainage cut. Gravel entering the incised channel has formed a small temporary spit on the western flank. This imagery is especially effective for study of vegetation. Algae on the clay platform show up bright red and saltmarsh is darker (bottom left). Waters around the breach are turbid due to wave erosion of the clay cliffs.

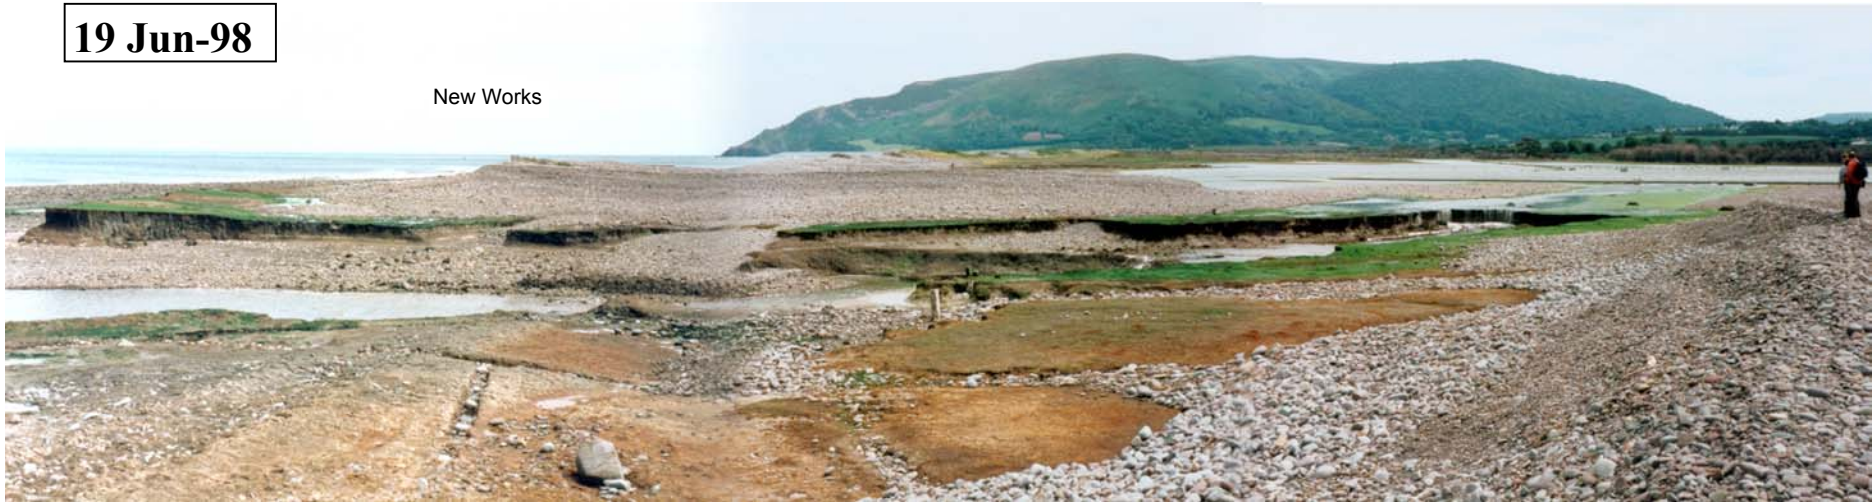
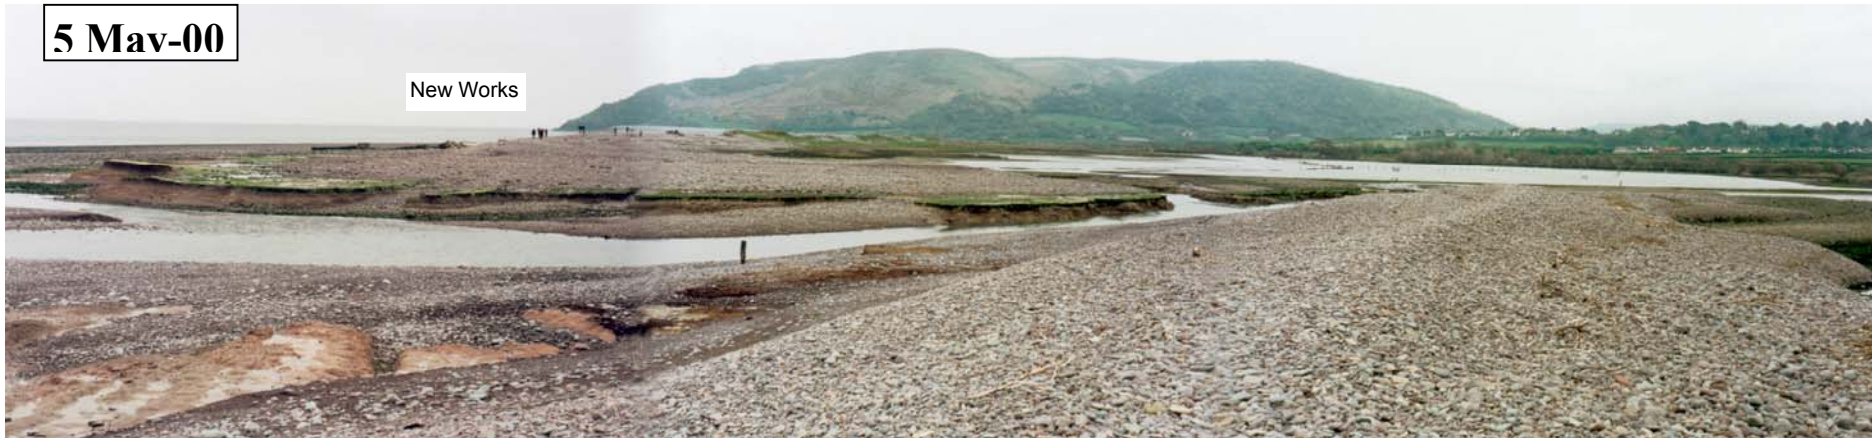
Figure 17. View eastwards over breach channel from the western gravel spit. Note the incision of the channel into the underlying clay and the slow retreat from June-98 to May-00 of the clay cliffs forming the channel flanks. The western spit (foreground) has grown and migrated towards the breach channel covering the clay platform. By contrast, the eastern spit has diminished and migrated NE away from the breach channel. Barrier losses are especially noticeable around New Works in the mid distance in May-00. The headward parts of the breach channel bifurcated in late 1998 and a well established NE arm is seen at the landward tip of the eastern spit in May-00. Note the linear furrows on the clay platform which are interpreted as the remains of previous drainage ditches/channels on the old marsh surface now transgressed by the barrier and eroded. It is thought that a major NNW – SSE trending ditch existed previously at the breach and was exploited by the exchange of tidal waters resulting in the formation of a permanent rather than temporary inlet. View is from W03.

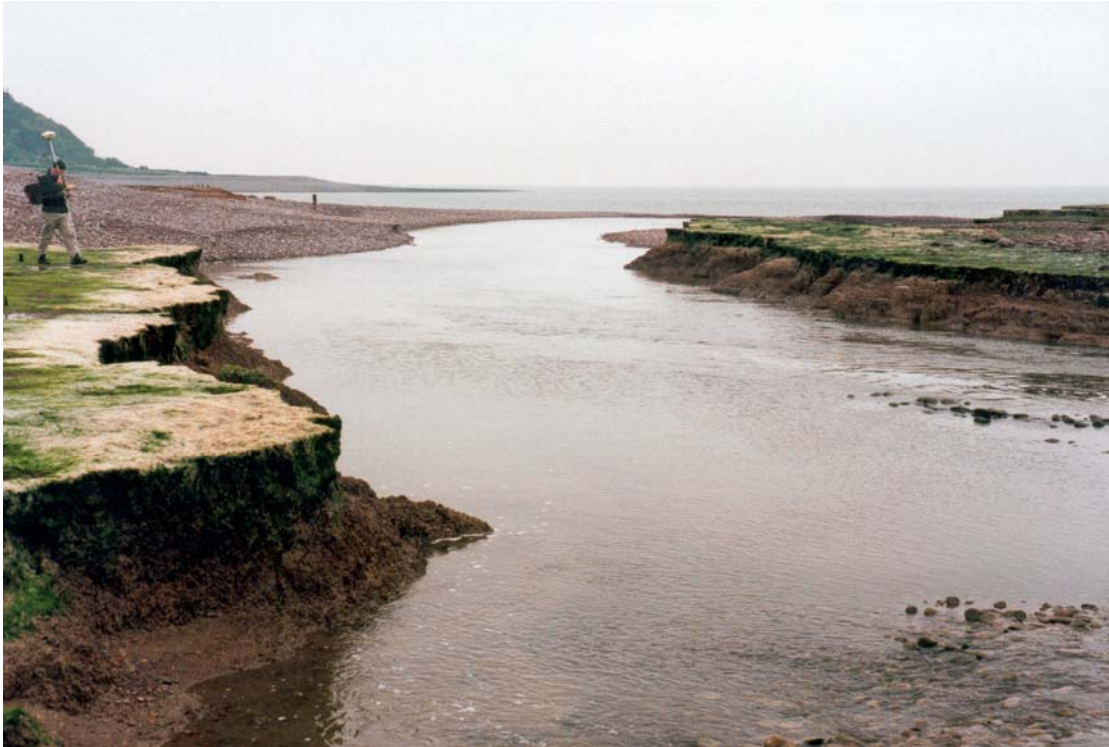
Figure 18. The landward extremity of the breach channel cut into Holocene clay back barrier deposits. The lagoon is flooded as the tide rises above the level of the clay platform at about 4m O.D. and then drains as it falls below that level forming a waterfall. The tidal exchange results in strong headward erosion of the clay cliffs. The channel bifurcated in late 1998 forming prominent north eastern and southern tributaries as seen in May-00. Also evident is the encroachment upon the channel of the western spit. Viewpoint is at profile W01.

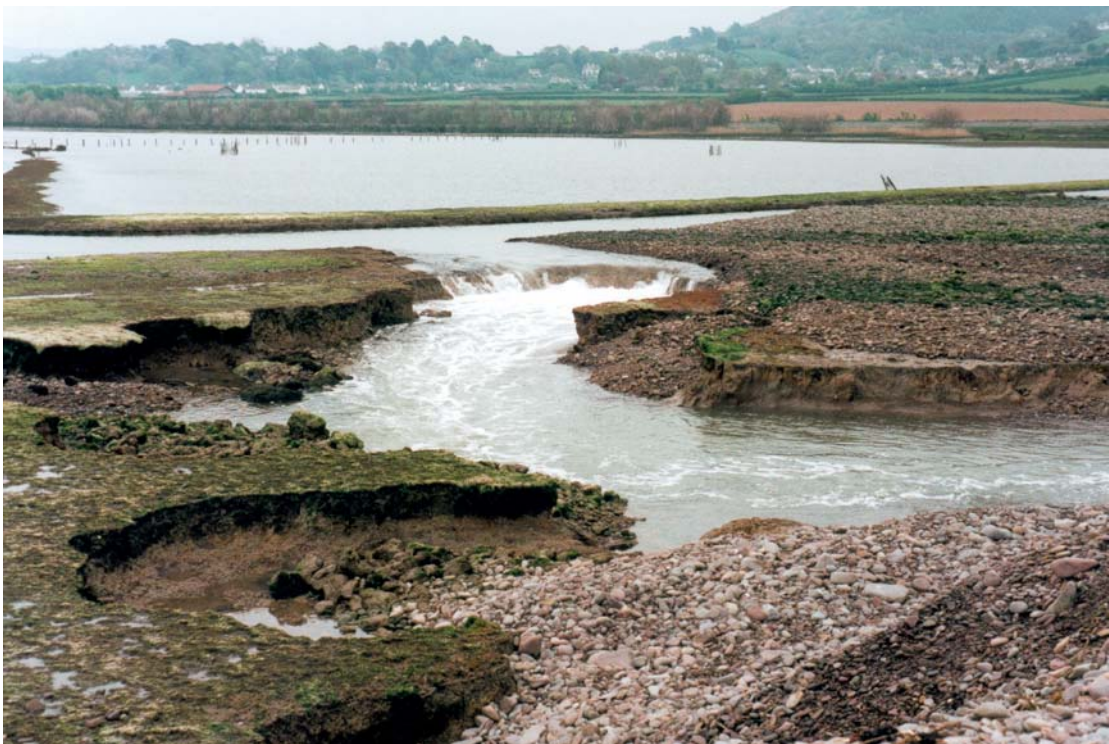
Figure 19. Breach Channel 5th May 2000 – view seaward. Note the western gravel barrier to the left spilling into the channel and the platform swept clear of gravel to the right by the retreat of the eastern spit. The clay cliffs flanking the channel have continued to retreat slowly.

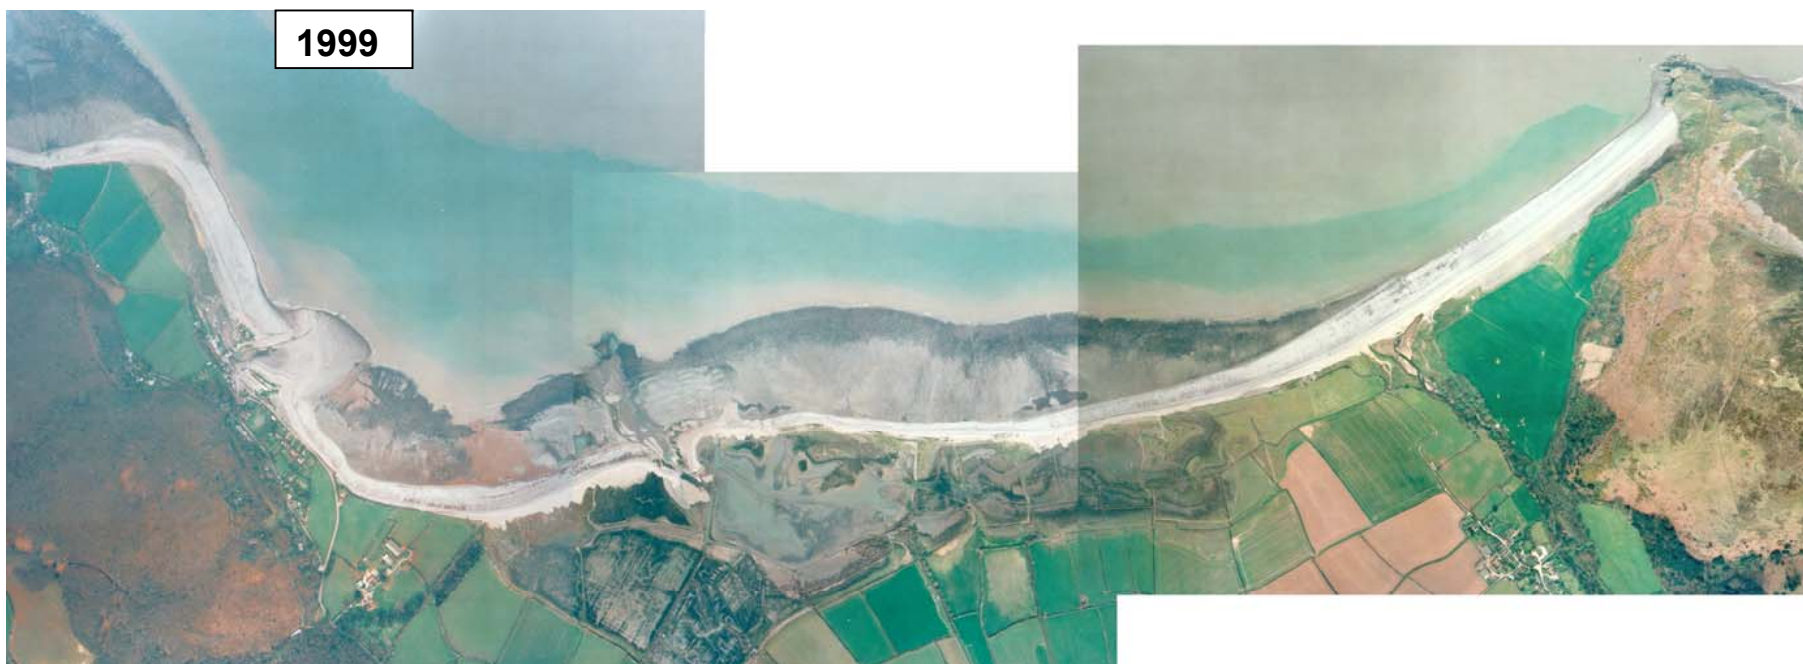
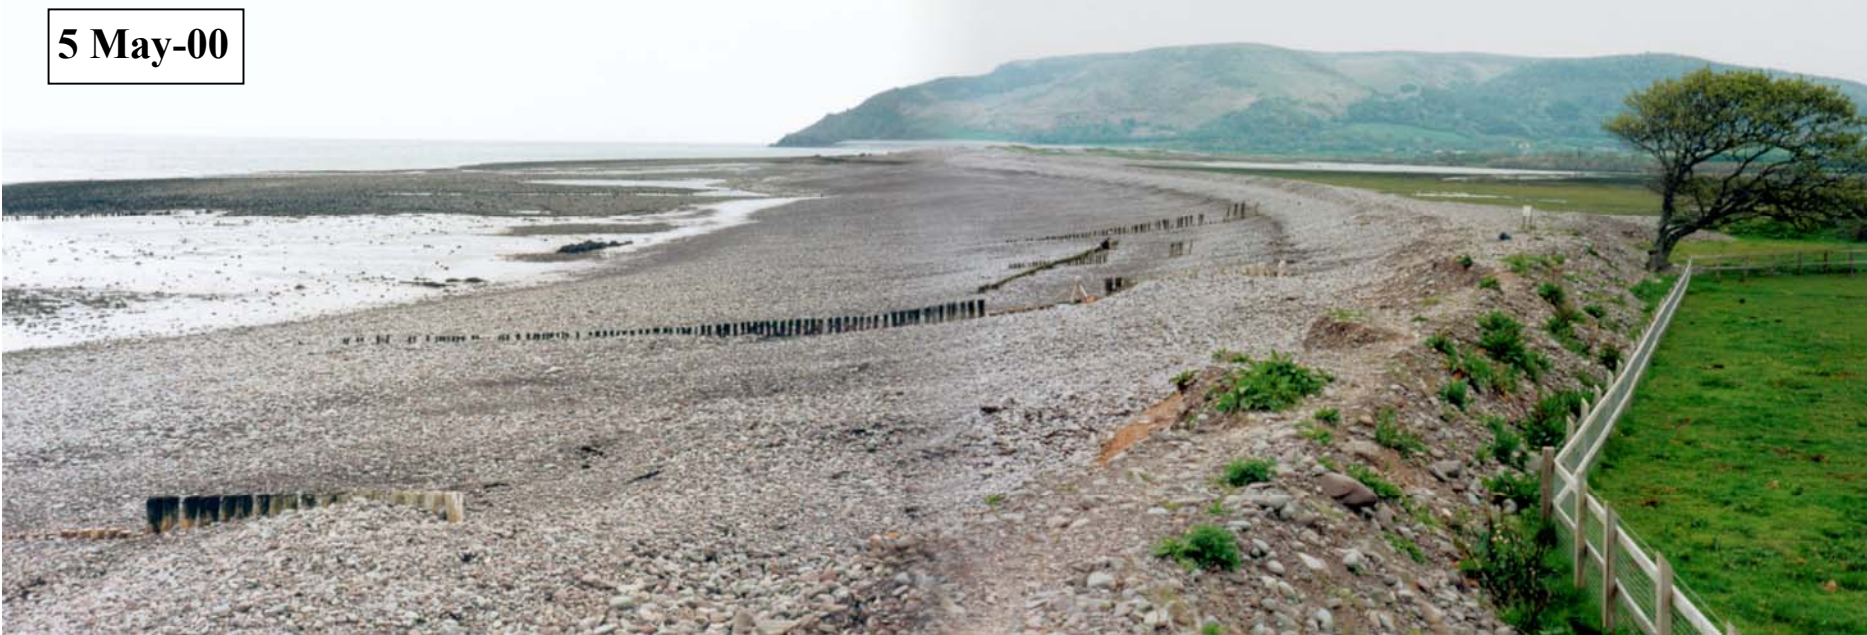
Figure 21. Aerial photograph mosaics of Porlock Bay in 1950 (monochromatic diapositive) and 1st April.1999. The 1950s barrier was continuous and enclosed a freshwater lagoon. Note the relic tidal channels discernible within the 1950s back-barrier marsh that provide evidence of previous intertidal episodes.

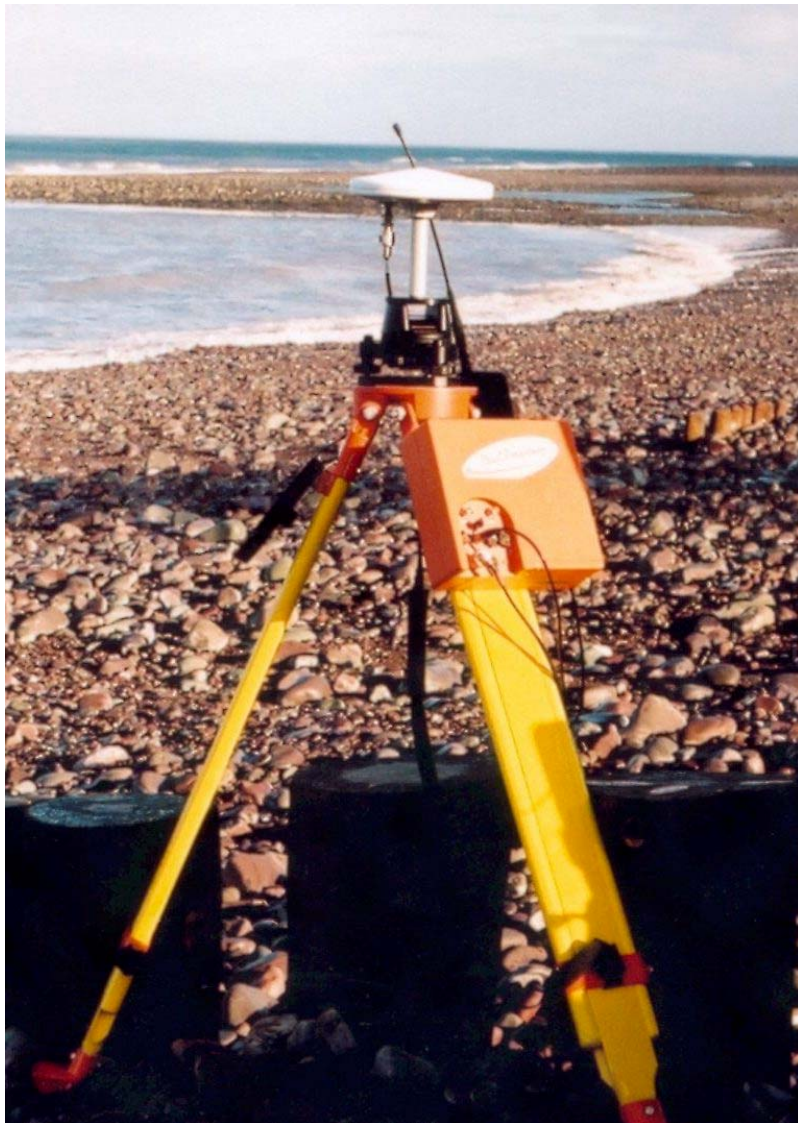
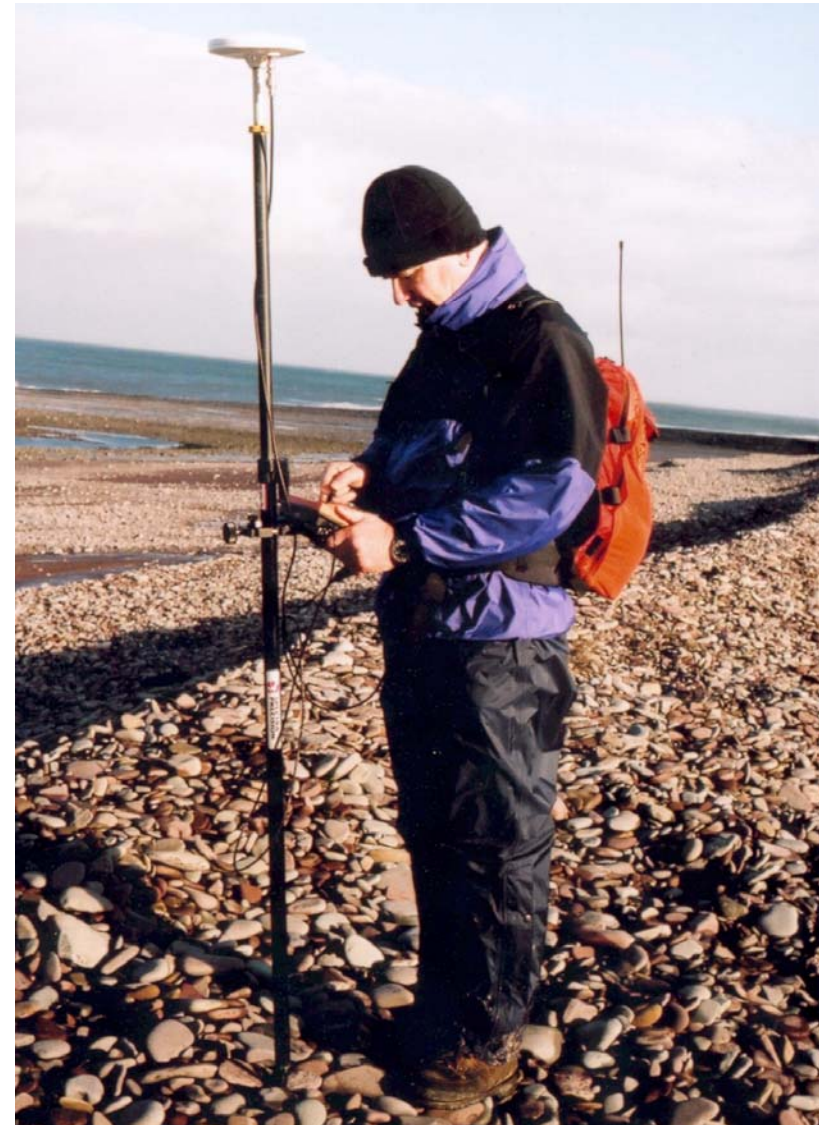
Figure 23 GPS survey equipment in operation. A static receiver is set up at a known point and the surveyor operates a roving receiver measuring profiles and other features of detail to complete the survey. Note that a radio link operates between the two enabling the surveyor to measure all points in real time.

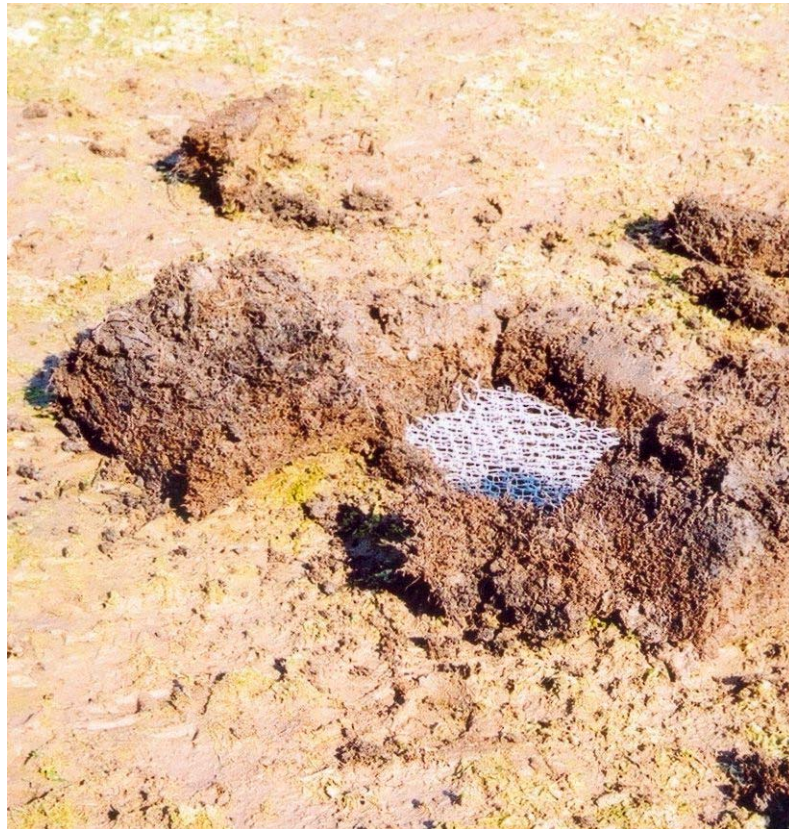
Figure 33 Insertion of accretion plate B (mid lagoon margin) at accretion profile E2. The wire mesh was buried carefully at 100mm depth by replacing the marsh turf to minimise disturbance. The site is relocated using a metal detector to pin point the wire mesh. To measure accretion a steel rule is pressed into the marsh surface until it encounters the wire mesh.

A total of twelve accretion plates were installed in May 2000 along the lagoon margins in order to measure the rates of sedimentation occurring as the lagoon and its saltmarsh vegetation develop (Figure 33). Three plates were inserted in short crossshore profiles at four distinct locations given in Figure 25. Profiles E1 and E2 are located on the northern lagoon margin and provide coverage of open mud and vegetation covered substrates (Figure 34). Profiles W1 and W2 are located within developing saltmarsh to the west of the barrier.

Each plate comprises a 0.2m square of wire mesh buried carefully at up to 100mm depth by cutting and replacing the marsh turf to minimise disturbance (Figure 33). The site is relocated using a metal detector to pin point the wire mesh. To measure accretion, a steel rule is pressed into the marsh surface until it encounters the wire mesh. Over time a picture can be developed of the changing level of the surface with respect to the mesh plate. It is assumed that the plate should remain static while the ground surface will rise or reduce by accretion or erosion. A mesh rather than a solid plate was preferred, as it should be permeable to plant root systems and rapidly become incorporated within the substratum.
