**Porlock Bay:
Geomorphological investigation and monitoring
Gravel barrier breaching and tidal lagoon development**

R&D Technical Report W5B-021/TR

Authors: M.J. Bray and W. Duane
RACER
Department of Geography
University of Portsmouth

August 2001

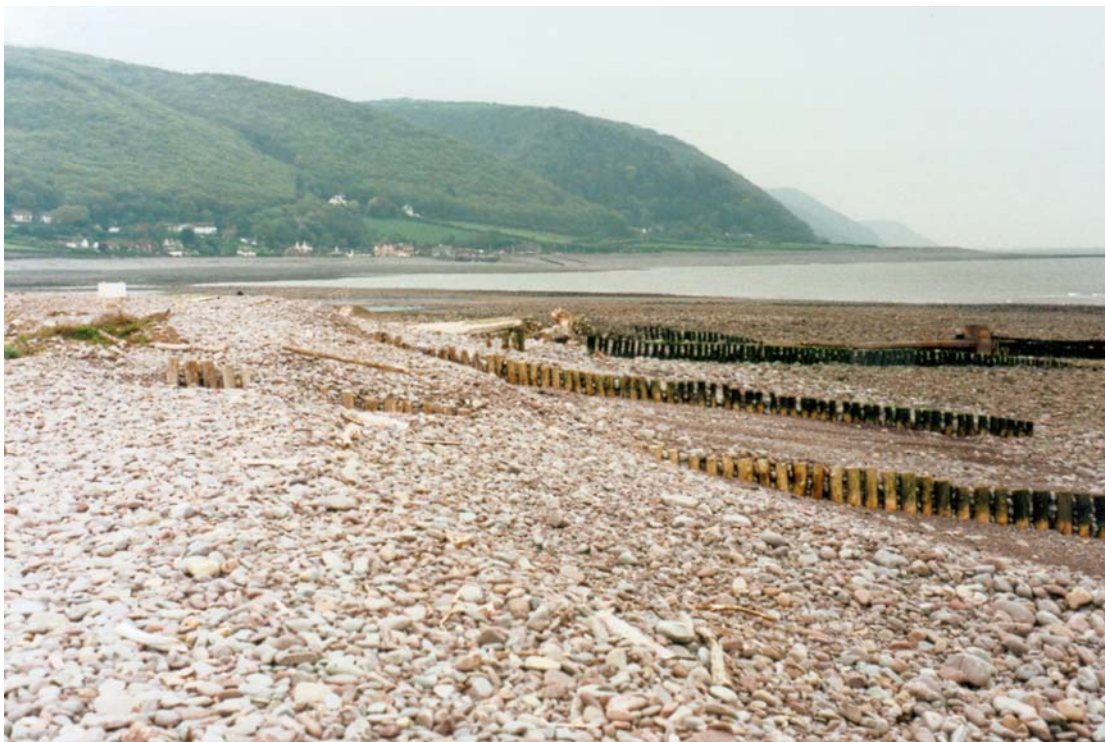
Figure 38. View west towards New Works from E08 on 19th June 1998. The barrier is controlled by a series of timber pile groynes constructed in 1967-68 and which have promoted some beach accretion.

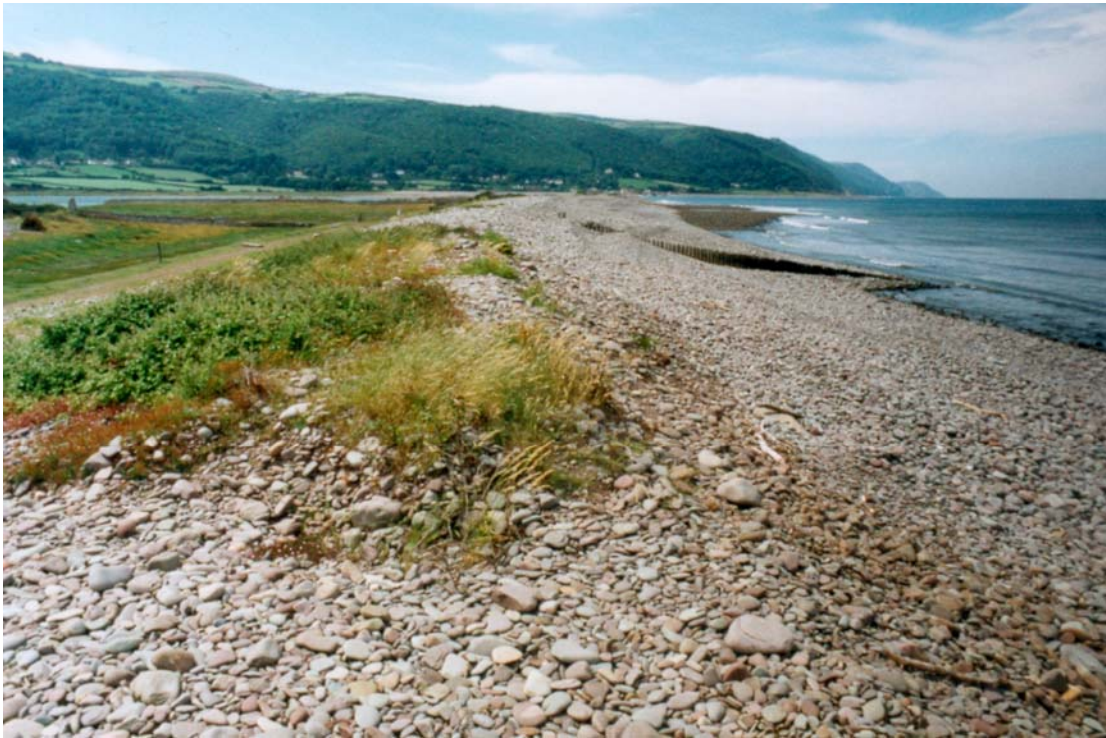
Figure 39. View west towards New Works from E08 on 4th May 2000. Note that there has been accretion at the barrier crest and around the groynes in the foreground. However, foreshore lowering and crest recession is evident around the structures at New Works leading to their progressive destruction (compared with the June 98 situation). The barrier in this area is relatively low and is subject to overwashing although it has migrated much more quickly landward to the west of new works than here to the east.

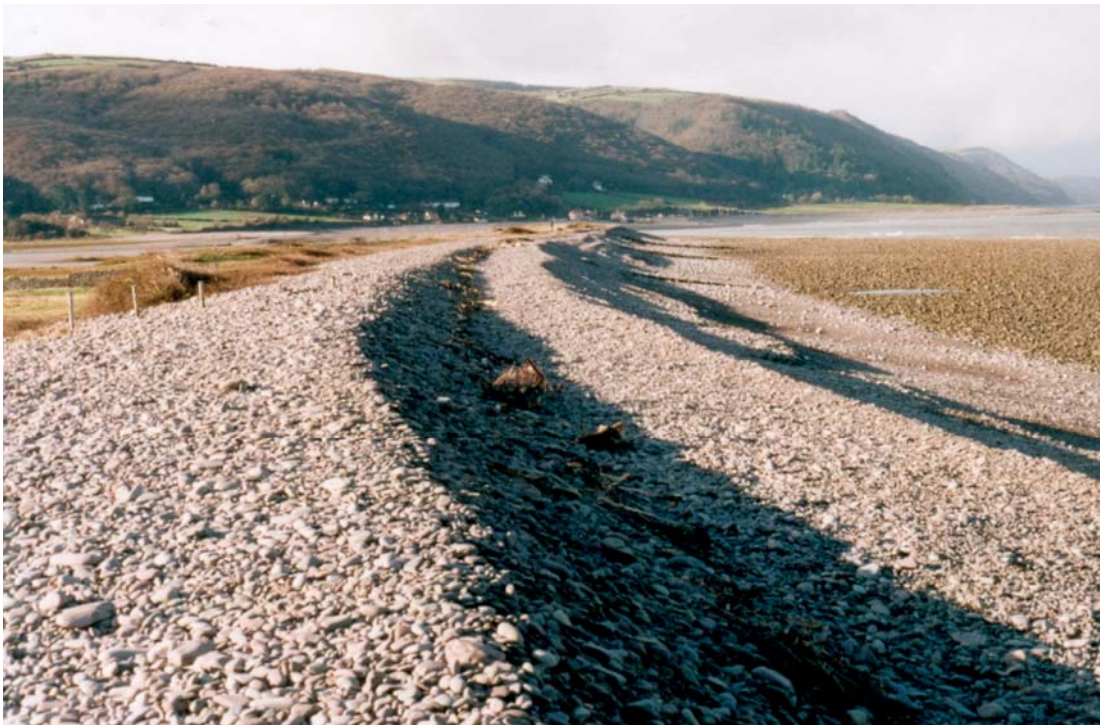
Figure 40. Barrier crest at E15 view westwards on 19th June 1998. The crest is relatively wide and stable although subject to some erosion of the vegetated scarp in the foreground. It retains much of the form of the previous artificially managed barrier. Note the high cliff headlands in the distance that prevent any major eastward drift of fresh sediments into Porlock Bay.

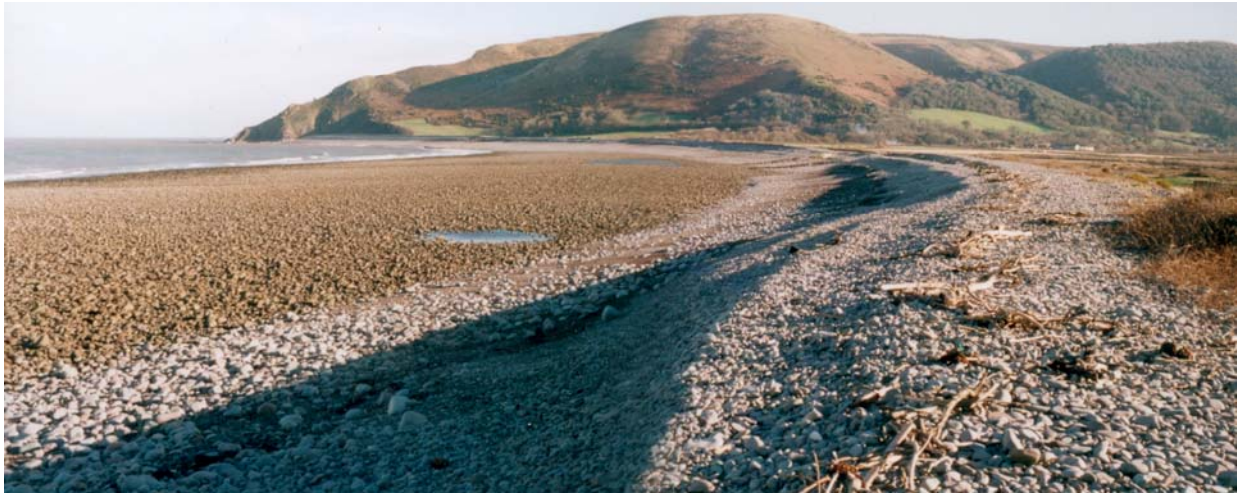
Figure 42. View east from E 13 over a stable portion of the barrier that has accreted at the crest (note the new berm deposited 1-2m seaward of the previous barrier crest). The wide low gradient boulder frame is seen comprising the lower foreshore and is effective at dissipating wave energy, perhaps contributing towards the stability of this portion.

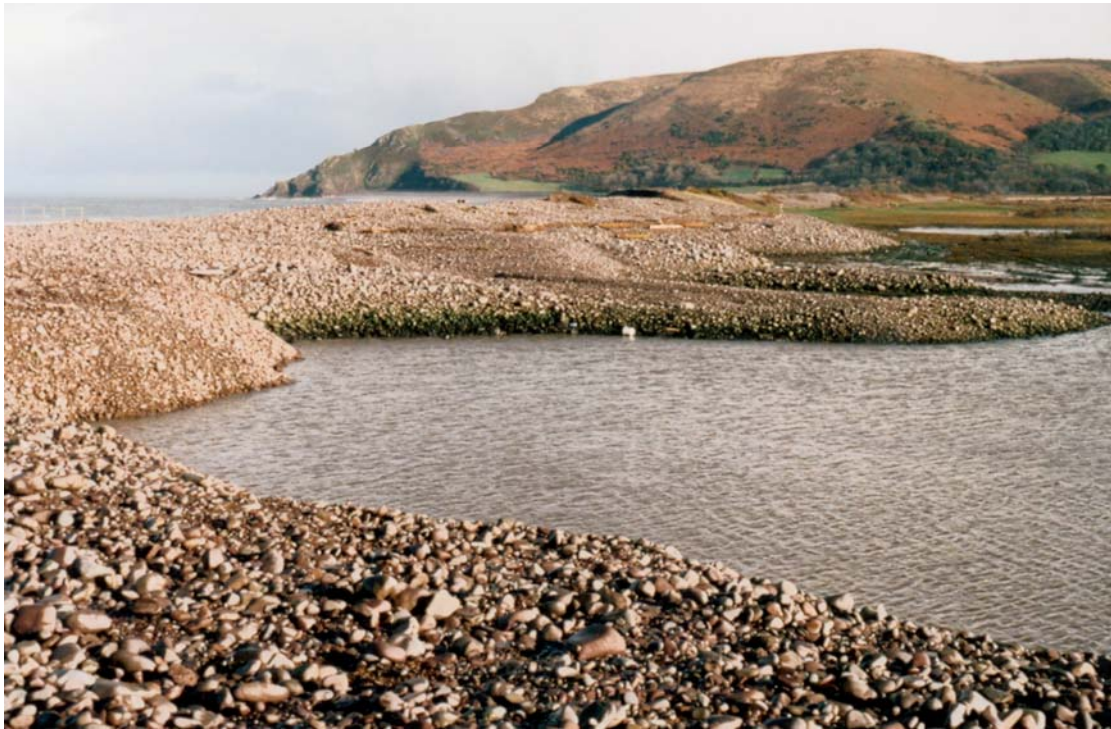
Figure 43. Newly formed washover fans extending over the developing saltmarsh behind the barrier at Porlockford, 8th December 2000. Note that the landward margins of these fans are surveyed using GPS and plotted as the “backtoe.”

Examination of the December 2000 washover margins (“backtoe”) clearly reveals significant landward extensions of the fans to west of the breach (Figure 28). The variable trends reported for 1888-1972 by Ryan (1999) are replaced by a landward extension of some 30-50m since 1972. It is likely that the majority of the extension occurred following cessation of beach management activities in the early 1990s. The production of extensive washover fans is a natural consequence of recent changes by which the formerly oversteepened barrier has been pushed landward and flattened as it seeks to achieve a more dissipative and stable natural profile. It should be noted that the washover fans migrate landward over the developing backshore saltmarsh resulting in slow loss of that habitat (Figure 43).

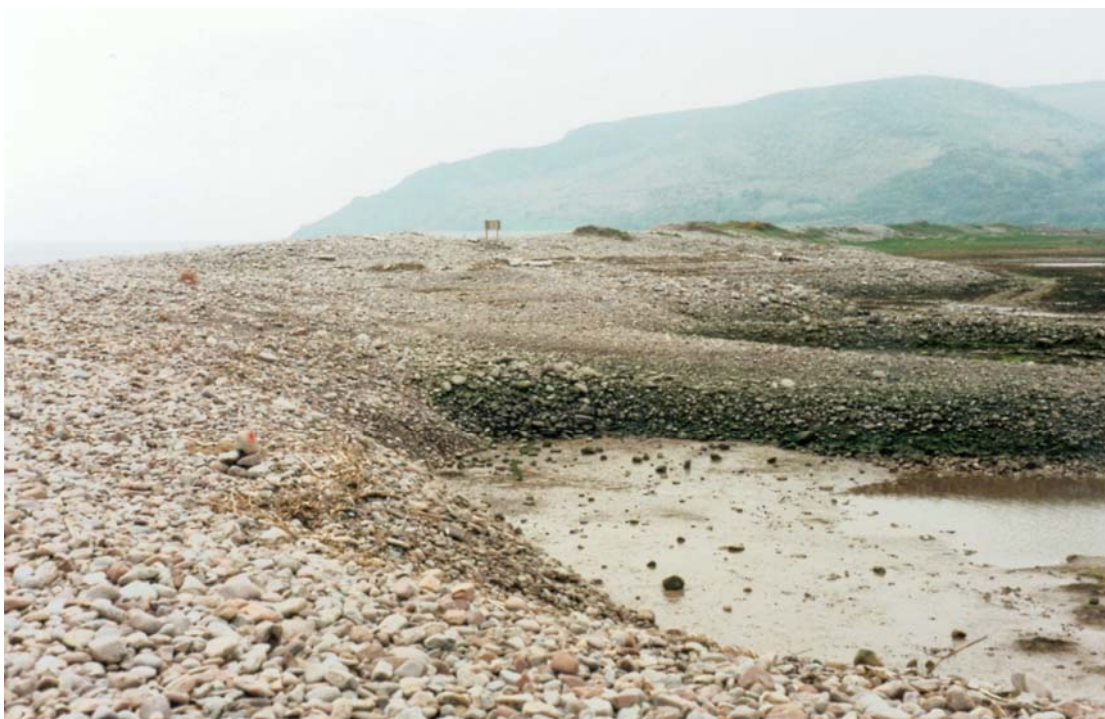
Figure 44. Washover fans on the backslope of the active gravel barrier at New Works 14th January 1999. During overwashing the crest is flattened and its material pushed landwards for form the washover fans. Note that the barrier is especially flattened to the immediate left (New Works), but becomes higher, steeper and narrower eastwards into the distance. Viewpoint is from midway between profiles E02 and E03.

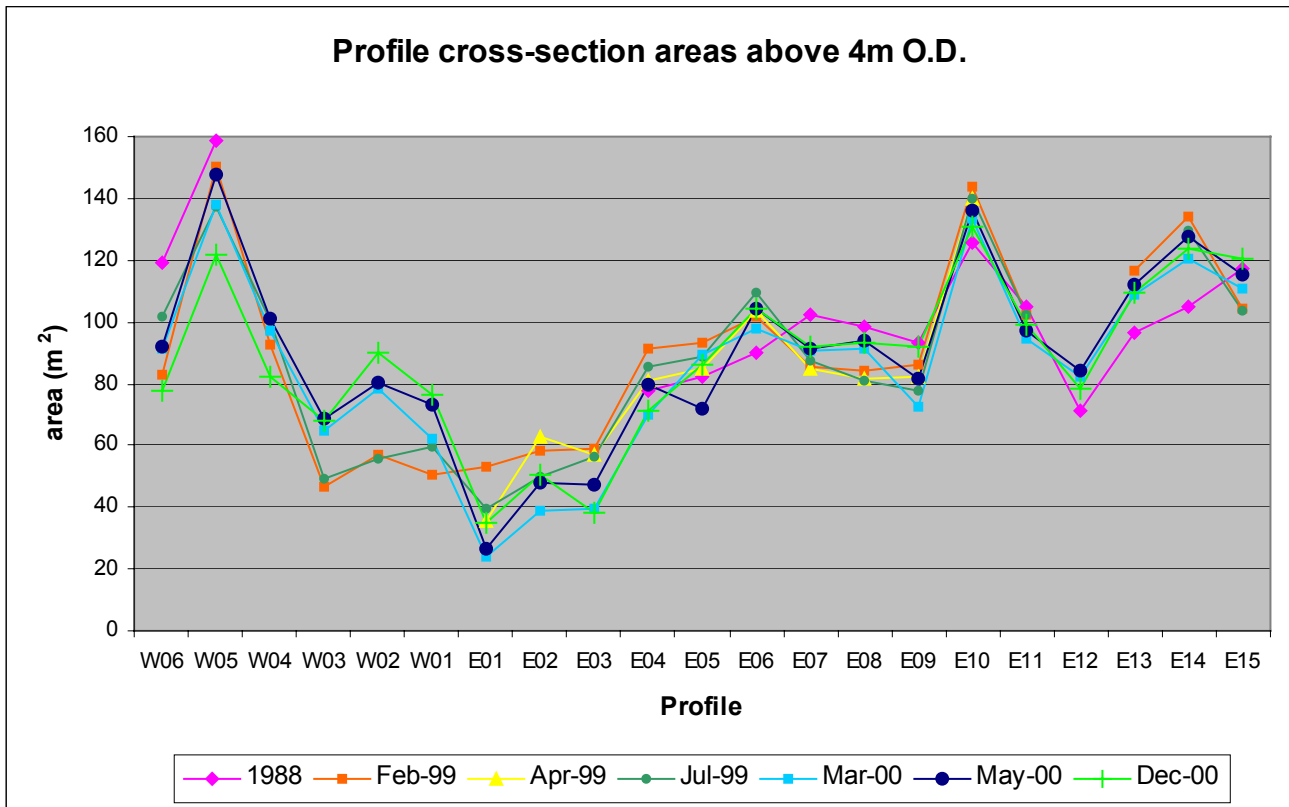
Figure 46. Screenshot of Porlock barrier volume analysis using BMAP software (US Army Corps of Engineers).

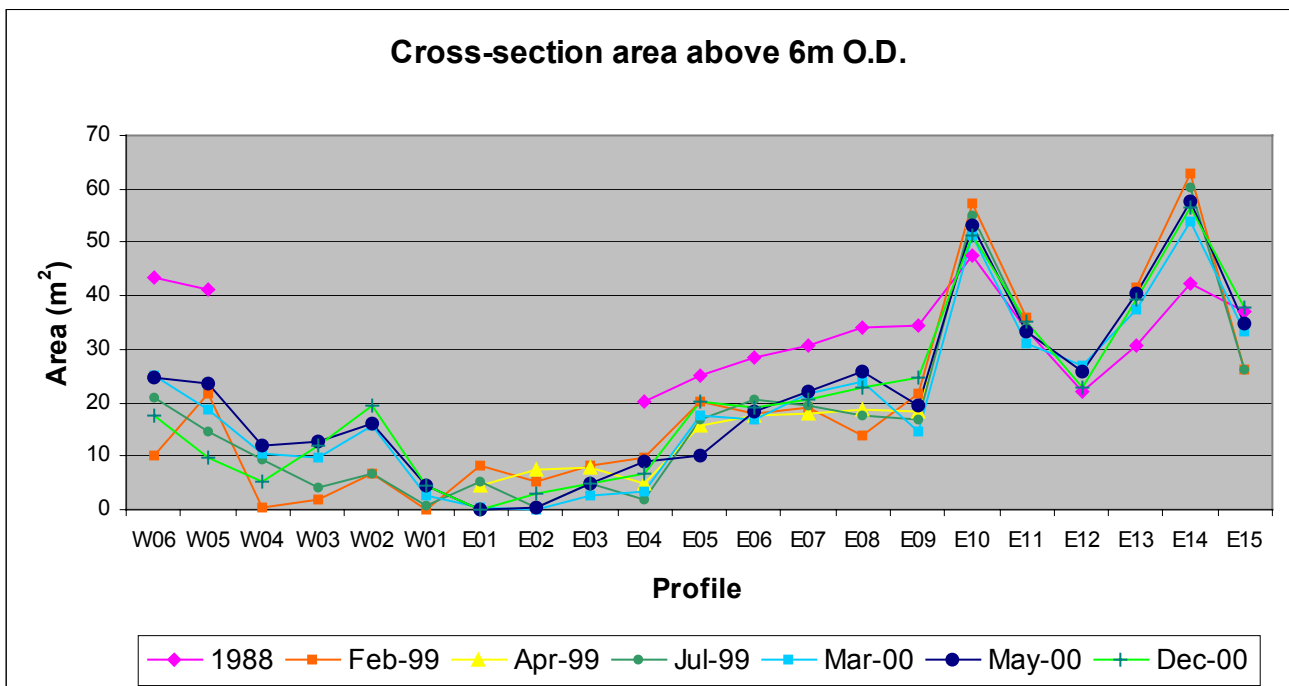
Figure 47. Cross-section areas of the gravel barrier above the 4m and 6m contours. Volumes above 4m indicate the approximate quantities of loose gravel available and volume above 6m indicates resistance against overwashing during extreme events.

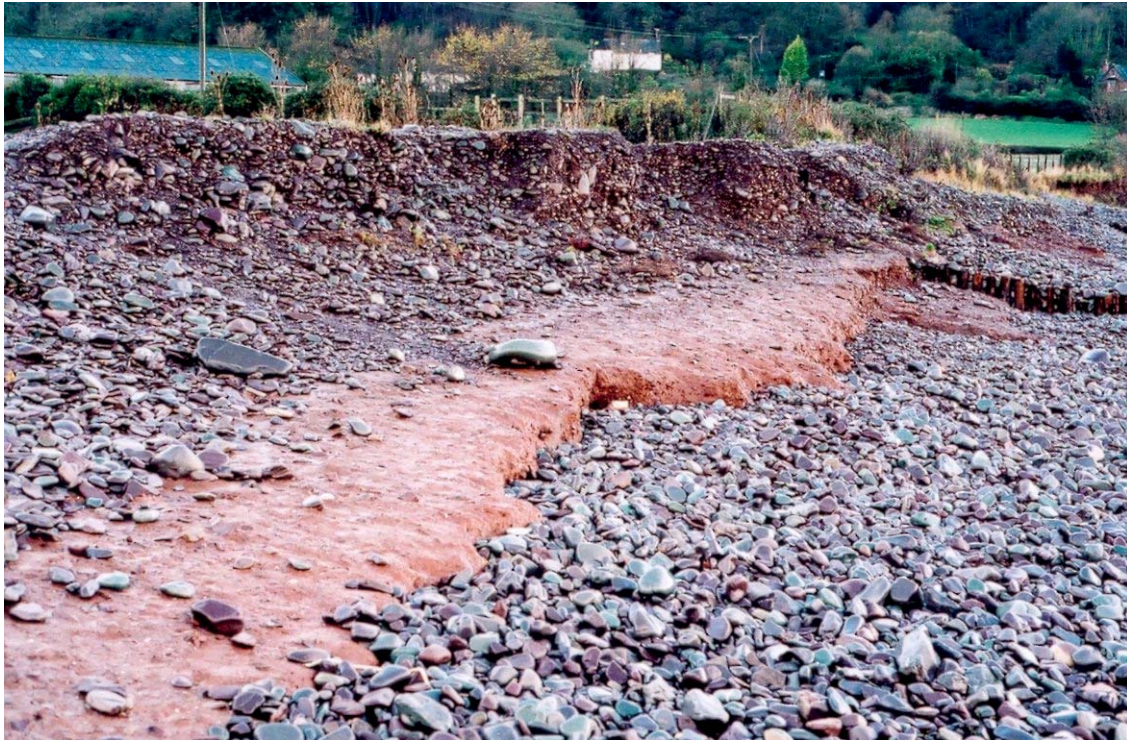
Figure 50. Depleted upper beach and eroded crest at Porlockford at the western extremity of Cell 3, 8th Dec-00.

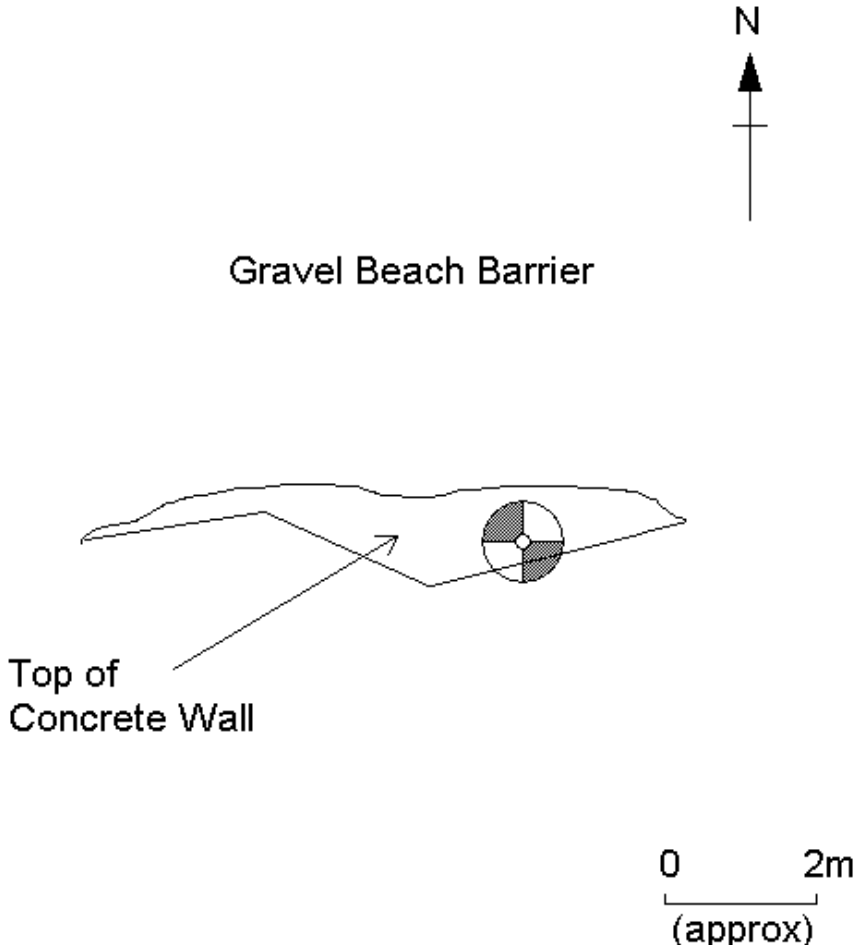
Station Name		Control 03	
Eastings Northings Elevation		287758.912 147948.669 6.15	
Spheroid	Airy 1936 (OSGB36)	Projection	UKTM
Semi-major axis (a)	6 377 563.396	Latitude of Origin	49° 00' 00" N
Semi-minor axis (b)	6 356 256.909	Longitude of Origin (CM)	02° 00' 00" W
Flattening (1/f)	299.324 964 5	Eastings at Origin	400 000.00
		Northings at Origin	-100 000.00
		Scale Factor at CM	0.9996012717
Elevation Datum	MSL at Newlyn		
Description Nail in top of concrete wall			
Plan View

<p style="text-align: center;">Gravel Beach Barrier</p> <p style="text-align: center;">Top of Concrete Wall</p> <p style="text-align: right;">0 2m (approx)</p>			
Survey Date		Feb 1999
