# Camelot CA Platform Camelot CA Pipelines Camelot CB Pipelines

## Decommissioning Programmes Close Out Report

**14 AUGUST 2013**

HELIX ERT	Page No. : Page 1 of 22 Rev. No. : 0
	<b>CAMELOT MATTRESS AND WELLHEAD REMOVAL</b>	
	Doc No: 11937 / 001 / PJR

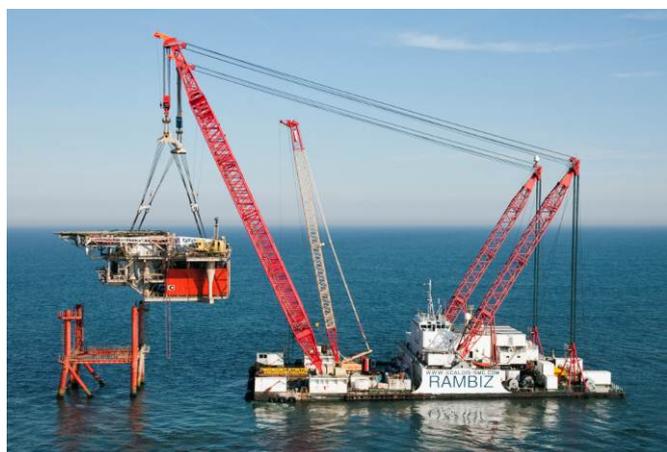
In July 2012 the HLV mobilised to the Camelot location and commenced the final removal operations. The first items removed were the six well conductors previously cut 5m below the natural seabed. Also removed were the seawater intake caisson and the produced water discharge caisson. During the conductor removal activities work platforms were built around the top of the jacket legs allowing the topside to be cut free of the jacket. With the heavy lift rigging connected to the re-instated pad-eyes the topside was lifted clear. The total load including rigging was found to be 1,220 tons which was well within the maximum estimated load of 1,492 tons used for the lifting design calculations. The topside was placed immediately onto a transport barge and sea-fastened along with the conductors and caissons. With the sea-fastening complete the transport barge departed for the Netherlands.

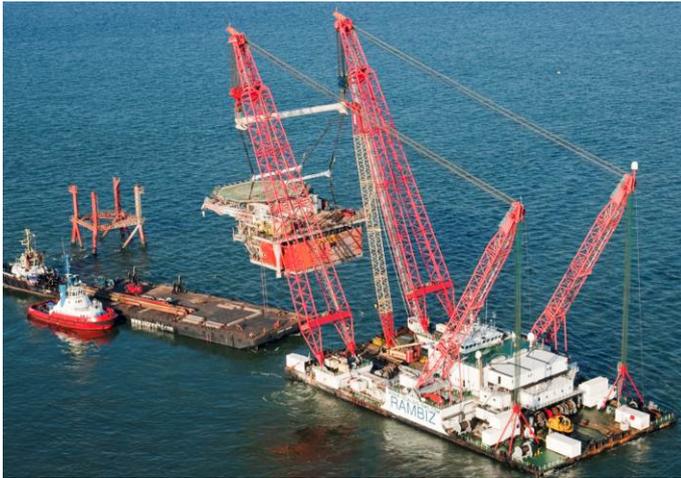
after the final cut. The total jacket load including rigging was found to be 600 tons which was well within the maximum estimated load of 914 tons used for the lifting design calculations. The HLV lifted the jacket up until the bottom of the cut legs was level with the bottom of the HLV hull. The jacket was then sea-fastened to the fixation points on the HLV hull so it could be transported to shore on the HLV hook.

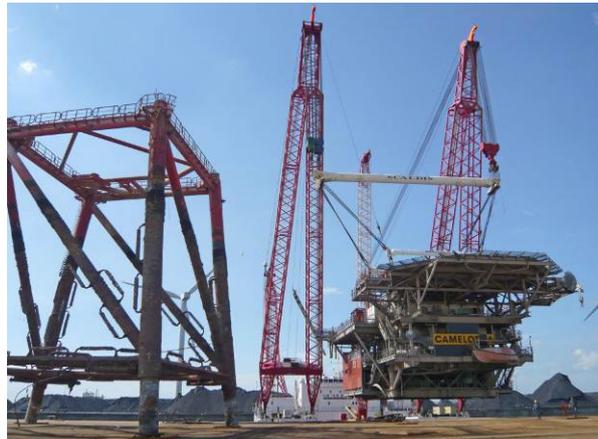
Having completed operations at the former Camelot location the HLV sailed to the Netherlands and placed the jacket structure onto the quayside of the dismantling facility. The HLV then picked up the topside from the transport barge and place this on the quayside next to the jacket. The use of the HLV in port allowed the unloading to be done without the assistance of any heavy lift self-propelled trailers.

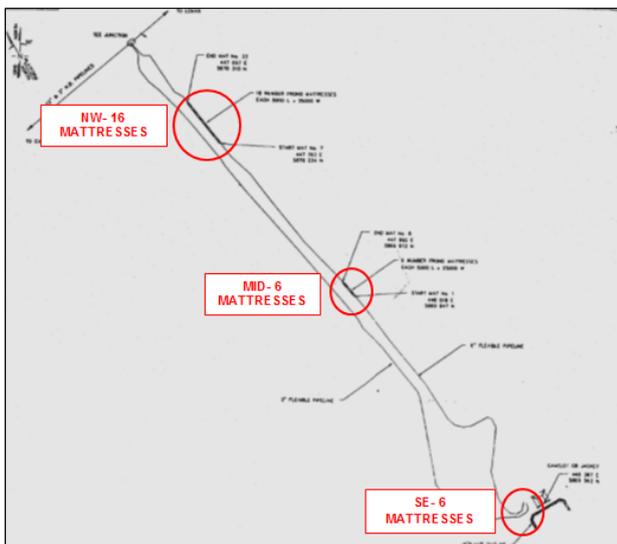
During the same DSV campaign in April 2012 a survey was taken of the old Camelot B location to verify pipeline burial. During this survey 4 no. of the reported original 10 no. mattresses present were recovered. The remaining 6 no. (if present) had been buried to a depth well in excess of the 0.5m probe investigation. At the same time, a survey of the tie in area at the host platform identified 4 no. concrete mattresses which were recovered.

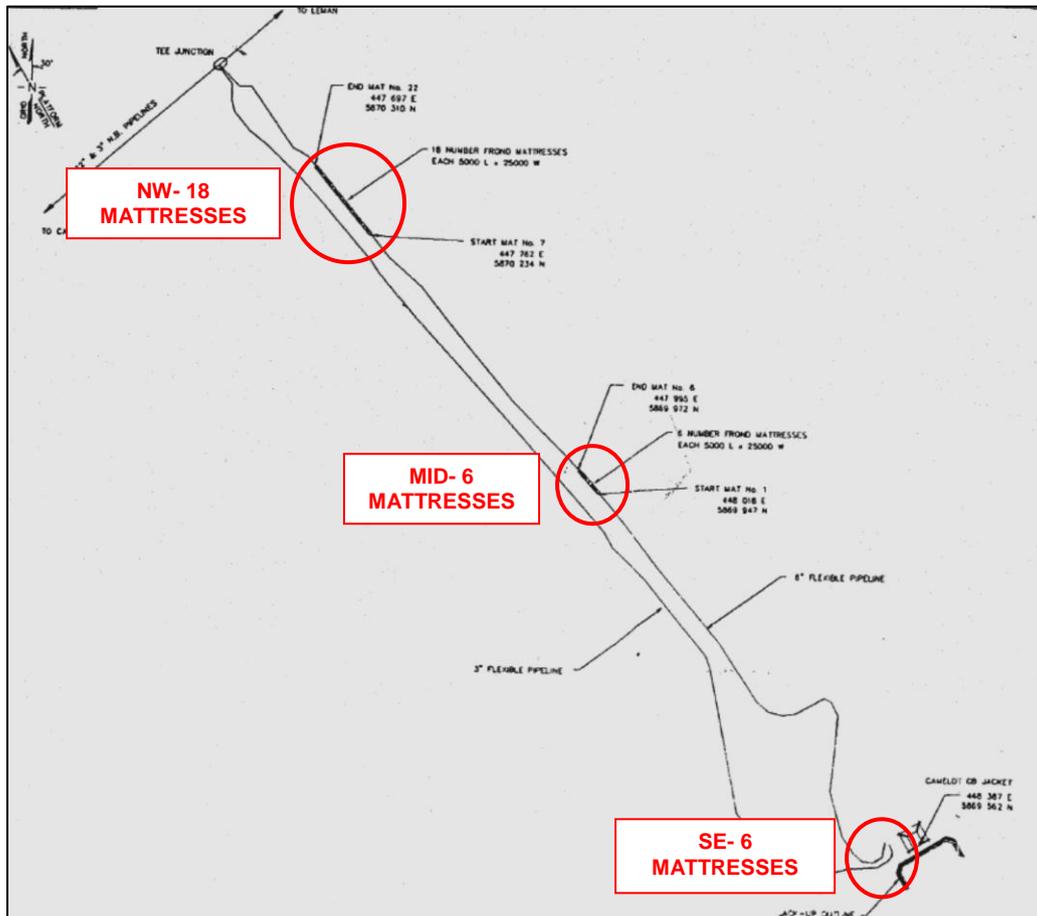
**Fig 2- Mattress Locations**

There are three locations where mattresses were expected to be located on the PL 878 / PL879 pipelines:

As part of this workscope, the mattresses were to be located and recovered where possible.

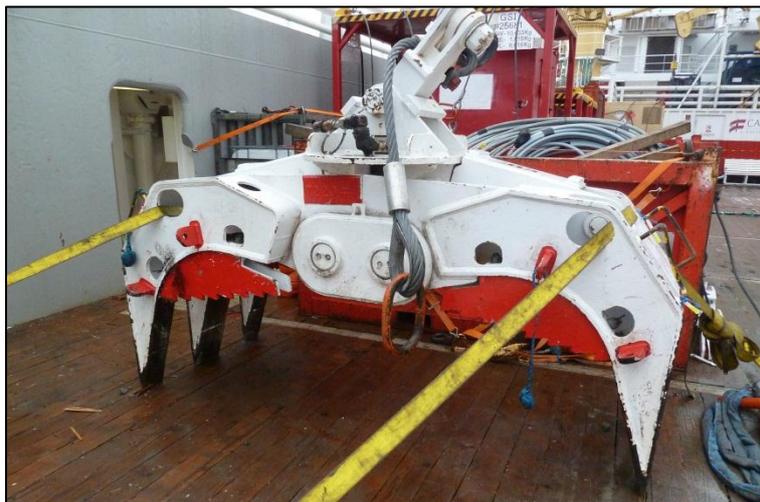
**Fig 3- Hydraulic Grapple**

A Hydraulic Grapple was utilised for the mattress recovery operations on the PL878 Pipeline. The Grapple c/w hydraulic hose bundle was deployed subsea on the main crane, and operated via a surface control panel under the direction of the GSI technicians. The Grapple has a SWL of 15Te.

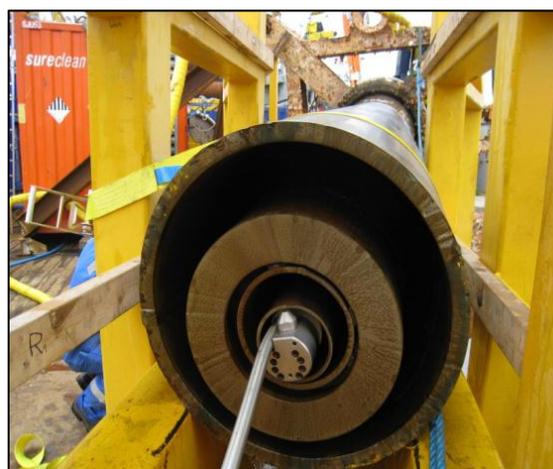
**Fig 4- Internal Multi String Cutting Tool**

The NCA Internal Multi-String Cutting Tool (IMSCCT) was mobilised for the 53/1a-5 Wellhead recovery operations. The IMCT is based on NCA's Abrasive Water Jet Cutting (AWJC) system and is capable up to five layers of casings from the inside of a well in one run.

The AWJC method uses a high-energy jet of water-borne abrasive particles with enough kinetic energy to cut even the hardest steel alloys quickly and safely. The IMCT produces a clean and even cut, which makes conductor recovery easy. The cut conductor segments are safe to handle as they are returned to shore.

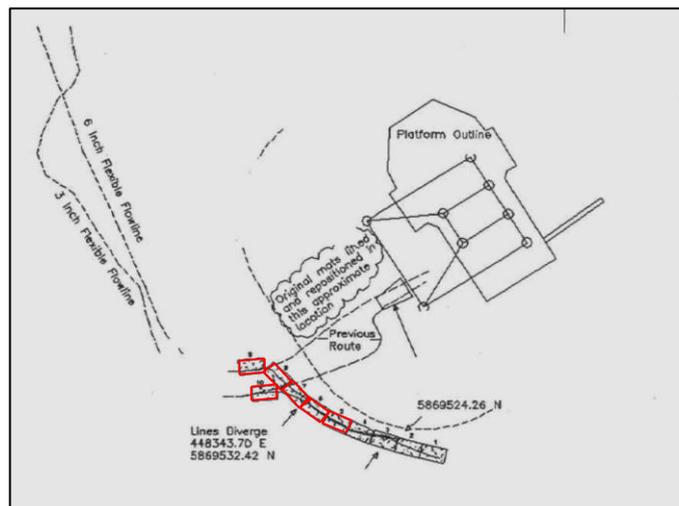
Fig 5- SE Mattress Location

Using the TSS440, the Pipelines PL878 / PL879 were positively identified and the grapple was deployed to commence mattress recovery operations. The Grapple achieved a depth of investigation of approximately 1m below seabed.

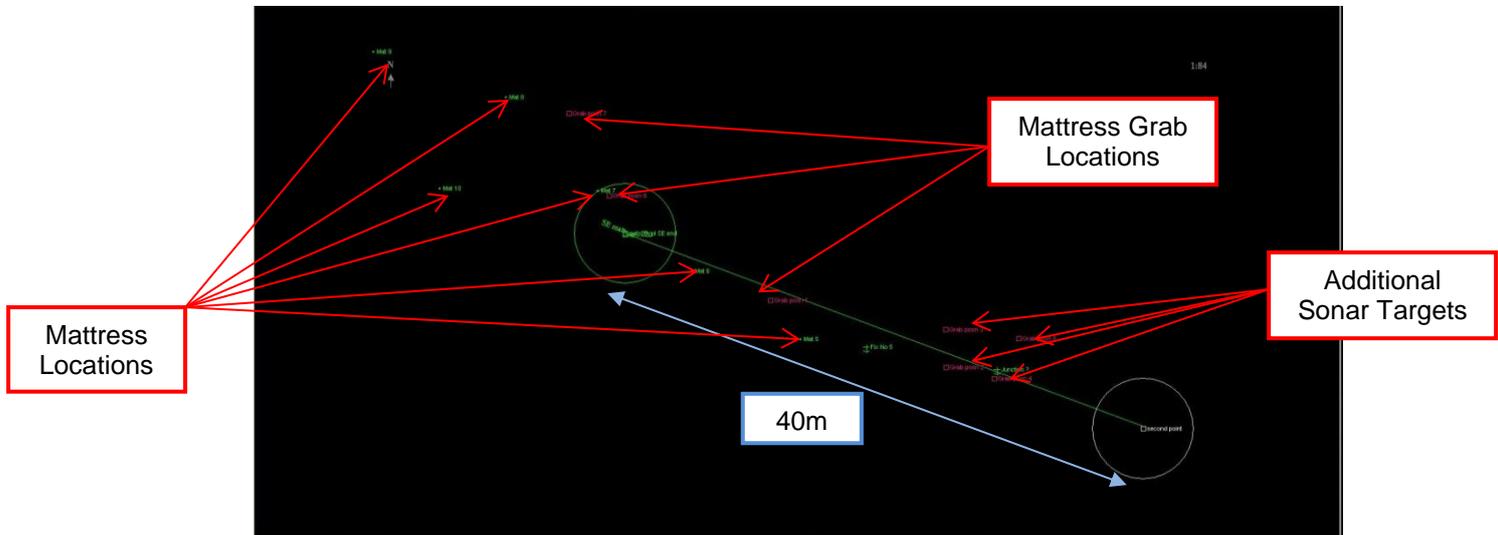
**Fig 6- SE Mattress Location NAV Screen Grab**

At the SE mattress location, seven attempts were made to locate and recover the mats using the hydraulic grapple, but no evidence of any mats was found. The grab locations can be seen in Figure 6. In addition, a sonar target was also investigated although nothing of interest was located:

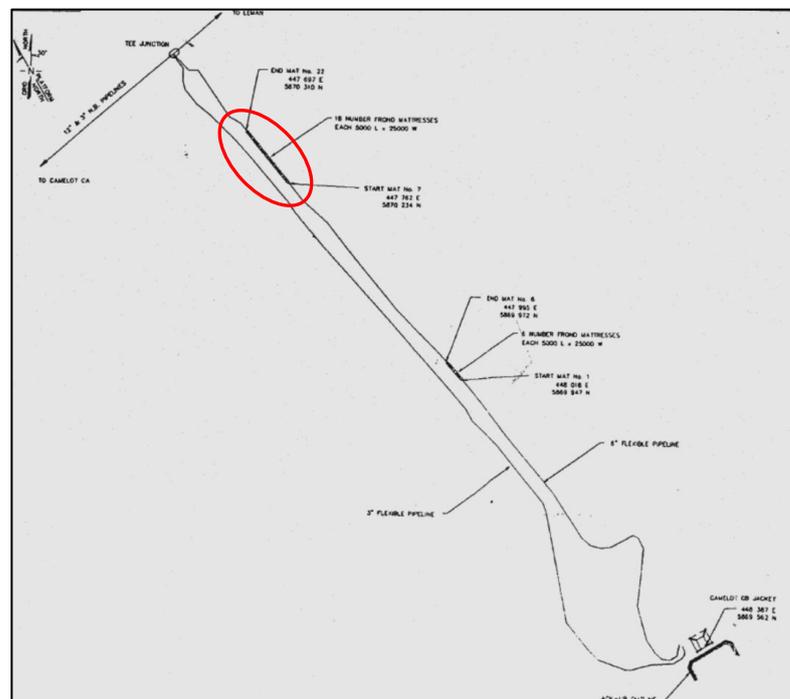
**Fig 7- NW Mattress Location**

Using the TSS440, the Pipeline PL878 was positively identified and the grapple was deployed to commence mattress recovery operations. The Grapple achieved a depth of investigation of approximately 1m below seabed.

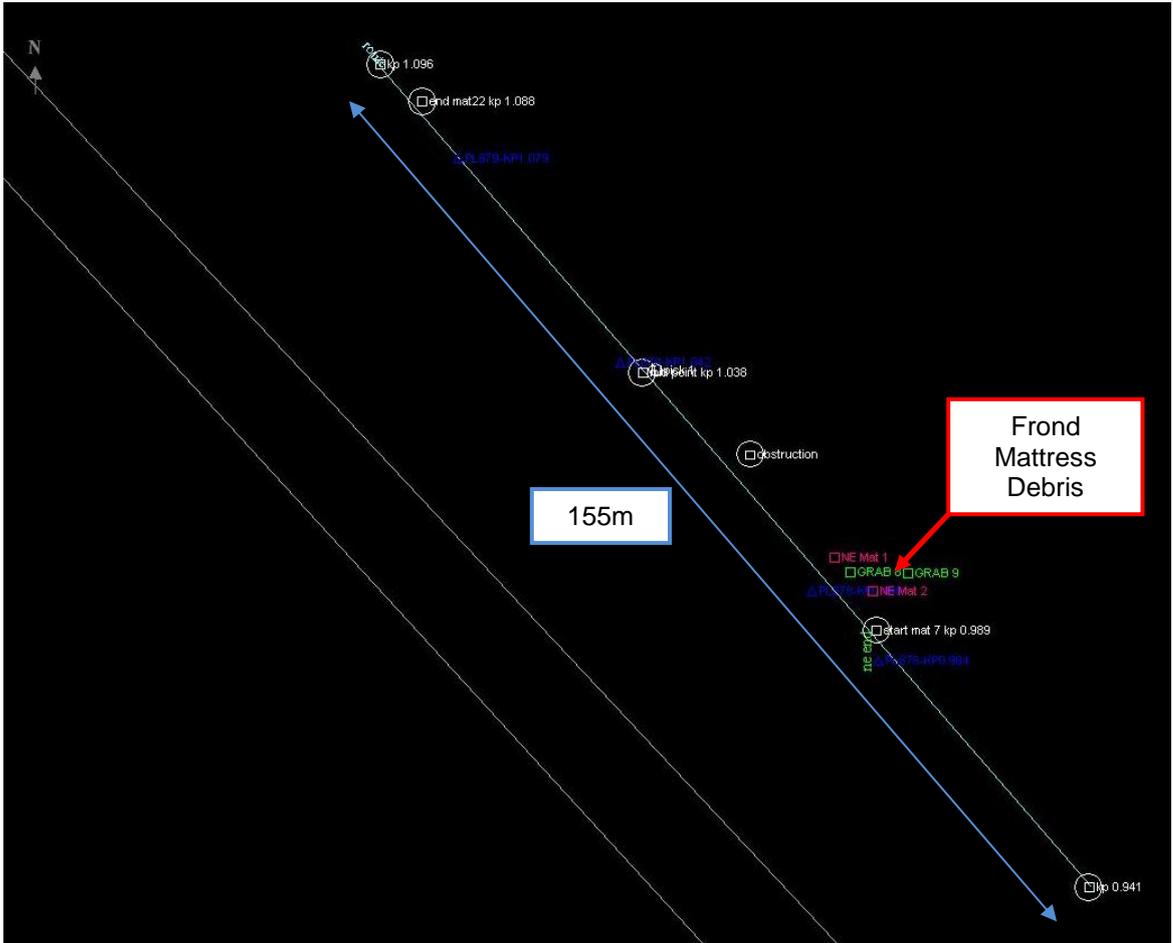
Fig 8- NW Mattress Location NAV Screen Grab

At the NW mattress location, nine attempts were made to locate and recover the mats using the hydraulic grapple. Two Grapples of Fronds were recovered to the vessel, the locations of these grabs can be seen in Figure 8. No evidence of any concrete mats was seen.

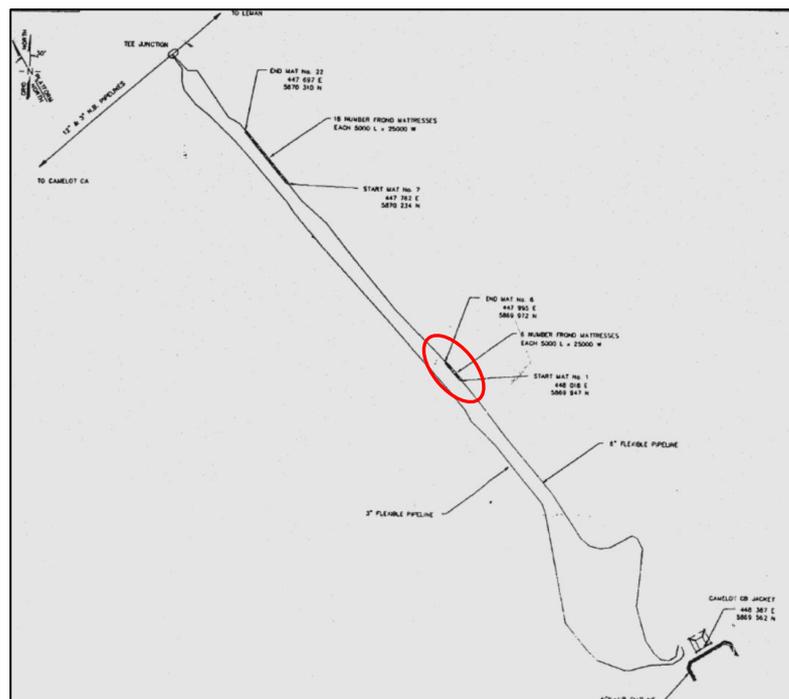
**Fig 11- MID Mattress Location**

Using the TSS440, the Pipeline PL878 was positively identified and the grapple was deployed to commence mattress recovery operations. The Grapple achieved a depth of investigation of approximately 1m below seabed.

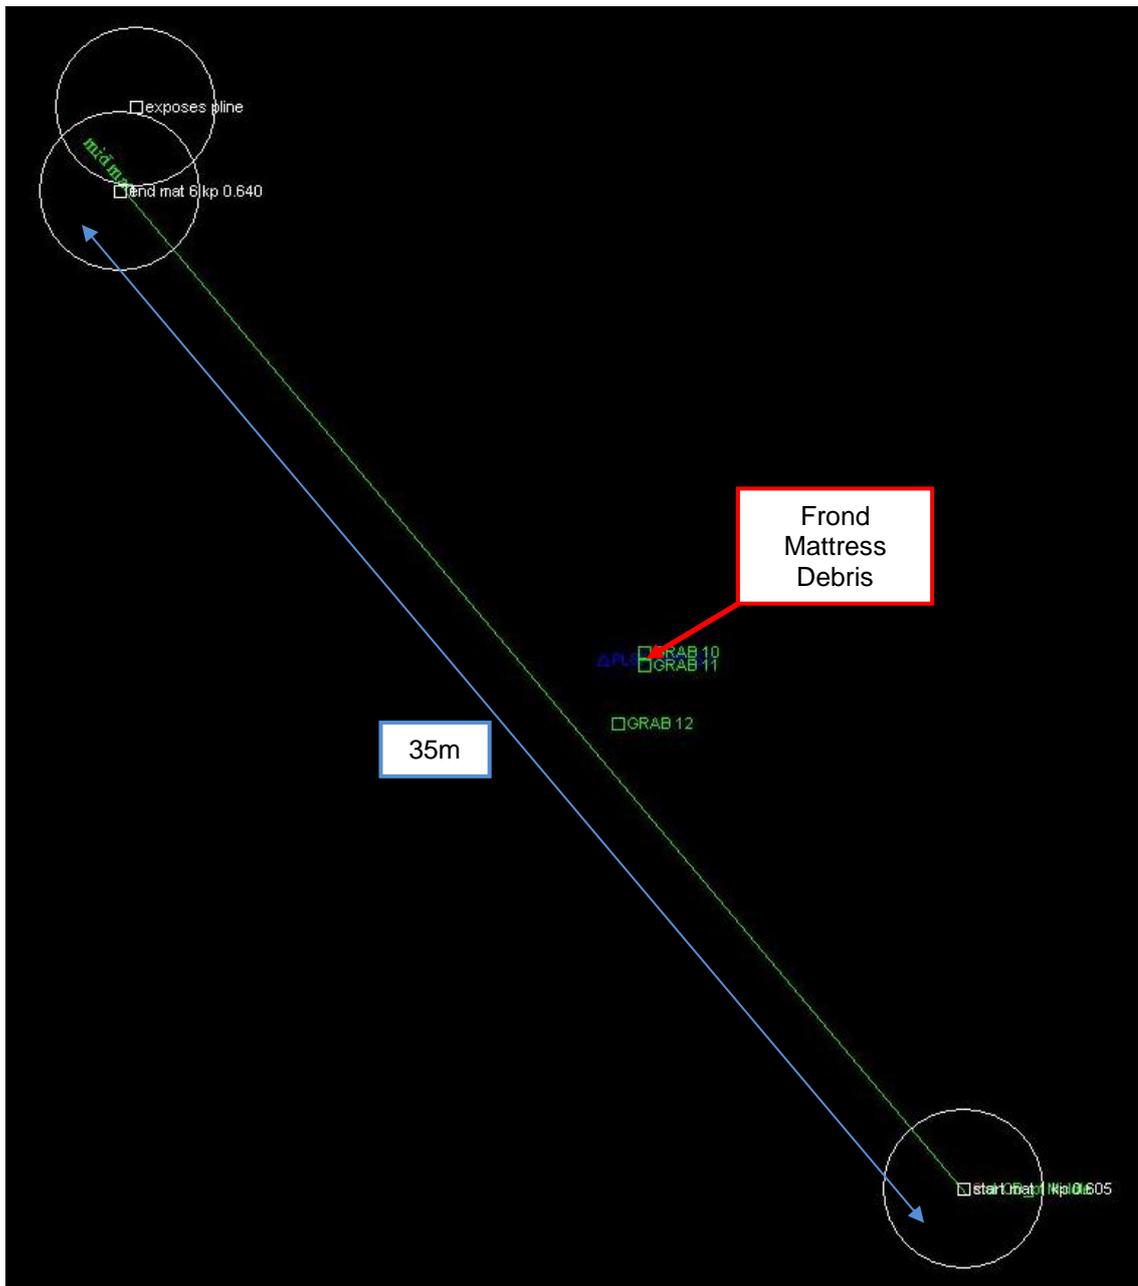
**Fig 12- MID Mattress Location NAV Screen Grab**

At the MID mattress location, three attempts were made to locate and recover the mats using the hydraulic grapple. Three Grapples of Fronds were recovered to the vessel, the locations of these grabs can be seen in Figure 12. No evidence of any concrete mats was seen.

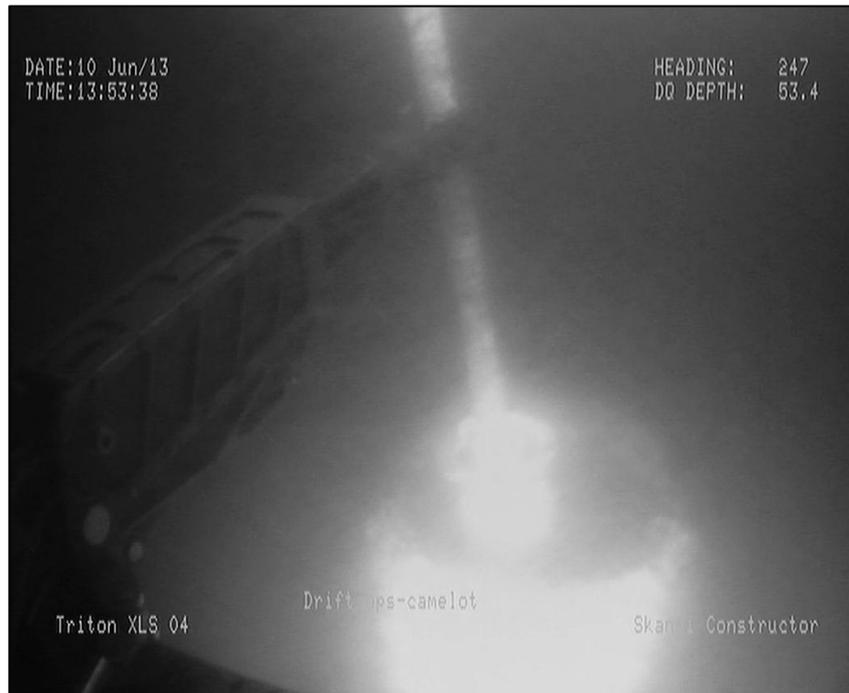
**Fig 14- 13 3/8" Drift Tool, 2' HUD**

The vessel set up over the Camelot 53/1a-5 wellhead (see **Appendix 4.1- Seabed Clearance Certificate** for geodetics and coordinates) and performed an As Found survey of the wellhead and surrounding area. Fishing net was found wrapped around the base of the wellhead however no other debris was found. The wellhead was initially drifted using a 13 3/8" Drift Tool and HUD was approximately 2' (Figure 14).

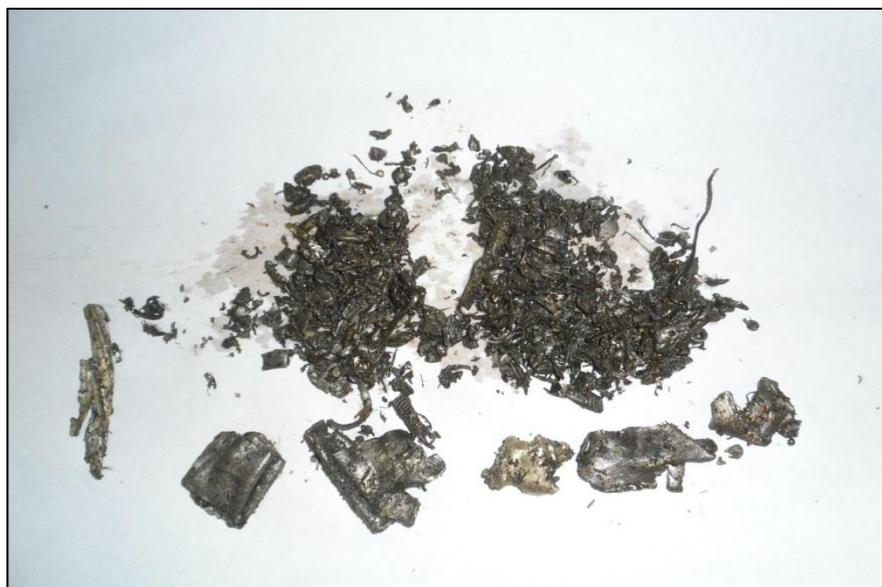
**Fig 15- Swarf sample recovered to the vessel**

Swarf and dense sludge were recovered with the drift tool. A sample of the swarf recovered to the vessel can be seen in Fig 14.

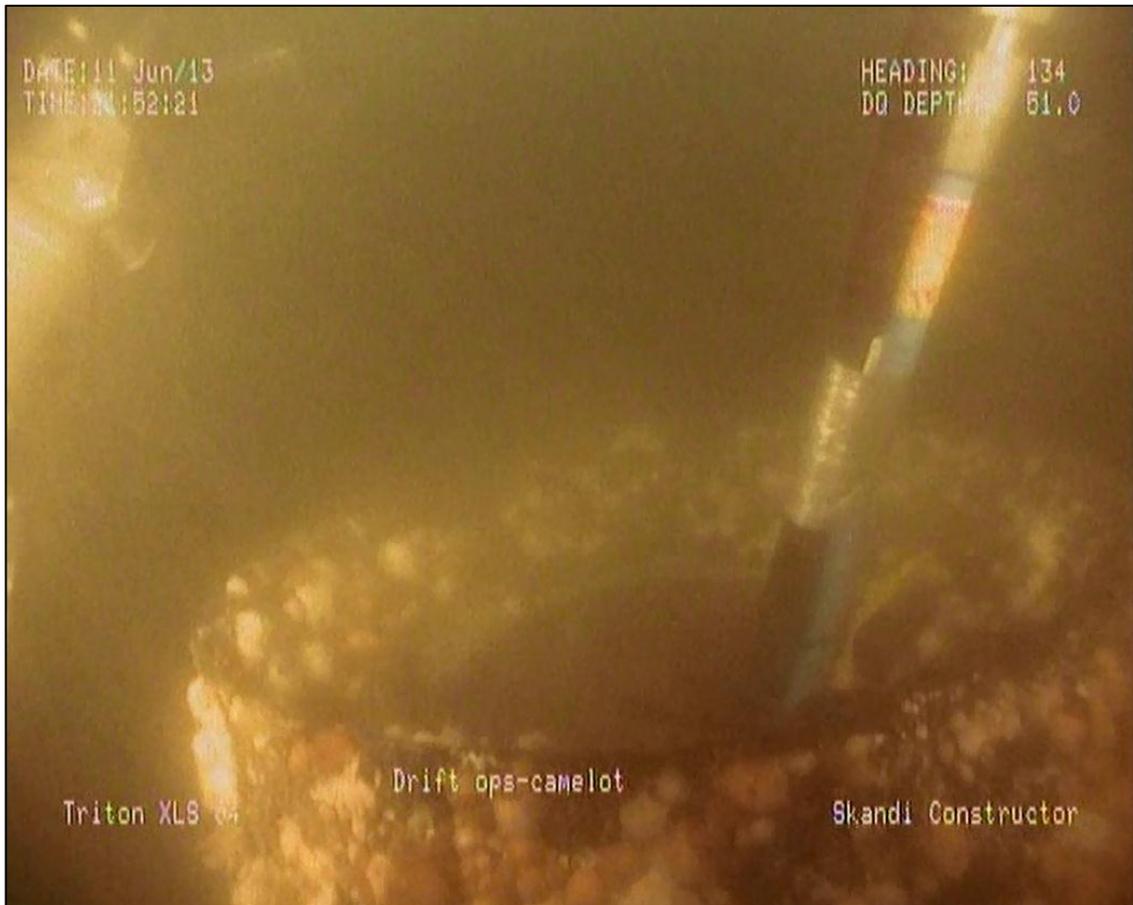
**Fig 16- Stage 2 Cleaning Ops**

A Twin Air Compressor c/w high pressure airline and drift tool stem was rigged up and deployed subsea for stage 1 cleaning operations. A High Pressure Pump c/w high pressure water jet line was rigged up with the high pressure airline and deployed subsea for stage 2 cleaning operations (Figure 16).

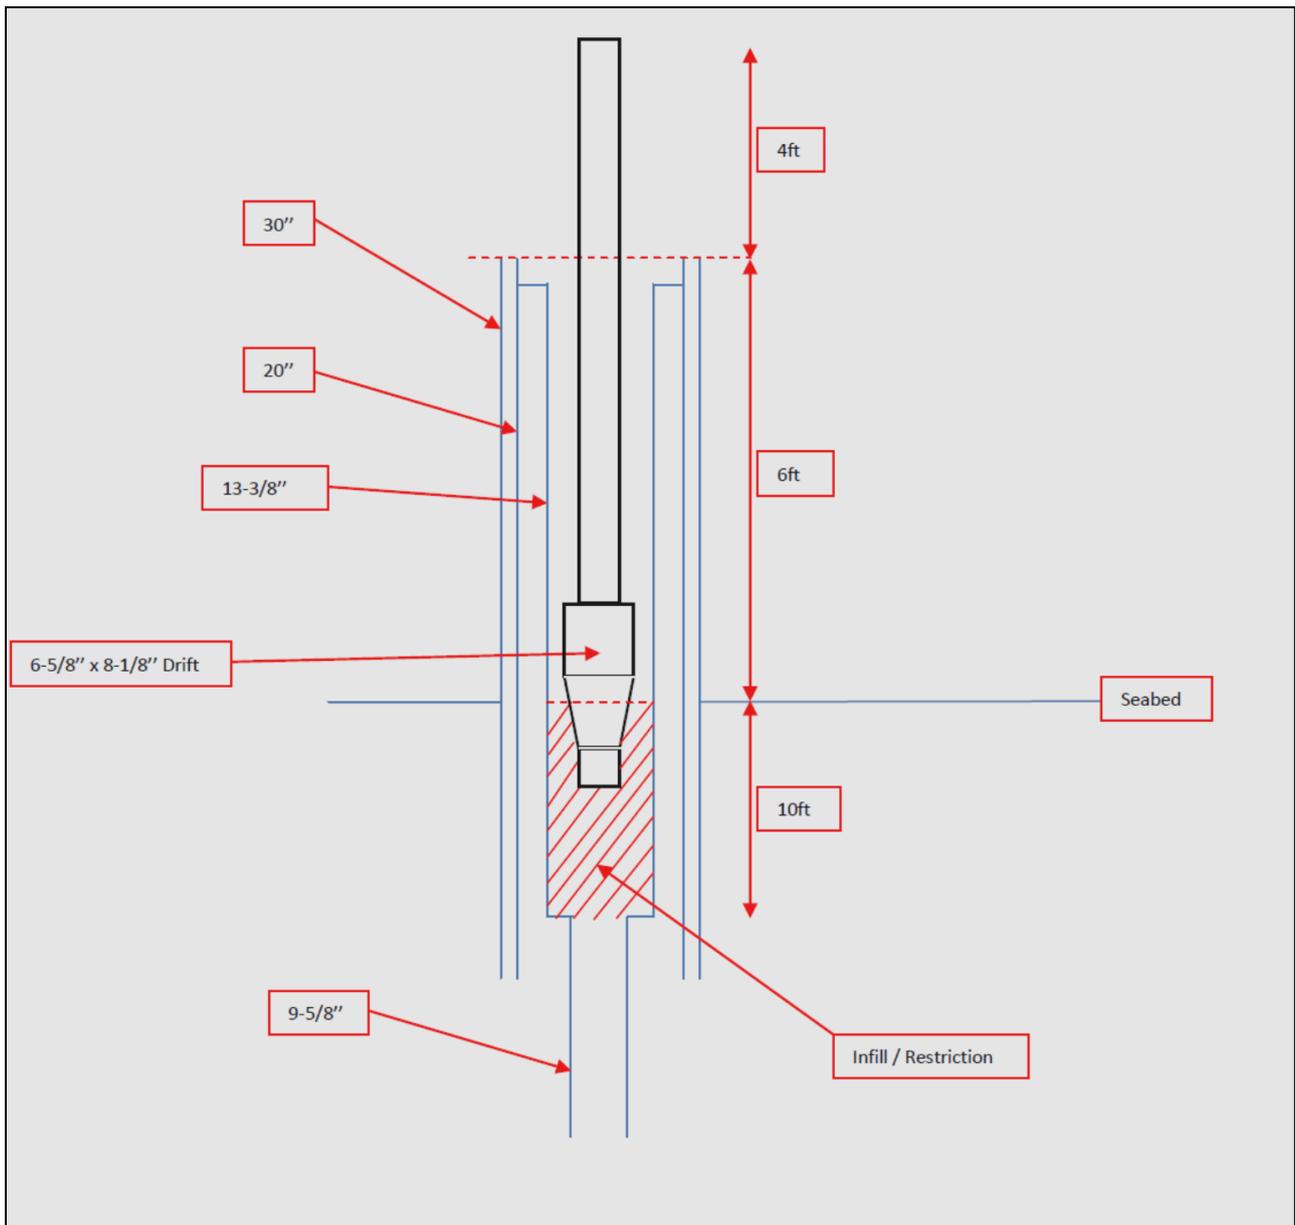
**Fig 17- Wellhead Drift Operations**

Stage 2 cleaning operations and 13 3/8" drifts were cyclically carried out. Drifts with a 6 5/8" x 8 1/8" Tool were also carried out. The HUD was approximately 6' indicating the possibility of an obstruction, as can be seen in Fig 17.

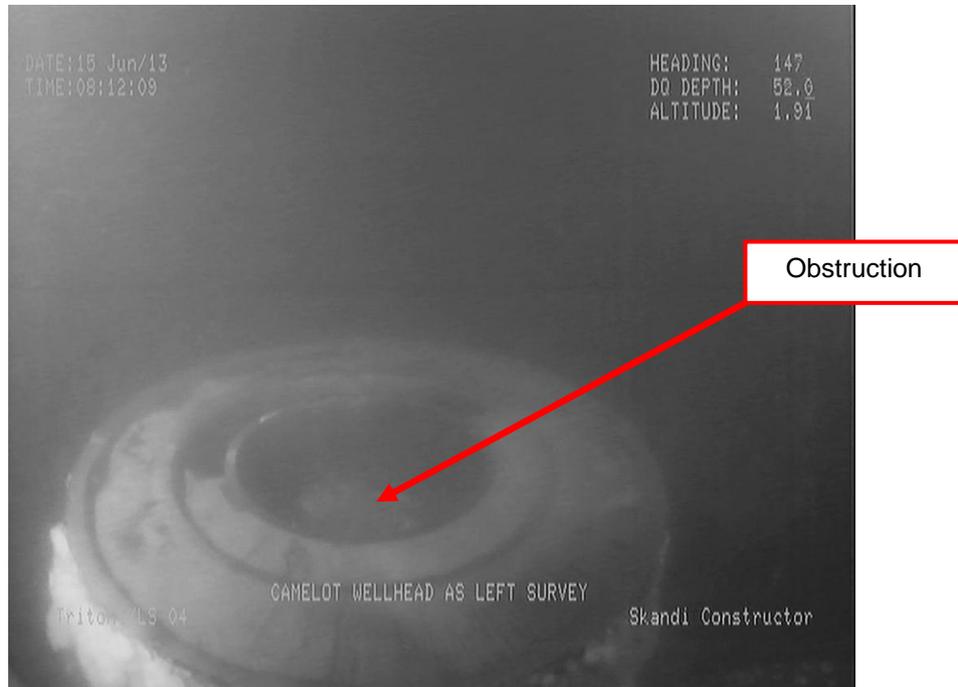
**Fig 20- Obstruction in 13 3/8" Casing**

An ROV As Left Survey indicated an obstruction in the 13 3/8" Casing (Figure 20), which would prevent any additional internal cutting tool being used until cleared. The estimated stickup above the current seabed level is approximately 3ft. A 360° Sonar Sweep was also performed and a Seabed Clearance Certificate completed.
