A5 Chalk Hill NMU Improvement Study

Study Report

47066667 – S04354

PREPARED FOR:
HIGHWAYS AGENCY & CARILLIONWSP

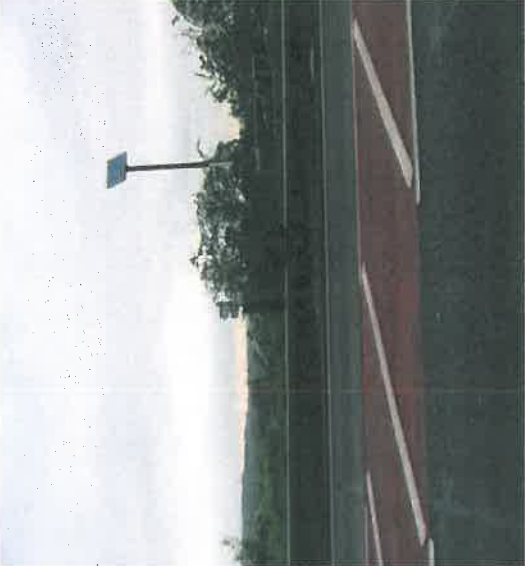
<p>View of existing wooden stile facing east.</p>

The existing stile that is currently placed over the safety fence is a potential hazard for those using it, but the safety fence itself is also a barrier to the users of the public right of way. The position of the wooden stile does not permit pedestrians to stand and wait having crossed the safety barrier due to its close proximity to the carriageway.

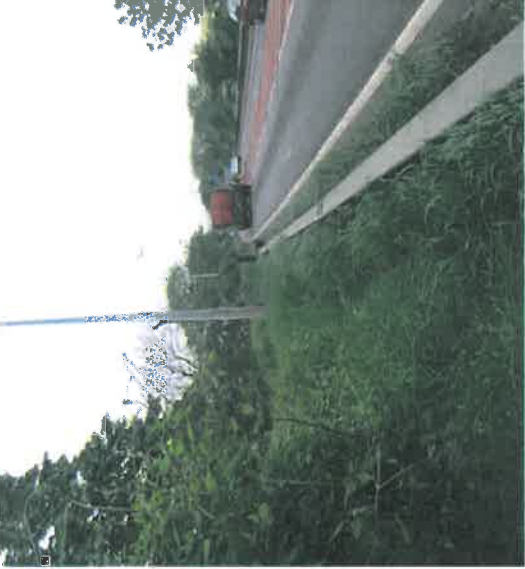
<p>View of existing wooden stile facing north.</p>

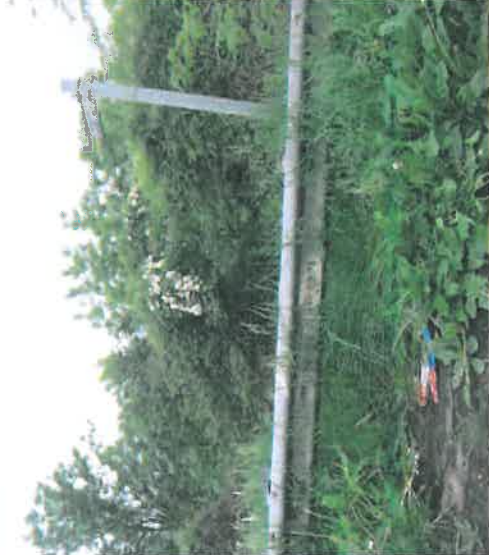
<p>View of access to steps on embankment at the A5 roundabout western verge</p>

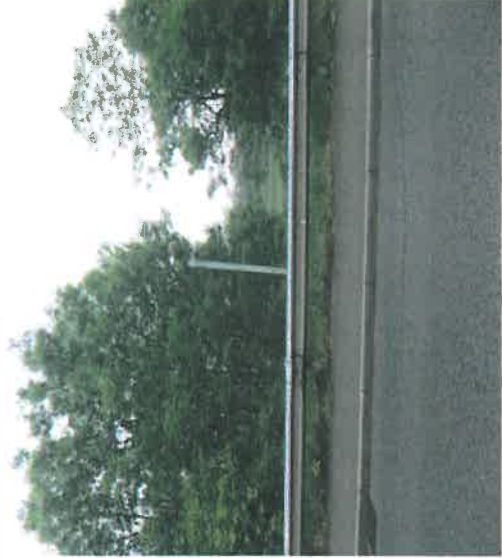
<p>View of access to steps on embankment at the A5 roundabout eastern verge</p>
