FLYER TO THE SHIPPING INDUSTRY

Six crew lost as a general cargo ship founders

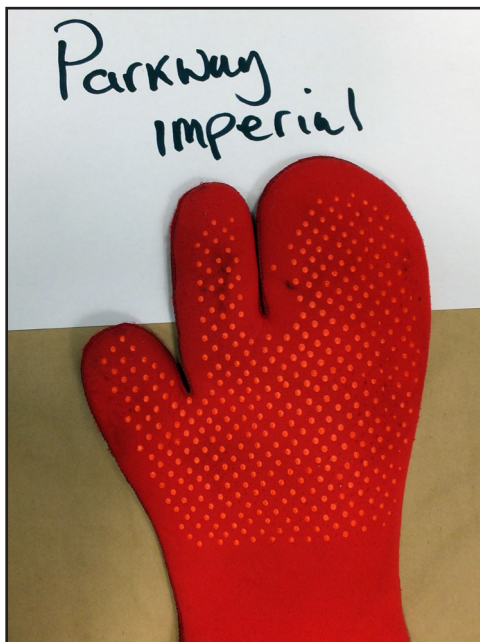
Figure 1: Immersion suit glove

As the vessel’s freeboard reduced, the master realised that the vessel was sinking and ordered the crew to prepare to launch the liferafts. At about the same time, the second officer collected the two search and rescue transponders (SART). However, he had difficulty activating them because of the design of the gloves integral to his immersion suit (**Figure 1**), and eventually had to use his teeth to operate them.

The liferaft's internal light soon extinguished, and the survivors continued to be hampered by the lack of dexterity afforded by the immersion suit gloves (**Figure 1**).

- The provision of LSA should be goal-based and holistic in order to ensure that the components are compatible and that the 'system' is fit for purpose. The compatibility of individual items of equipment cannot be taken for granted, even where the LSA provided meets the required performance standards.
