MAJOR INJURY

Whilst installing minipiles on a project at London Bridge redevelopment a Bachy Soletanche employee working within our Specialist Geotechnics team sustained a crush injury to his left hand which has resulted in a Major RIDDOR reportable accident

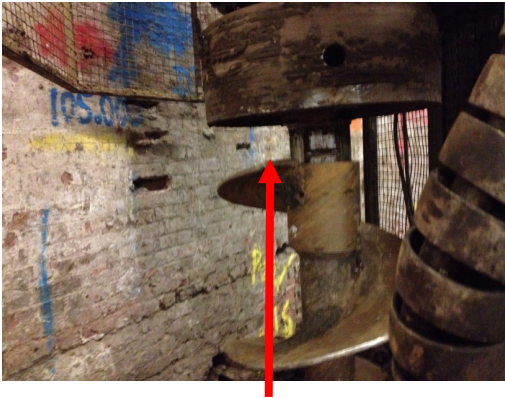
The team were in the process of installing the 9th auger in a sequence of 28. The rig gates were opened and a flight auger had been lifted onto the 8th auger by the rig winch. The pile arising's from the previous flights had not been removed. Once the flight auger was in position the operator lowered the duplex head to engage the 9th auger. The IP climbed onto the pile arising's and waited for the head to fully engage so he could insert a retaining pin to fully secure the auger. At this point there was a breakdown in communication between the rig operator and the spanner man. The rig operator was still in the process of lowering the head however the IP believed that the operation had been completed. The IP had placed his left hand on the top flight of the auger and was bending down in order to locate the retaining pins. The skirt of the duplex head was lowered onto his left hand trapping it between the top flight and the skirt.

The IP was stood directly next to the auger on top of the pile arising in anticipation of the head engaging in order for him to insert the retaining pins. As the duplex head engaged there was no reason for IP to be stood so close to the moving machinery. The rig operator should not have allowed anyone to be stood so close to the moving parts. The working environment inside the guarding and around the casing was not a suitable or stable working platform. The spanner man was required to stand on the pile arising's which were uneven underfoot and also placed his chest, shoulders and head above the connection point. When stood at this point there was a need to bend down or stoop in order to insert the retaining pin. Due to the uneven ground this may have led the IP to place his left hand on the top flight in order to steady himself to enable him to insert the pin.

Hand resting on the top flight as duplex lowered onto the next auger

Following the identification of potential entrapment between the skirt and the flight auger, engineers have re-designed the duplex head. The stem of the head has been lengthened and the skirt has been reduced by 50mm, this completely eliminates the potential of entrapment of hands or other body parts.

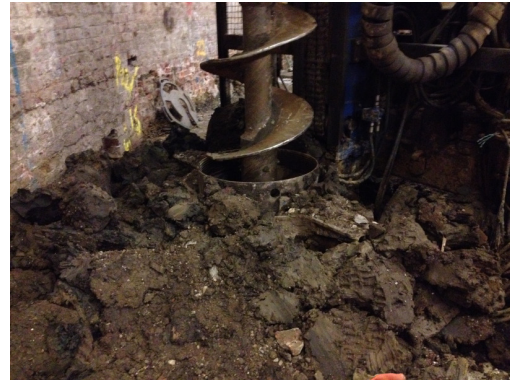
Buildup of spoil leading to uneven ground conditions
