## Lifting of a steel gantry

A member of our supply chain had been engaged to remove a steel gantry spanning 34m across a motorway exit and one mainline carriageway. The plan was to use a crane to lift the gantry's girder off its supporting legs and to remove it from site.

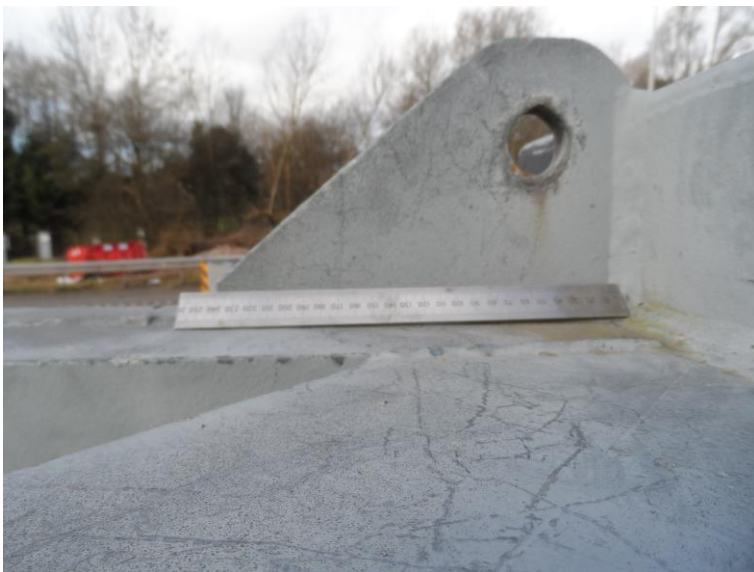
The drawings did not include details on the lifting lugs found on the gantry in the four upper corners (below). The lifting lugs had no assessment calculation or inspection to confirm their suitability for use in the lifting operation of the gantry's girder. After the lifting operation, it was noted that the lifting lugs showed signs of being distressed / damaged.

- Ensure that all elements within the load path, to be lifted by a crane, are assessed and checked by a competent person
- All lifts of this nature are considered complex and require a detailed lifting plan
- The lifting plan needs to identify the means of attachment to the load as well as a checked calculation of the loads weight
- If there is any doubt as to the suitability of plant / equipment, method of lifting or competence of personal, the lift should be postponed until concerns are satisfied
- A full investigation has been carried out and we will share learning from this
