# Spectrum Engineering Services

Smart Meter RF Survey Site Report

Ashton Court

Appendix A.1

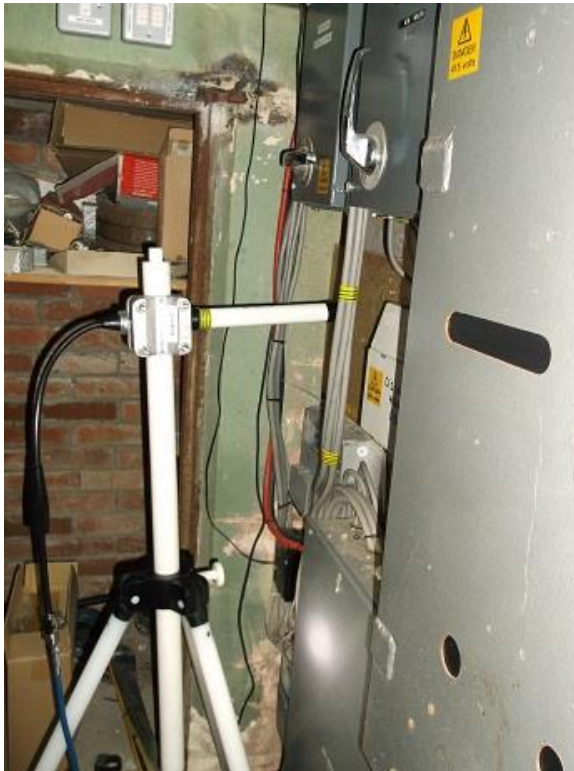
**Figure 4 Transmit Location 1 Electricity Cupboard (Room 49)**

1. Electricity Cupboard (Room 49) (100 mW).
2. Office (Room 38) (100 mW).
3. IT Room (Room 88 1<sup>st</sup> Floor) (100 mW).
4. Ranger Flat (500 mW).

Location	Location Name	Height
Tx 1	Electricity Cupboard (Room 49)	1.5 m
Tx 2	Office (Room 38)	1.5 m
Tx 3	Ranger Flat	1.5 m
Tx 4	IT Room (Room 88 1 <sup>st</sup> Floor)	1.5 m

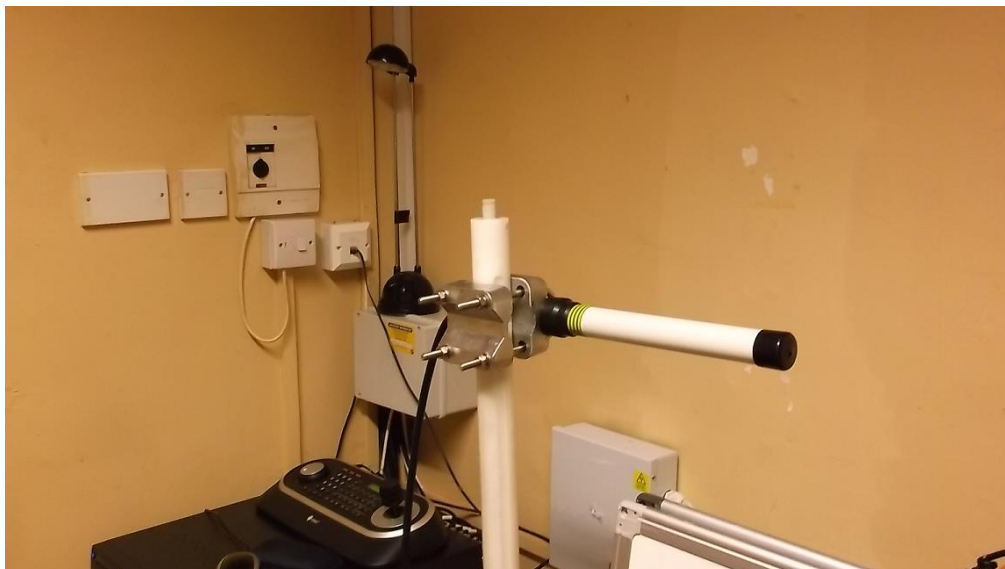
**Figure 5 Transmit Location 2 Office (Room 38)**

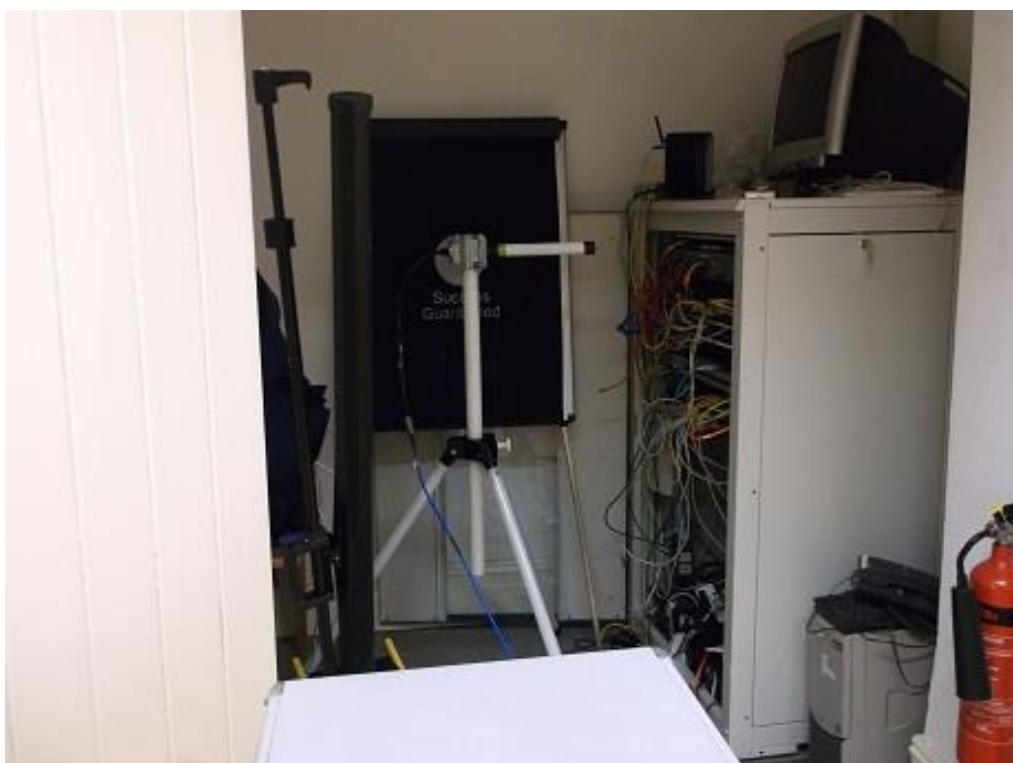
**Figure 6 Transmit Location 3 IT Office (Room 88)**

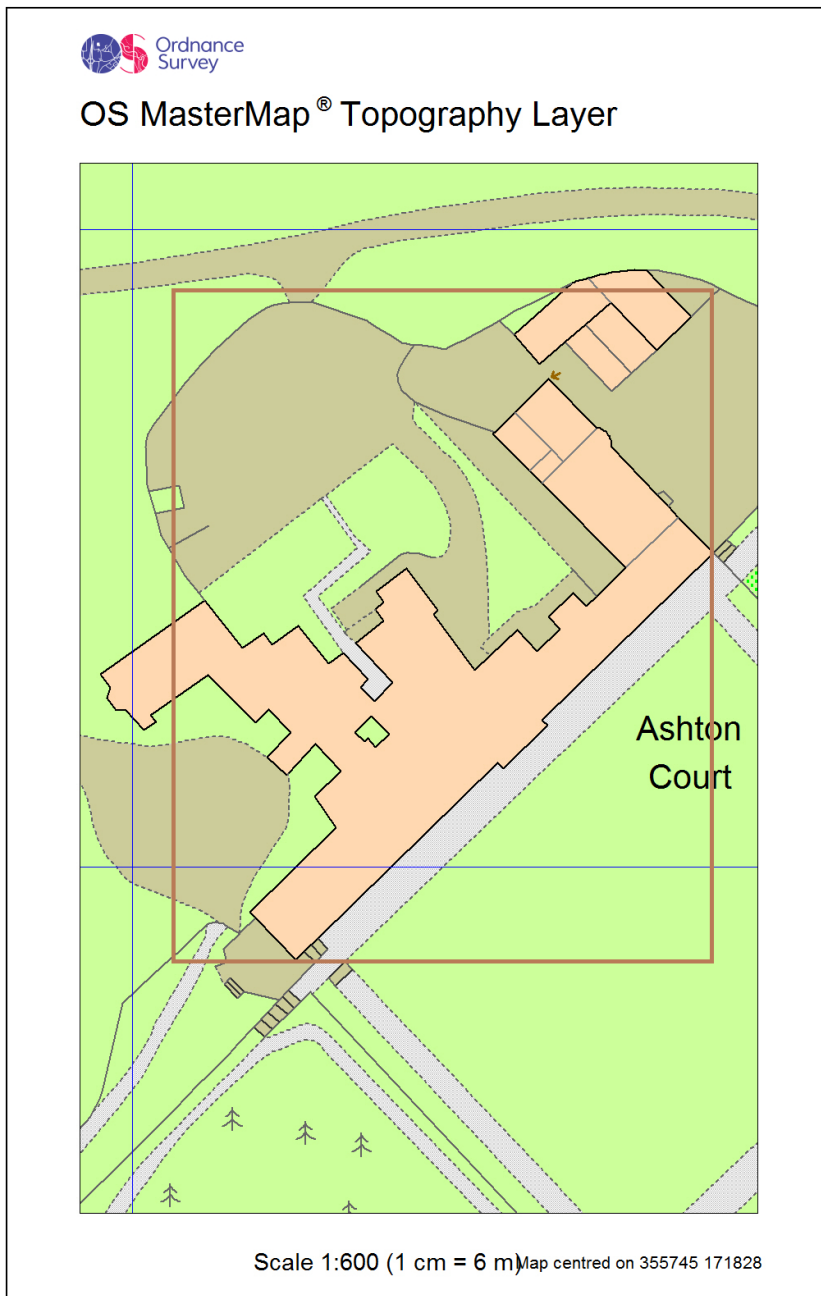
See Appendix A – Building Plan, which contains a plan of the property with a grid used to identify the test locations and Appendix B – Test Locations contains a table which details the test locations. The grid used in Appendix A represents a 4 meter square and is scaled to the Ordnance Survey plan drawings.

Team	Test	Floor	Inside/Outside	Grid Reference
-	Tx 1	Ground	Inside	O4
-	Tx 2	Ground	Inside	Q7
2	Rx 1	Ground	Inside	Q4
2	Rx 2	Ground	Inside	O5
2	Rx 3	Ground	Inside	O4
2	Rx 4	Ground	Outside	P6
2	Rx 5	Ground	Inside	R3
2	Rx 6	Ground	Inside	P6
1	Rx 7	Ground	Outside	V6
1	Rx 8	Ground	Outside	P1
1	Rx 9	Ground	Inside	T8
1	Rx 10	Ground	Inside	T10
1	Rx 11	Ground	Inside	P12
1	Rx 12	Ground	Inside	P13
1	Rx 13	Ground	Inside	N15

Team	Test	Floor	Inside/Outside	Grid Reference
-	Tx 3	Second	Inside	S14
-	Tx 4	First	Inside	I19
1	Rx 14	First	Inside	E15
1	Rx 15	First	Inside	G13
1	Rx 16	First	Inside	I21
1	Rx 17	First	Inside	N19
1	Rx 18	Ground	Inside	F13
1	Rx 19	Ground	Inside	F16
1	Rx 20	Ground	Outside	C16

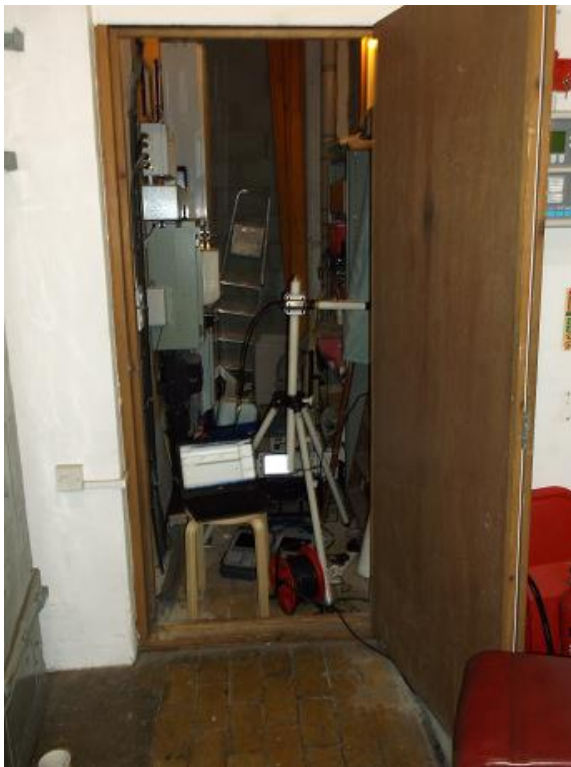
**Figure 4 Transmit Location 1 Electricity Cupboard**

Location	Location Name	Height
Tx 1	Electrical meter room ground floor	1.5 m
Tx 2	Plant room Ground floor	1.5 m
Tx 3	Electrical meter room ground floor	1.5 m

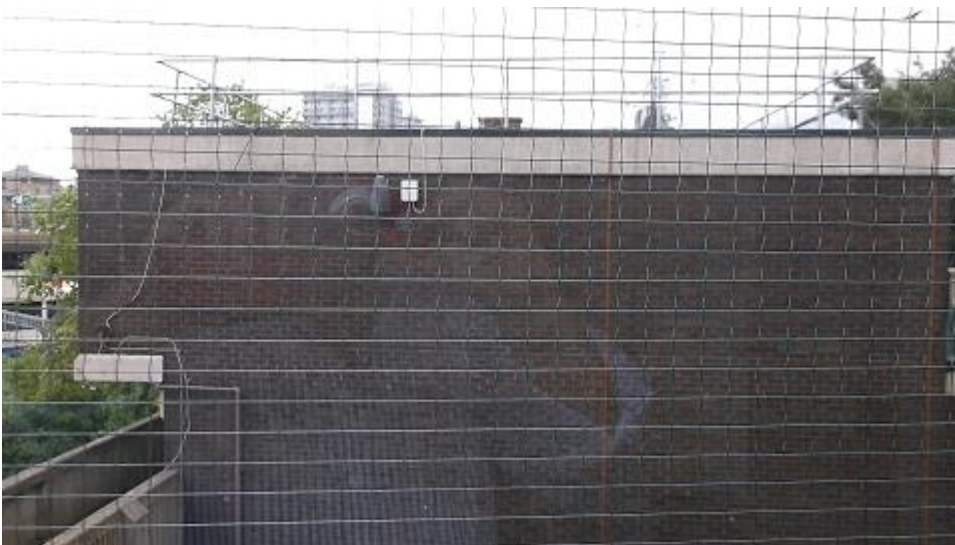
Figure 5 Top floor of Culham House Tx 3

Location	Location Name	Height
Tx 1	Outside rear of flats	1 m
Tx 2	Shed on ground floor of flats	1 m
Tx 3	Top floor of Culham flats	1 m

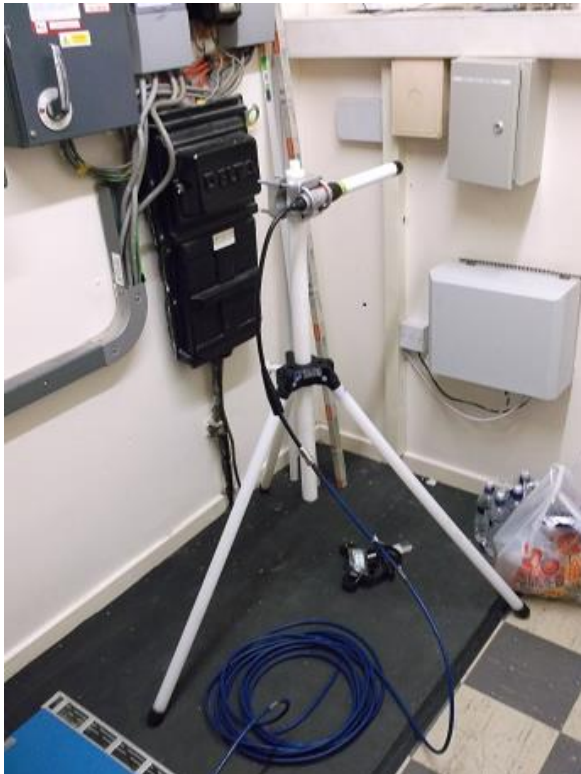
**Figure 4 Transmit Location 1 Electricity Cupboard**

Location	Location Name	Height
Tx 1	Electrical meter room ground floor	1.5 m
Tx 2	Outside next to wall	1.5 m
Tx 3	Electrical meter room ground floor	1.5 m

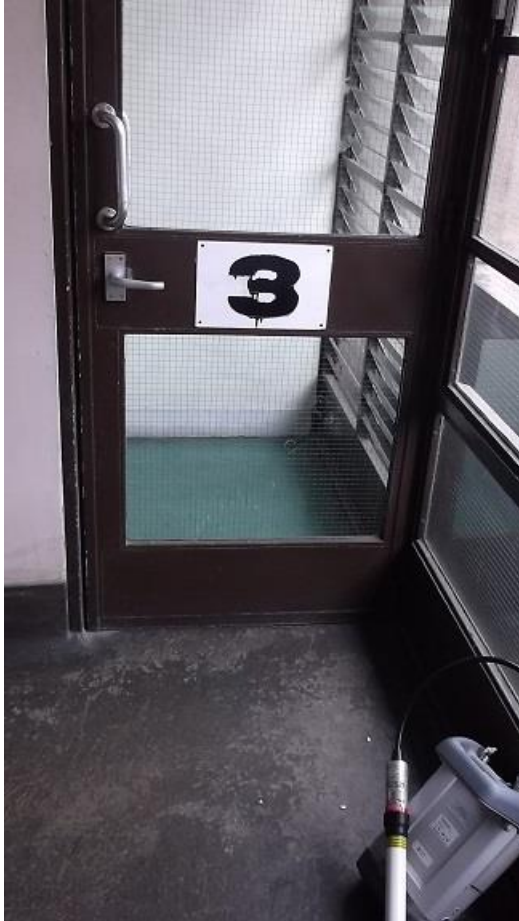
Figure 4 Typical Test Location on the Central Staircase

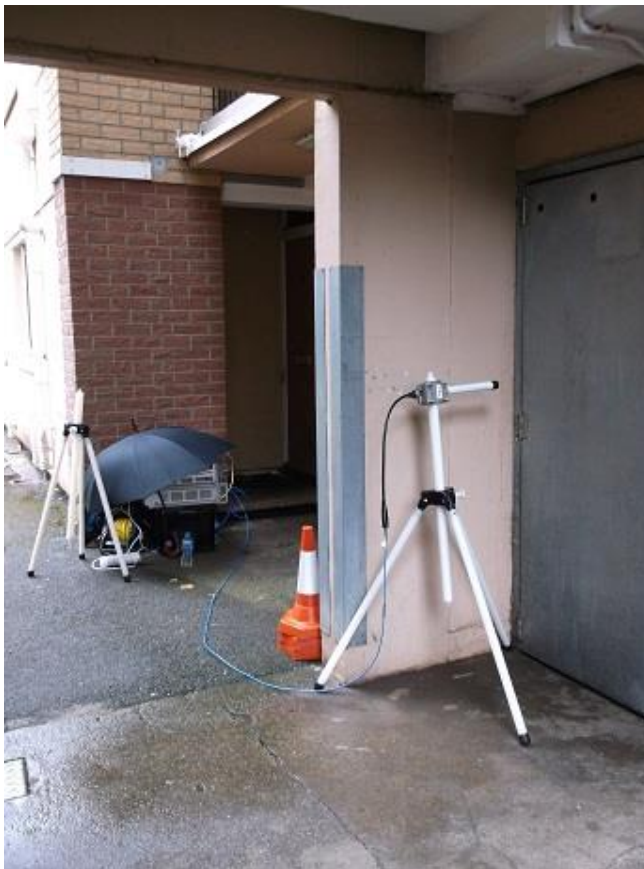
**Figure 4 Transmit Location 1 and 2 (inside door to right of Test Equipment)**

Location	Location Name	Height
Tx1	Outside plant room window	1.5 m
Tx2	In plant room	1.5 m

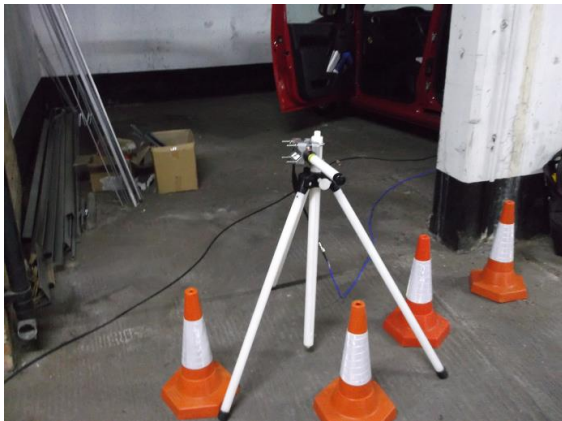
**Figure 3 Day 1 Transmit Location 1**

Location	Location Name	Height
D1 – Tx 1	Basement Garage	1.5 m
D2 – Tx 1	Inside main entrance electrical cuboard	1.5 m
D2 – Tx 2	Front of property plant room	1.5 m
D2 – Tx 3	Top floor rear of Parkinson House	1.5 m

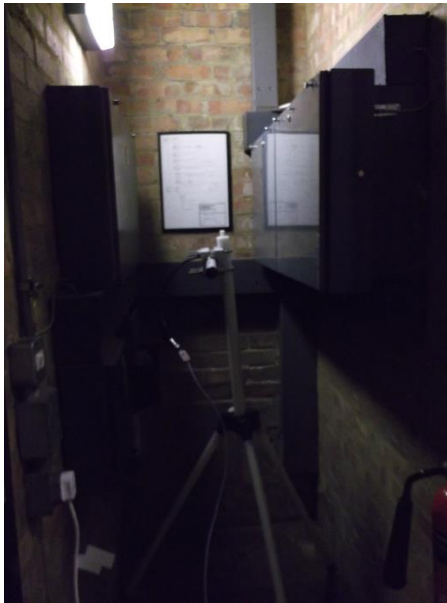
**Figure 4 Day 2 Transmit Location 1**

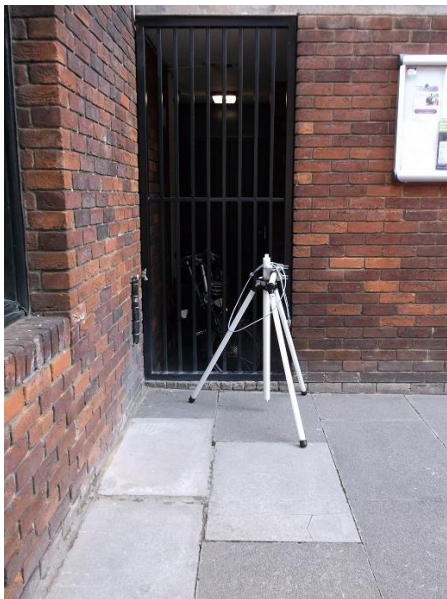
**Figure 5 Day 2 Transmit Location 2**

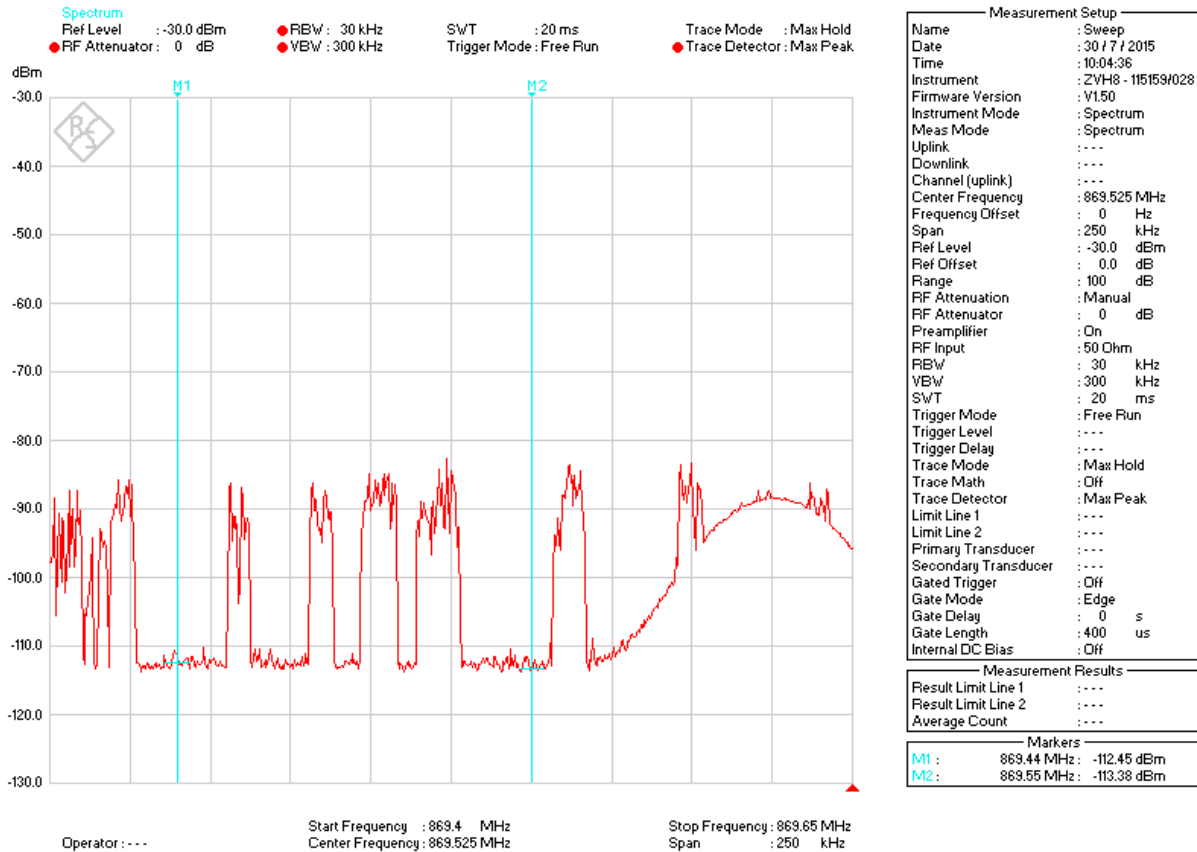
Figure 6 Scan of the 868 MHz Band

The following interference sweep was carried out to determine the frequencies that could be used for the subsequent testing. Figure 6 shows a sweep of the 868 MHz band and the activity in the band.

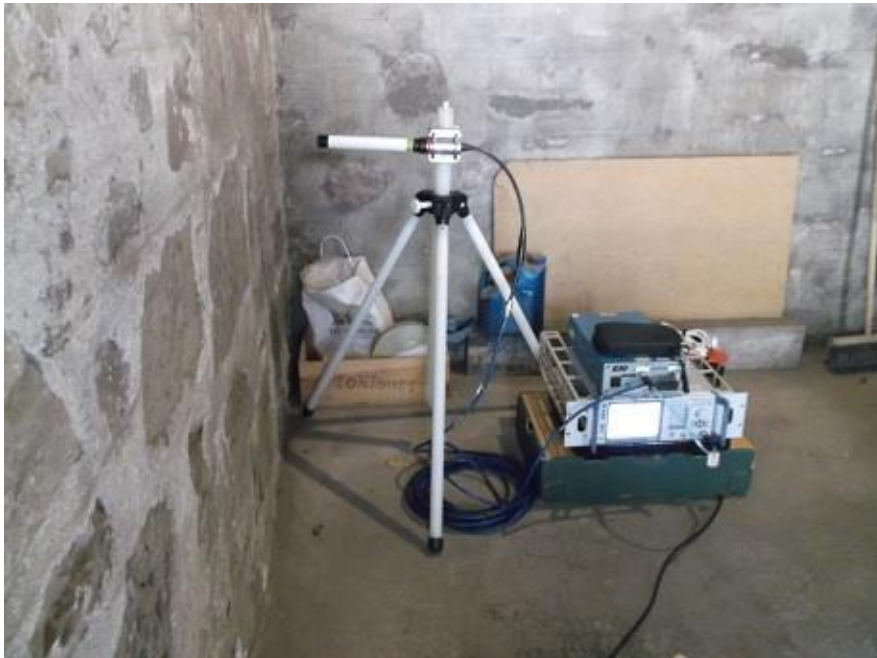
**Figure 3 Transmit Location 1**

Location	Location Name	Height
Tx1	Inside stone outbuilding at rear	1.5 m
Tx2	Outside rear door of property	1.5 m

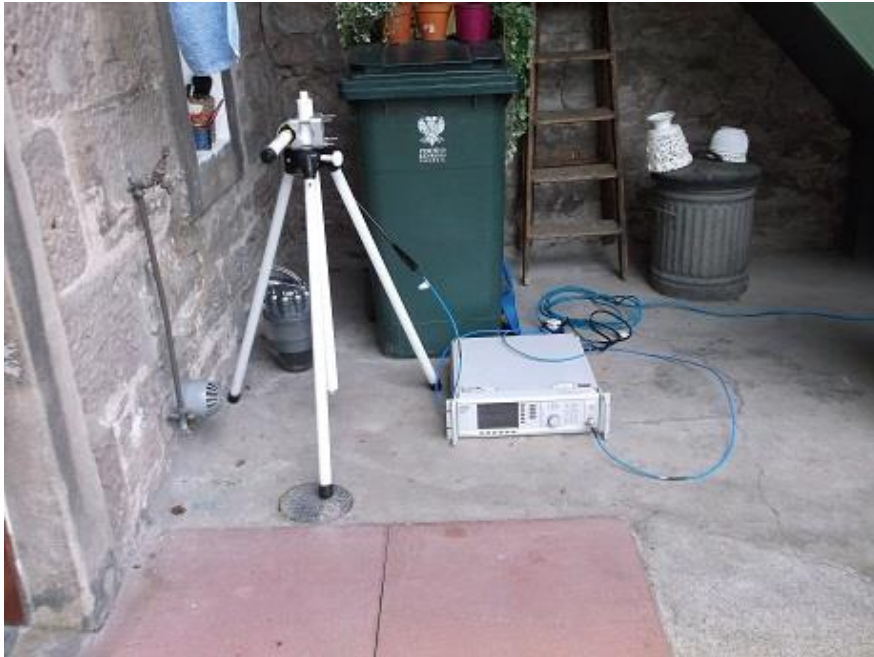
**Figure 4 Transmit Location 2**

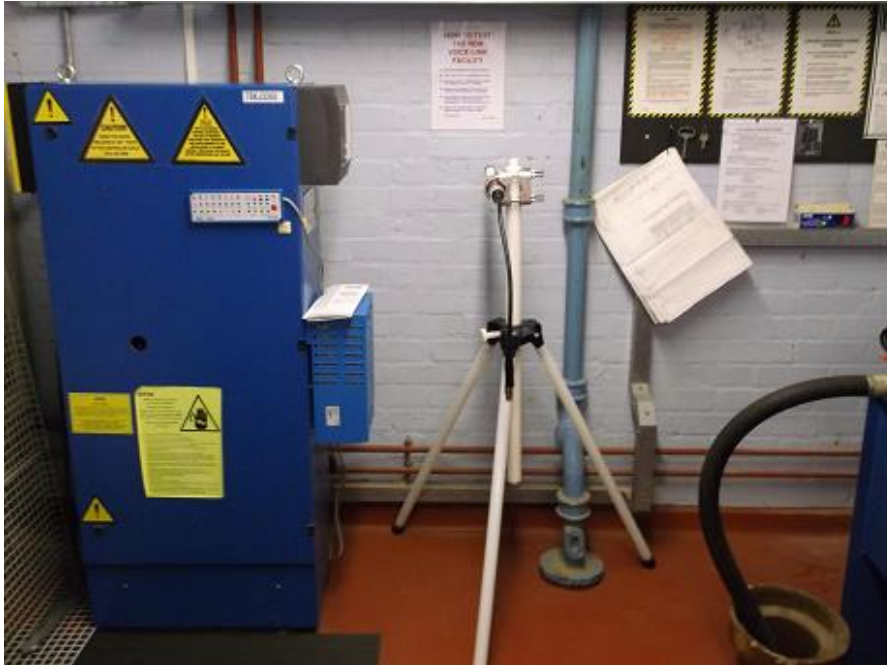
**Figure 3 Transmit Location 1**

Location	Location Name	Height
Tx 1	Outside plant room window	1.5 m
Tx 2	In plant room	1.5 m
Tx 3	Top floor landing	1.5 m

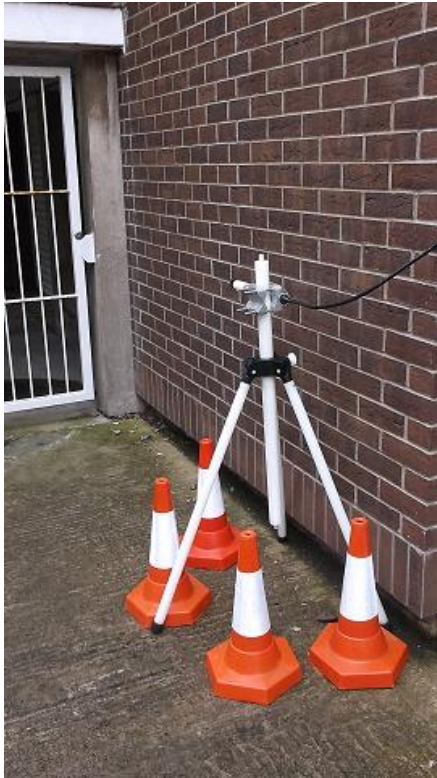
**Figure 4 Transmit Location 2**

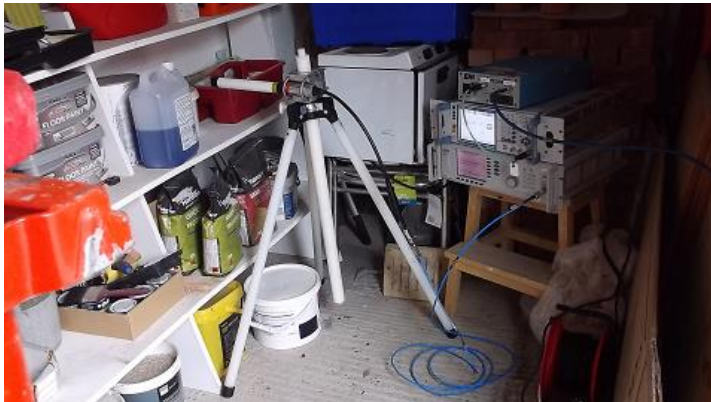
**Figure 3 Transmit Location 1 Electricity Cupboard**

Location	Location Name	Height
Tx 1	Inside electrical cupboard	1.5 m
Tx 2	Outside next to wall	1.5 m

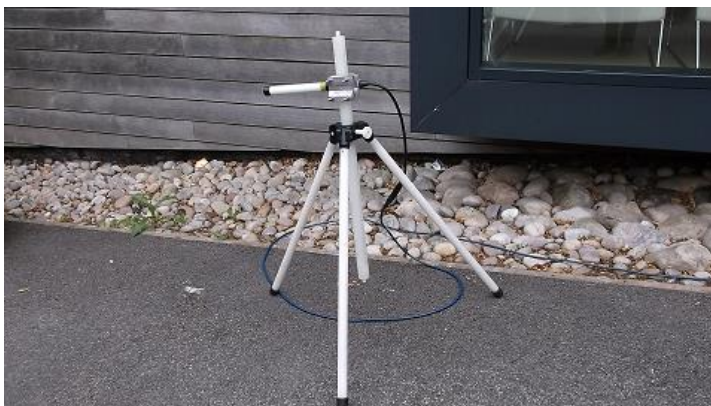
**Figure 4 Outside Transmitter Location 2**

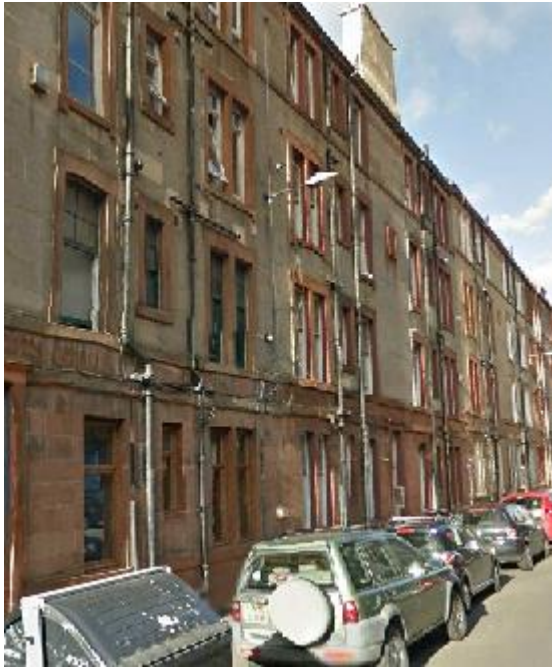
**Figure 1 Typical View Rossie Place**

Detail	Description
Property Identifier	Rossie Place
Property Type	Terraced block
Material of Construction	Sand Stone and Tile
Type of Exterior Wall	Sand Stone
Property Age	Built in 19 <sup>th</sup> century
Gas Meter Location	In flat
Electricity Meter Location	In flat

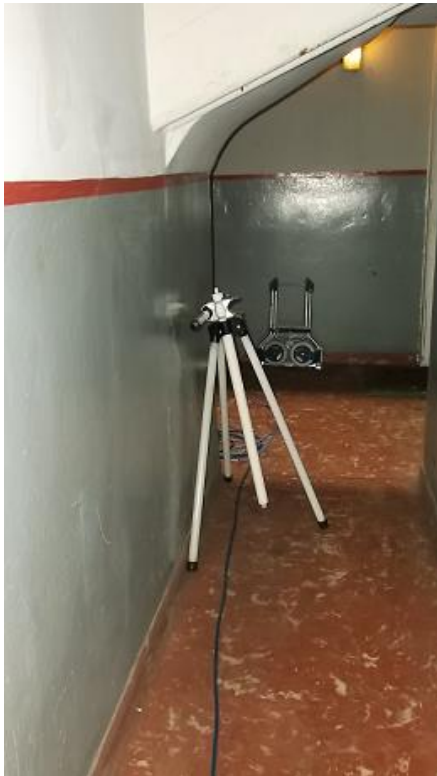
**Figure 3 Transmit Location 1 Indoors**

Location	Location Name	Height
Tx 1	Inside passageway	1.5 m
Tx 2	Outside rear door	1.5 m

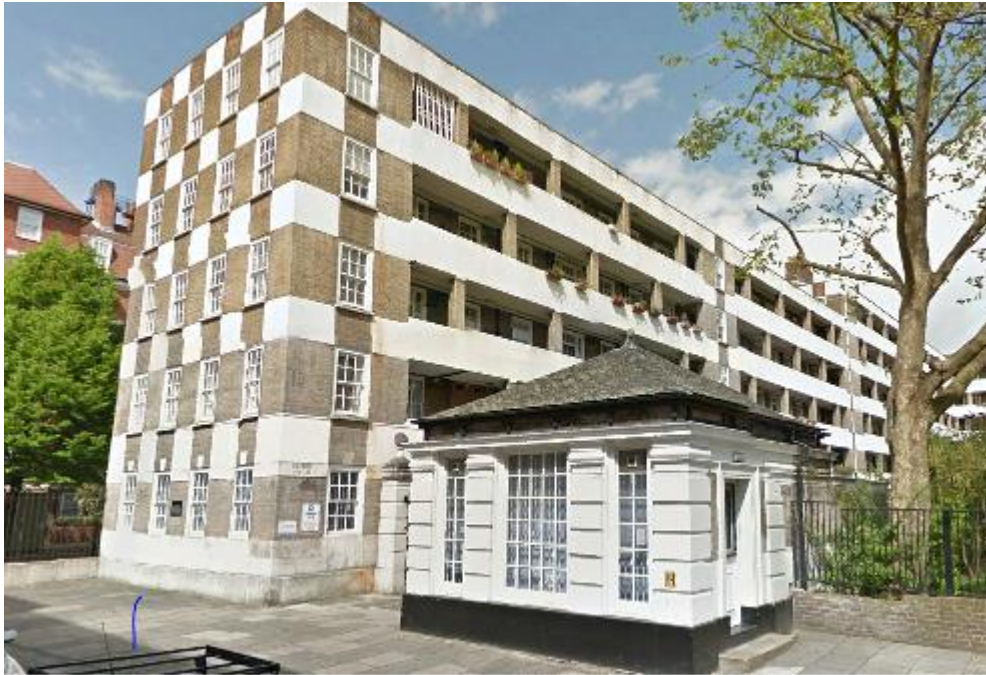
**Figure 1 External View Tothill House**

Detail	Description
Property Identifier	Tothill House, London
Property Type	Elongated Block
Material of Construction	Render and concrete
Type of Exterior Wall	Concrete
Property Age	Built in 1928
Gas Meter Location	Assumed in flats
Electricity Meter Location	Assumed in flats

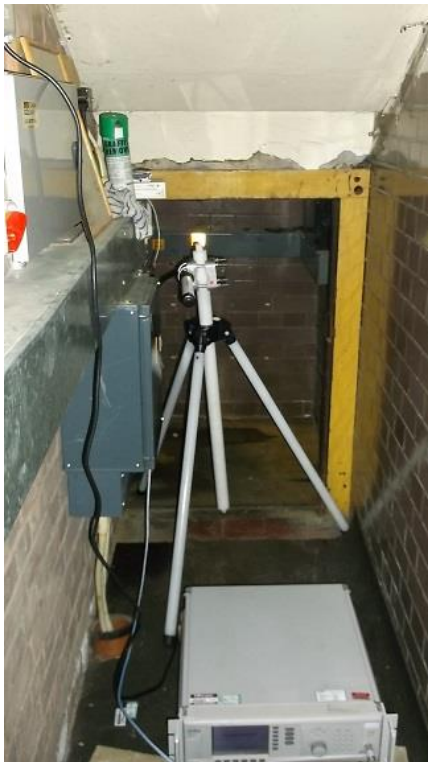
**Figure 3 Transmit Location 1**

Location	Location Name	Height
Tx1	Internal stairwell	1.5 m

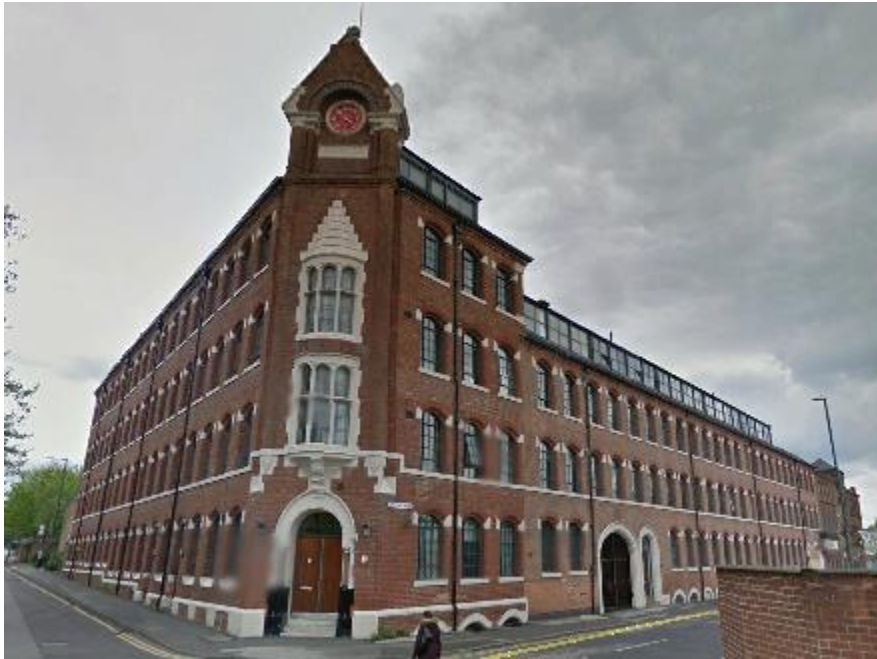
**Figure 1 Typical View William Bancroft Building**

Detail	Description
Property Identifier	William Bancroft
Property Type	Converted Building
Material of Construction	Brick and Concrete
Type of Exterior Wall	Brick
Property Age	Built in 19 <sup>th</sup> century
Gas Meter Location	Basement meter room
Electricity Meter Location	Basement meter room

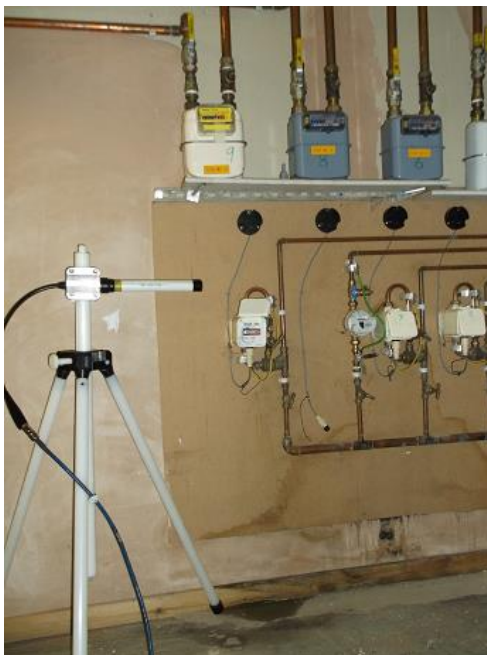
**Figure 3 Transmit Location 1 Electricity Cupboard**

Location	Location Name	Height
Tx 1	Inside basement next to gas meters	1.5 m
Tx 2	Outside next to wall	1.5 m
