## Geotechnical Design Report

M11 Junction 6 Site B

Highway Agency

CON-GE-BHAM-52200806-001

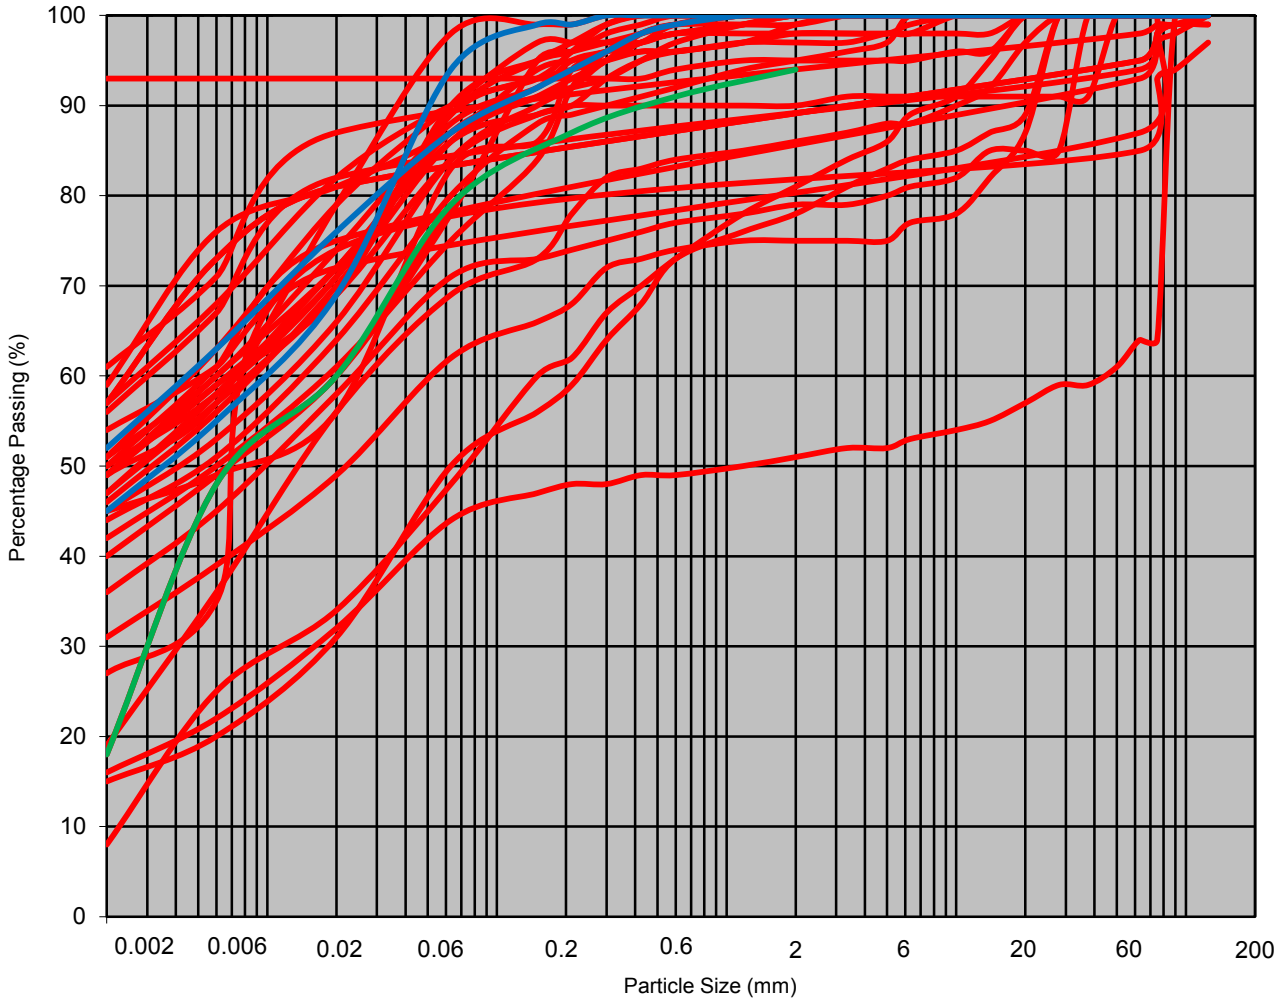
### Particle Size Distribution - All Strata

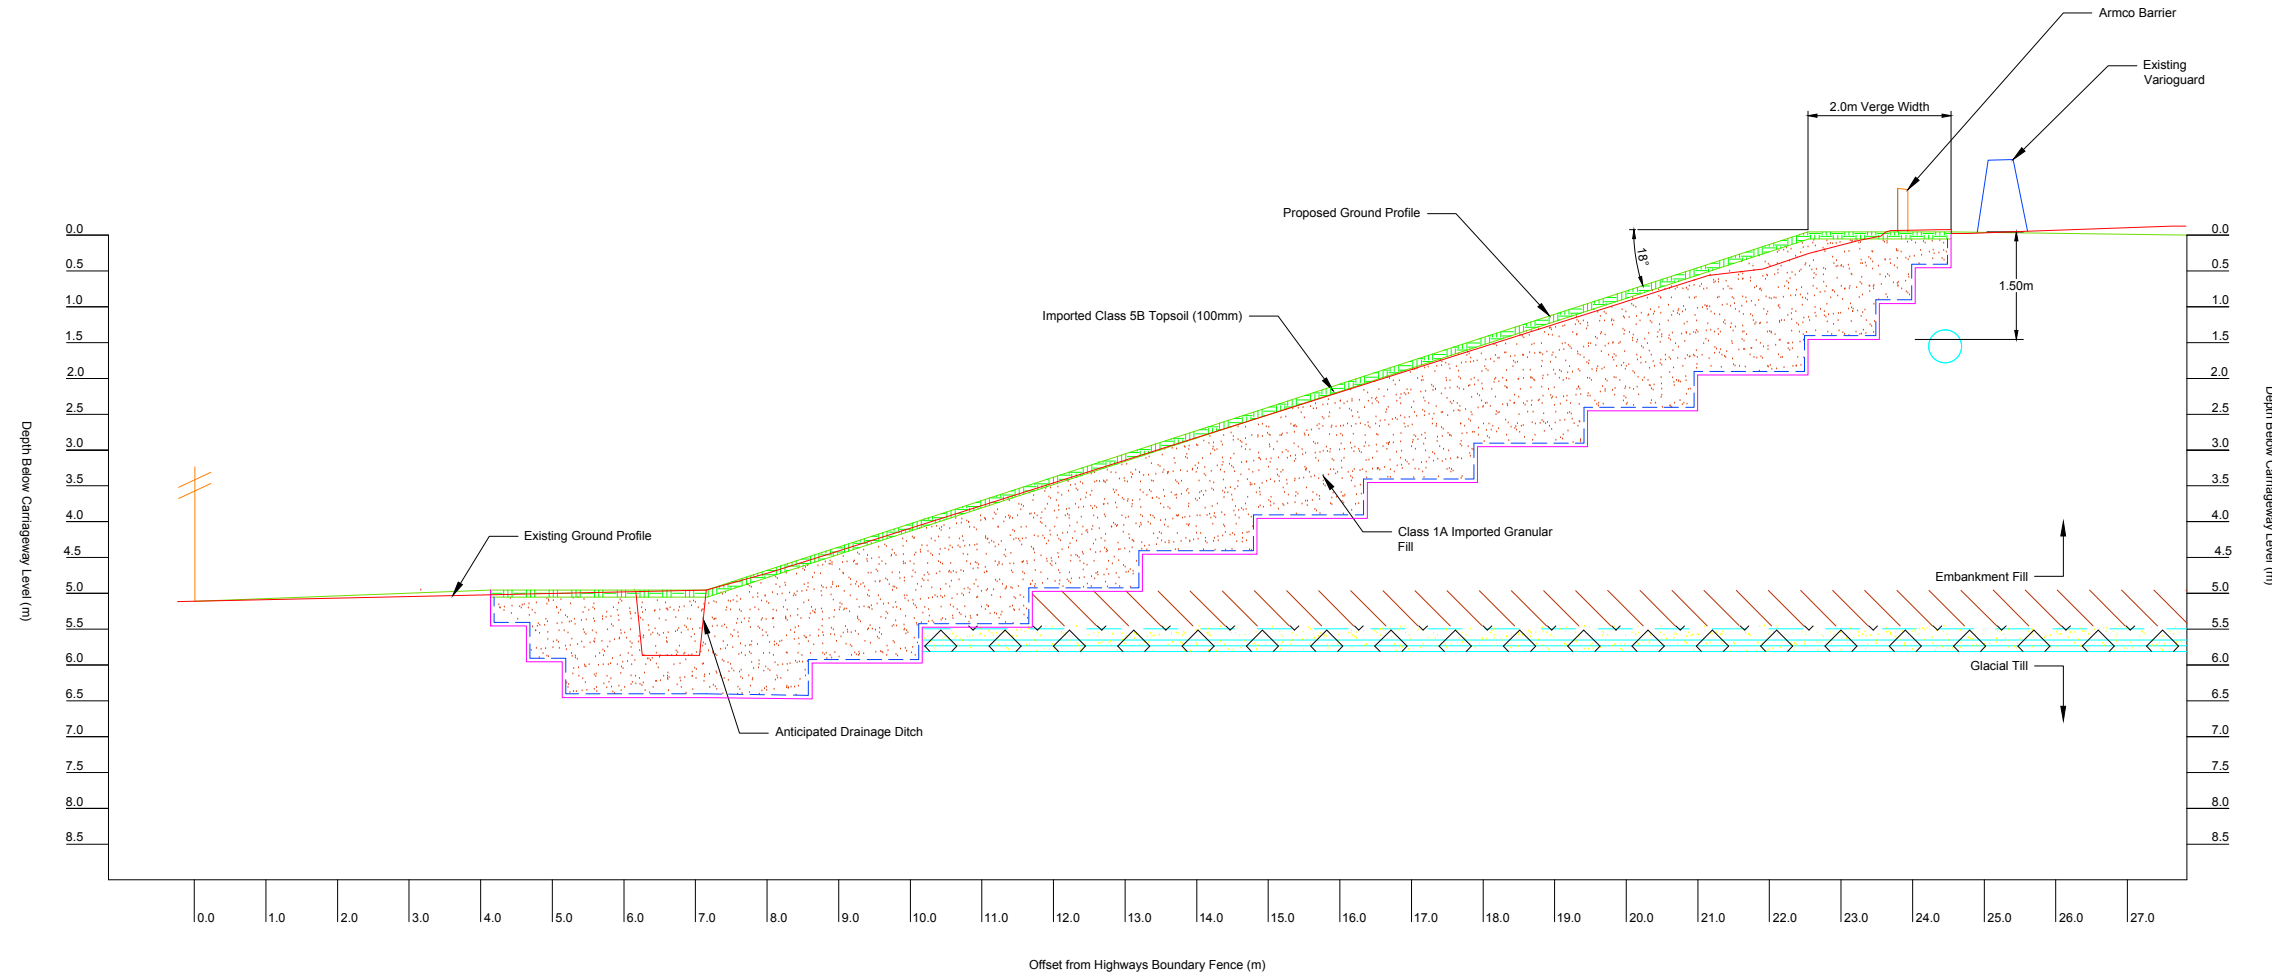
**Benching Detail**  
Scale 1:20

Drawing No. HA537529-AMEY-GE-DR-003 to 005 shows details of the proposed remedial solution. The extents of the proposed remedial works are based around the extents of the observed geotechnical defects (refer to Drawing No. HA537529-AMEY-GE-DR-001 and HA537529-AMEY-GE-DR-002). It is proposed that the entire length of earthworks that encompass these defects are treated. This is considered necessary as the defects are closely spaced and the embankment profile is seen to be consistent between observed geotechnical defects as seen in the topographic surveys.
