Appraisal of river restoration effectiveness: Shopham Loop monitoring report

Report – SC070024/d

The project used the Shopham Loop restoration scheme on the River Rother in West Sussex as a secondary case study, setting WFD relevant objectives against which to measure the effectiveness of the scheme. The objectives relate to hydromorphological and biological conditions within the river.

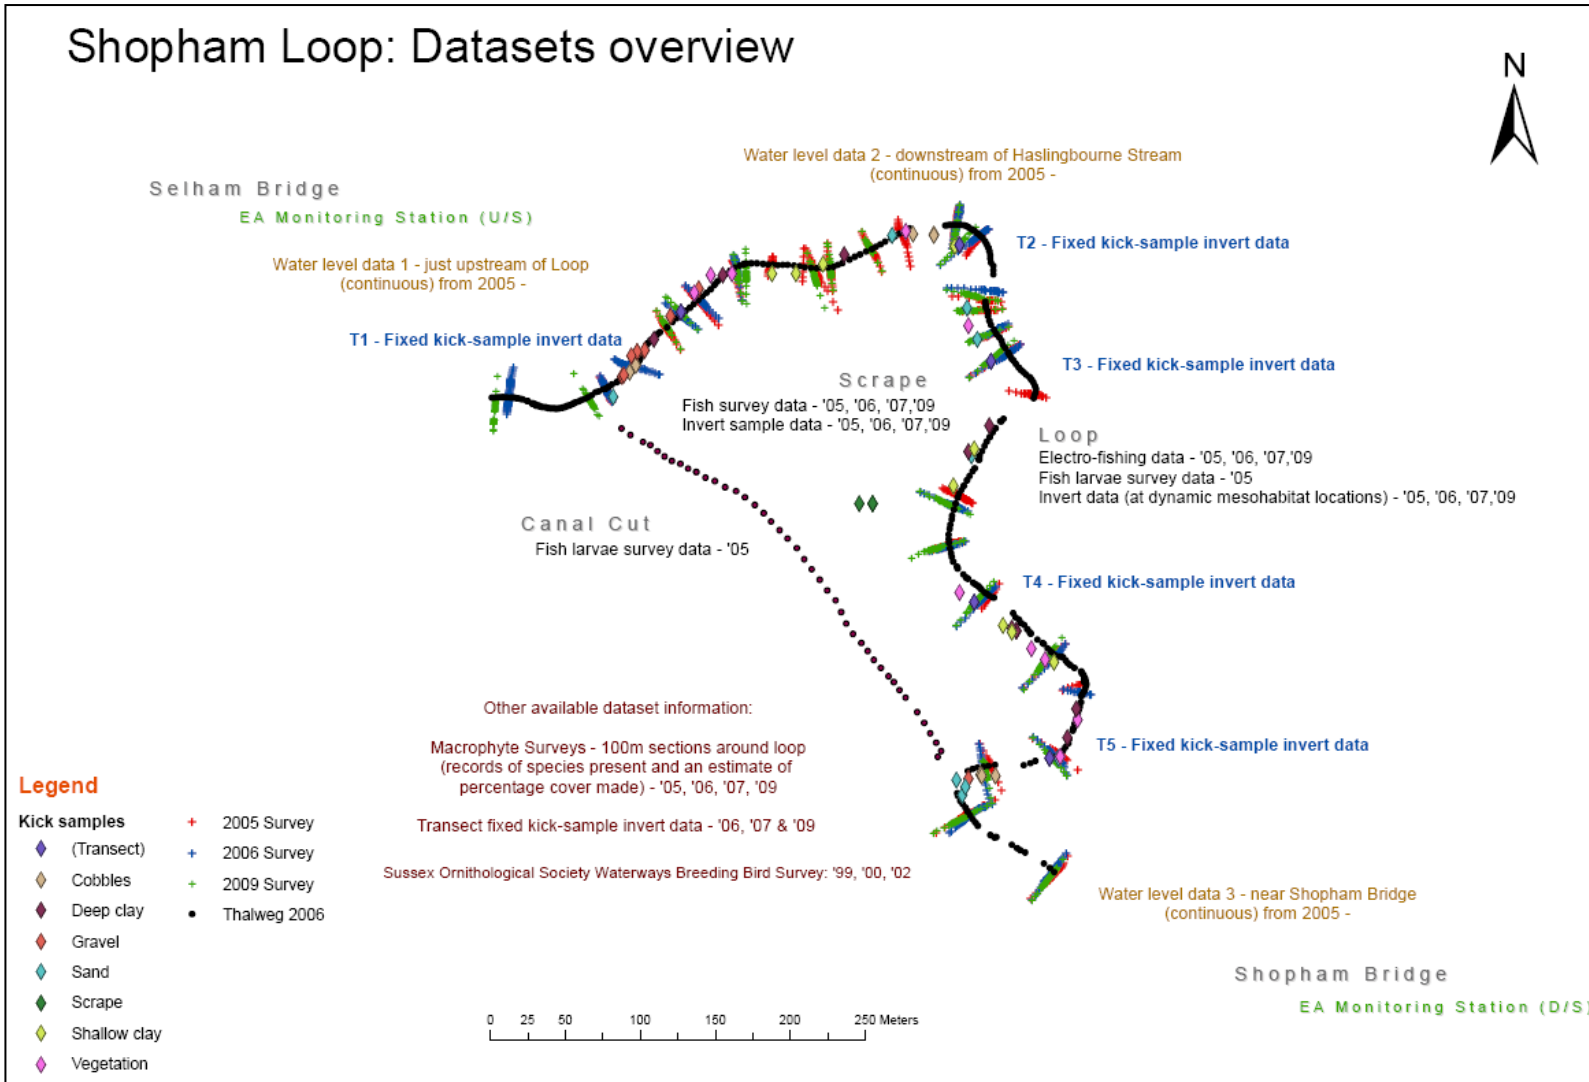
Figure 3.4 Monitoring locations at Shopham Loop

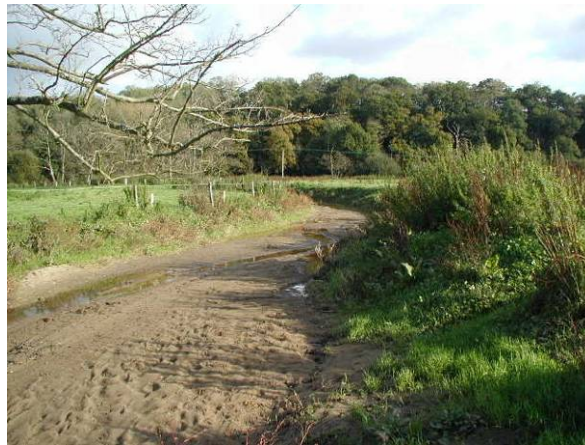
Pre-restoration, the preferential course of the River Rother was via the canal cut while Shopham Loop only conveyed flow in flood events. Over time, deposition of sand in the loop during these flood events caused the loop to become cut off. This resulted in the upstream section of the loop becoming dry for most of the year (Figure 5.1). The downstream end of the loop conveyed flow from the Haslingbourne Stream, but flows from this tributary were low and the Shopham Loop channel was over-wide and over-deep resulting in slow flows and the establishment of terrestrial vegetation in the channel.

Figure 5.1 Pre-restoration: no flow in the upstream end of Shopham Loop

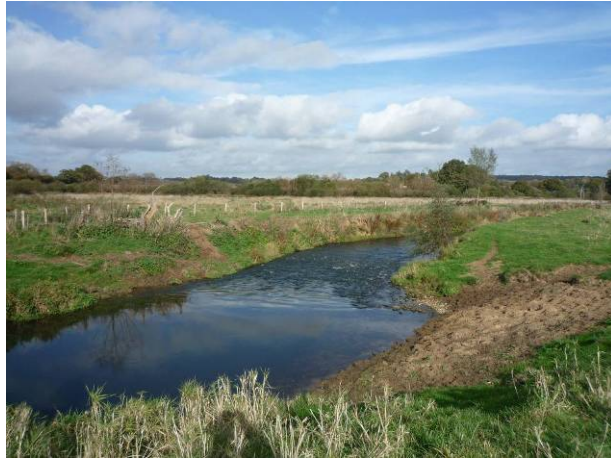
Post-restoration, physical biotope mapping performed in October 2009 showed a relatively diverse range of flow types, with varied velocities. A gravel riffle was found at the upstream end of the loop, exhibiting fast flow with unbroken standing waves (Figure 5.2). Downstream of this and as far as the Haslingbourne Stream confluence, the biotope was a run, with fast rippled flow. From this point, to the exit of the loop, flow alternated between more uniform, slow flowing glides (Figure 5.3) and faster flowing runs. At the exit of the loop, the bed control installed as part of the restoration was creating a riffle with fast shallow flow (Figure 5.4). Overall, the loop displayed a variety of flow types, with varied velocities. Large woody debris throughout the reach was further contributing to varied flow velocities by restricting flows in localised areas.

Figure 5.2 Gravel riffle at upstream end of meander loop post-restoration

The installation of the bed controls at the upstream and downstream end of the loop created gravel riffles displaying fast, shallow flow – conditions not present in the loop pre-restoration.

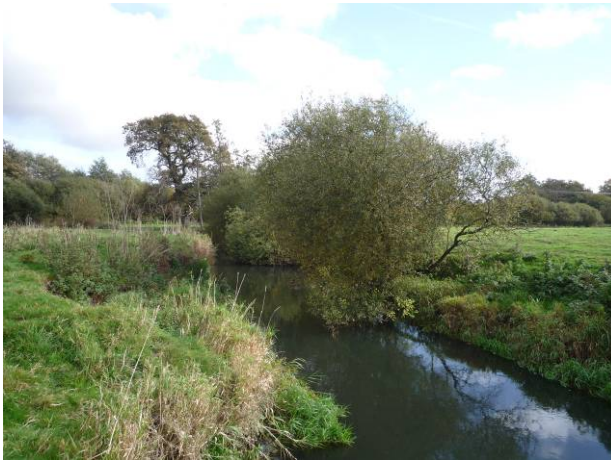
Figure 5.3 Glide section of Shopham Loop post-restoration

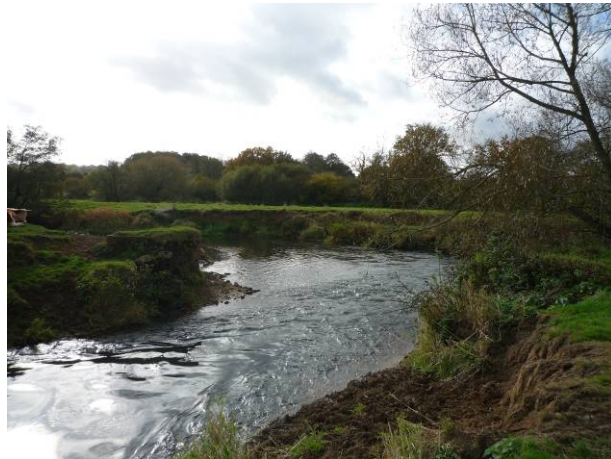
Figure 5.4 Riffle at downstream end of Shopham Loop post-restoration

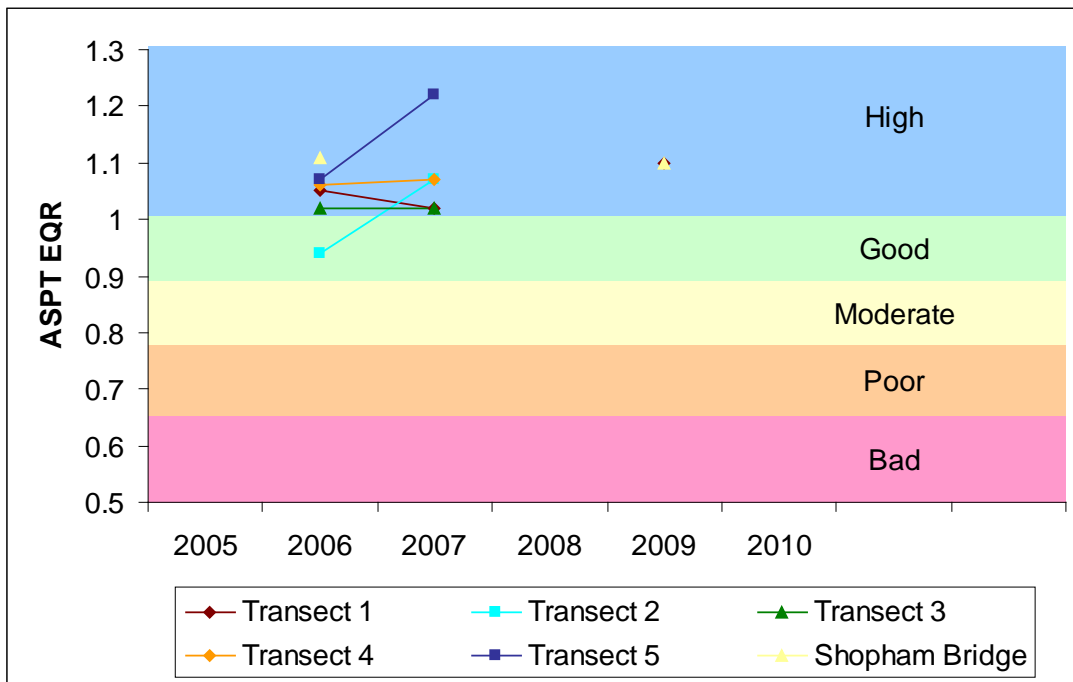
Analysis of RICT outputs can help explain what is driving the macroinvertebrate community composition. Based on ASPT score alone, the loop transects score either 'good' or 'high' (Figure 5.6). Based on NTAXA, only some areas of the loop attained 'good' or 'high' status (Figure 5.7). This suggests that water quality is not the deciding factor for macroinvertebrate community composition because the ASPT EQR is steady at either good or high. The variation in the number of taxa could be due to habitat or sampler effort, which could change with water depth. Very deep water can affect the sampling and could, in theory, reduce the number of taxa found without compromising the ASPT value. Another likely explanation is, if the habitat is shifting and changing, this would inhibit the number of taxa found without significantly compromising the ASPT as long as there was some acceptable quality habitat within the transect area. This variability suggests that the loop was still adjusting in 2007. Transect 1 performs favourably because it is located in the cobble area at the upstream end of the loop.

Figure 5.6 ASPT EQR derived from RICT for Shopham Loop transects and Shopham Bridge

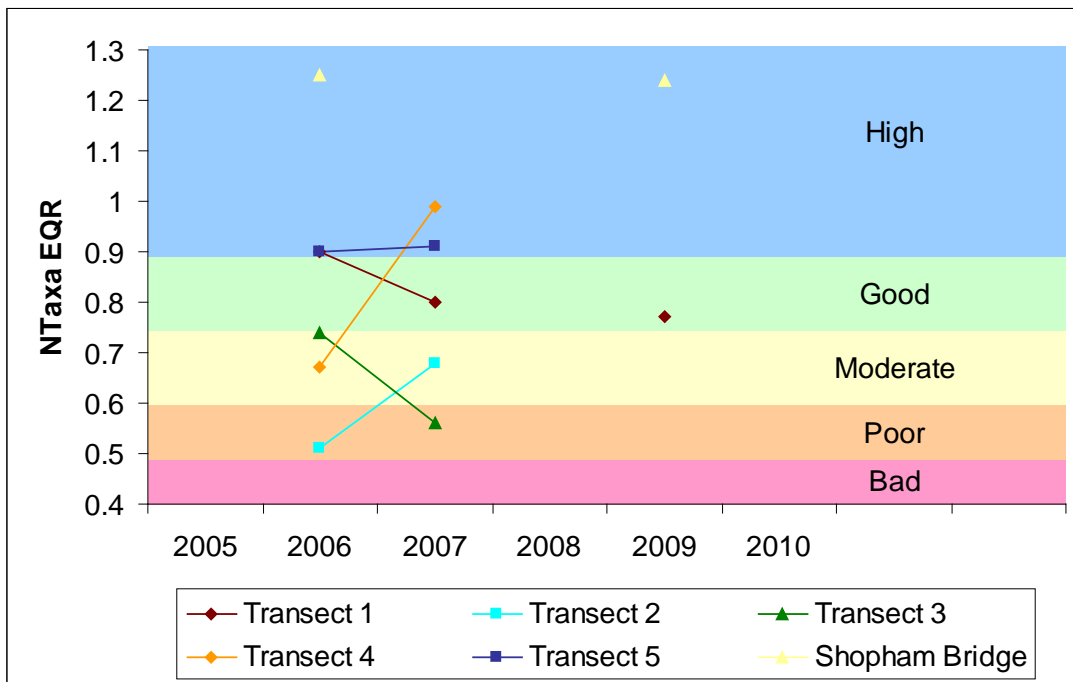
Figure 5.7 NTAXA EQR derived from RICT for Shopham Loop transects and Shopham Bridge
