## Title description: Slips, trips and falls on the same level

**Slips, trips and falls on the same level** resulted in 3 injuries Reportable to the HSE under RIDDOR between August and October 2014, one at the M62/J18-19 Air Quality Barrier scheme (in Greater Manchester) and 2 on the M1/J39-42 Smart Motorway scheme (in West Yorkshire)

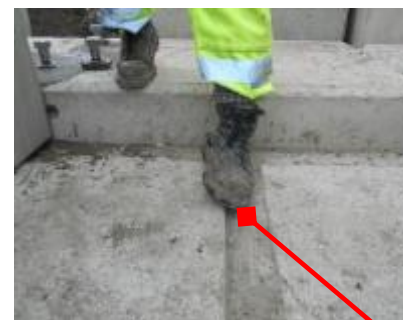
Photo 1 – Reportable O7D injury

A Site Supervisor (IP) sustained ligament damage to his Left Ankle

- Whilst walking along a line of PCC base units (see photo 1, right), IP tripped after stepping on a shallow recess (20mm deep) in the concrete surface, which caused him to stumble and fall, turning his Left Ankle over in the process
- The resultant injury prevented him from carrying out his normal duties for a period of 12 calendar days, making his injury Reportable to the HSE

IP turned his ankle after stepping on floor surface across 20mm raised concrete edge

**Safe access and egress** – Effective planning and preparation of work areas to ensure safe routes are produced and then used

**Hazard identification** - Walking of routes to identify and then remove or control hazards prior to commencement of tasks (at least daily)

**Housekeeping** – Good order to be maintained at all times, with work areas left safe and tidy at the end of each shift / completion of tasks

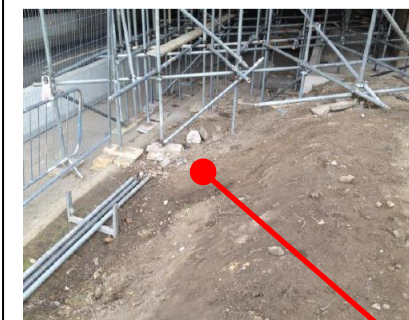
Photo 2 – Reportable Major injury

A Scaffolder (IP) sustained a Fracture to a Bone in his Right Wrist

- IP was standing at the bottom of a short slope and facing away from the structure when he picked up a scaffold tube from a pallet (see photo 2, right)
- As he turned through 90 Deg to face the structure, he slipped on the dusty ground surface, which caused him to stumble and fall to his knees
- As he put out his Right Hand and Arm to arrest his fall, IP struck a component on the completed scaffold located to his immediate right, sustaining injury to his Right Wrist in the process
- Post injury: The ground surface was recorded as dusty following a period of dry weather

IP slipped on dusty ground surface at location shown, hitting his hand on scaffolding as he stumbled and fell

**Monitor and review** – During and after periods of dry or inclement weather, following changes to personnel, task and/or safe system of work, and to control interfaces with other operations/teams
