REnescience Northwich

Appendix F: Application Site

Condition Report

Document reference and dates for Site Condition Report at permit application and surrender	JAS8407_ASCR_rev1_20151127
--	----------------------------

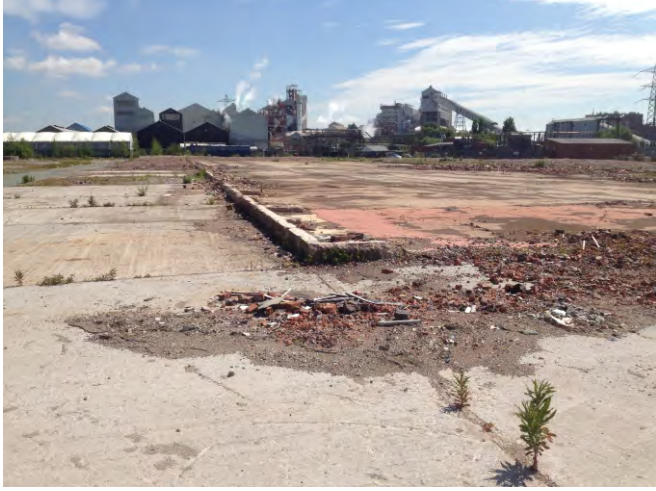
Area of former works

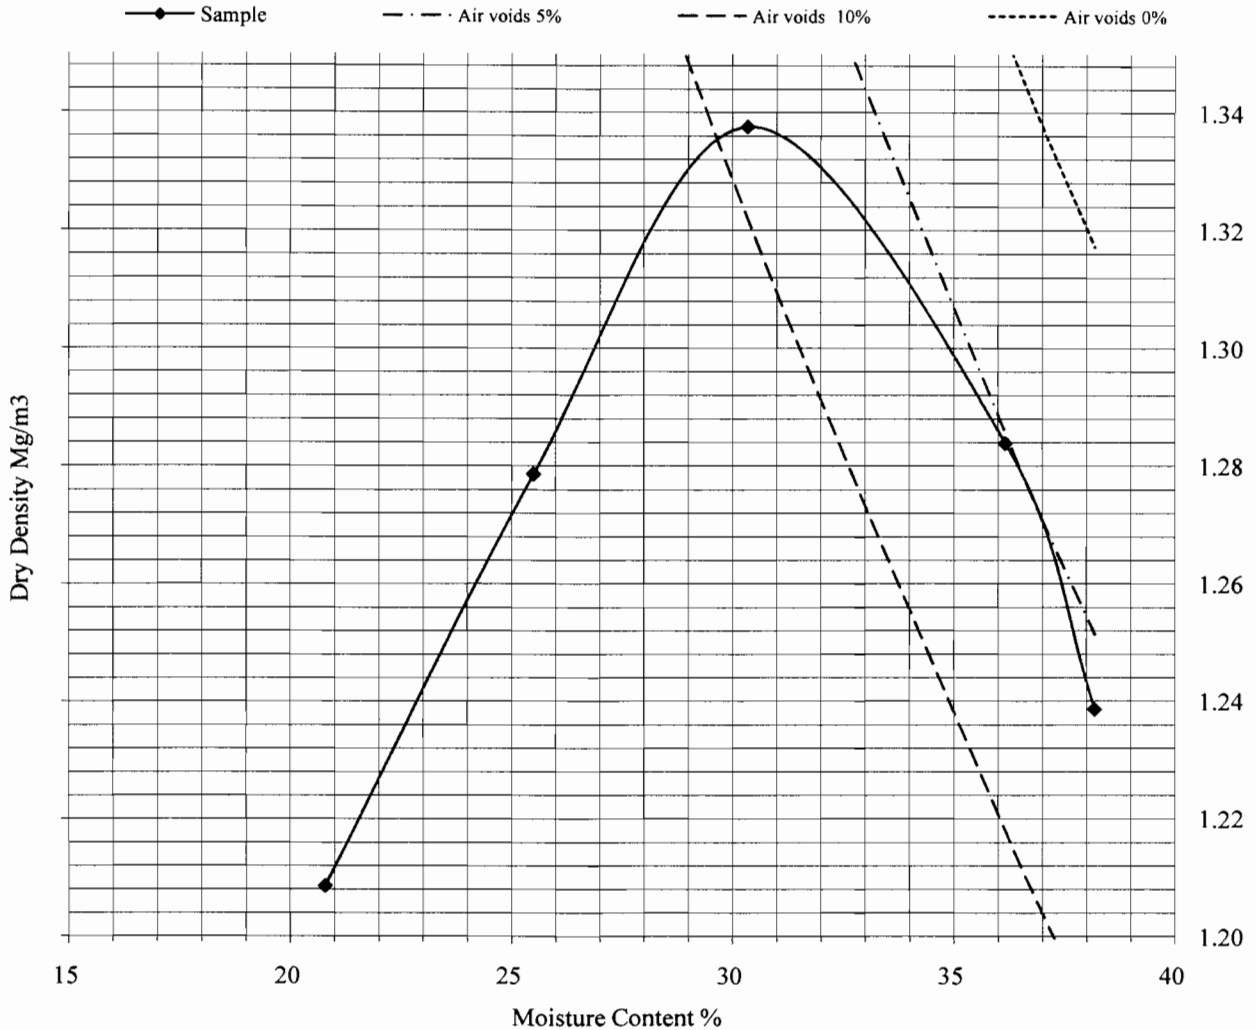
Hole Number: **BH1** Sample Number: **B2** Depth (m): **0.50-1.00**

Initial Moisture Content:	36	Method of Compaction	2.5Kg Rammer / Single Sample
Particle Density (Mg/m ³):	2.65* Assumed	Material Retained on 37.5 mm Test Sieve (%):	0
Maximum Dry Density (mg/m ³):	1.34	Material Retained on 20.0 mm Test Sieve (%):	10
Optimum Moisture Content (%):	30	Sample Preparation Clause :	3.2.4.2

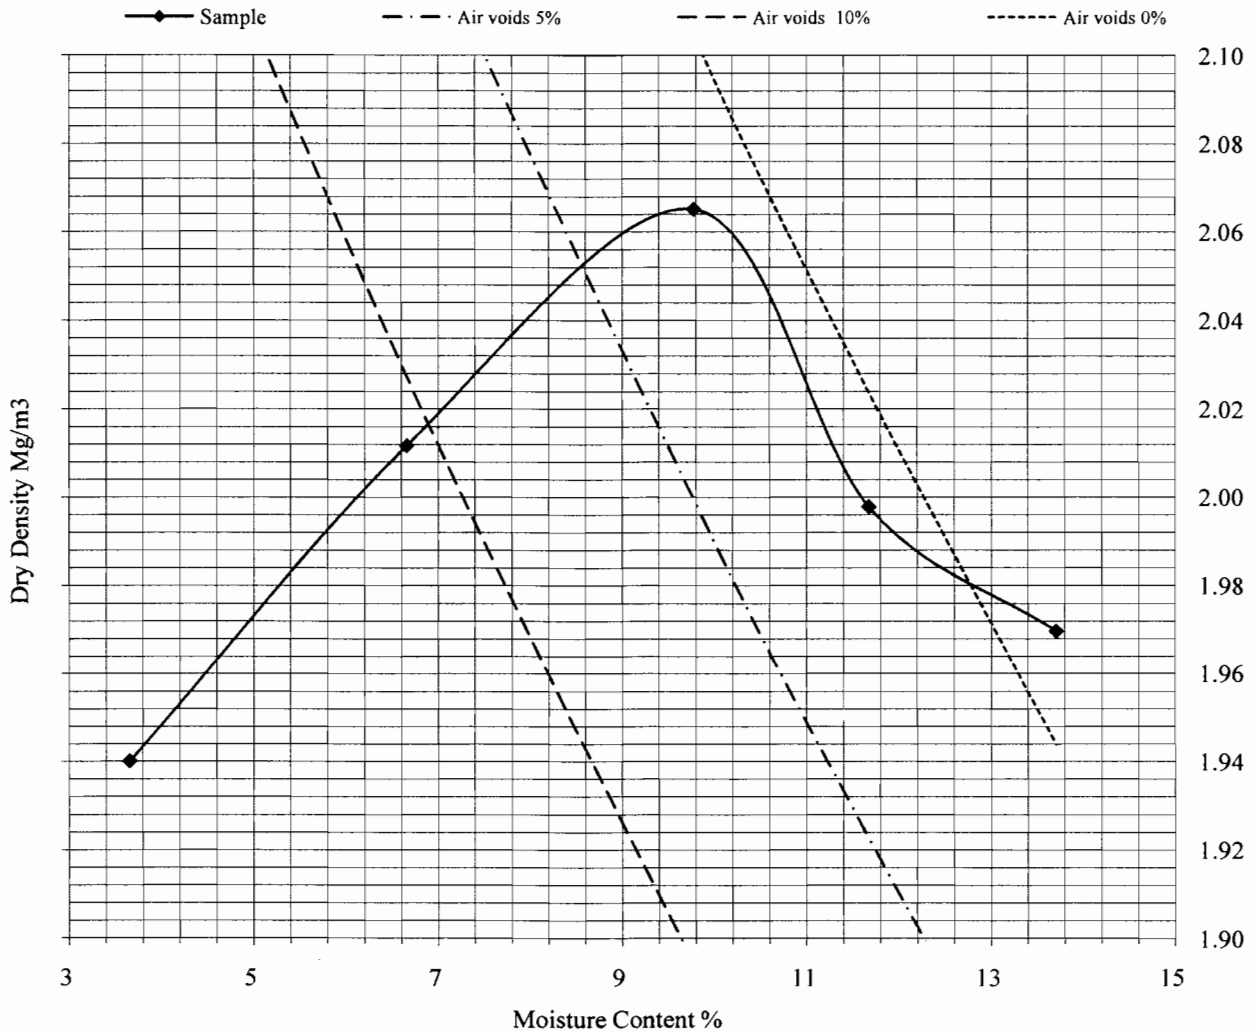
Hole Number: **BH5** Sample Number: **B1-+B2** Depth (m): **0.50-1.00**

Initial Moisture Content:	14	Method of Compaction	2.5Kg Rammer / Single Sample
Particle Density (Mg/m ³):	2.65* Assumed	Material Retained on 37.5 mm Test Sieve (%):	0
Maximum Dry Density (mg/m ³):	2.07	Material Retained on 20.0 mm Test Sieve (%):	8
Optimum Moisture Content (%):	10	Sample Preparation Clause :	3.2.4.2

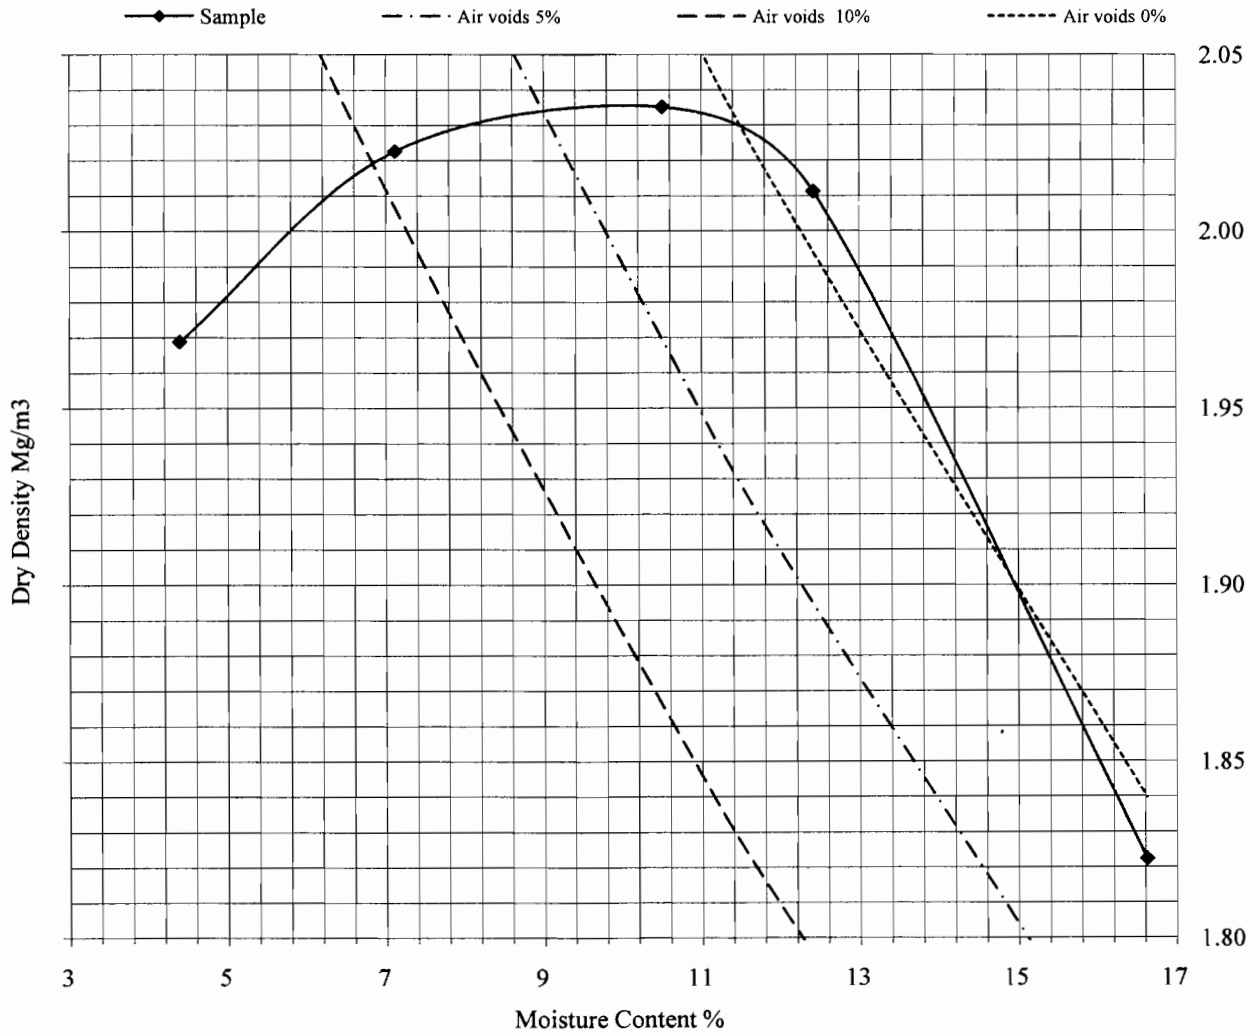
Hole Number: **BH7** Sample Number: **B1** Depth (m): **0.70-1.20**

Initial Moisture Content:	12	Method of Compaction	2.5Kg Rammer / Single Sample
Particle Density (Mg/m ³):	2.65* Assumed	Material Retained on 37.5 mm Test Sieve (%):	74
Maximum Dry Density (mg/m ³):	2.04	Material Retained on 20.0 mm Test Sieve (%):	84
Optimum Moisture Content (%):	11	Sample Preparation Clause :	Non-Standard

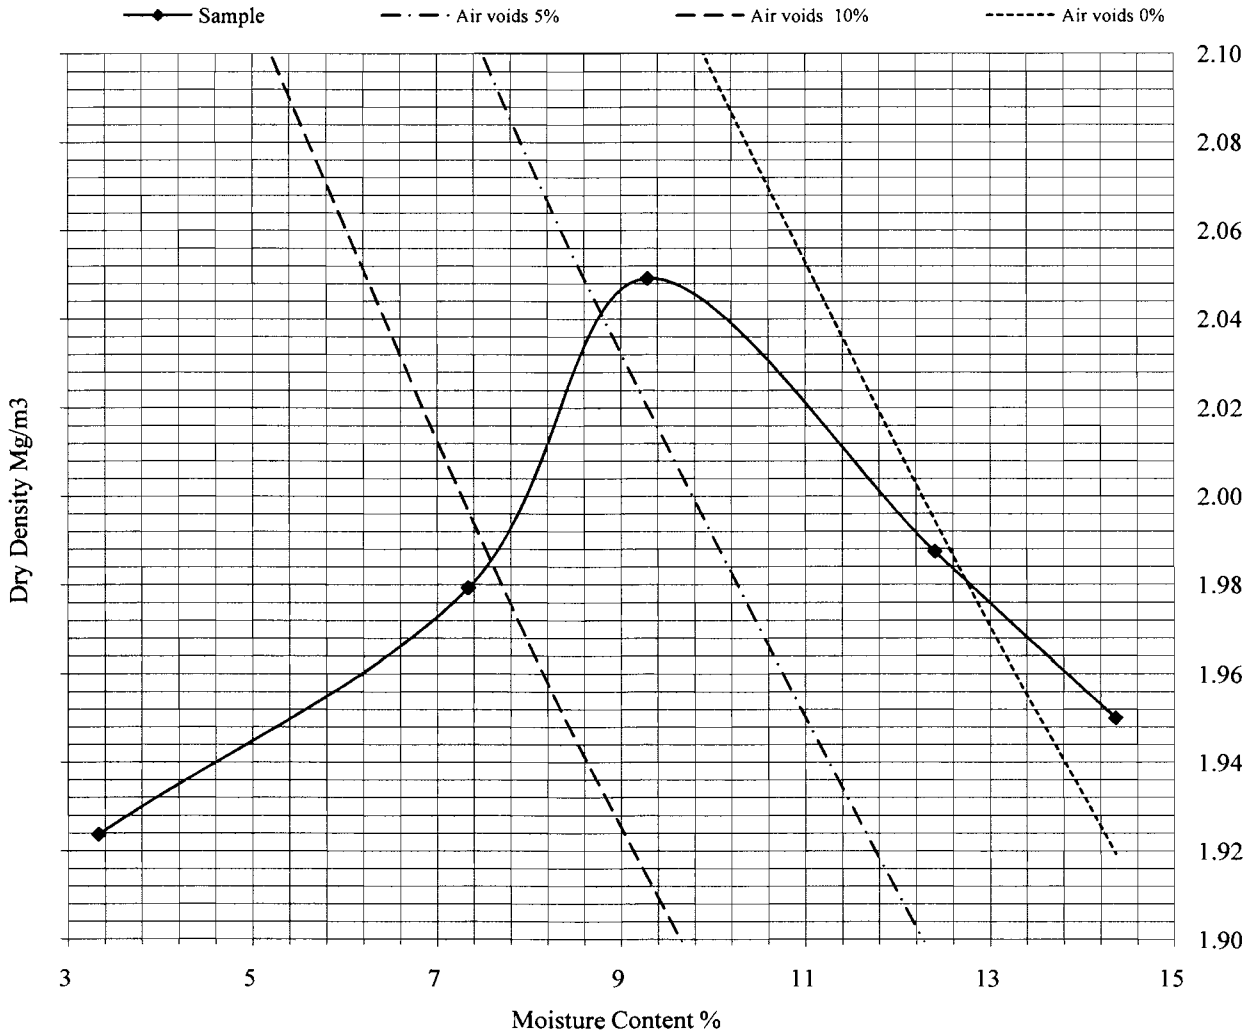
Hole Number: **BH8** Sample Number: **B2** Depth (m): **0.50**

Initial Moisture Content:	14	Method of Compaction	2.5Kg Rammer / Single Sample
Particle Density (Mg/m ³):	2.65* Assumed	Material Retained on 37.5 mm Test Sieve (%):	0
Maximum Dry Density (mg/m ³):	2.05	Material Retained on 20.0 mm Test Sieve (%):	14
Optimum Moisture Content (%):	9.3	Sample Preparation Clause :	3.2.4.2

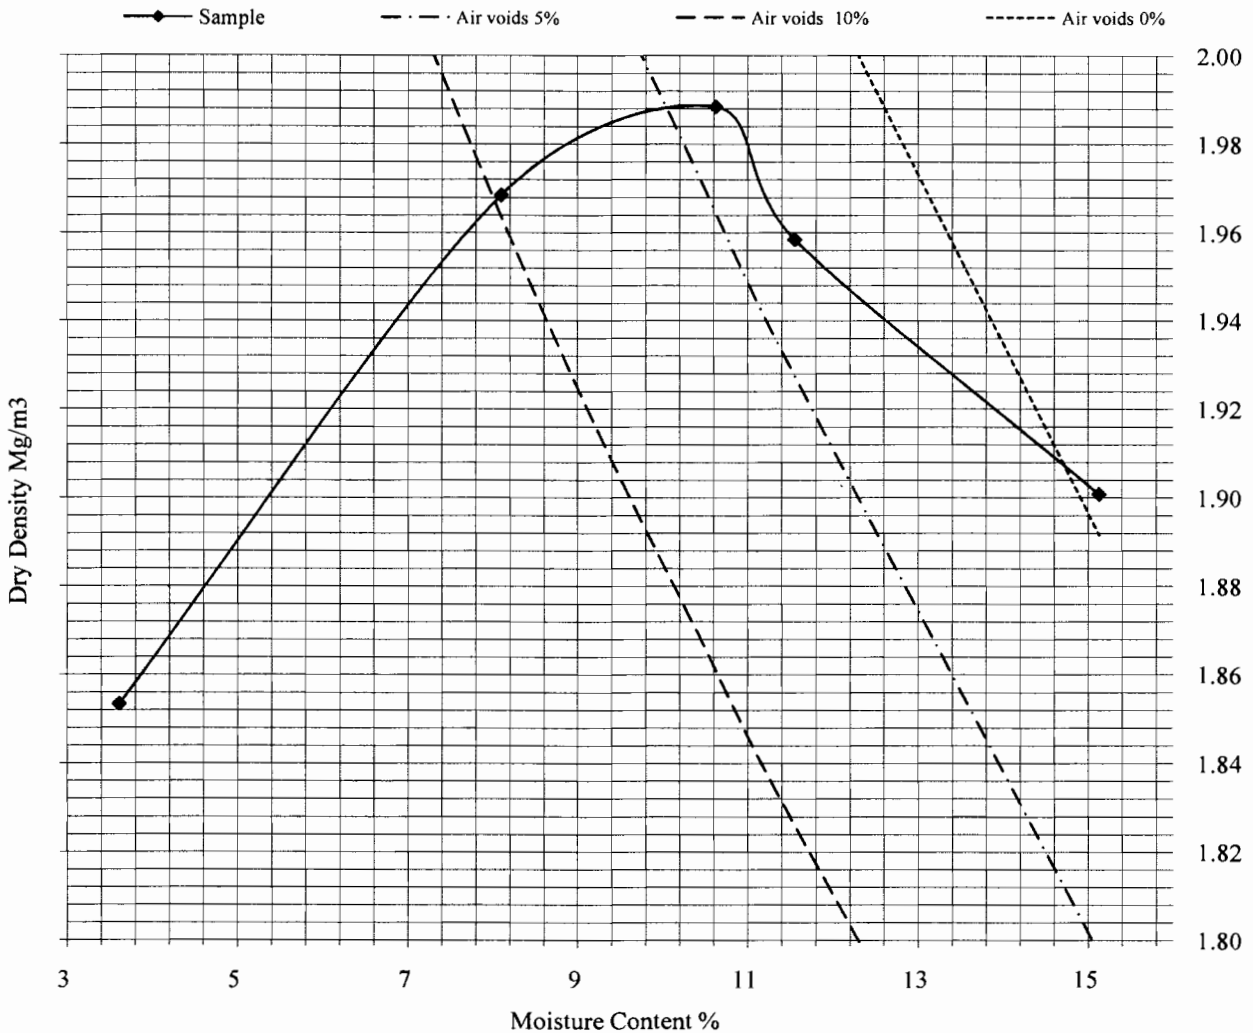
Hole Number: **BH10** Sample Number: **B2** Depth (m): **1.20-1.70**

Initial Moisture Content:	15	Method of Compaction	2.5Kg Rammer / Single Sample
Particle Density (Mg/m ³):	2.65* Assumed	Material Retained on 37.5 mm Test Sieve (%):	0
Maximum Dry Density (mg/m ³):	1.99	Material Retained on 20.0 mm Test Sieve (%):	0
Optimum Moisture Content (%):	11	Sample Preparation Clause :	3.2.4.1

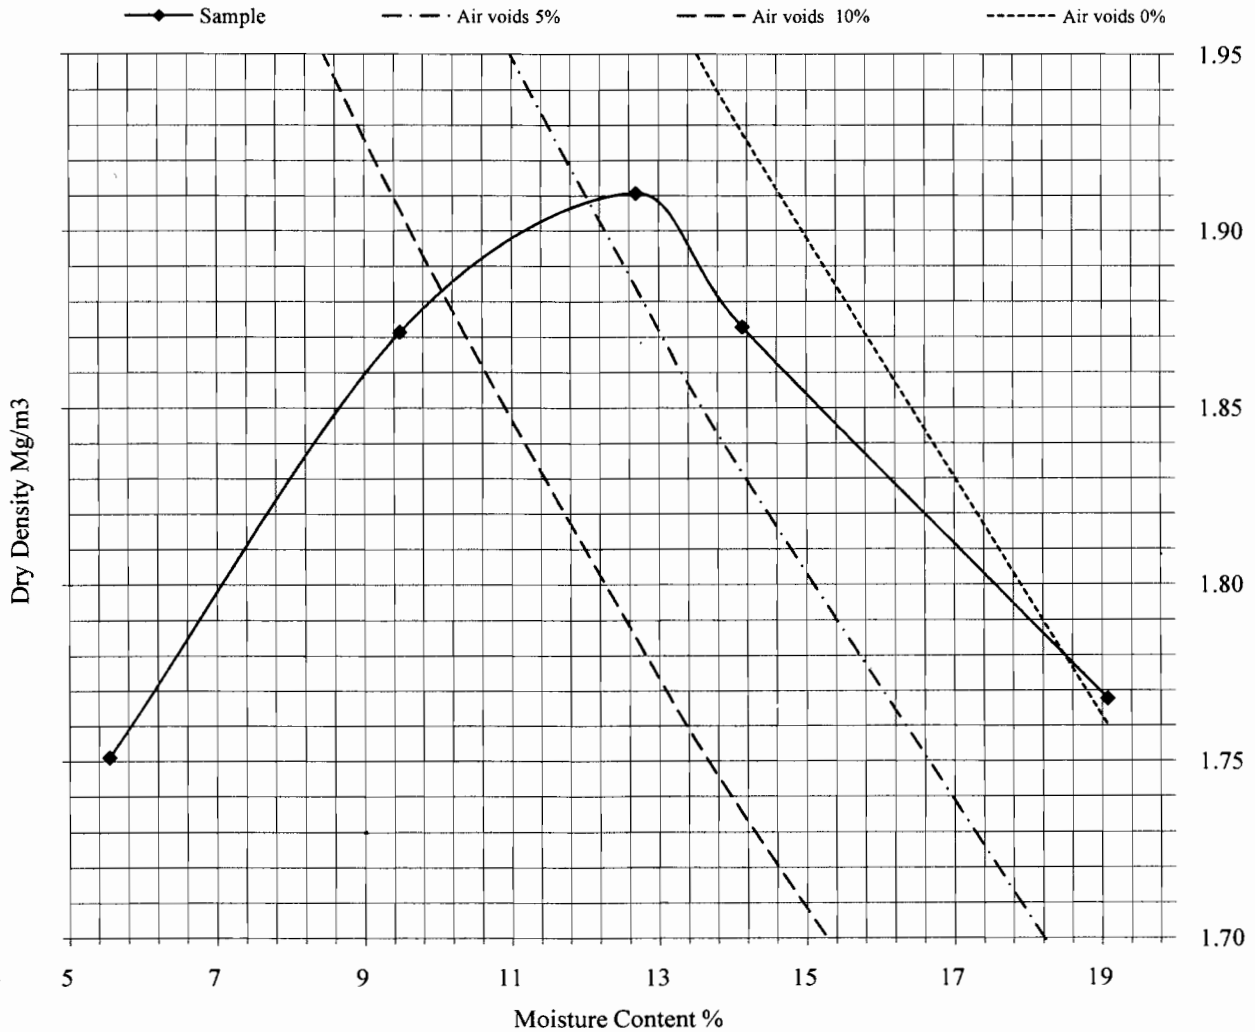
Hole Number: **BH14** Sample Number: **B1** Depth (m): **0.80-1.20**

Initial Moisture Content:	19	Method of Compaction	2.5Kg Rammer / Single Sample
Particle Density (Mg/m ³):	2.65* Assumed	Material Retained on 37.5 mm Test Sieve (%):	47
Maximum Dry Density (mg/m ³):	1.91	Material Retained on 20.0 mm Test Sieve (%):	57
Optimum Moisture Content (%):	13	Sample Preparation Clause :	Non-Standard

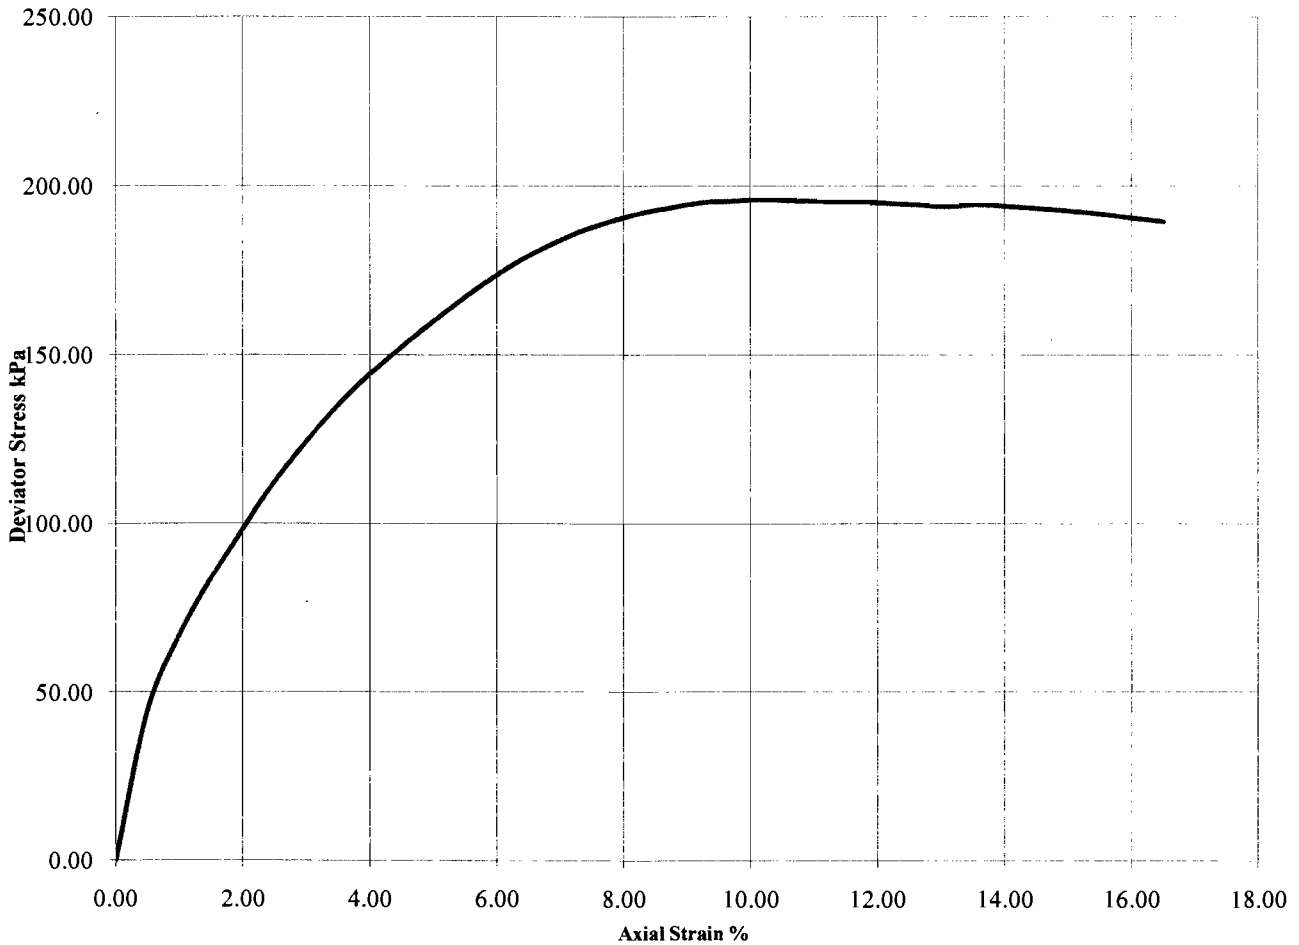
Depth (m): **2.00-2.45**

Diameter (mm):		102		Height (mm):		206		Test:		100mm Multistage	
Specimen	Moisture Content (%)	Bulk Density (Mg/m ³)	Dry Density (Mg/m ³)	Cell Pressure (kPa)	Deviator Stress (kPa)	Cohesion (kPa)	Failure Strain (%)	Mode of Failure	Remarks		
A	35	2.04	1.51	22	196	98	9.7	compound			
				44	196	98	10.2				
				88	195	97	13.6
