Near miss at Surbiton, south-west London, 2 November 2016

2. Summary of the incident

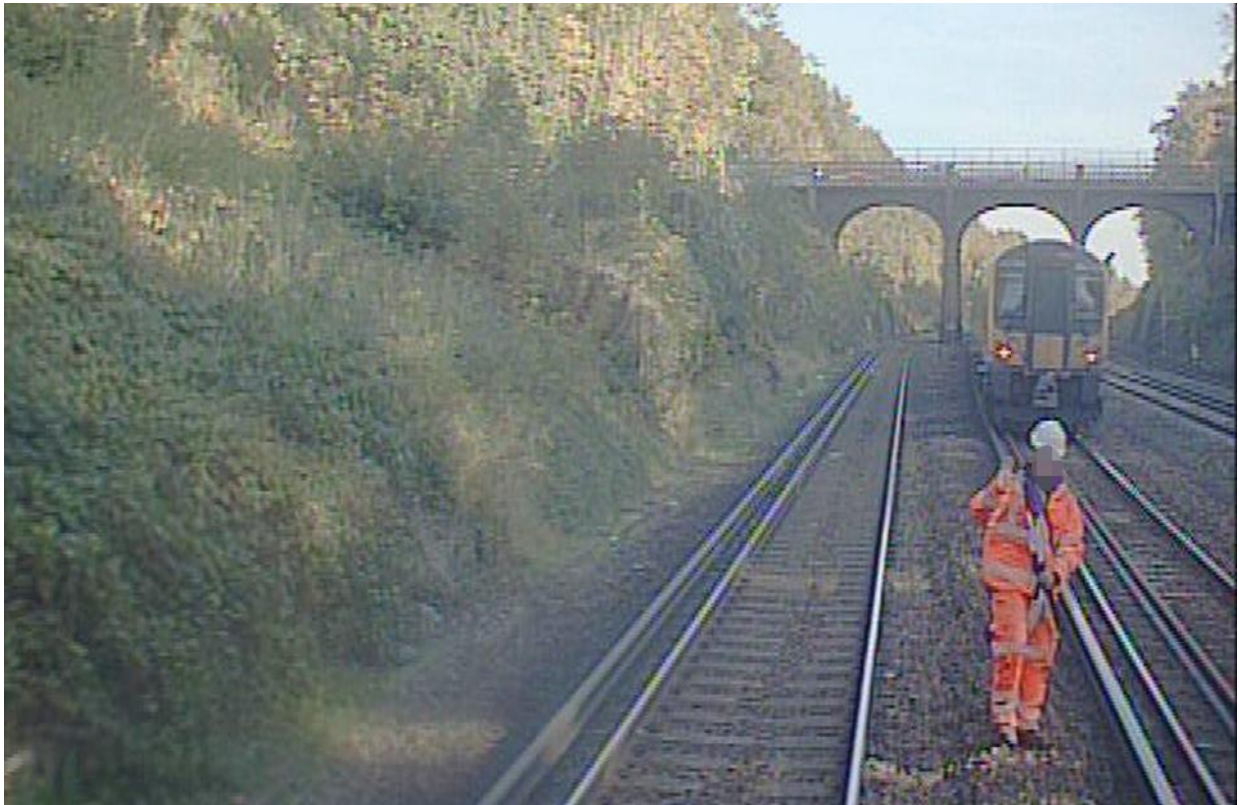
Still image from forward facing CCTV image from the second train, looking away from Surbiton, showing the rear of the first train (courtesy South West Trains)

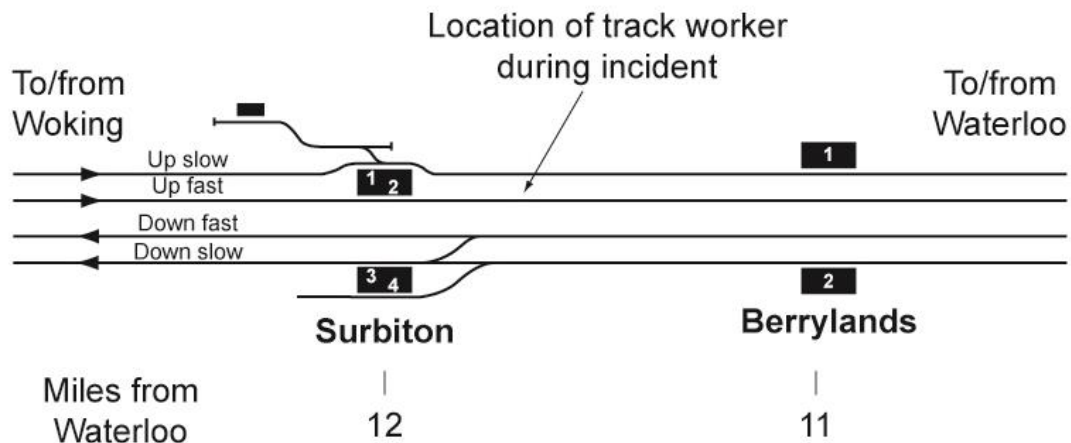
Schematic diagram of track layout

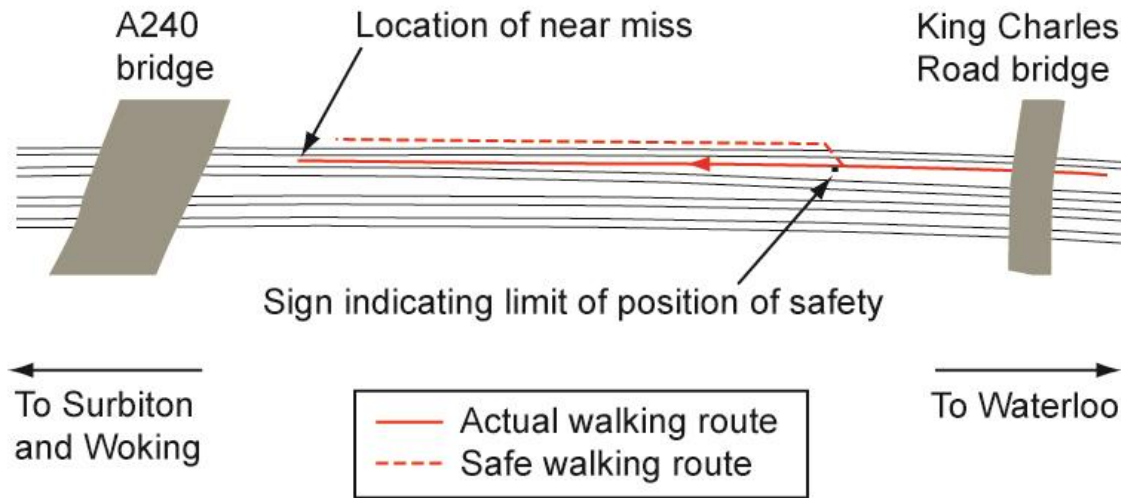
Where the railway passes underneath the King Charles Road bridge, the six foot is described as a ‘wideway’ because it is wide enough to provide a position of safety. The wideway narrows to a conventional six foot before the bridge carrying the A240 road over the railway.

Track layout showing the route taken by the track worker (the up slow line is at the top)

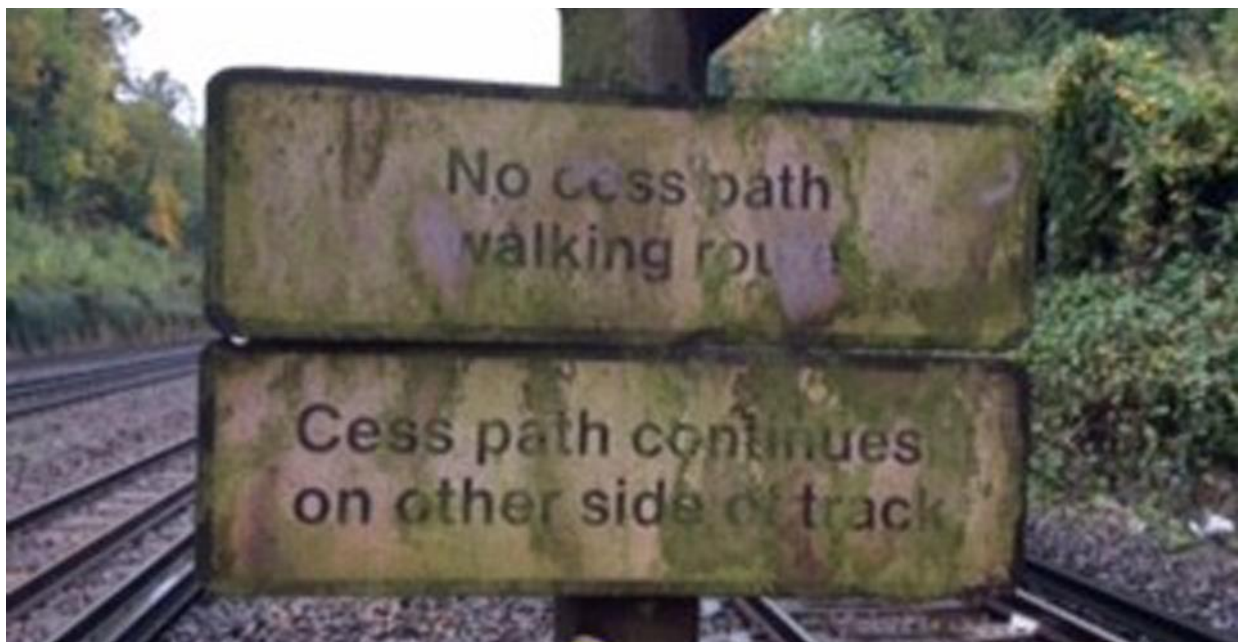
The COSS expected that when the track worker reached the limit of the position of safety, due to narrowing of the midway, he would cross the up slow line and continue to walk along the up cess (the space alongside the up slow line). Although there is a sign denoting the limit of the position of safety in the midway, the COSS had not told the track worker that he would have to cross over to the cess. When the track worker reached the sign, which was in poor condition and referred to a 'cess path' despite being situated in the midway, he continued walking along the six foot towards Surbiton. The track worker was therefore not in a position of safety when he saw a train approaching him on the up fast line. After signalling the approach of the train to the site lookout, he then became aware that a train was also approaching him on the up slow line.

Photograph taken after the incident, showing the sign indicating the limit of the position of safety in the midway (courtesy Network Rail)

The incident resulted from a combination of the track worker's unfamiliarity with the area and an apparent lack of awareness of the risk he was taking. The incomplete briefing from the COSS, which did not adequately explain that the position of safety would move from the midway to the cess after passing under the King Charles Road bridge, was also a factor.
