### Incident description:

An incident occurred recently within a CPS depot - an operative was unloading a vehicle and the safety hand railing gave way. Fortunately there was no injury.

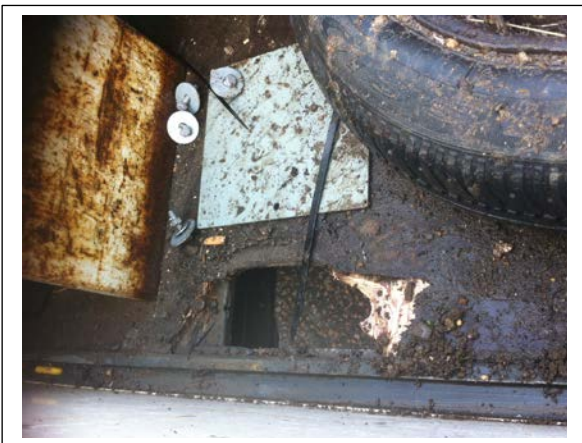
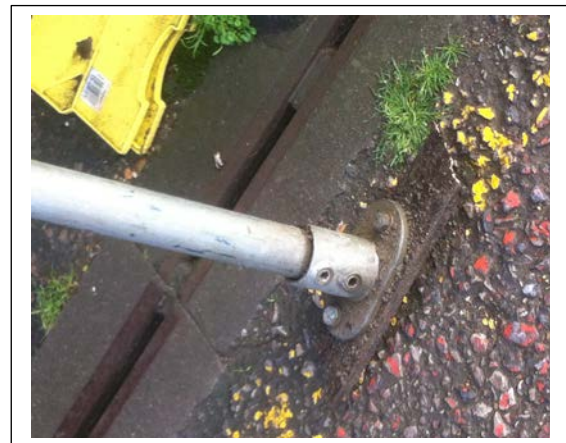
Possible cause: The handrail was connected to the wooden floor of the vehicle and this has degraded over time.

During vehicle checks over the next few months please pay additional attention to other safety features not listed on the daily check sheet –

- Hand rail systems
- Any associated fittings
- Under slung and bed toolboxes
- Doors and roller shutters
- Hinges on tail gates etc
- Condition of bed (trip hazards)
- Any other equipment associated with the vehicle or its operation
