SERVICE INQUIRY INTO THE DEATH OF A CIVILIAN CLIMBER DURING RESCUE 137 ON 25 FEB 13

2 GP CONVENING ORDER FOR A SERVICE INQUIRY CONVENED TO INVESTIGATE THE DEATH OF AN INJURED CIVILIAN CLIMBER ON 25 FEB 13, DURING RESCUE 137 BY 202 SQN ON THE BEN NEVIS MOUNTAIN RANGE, SCOTLAND.

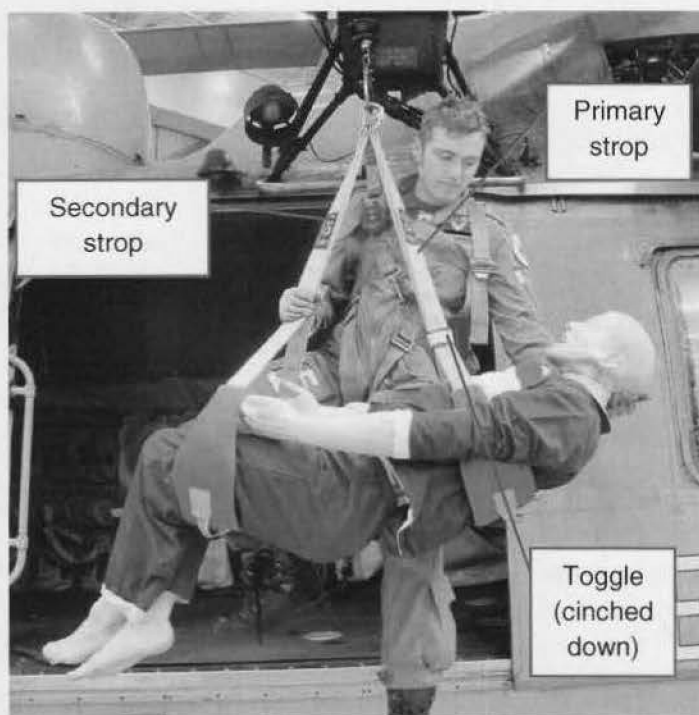
Figure 2 – Dummy in double lift with 2 strops

²² The method for a double lift with 2 strops is defined in the SARF SOPs Sea King Mk3 & Mk3A Edition 2 Chapter 7 (Exhibit 13). It is designed to enable a casualty to be lifted in a horizontal position. A primary strop is placed over the casualty's head and shoulders and positioned so that it rests under his armpits. A toggle on the strop is then cinched down to secure the strop on the casualty. A secondary strop is threaded around the casualty's legs under his knees. The strops are webbing straps, the ends of which terminate in metal D-rings. These D-rings can be connected either directly to the winch hook or, to make clipping and unclipping quicker and easier, via a SPOAK. The strop-ends are normally held together by the toggle. In order to allow the secondary strop to be threaded around the casualty's legs, however, it is normally 'broken'; that is, one end of the strop is unthreaded from the toggle. In preparation for a double lift with 2 strops, therefore, the primary strop is not broken and connected to the winch hook with the SPOAK; the secondary strop is broken and usually connected to the winch hook with the same SPOAK.

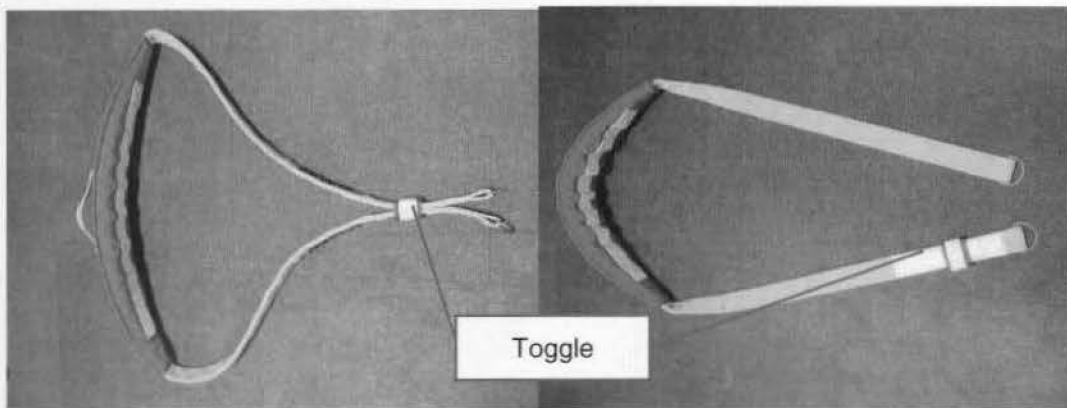
Figure 4 – Primary and Secondary strops, normal (left) and 'broken' (right)

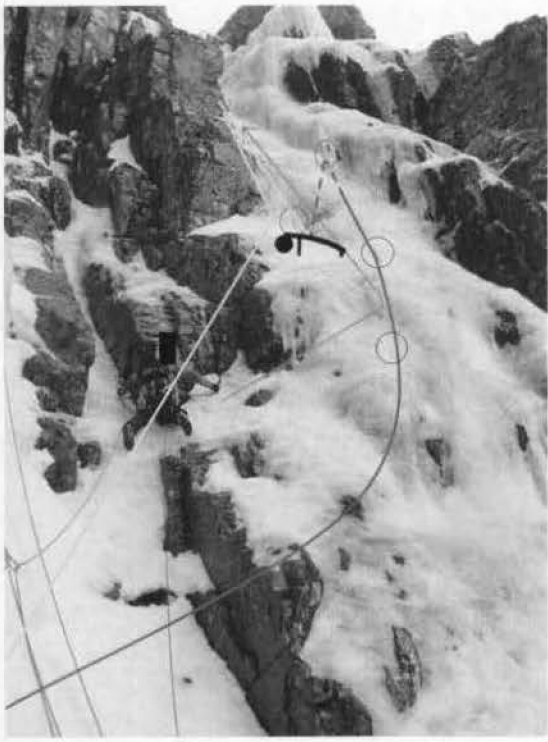
Figure 16 – Most likely rope system on arrival of Winchman

31. **Full blue rope system reconstruction.** Noting that the formation of a loop around the Casualty was very unlikely, the Panel were unable to fully reconcile the Winchman's recollection of the rope situation at the Casualty with the available photographic and physical evidence. The Panel therefore considered how the known facts could be developed to reconstruct the blue rope system that best fitted all evidence and was consistent with climbing norms. Figure 15 represents the most likely reconstruction of the blue rope system upon the arrival of the Winchman; superimposed on the rock face at Figure 16.

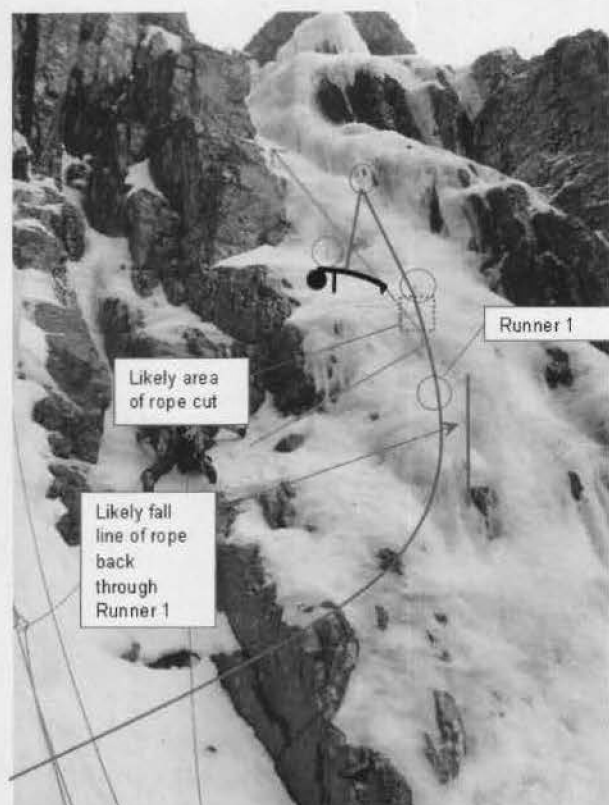
Figure 17 – Severed blue rope fall-line

²⁸ Approximately 2 m below and to the right of the Casualty. Accurately established by W18.
