SAFETY ALERT

**Subject: WASTE SKIPS - OPERATIONAL SAFETY AND
CONDITION CONCERNS**

Number: SA 2015/06

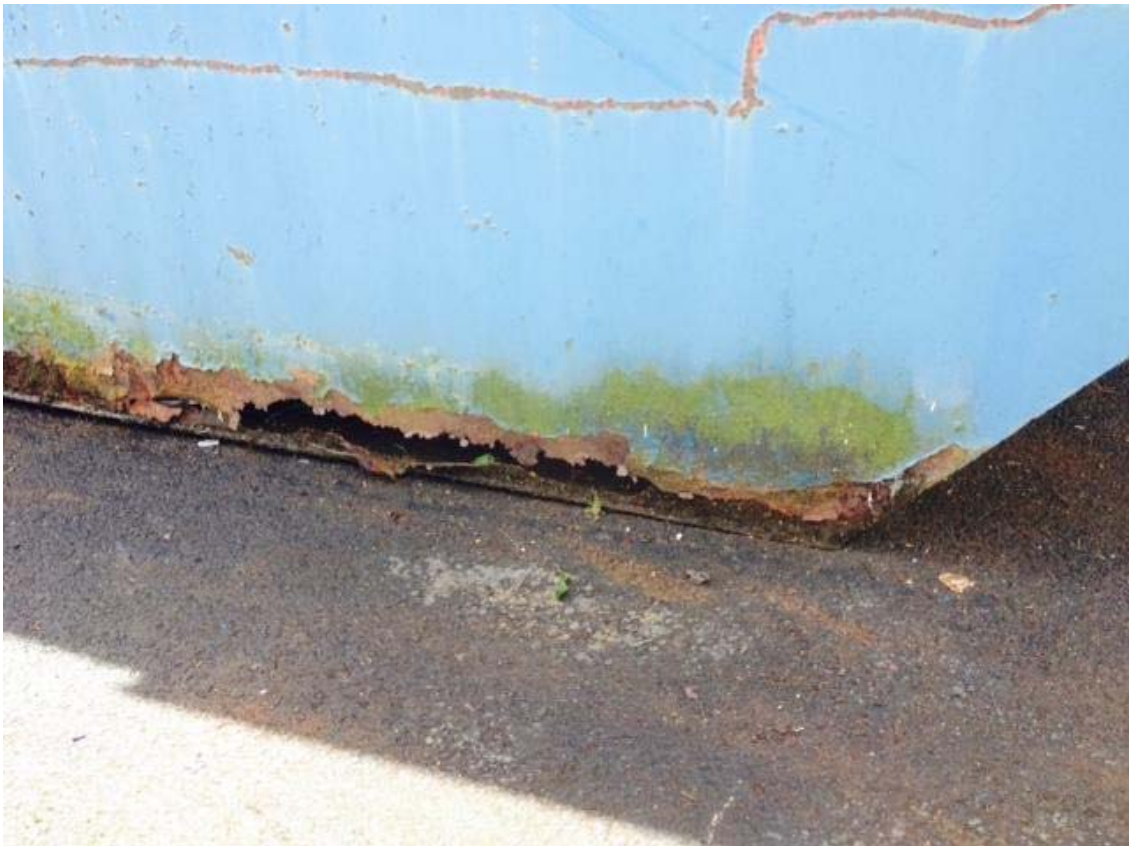
- a. corroded skips where the structural integrity could be compromised with the potential of failure during lifting operations (figure 1);
 - b. Roll on, Roll off (RORO) skips with broken bracket on rear skip door not engaging with the latching mechanism with potential of failure during lifting operations (figure 2);

Figure 1 showing extensive corrosion

5. All waste skips on the MOD Estate are to be inspected prior to use to ensure that they are suitable for the intended use and that they are being correctly operated. Where defects are identified, the skip is not to be used and the supplier is to be notified and requested to rectify or replace defective item. Further guidance can be found at <http://www.hse.gov.uk/pubns/waste06.pdf>. Additionally, readers are reminded that their risk assessments should clearly identify that personnel should be excluded from the hazard area during all lifting operations.
6. Further instructions will follow, if required, with the issue of a **Part B** to this Safety Alert.

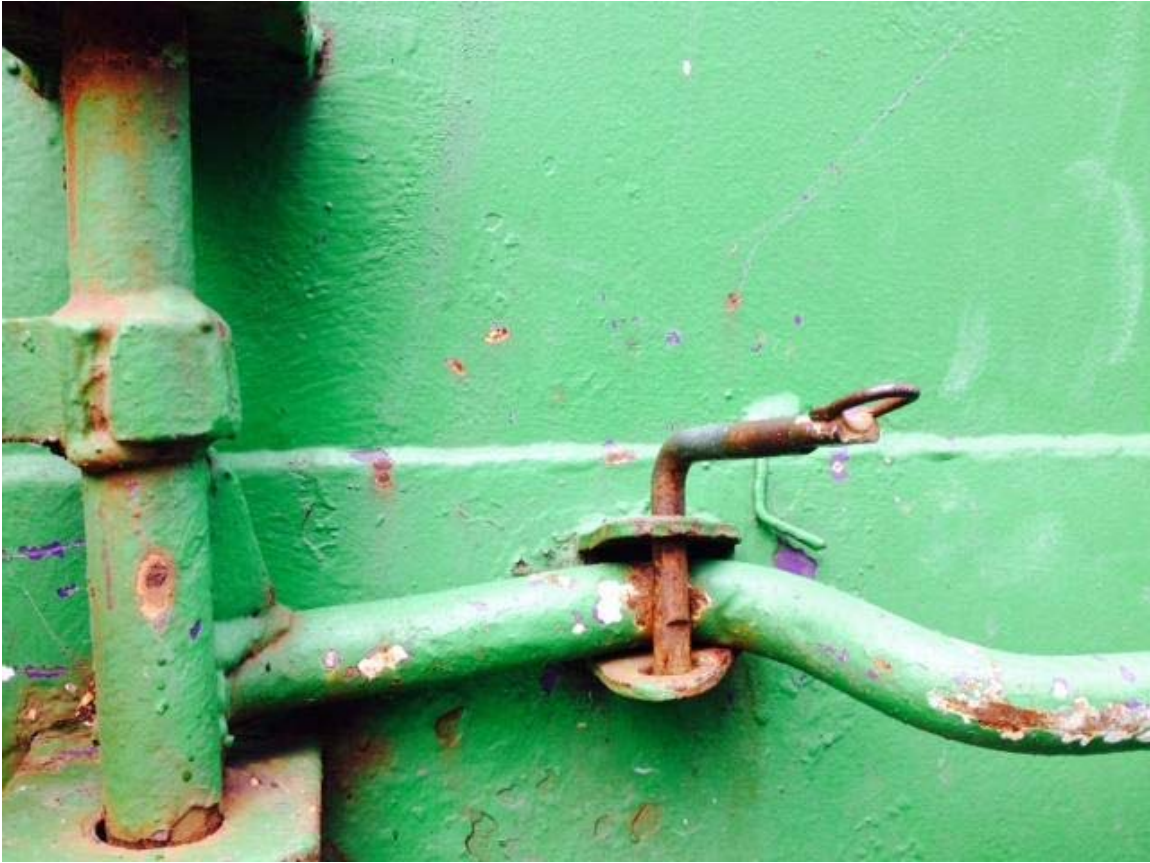
- c. RORO skip rear door handle locking pin partially engaged and of light duty manufacture with possibility of failure under load (figure 3).
 - d. RORO lifting hooks of poor design that, without modification could enable false engagement with significant potential of skip becoming detached during lifting operations.(figure 4). See also HSE Safety Alert. <http://www.hse.gov.uk/waste/hookloader.htm>.

Figure 3 showing light duty mechanism with partly engaged safety pin

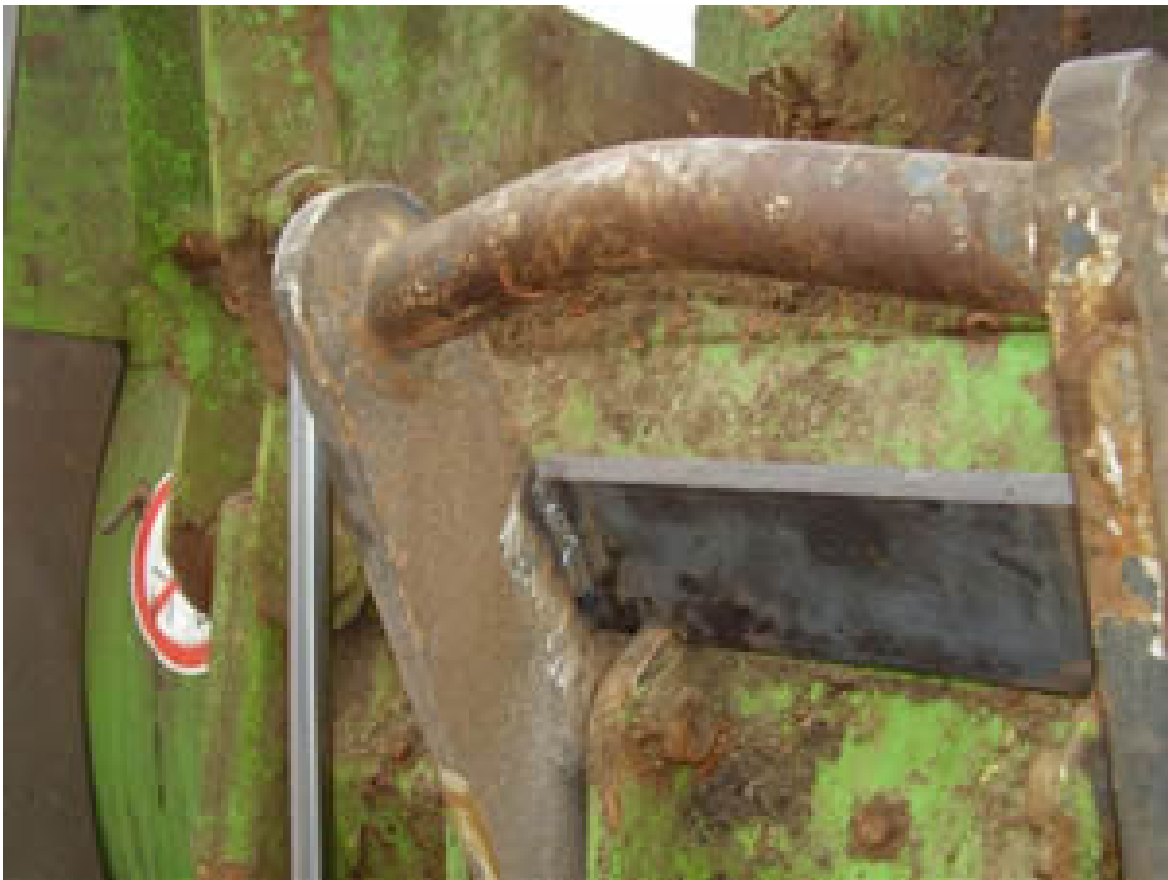
Figure 4 showing lift hook modified to reduce risk of false engagement

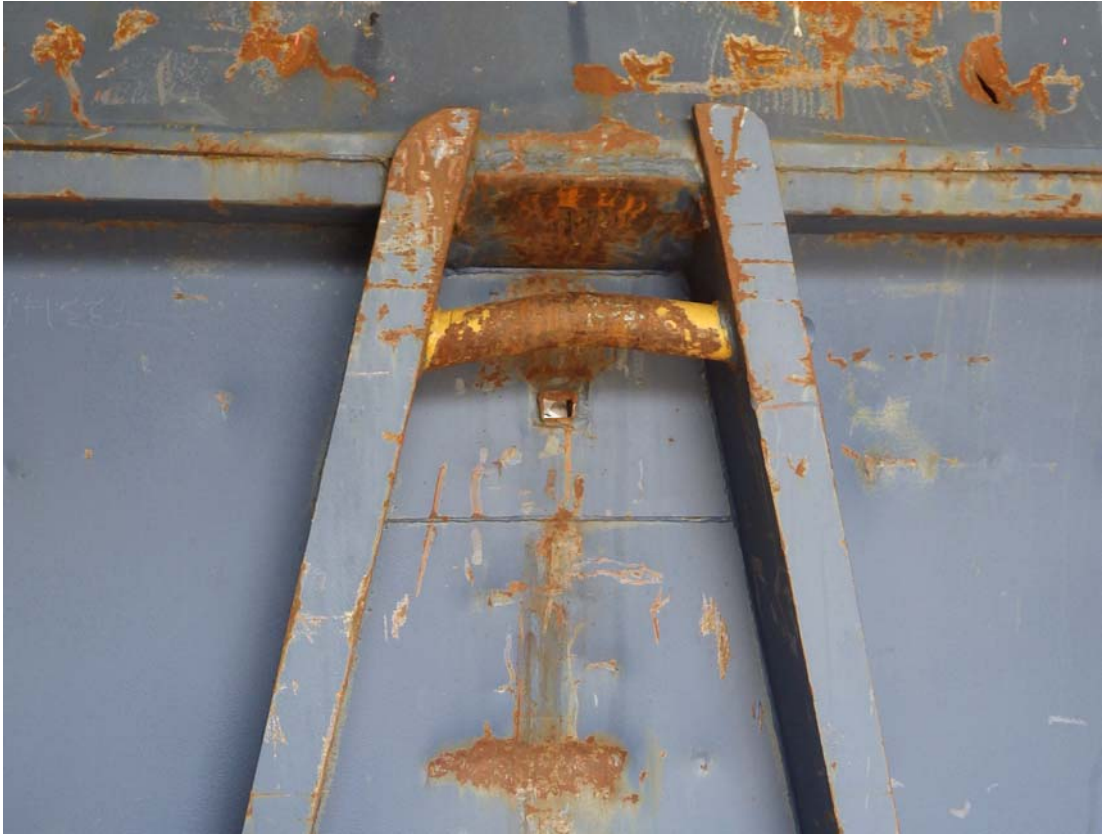
Figure 5 showing deflector plate positioned above bale bar preventing incorrect engagement

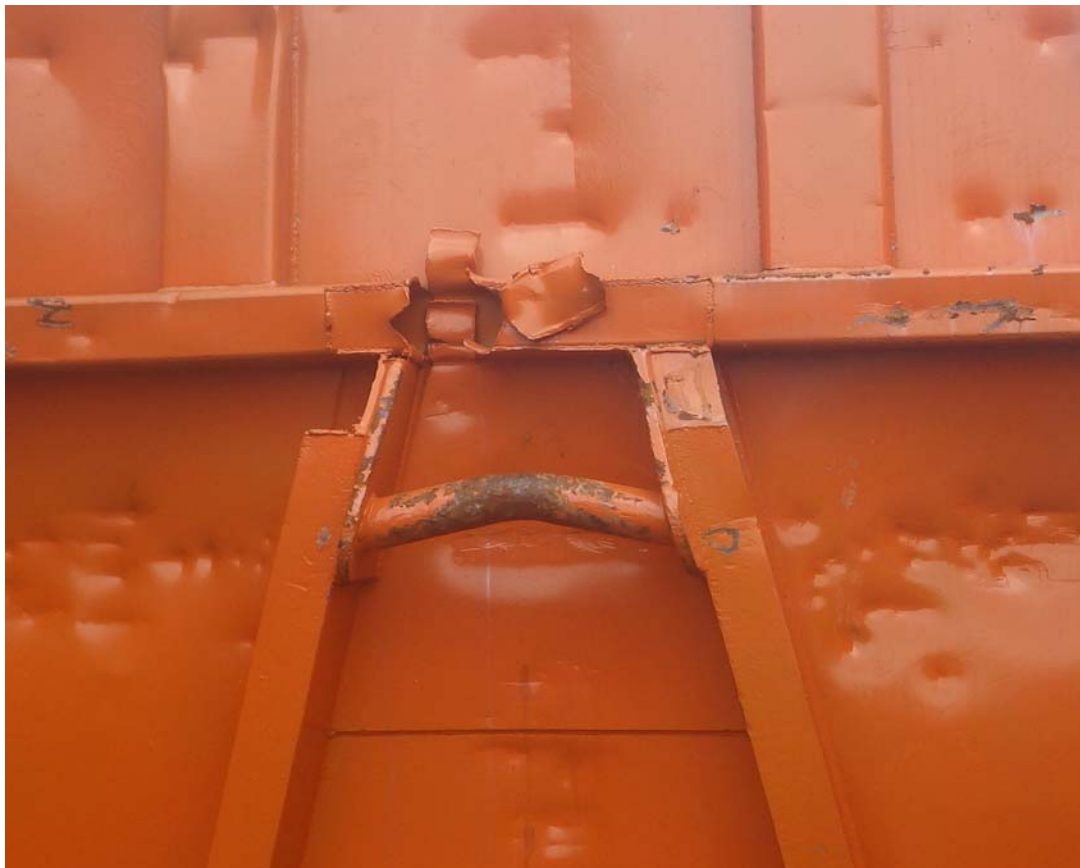
- e.. RORO skip with missing deflector plate exhibiting damage resulting from incorrect lift hook engagement (figure 6).

Figure 6 showing missing deflector plate and damage due to incorrect engagement
