# Near miss at Thorney Marsh Lane level crossing, Castle Cary, Somerset, 26 November 2016

## 2. Summary of the incident

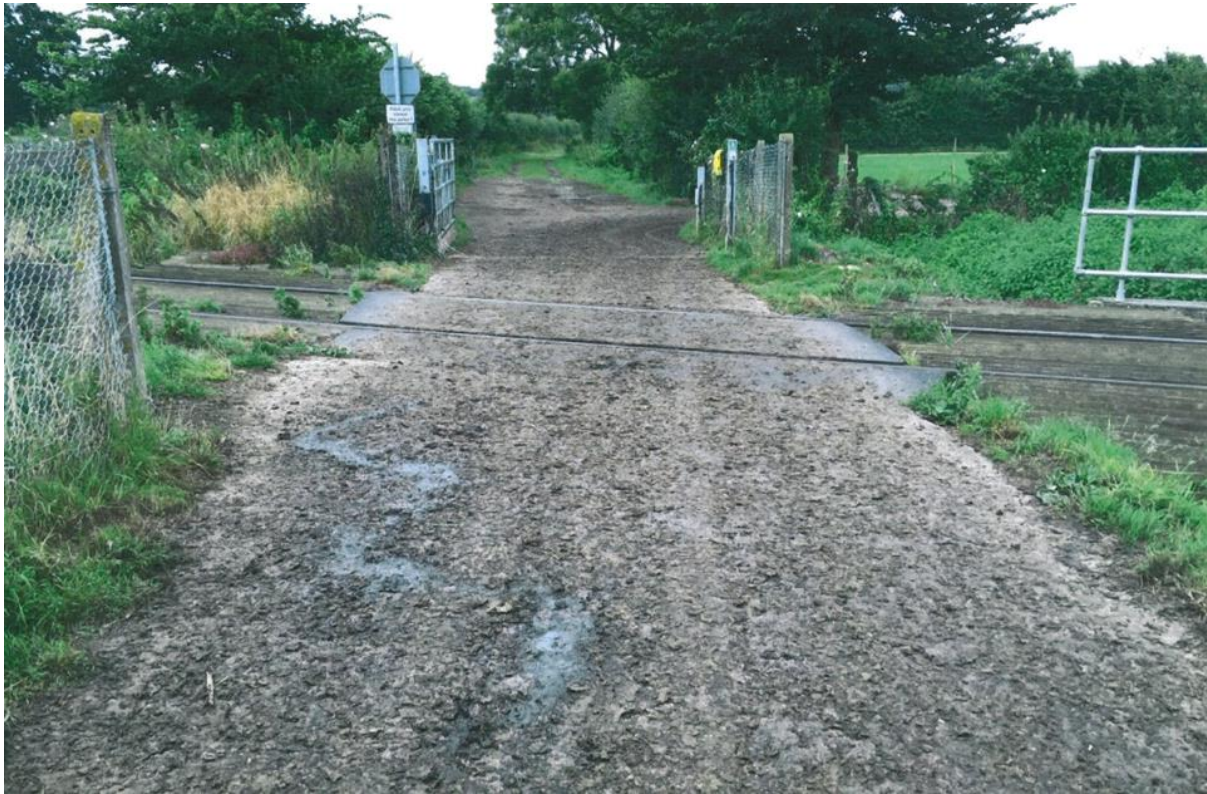
**Thorney Marsh Lane level crossing (photo courtesy of Network Rail)**

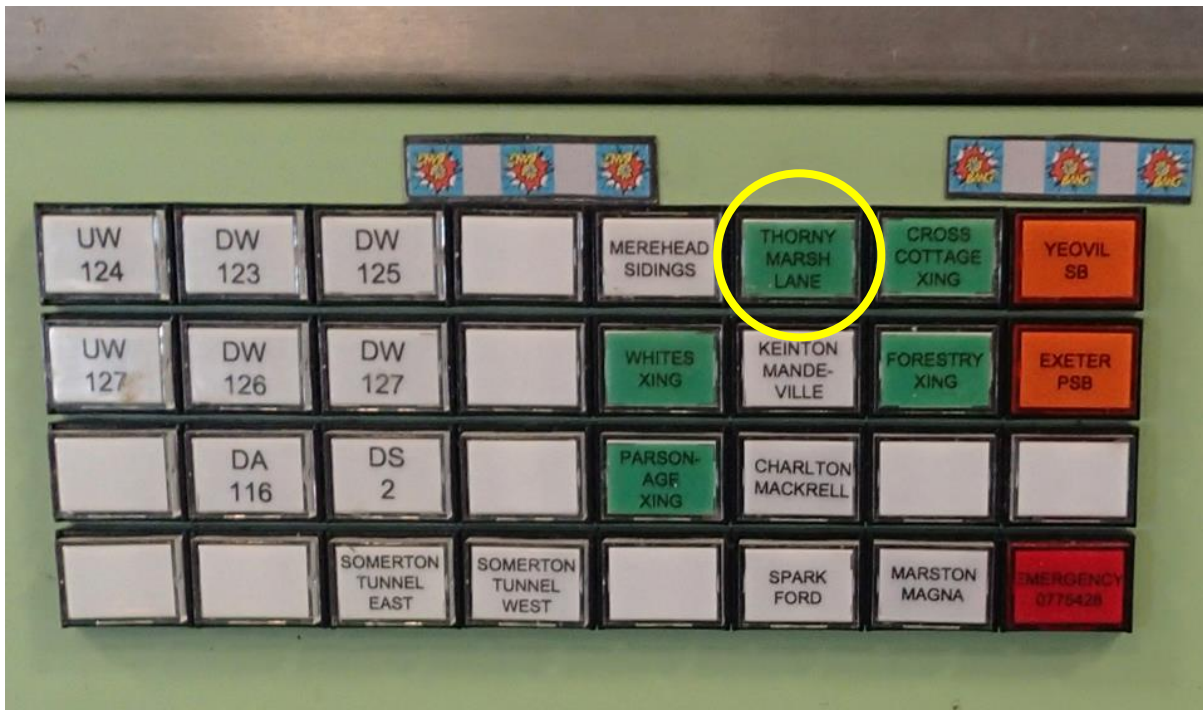
The crossing is equipped with a telephone and signs which instruct crossing users to call the signaller for permission to cross if they are crossing with vehicles or animals. The crossing telephone is connected to Westbury signal box where it is displayed along with other crossings in the area on a telephone concentrator panel.

**Telephone concentrator on signaller's control panel. Button for Thorney Marsh Lane crossing circled**

During the call the signaller looked at the display panel which showed that the Westbury to Weymouth train was occupying the section of track which starts approximately 2.4 km before the crossing and extends to a point approximately 12.8 km beyond the crossing. The display does not show the location of the train within this 15.2 km long section of track. For this reason, in order to give a user permission to cross when a train is in this section, the signaller must ask them if they have already seen the train pass the crossing.
