# Near miss with a pedestrian, Trinity Lane footpath crossing, Waltham Cross, Hertfordshire, 29 November 2016

## 2. Summary of the incident

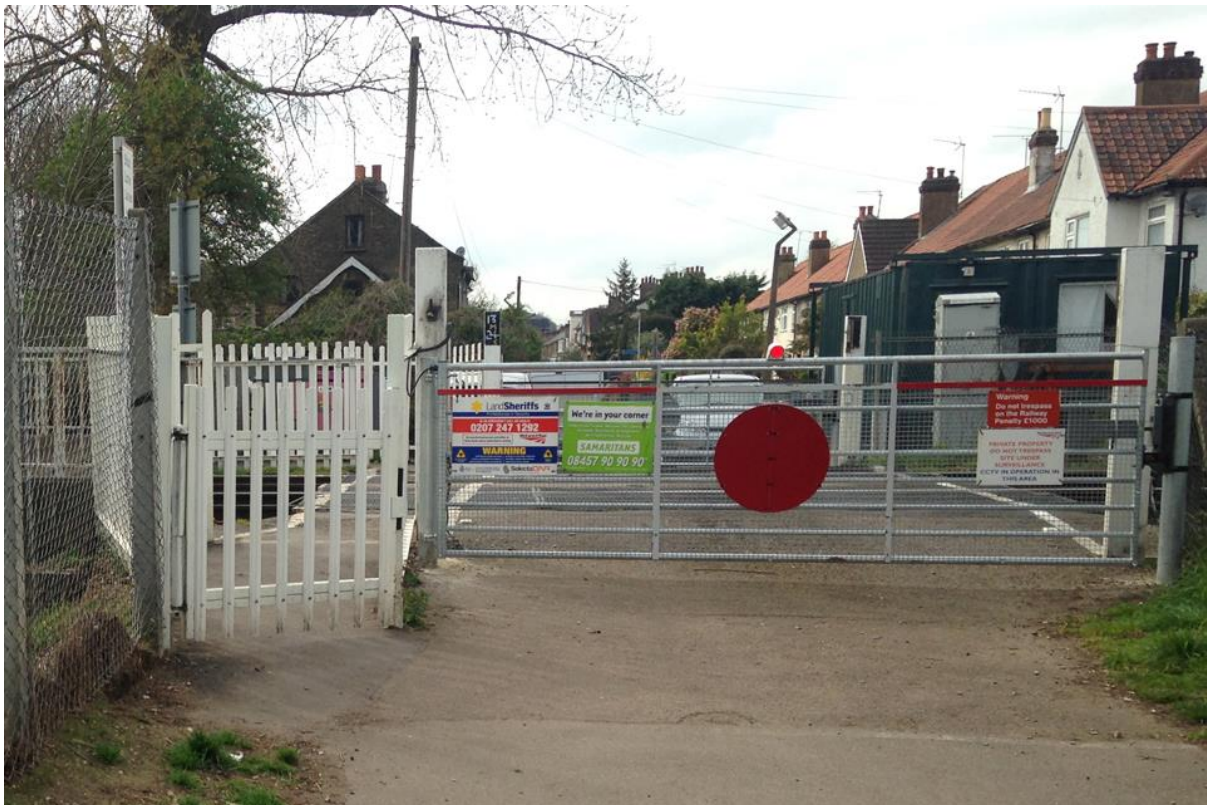
Pedestrians access the footpath crossing through self-closing wicket gates. They cross the railway on a path, marked on a rubber crossing deck, which is perpendicular to the railway. The deck is shared with an adjacent manually-controlled gated level crossing used by vehicles. Authority to use the vehicle crossing is given by a crossing keeper. However, users of the footpath crossing are expected to be vigilant and to look and satisfy themselves that no trains are approaching. Standard signs, as normally used at footpath crossings, are provided on both sides of the crossing to remind them.

Trinity Lane footpath and vehicle level crossings, from the east (image courtesy of Network Rail)

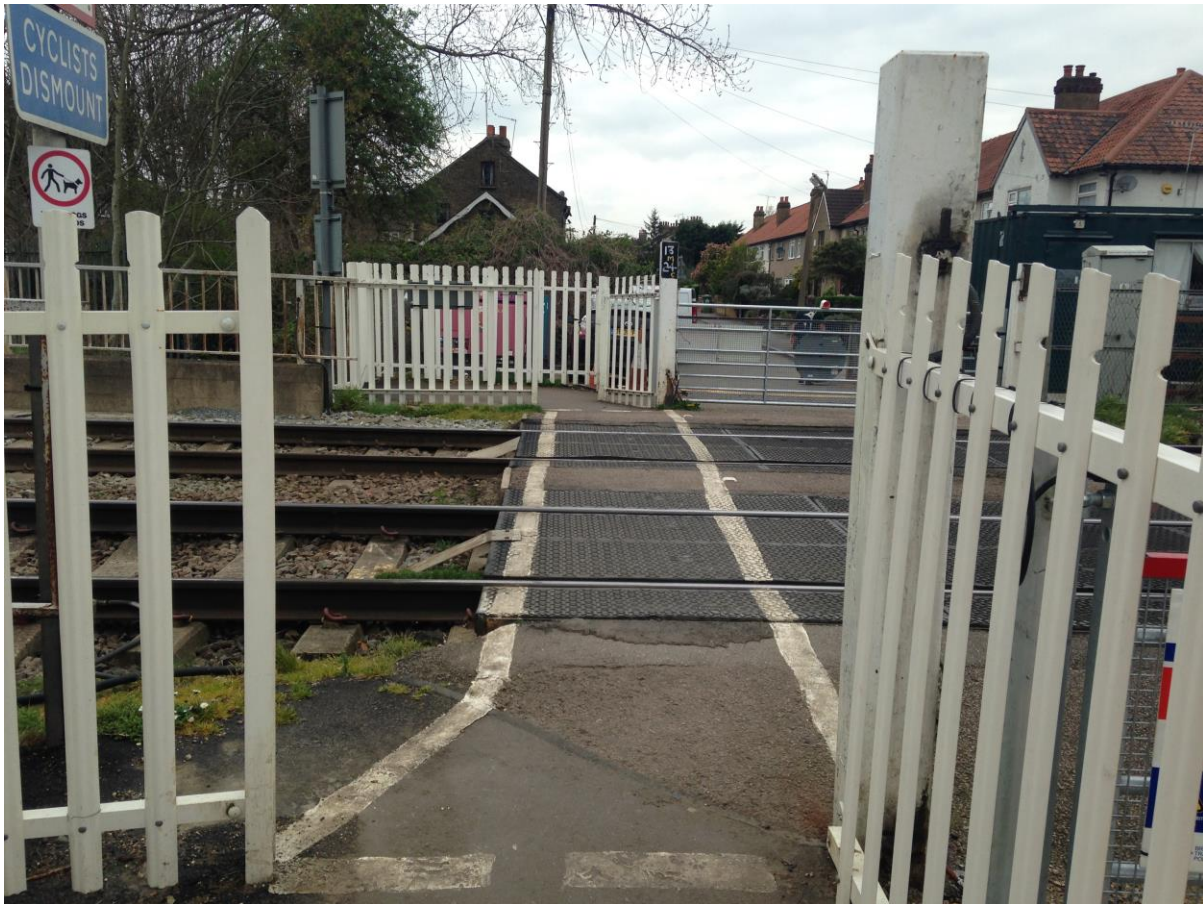
**Trinity Lane footpath crossing (image courtesy of Network Rail)**
