# **How Accident Investigation Can Influence Railway Technology**

**A.R. Hall and W.G. Rasaiah**  
**Rail Accident Investigation Branch**  
**Derby, United Kingdom**

This paper discusses how accident investigation can contribute positively to the development of safety related railway technology. It explains what guides the accident investigator's decisions when formulating investigation recommendations. The paper then considers how existing and potential routes from investigation to research and technological development can be improved in order to maximise the safety benefit from investigations. This will require wider and better communication between accident investigation bodies and the railway industry than purely formal, legal routes. The paper includes four case studies based on the RAIB's experiences which demonstrate how accident investigation can positively influence railway technology to bring about safety improvements. The case studies cover improving the integrity of critical final drive gearbox bearings, reducing freight train derailments, controlling post-derailment vehicle behaviour, and improving the survivability of passengers in high speed derailments.

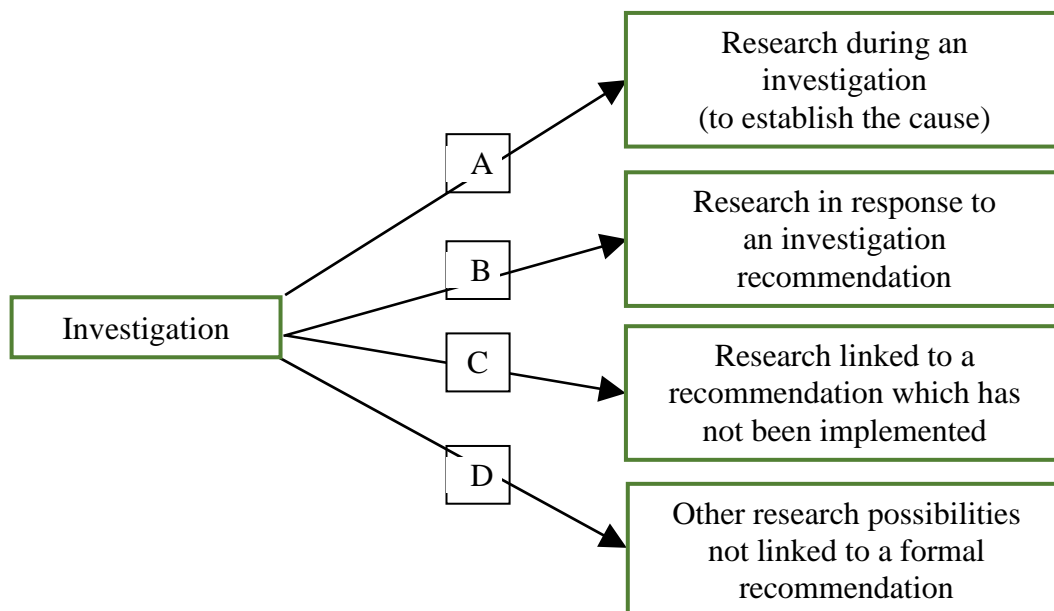
There are four potential routes from accident investigation to research and technology development, as shown in Figure 2:

Figure 2: Routes from accident investigation to research and technology development

- a) Route A involves research during the course of an investigation which is led by the accident investigation body and supported by industry. In the UK, the RAIB will take the lead in carrying out the required research to fulfil its duty to establish the causal chain of an accident to a sufficient degree that it can make evidence based recommendations. By its nature, the scope of such research will be limited to meet the requirements of the investigation and will need significant further work to develop into useful technology (case study 6.1).

- b) Route B is the most common route, and involves research and development undertaken by the industry as part of its implementation of a safety recommendation from the RAIB (or potentially from the industry's own investigation). In such cases the RAIB will have made the recommendation because it considers it is necessary to bring about a required safety improvement. The research could be undertaken in house by the duty holder or by a consultancy or academia; depending on resources and skills (case study 6.2).

- c) Route C involves research areas linked to safety lessons or recommendations from the RAIB which have been considered by industry but not implemented on the grounds that it considers the costs are likely to be disproportionately greater than the benefits. As a consequence of the non-implementation, significant areas of understanding and knowledge may not be developed because those ideas are not sufficiently aired for others (e.g. academia) to consider (case studies 6.3 and 6.4).

- d) Route D involves research which the circumstances of a single accident may not justify, and therefore the RAIB may decide it is not appropriate to make a formal recommendation for the research. In such cases the RAIB may highlight the potential for safety learning in its report in a separate section from the recommendations.

Currently, there are well proven mechanisms for routes (a) and (b). However, there remains a need for developing routes (c) and (d) so that academia, and research and technology organisations are kept informed of potential research ideas, which they may consider fit better with their own goals than those of industry duty holders. For example, a research idea may be suitable for undergraduate or post graduate projects to take forward. If early research finds that some of these projects have significant merit, it could spawn more significant programmes of research and innovation, which could then filter back into industry.

The key to developing routes (c) and (d) in Figure 2 is good communication of ideas for research and technology between the accident investigation body, industry and academia. This could include the provision of assistance by the accident investigation body to aid understanding and define the issues which led to the accident(s), without becoming involved in solutions which could compromise the accident investigation body's independence.

A pre-requisite for developing routes (c) and (d) in Figure 2 is also the willingness of research and technology organisations and rail industry sponsors to think wider than an individual accident that has been investigated. Historically, the UK rail industry would not have achieved current levels of active and passive safety for example, if the safety authority and industry had not thought wider than the watershed accidents which drove forward the key changes that were necessary at the time. Two examples of this are:

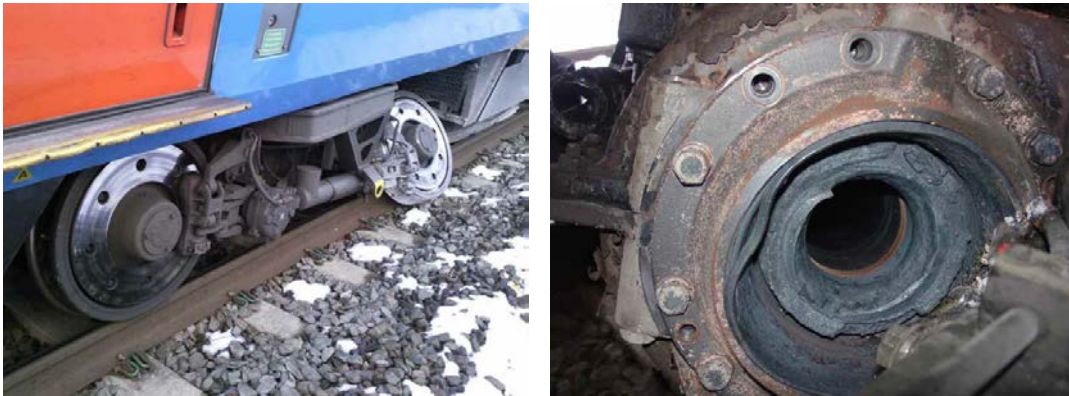
The derailment was caused by the fracture of a powered axle on the fourth vehicle (Figure 3) which occurred because the gear-side output bearing of the final drive had stiffened up to the point it could not rotate normally. When this happened the axle spun within the inner race of the bearing. The consequent generation of a large amount of frictional heat between the axle and bearing resulted in the axle being locally heated to a high temperature and weakened to the point it could no longer carry its normal loading.

Figure 3: Passenger train derailment at East Langton; the derailed wheel (left) and the fractured axle (right)

Key evidence about the condition of the bearing and its fit onto the axle was destroyed in the failure but it was possible to identify that the failed output bearing probably had a loose fit on the axle. It became apparent during the investigation that little was known about the effect of loose fits on final drive output bearings and whether it could lead to a catastrophic failure of an axle rather than failure of the bearing only, and if so, the precise mechanism of failure. Tests, procured by the vehicle manufacturer in support of the investigation were carried out at the gearbox manufacturer's testing facility to investigate the failure mechanism. Unfortunately the tests proved inconclusive and although it was not possible to be certain that a loose bearing fit could lead to a catastrophic failure, there was however sufficient evidence in the RAIB's view for it to conclude that the failure was probably caused by the loose bearing fit.

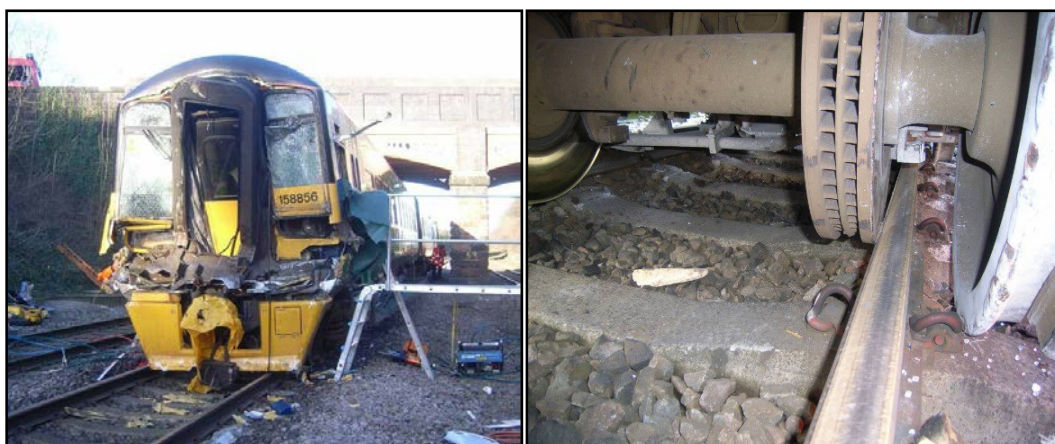
Figure 5: Derailment at Barrow on Soar; damaged leading end of train (left); guidance provided by the brake discs (right)

The relatively low consequence of this accident was attributed to two principal factors. Firstly, the strength of the driver's cab was sufficient to prevent the driver sustaining more serious injuries due to loss of survival space. Secondly, following derailment, the wheels of the leading bogie ran close to the running rails without deviating laterally, despite the track being curved. This was because the running rail had become trapped between the wheel and left-hand brake discs on each of the two derailed wheelsets (Figure 5). The wheelset design was such that the cast iron axle-mounted brake discs extended just below the head of the running rail when the derailed wheels were running on the sleepers, and hence the derailed bogie was effectively guided by the running rails. The guidance provided by the brake discs

probably prevented a secondary collision with the road bridge near the stopping position.

The observation that brake discs and some axleboxes can provide effective guidance to derailed bogies, even though they had not been specifically designed to do so, has also been noted by the RAIB in other derailments.

In view of the likely safety benefit of having such a capability in future rolling stock, the RAIB made a recommendation that the industry should investigate the practicability of design elements on the bogie that limit the degree of deviation from the track following derailments. The industry rejected the recommendation following a preliminary assessment on the grounds that any resultant solution may increase the risk of a derailment in the vicinity of points or crossings.

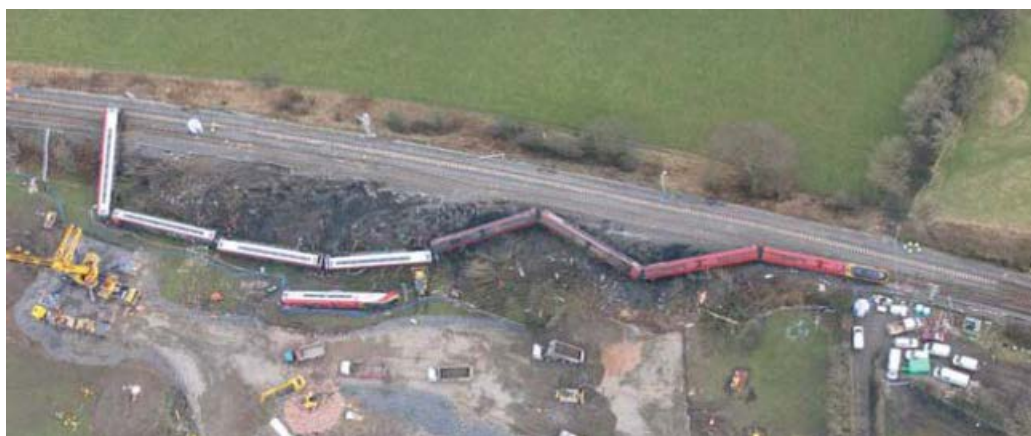
On 23 February 2007, a nine-car passenger train, travelling from London to Glasgow on the West Coast Main Line, became derailed at a set of faulty facing points near Grayrigg in Cumbria [8]. The train speed at the time was 95 mph (153 km/h). All nine vehicles derailed; eight vehicles fell down the nearby embankment and five of these vehicles rolled over onto their sides (Figure 6). The train came to rest within a distance of around 320 metres from the point of derailment. The leading vehicle became detached from the rest of the train and came to rest at the bottom of the embankment, having rotated through 190 degrees.

Figure 6: Derailment at Grayrigg

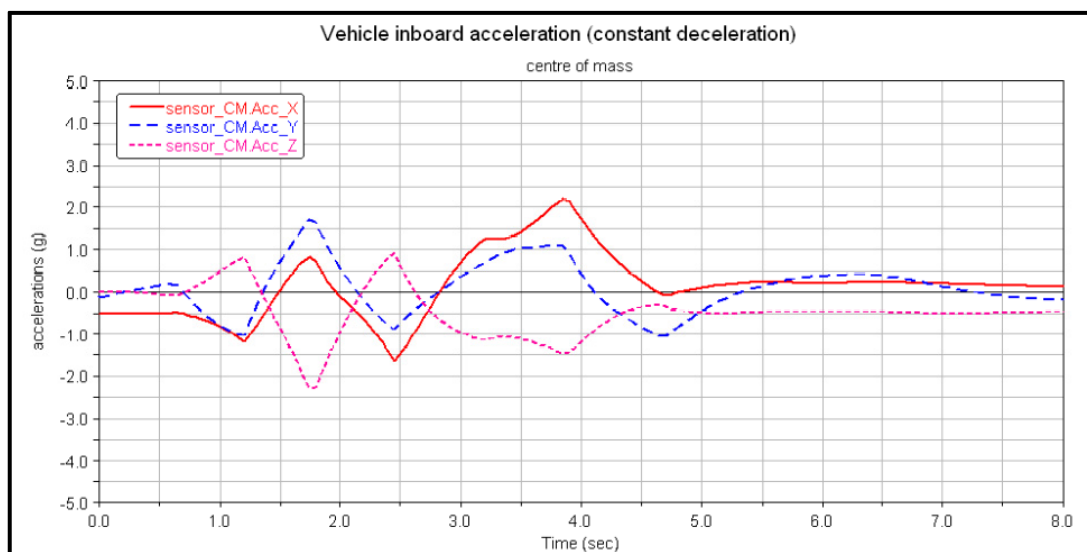
injuries and 58 passengers suffered minor injuries. The principal cause of injuries at Grayrigg was the secondary impact of occupants against the vehicle interior and other occupants. The leading vehicle was subjected to the most extreme movements of any of the vehicles and it had the highest concentration of injuries. Simulations showed there had been significant vertical and lateral accelerations (Figure 7) in addition to the longitudinal forces associated with retardation from bogies. Current UK standards for interior crashworthiness are based on longitudinal accelerations and do not specifically consider accelerations in the lateral and vertical directions.

Figure 7: Estimated acceleration pulses for the leading vehicle at Grayrigg

The subsequent RAIB investigation report [8] made five recommendations related to improving passive safety, which included research to study the effect of multi-axial pulses on passengers and interior safety. It is not unreasonable that in the future, vehicle designers should routinely include consideration of vertical and lateral accelerations pulses when they design interior fixtures and fittings such as seats, luggage racks and tables, in order to minimise the risk of serious injury in high speed derailments.
