Ref. FOI2016/07873

Defence Infrastructure Organisation
Land Quality Assessment
Phase 1 Desk Study
Chalgrove Airfield, Chalgrove
Final

October 2014
Contract Number:

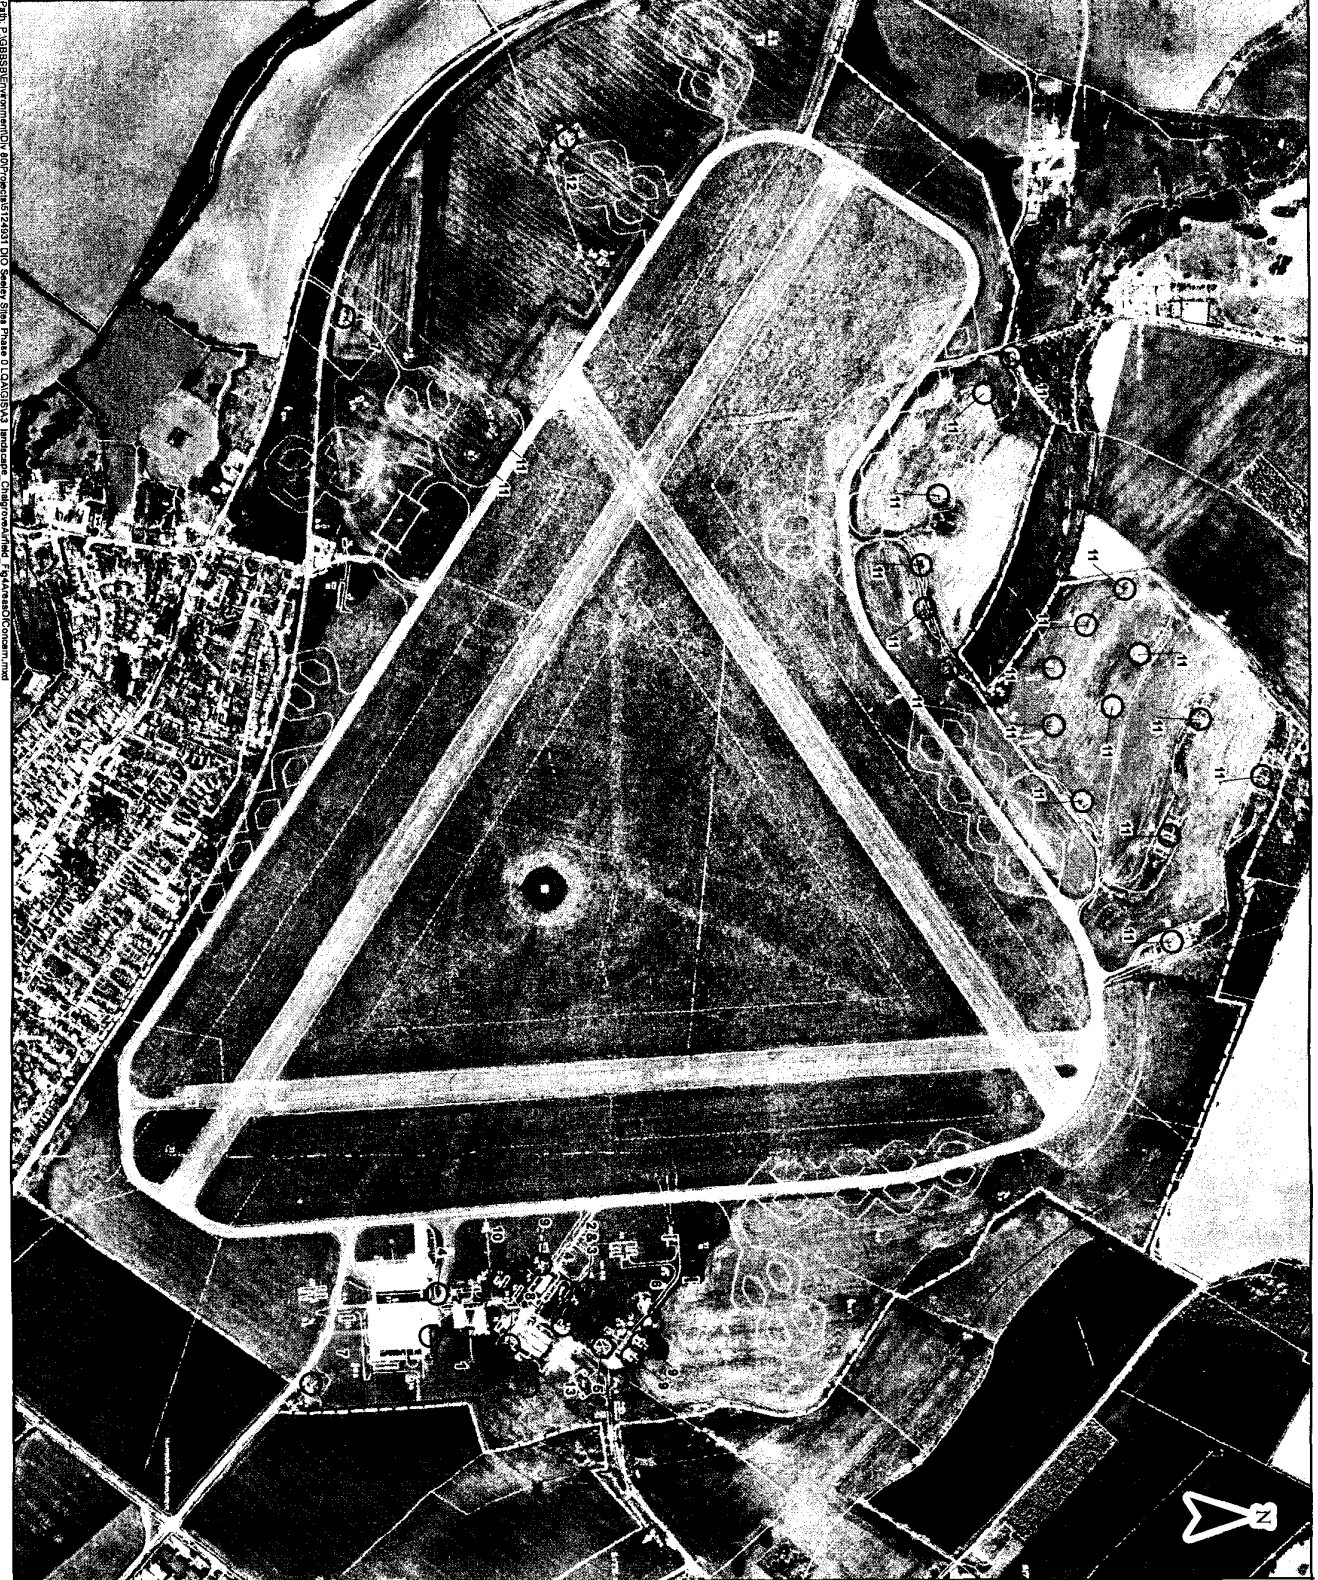
1. Two current heating oil tanks and associated below ground pipework
2. Current bulk fuel installation
3. Former petrol tanks and dispensing pump
4. WW2 bulk oil installations (23 & 24)
5. WW2 fuel compound (30)
6. WW2 petrol store (50)
7. WW2 bulk fuel installations (51 & 52)
8. WW2 lubricant/flammables store (42)
9. WW2 motor transport shed (47) and store (49)
10. WW2 photographic block (68)
11. WW2 explosives stores and burning grounds (69-70 & 88-107)
12. WW2 shooting in butt (59)
13. WW2 below ground drains

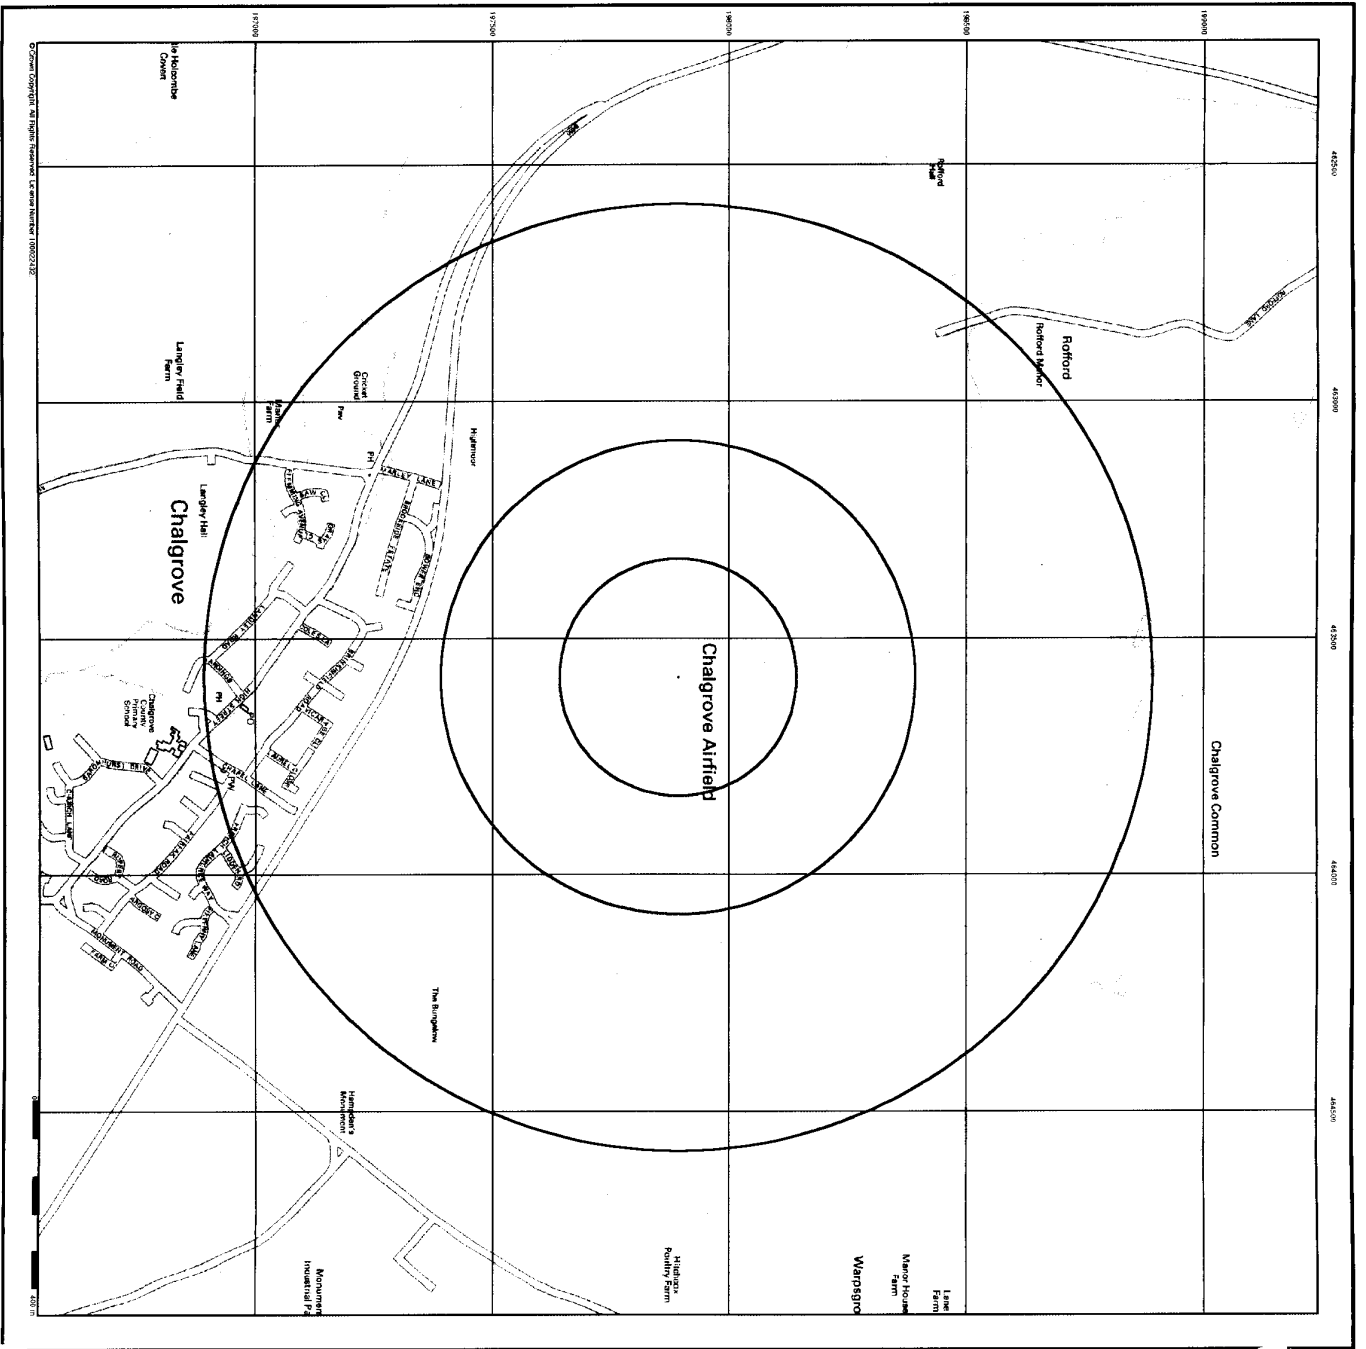
Artificial Ground and Landslip

Artificial ground is a term used by BGS for those areas where the ground surface has been significantly modified by human activity. Information about previously developed ground is especially important, as it is often associated with potentially contaminated material, unpredictable engineering conditions and unstable ground.

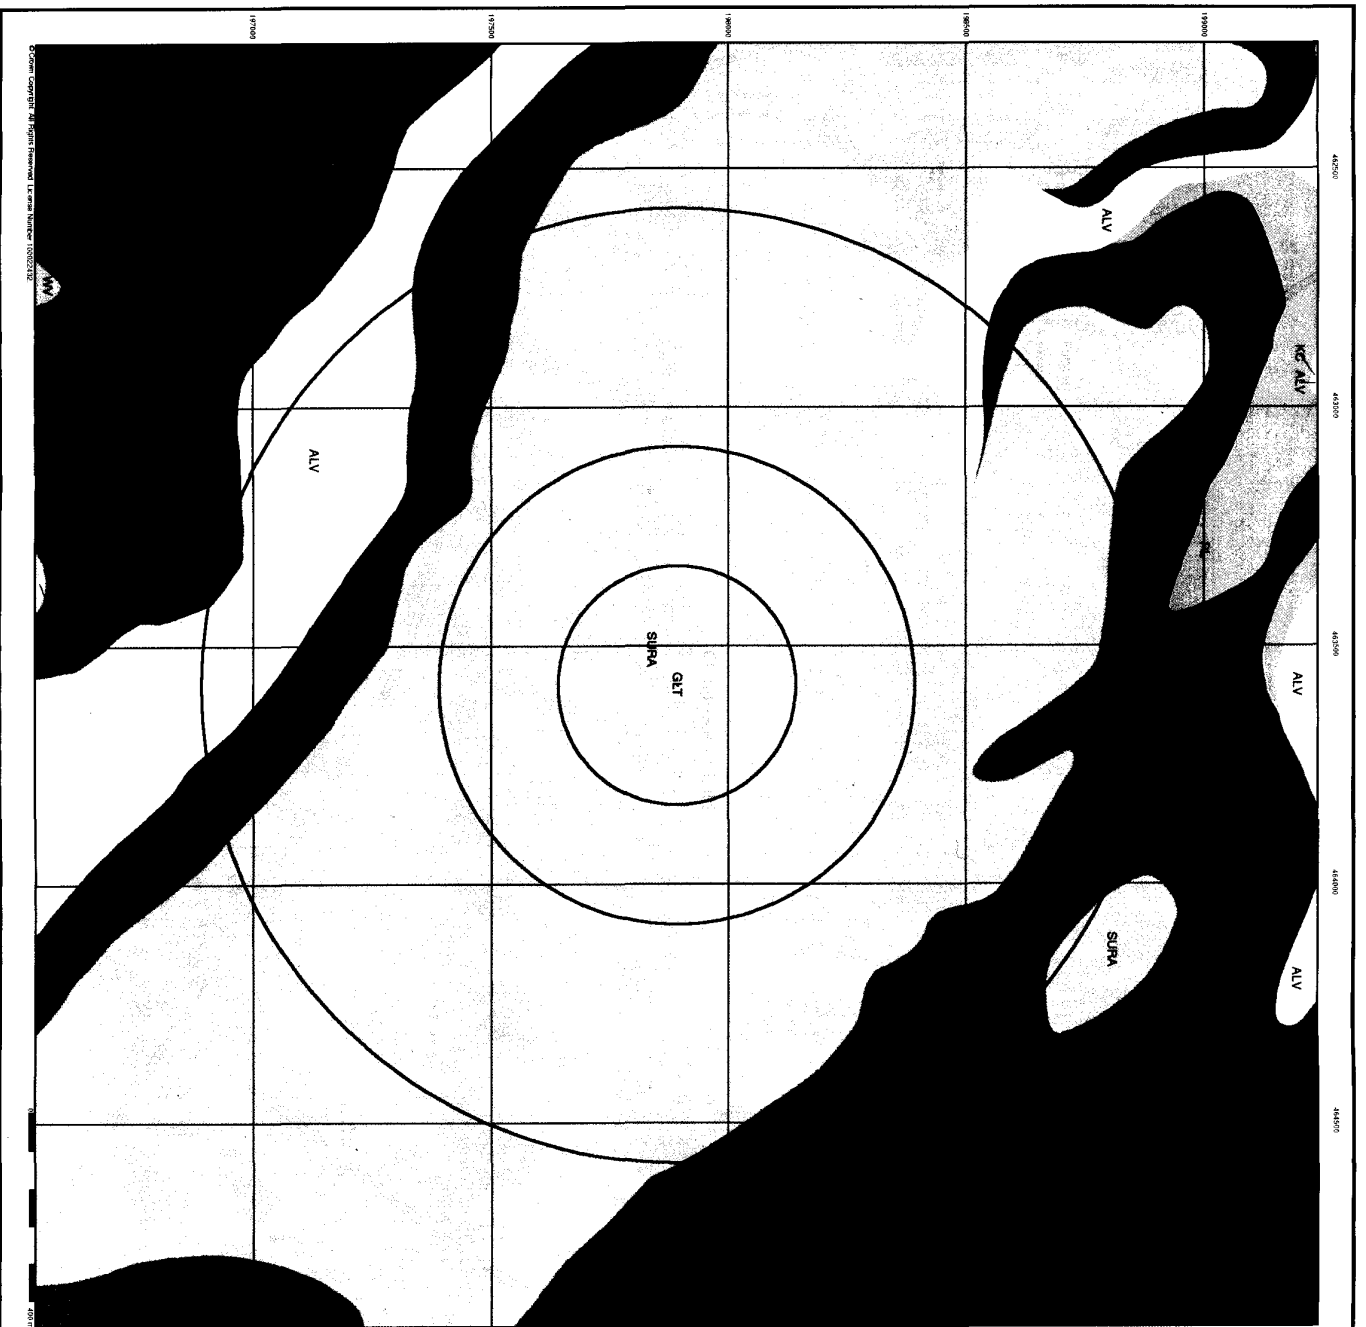
Combined Surface Geology

The Combined Surface Geology map combines all the previous maps into one combined geological overview of your site. Please consult the legends to the previous maps to interpret the Combined "Surface Geology" map.
