Rail Accident Investigation Branch

Rail Accident Report

**Fatal accident at Alice Holt footpath crossing,
Hampshire
5 October 2016**

Report 14/2017
October 2017

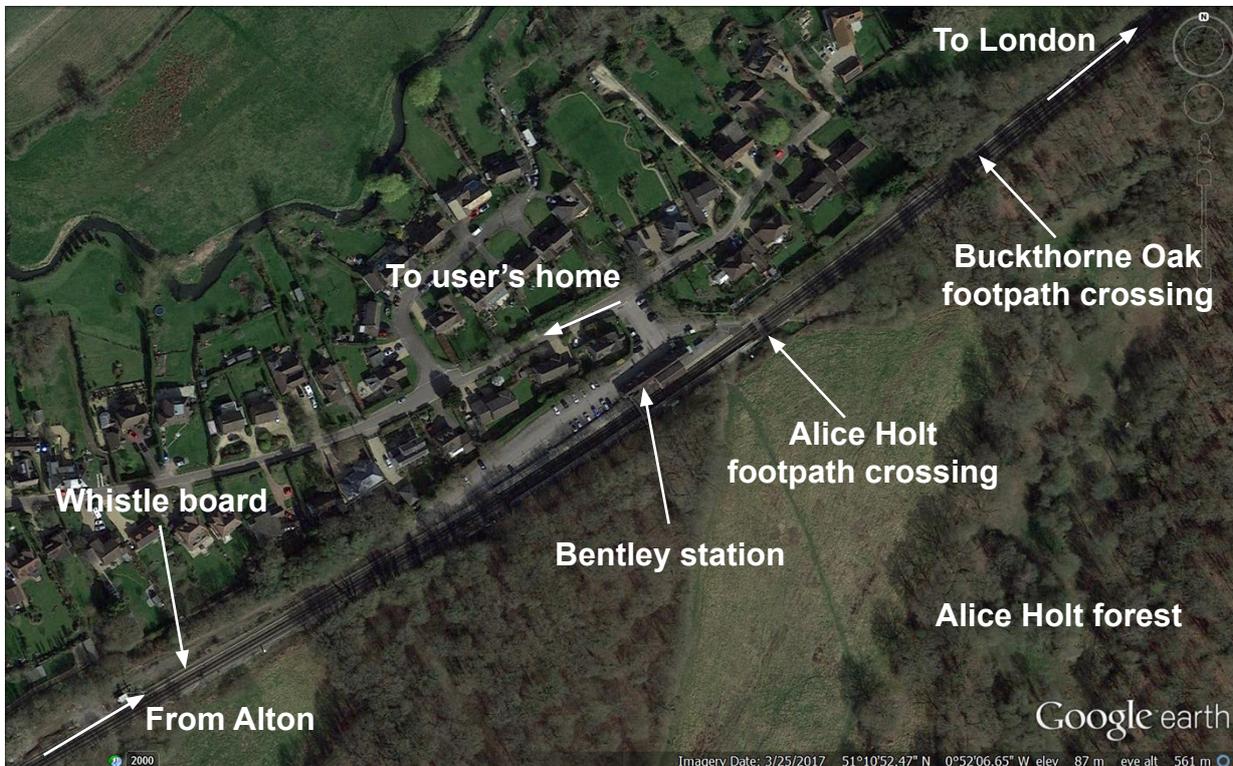
Figure 2: Features surrounding Alice Holt footpath crossing

- Alice Holt footpath crossing is situated at 44 miles 20 chains² on the Alton branch line, at the eastern end of Bentley station. The branch line comprises a single track between Farnham and Alton, designated the 'Alton single' line, with a loop line through Bentley station, designated the 'Down Bentley Loop'. Alice Holt level crossing crosses both the Alton single line and the Down Bentley Loop (figures 2 and 3). Since 2011, the footpath has been part of the Shipwrights Way long distance walking and cycle route between Bentley and Portsmouth.

- 5 The line is mainly used by passenger trains. In the vicinity of Alice Holt crossing there is a maximum permitted speed of 70 mph (113 km/h) for passenger trains in both directions on the Alton single line and 40 mph (64 km/h) on the Down Bentley Loop. There are lower permitted speeds for freight trains. Signalling on the branch line is by *track circuit block*, controlled from Woking Area Signalling Centre.

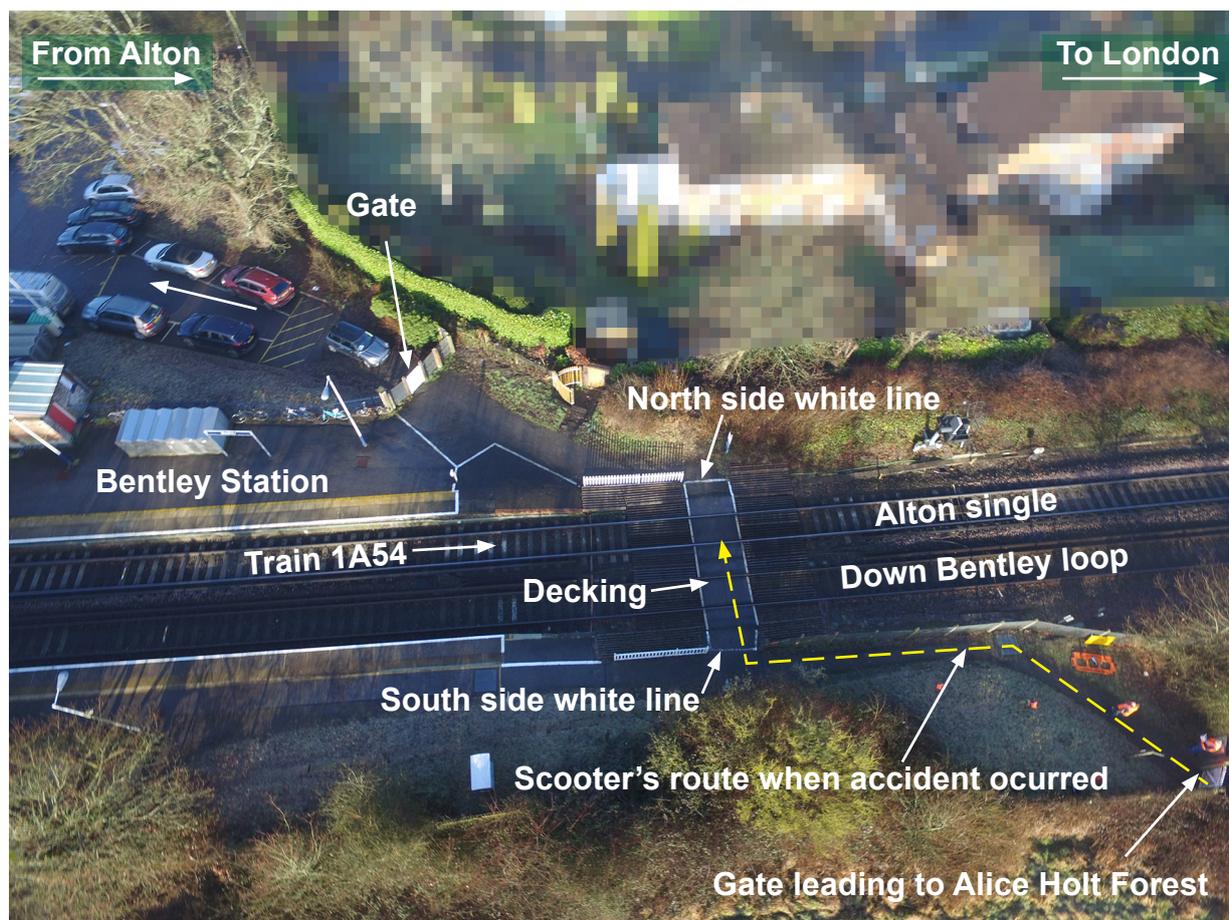
Figure 3: Layout of Alice Holt footpath crossing

- 11 The railway at this location runs approximately east to west. Self-closing wooden wicket gates at the railway boundary provide access to tarmac footpaths leading to a level timber *crossing deck*. The paths run parallel to the railway line as they approach the crossing decking which is 8.7 metres long, 2.4 metres wide and runs perpendicular to the rails (figure 3). Lineside signs (*whistle boards*) located 305 metres on the Alton side of the crossing and 415 metres on the London side of the crossing instruct train drivers to sound their train's warning horn.

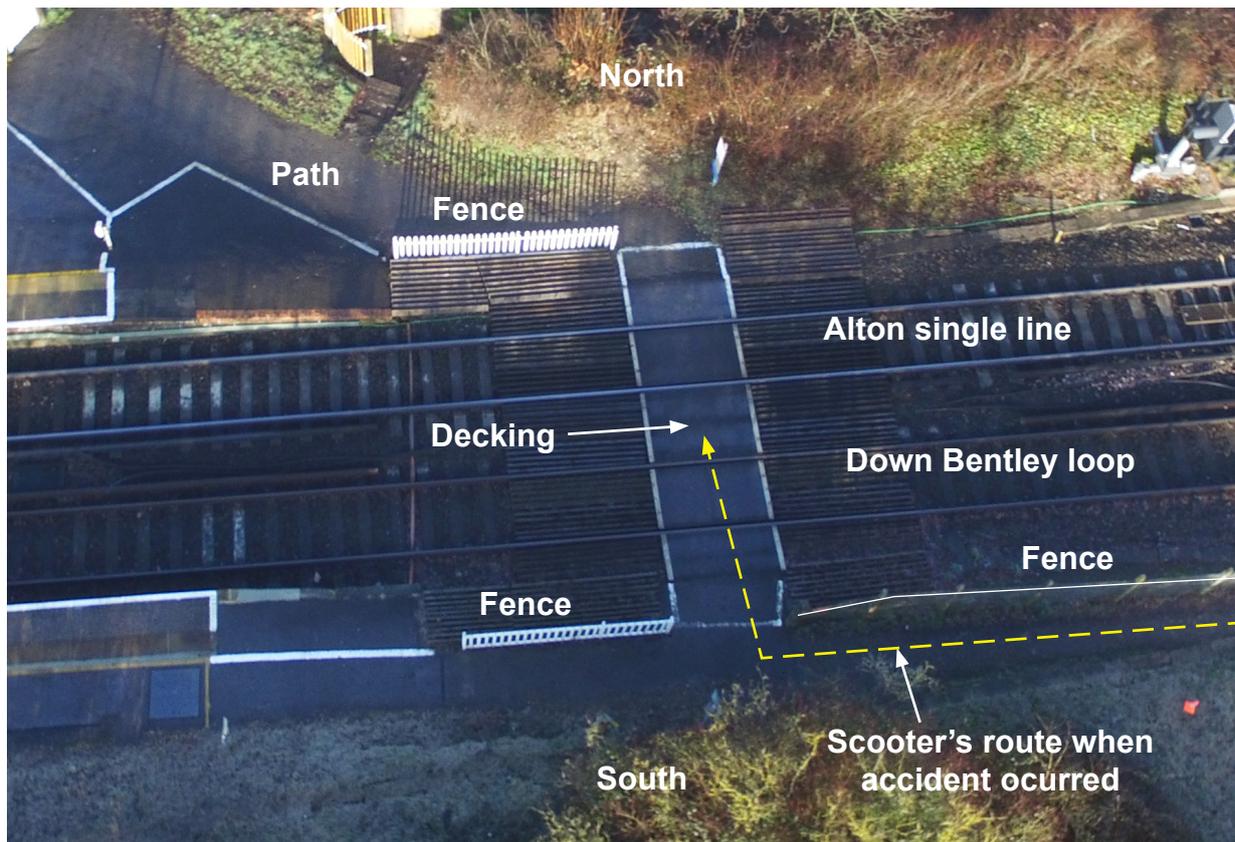
Figure 4: Arrangement of fences, white lines and decking at Alice Holt footpath crossing

- 12 Fencing separates the footpath from the adjacent railway on the southern side of the railway, with a gap at the end of the crossing. A fence separates the footpath from the adjacent railway on the Alton side of the northern end of the crossing (there is no path in the other direction at the northern end). White lines on the ground, around 2 metres from the nearest rails, mark the ends of the decking (figure 4). A sign near each end of the crossing instructs users to 'Stop Look Listen' and 'Beware of trains' (figure 5). The white lines are at the position described as the decision point within Network Rail and Office of Rail and Road (ORR) level crossing documentation. Level crossing management processes assume users look and listen for trains, and decide whether to cross the line while at the decision point. The practical limitations of a mobility scooter user's position are discussed in paragraphs 68 to 70.

- 95 Network Rail has lowered all three fences at Alice Holt level crossing and has widened the path on approach to the south side of the crossing. Resurfacing of the crossing is included as a recommendation in the November 2016 risk assessment of the crossing.

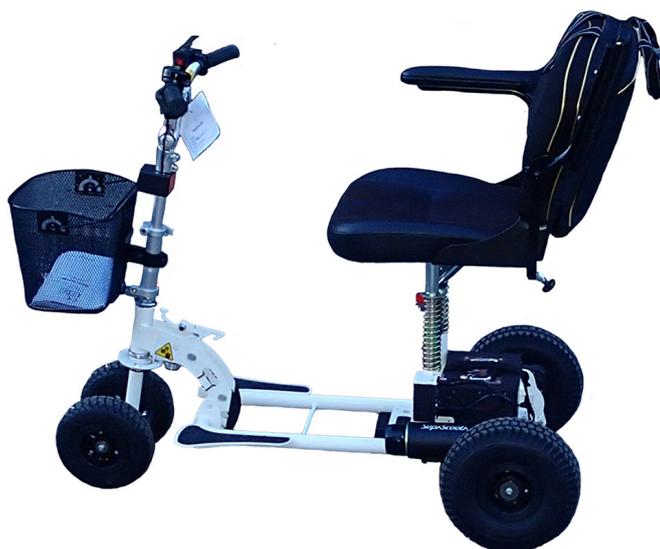
Figure 6: A mobility scooter of the type, but not the colour, involved in the accident

- 15 The mobility scooter involved in the accident was around six months old at the time of the accident. It was a SupaScoota Sport XL with twin 180 Watt motors (figure 6) and was fitted with lithium batteries which, according to the manufacturer's data, gave the scooter a range of around 11 miles (18 km).
- 16 The scooter was fitted with a device to limit its maximum speed to 4 mph (1.8 m/s) in order to comply with UK regulations for 'class 2 invalid carriages'. This class of mobility carriage should not be used on public roads except to cross them or where there is no pavement³. The scooter manufacturer's data for other markets indicates that, without the speed limiting device, the maximum speed of this model of scooter would be 5.6 mph (2.5 m/s).

- 17 This model of scooter is also fitted with a device limiting cornering speed in order to reduce the likelihood of the scooter overturning. This slowed the scooter in proportion to how far the handlebars were turned.
- 18 *Forward facing closed circuit television (FFCCTV)* from train 1A54 shows that, in the moments before the accident, the scooter was travelling at approximately its maximum speed (paragraph 30). The station CCTV shows the scooter turning normally when using the crossing about 38 minutes before the accident (paragraph 26). There is therefore no evidence of any scooter defect relevant to the accident.

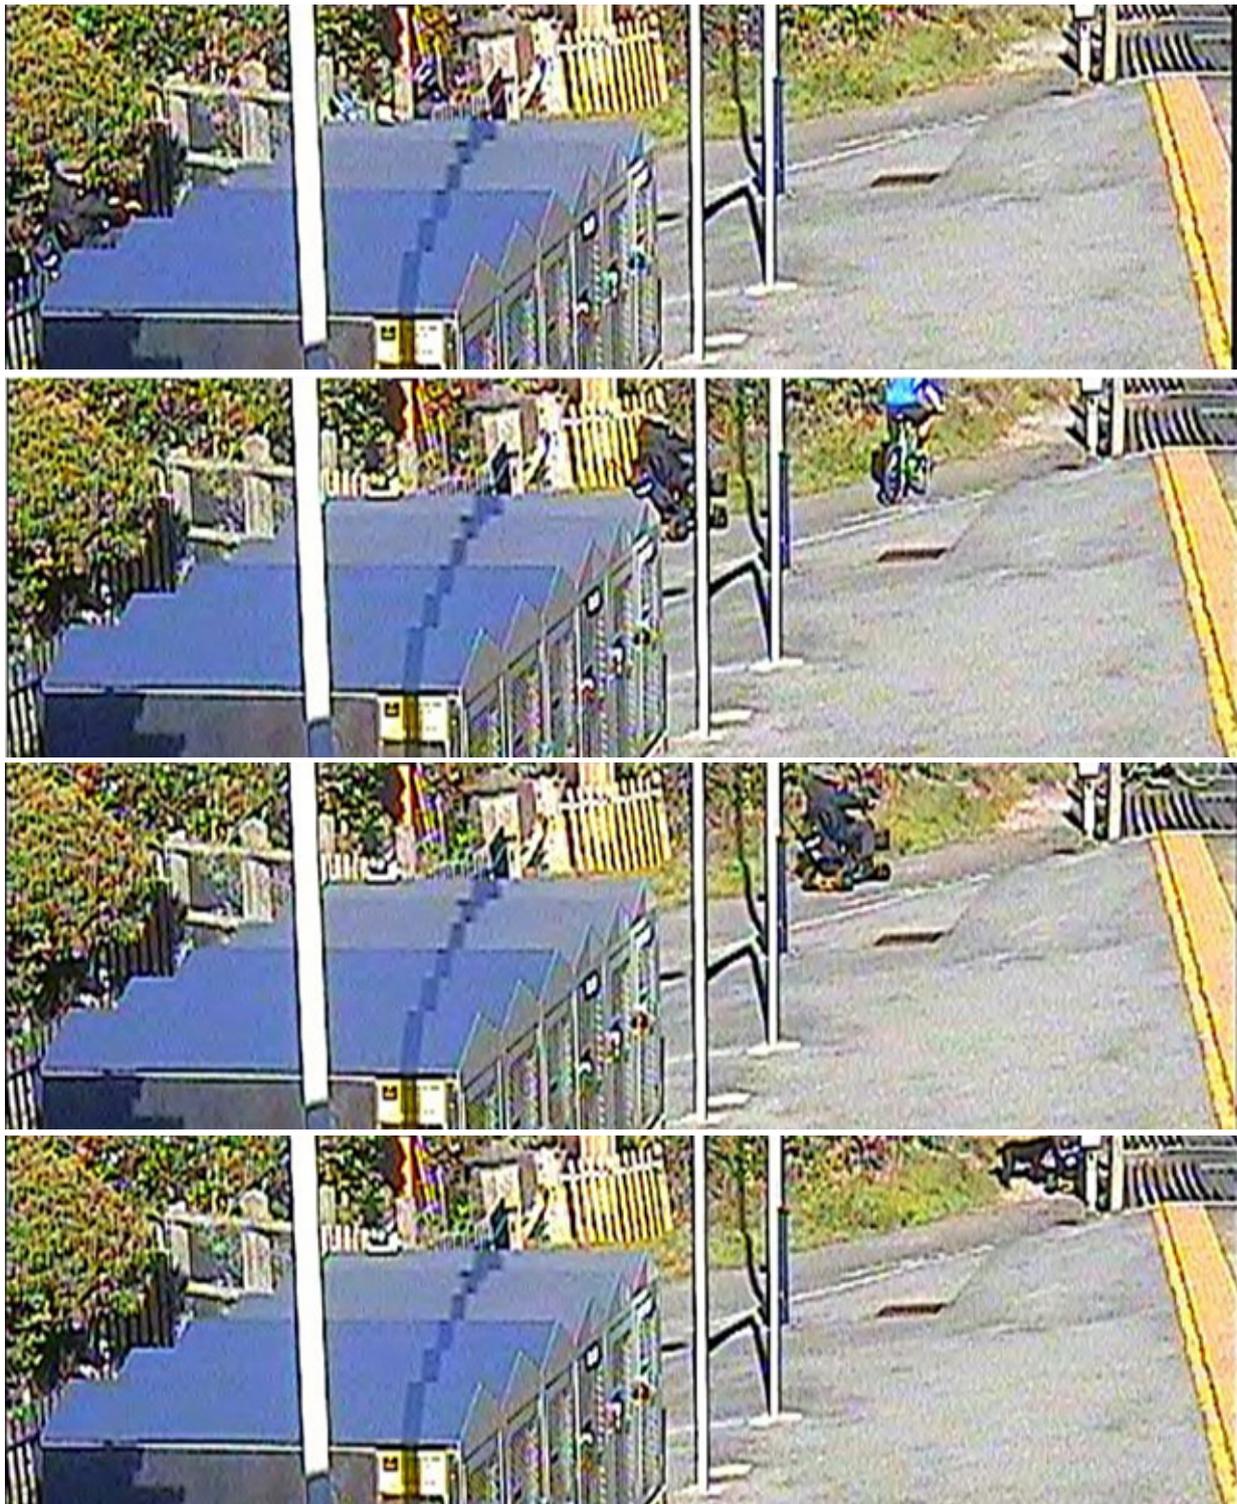
Figure 7: The mobility scooter user crossing from the north side, 38 minutes before the accident

- 26 Station CCTV recordings show that, on the outward journey, the mobility scooter user travelled through the station car park and along the path leading to the north side of the crossing around 38 minutes before the accident (figure 7). Just before reaching the north side of the crossing, the user stopped for 6 seconds, with his dog at his side. The scooter then moved forward and turned slowly onto the crossing before accelerating towards the southern side of the crossing and out of the CCTV coverage. The framing of the CCTV image is such that the user's head cannot be seen, so the RAIB is unable to tell which directions he looked before moving forward. The CCTV shows that the user's dog started to move forward at the same time as the mobility scooter but, because the dog moved faster, it crossed the railway ahead of the scooter.

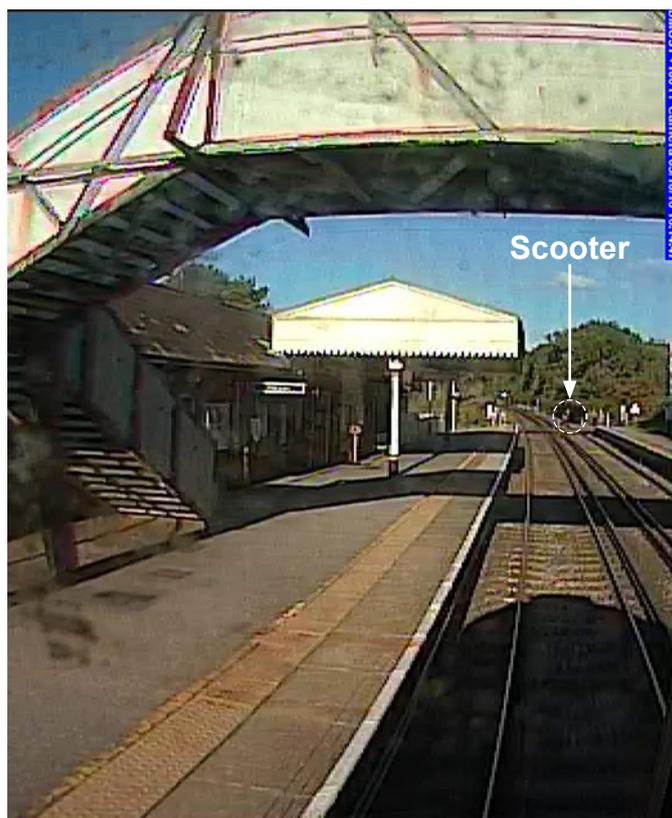
Figure 8: View from the train's forward facing CCTV at the moment brakes were applied, when the scooter was about to complete crossing the Down Bentley Loop

- 30 The train driver sounded the train horn at the whistle board (paragraph 11), around ten seconds before reaching the crossing, while travelling at close to 70 mph (113 km/h)⁴. The train's FFCCTV shows that the scooter was not visible to the train driver until about four seconds before the impact. Upon seeing the mobility scooter crossing the line, the driver applied the train's full service brake, followed by sounding the train's horn and applying the emergency brake just before impact. From the initial brake application until the train came to rest 327 metres past the crossing, its average deceleration rate was 14%g, compared to the 12%g minimum specified for emergency brakes on this type of train⁵.

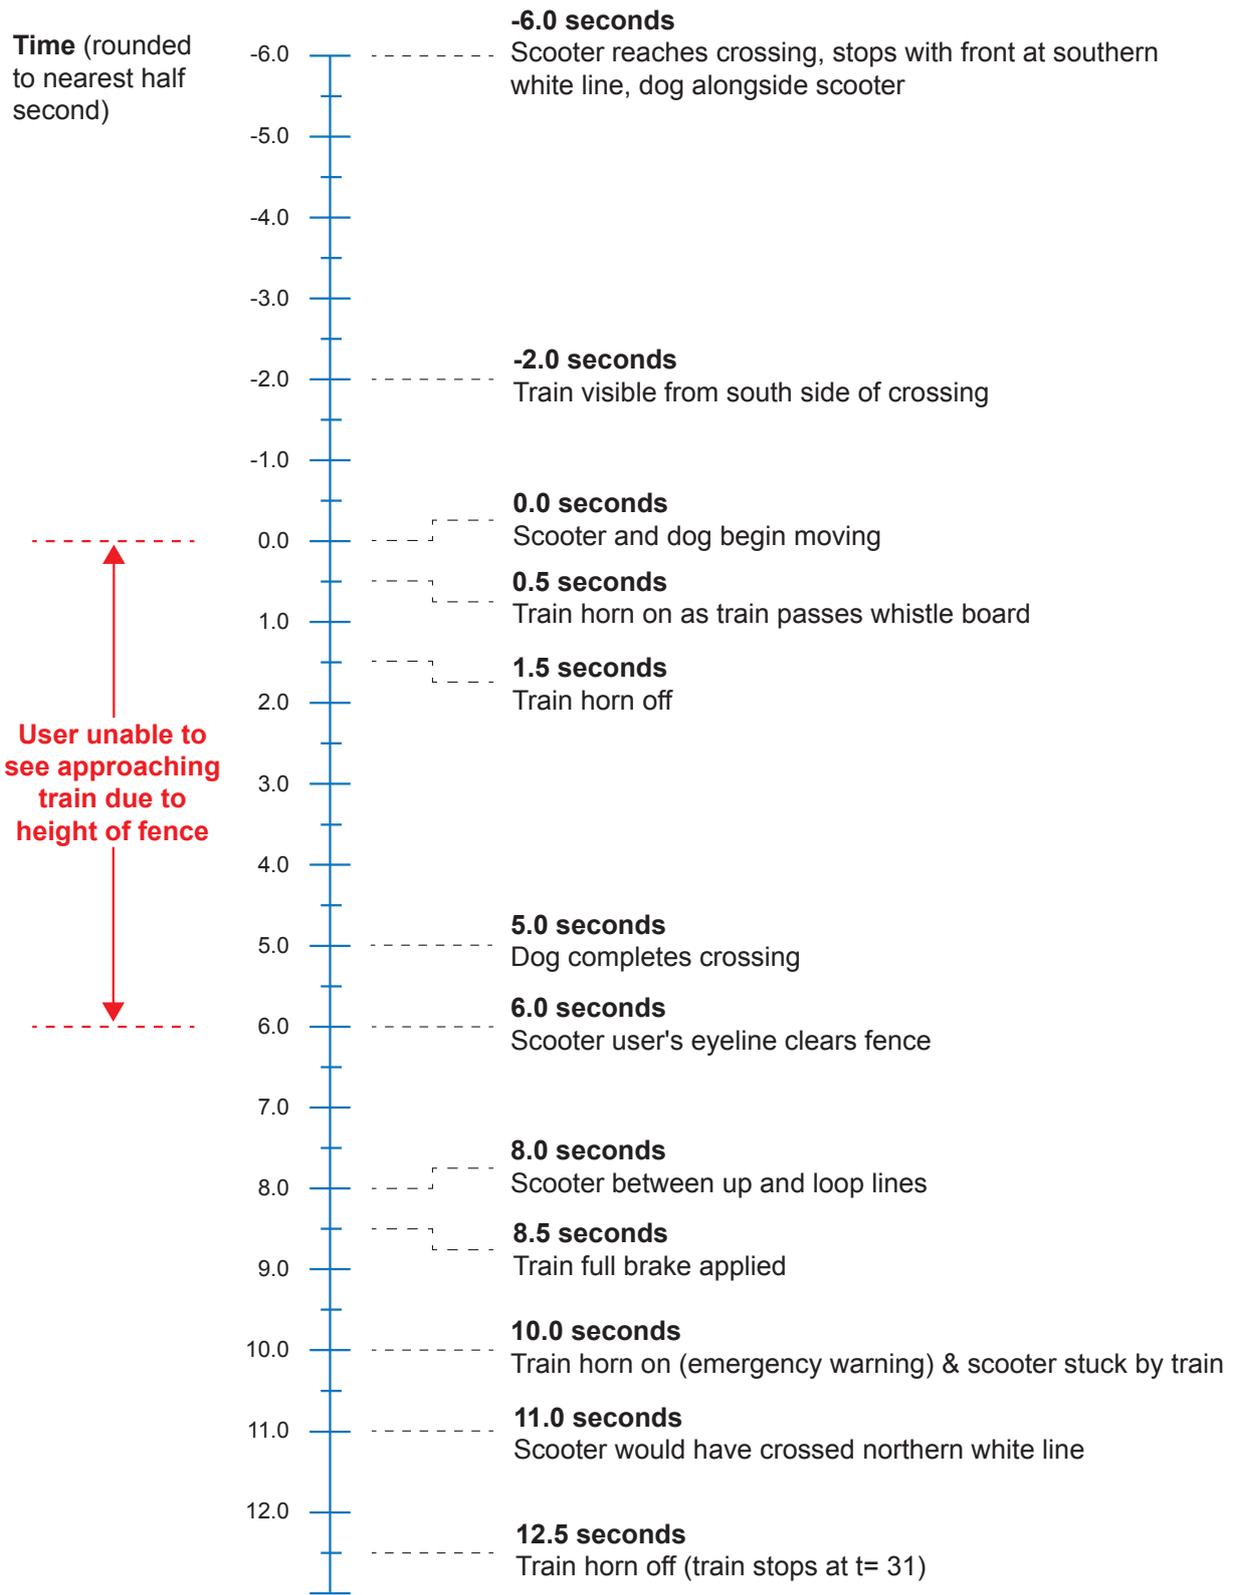
Figure 9: A timeline of the accident, derived from the available CCTV recordings

- 48 Despite the absence of direct evidence of the mobility scooter user's actions on the southern approach to the crossing, it has been possible to derive an indicative timeline of events leading up to the accident. This is based on the reasonable assumption that the actions of the mobility scooter user on his return journey would have been similar to those observed on the northern side of the crossing as he made his outward journey (the layout of the north and south sides of the crossing are similar). Other inputs to this indicative timeline have included;

- 50 The scooter then moved off (designated $t=0$ seconds in this description and figure 12) and began to turn towards the decking. The user then could not see trains approaching from Alton because the view from his scooter was obscured by the fence separating the path from the railway. When visiting the site after the accident, the RAIB noted that the fence height was sufficient to obstruct the view of a mobility scooter user. An adult of average height could see over it.

- 51 The limitation on scooter speed during turning meant that the fence then prevented the user seeing trains approaching from Alton for about 6 seconds until, at $t=6$ seconds, his head passed through the gap. It is uncertain whether he looked towards Alton at, or shortly after, this point (figure 11). It is possible he did not do so because he was concentrating on controlling his scooter and/or he was looking for trains approaching from the opposite direction.

- 52 The scooter then accelerated to its maximum speed of 4 mph (1.8 m/sec) as it continued over the crossing. About 3.5 seconds later ($t=9.5$ seconds) the train collided with the rear of the scooter.

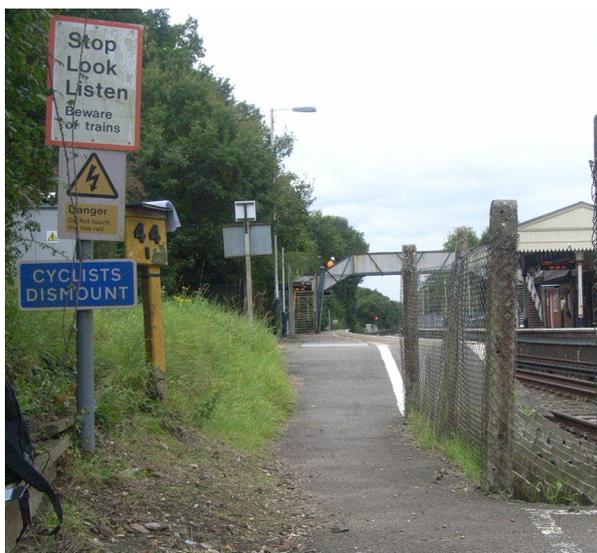
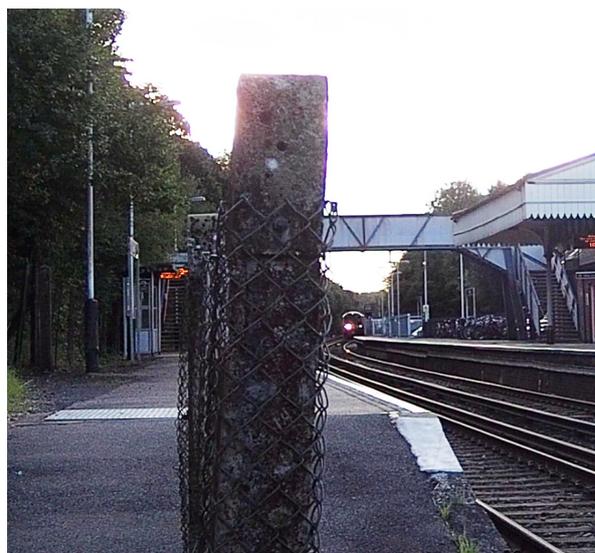
Figures 10 and 11: View of approaching trains before and after the white line, from the height of the mobility scooter user

- 53 The possible scenario described above, and likely variants, were a result of the following factors:
- The mobility scooter user was probably unaware (at $t=0$ seconds in the scenario) that it was unsafe to cross when the front of his scooter was at the white line. This cannot be stated with certainty because there is no direct evidence that he stopped just before the white line.

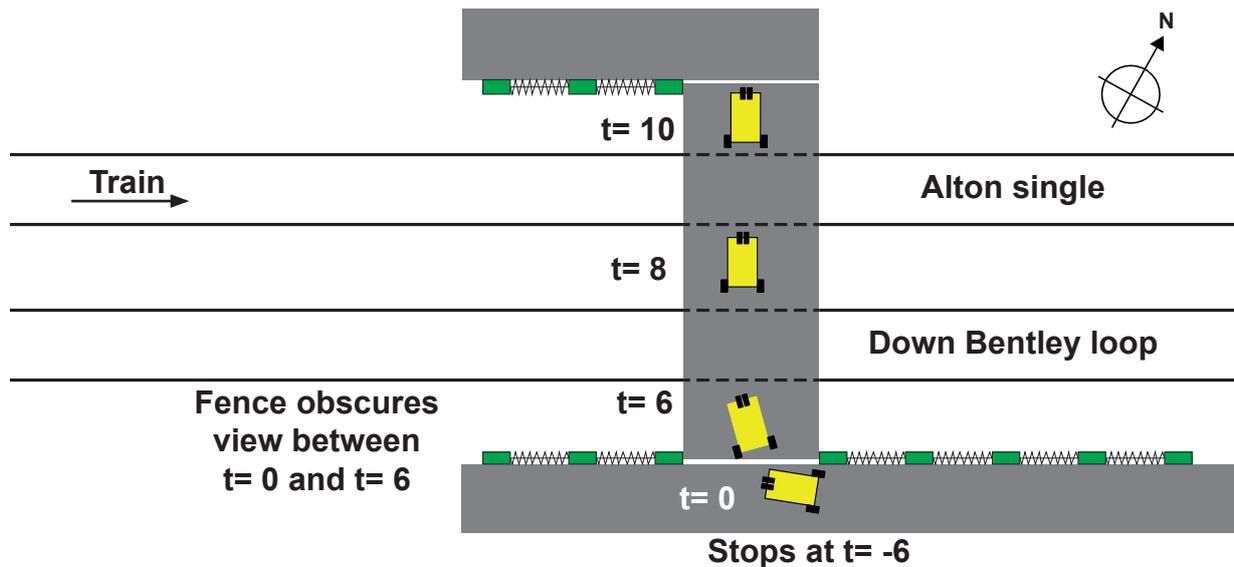
Figure 12: positions of the mobility scooter at key times during the crossing

- 55 **The user was probably unaware that it was unsafe to cross when the front of the scooter was at the white line.**
- 56 It is probable that the user made his initial decision to start to cross when the front of the scooter was at the white line. The train would have passed the sighting point approximately two seconds before the scooter started moving.

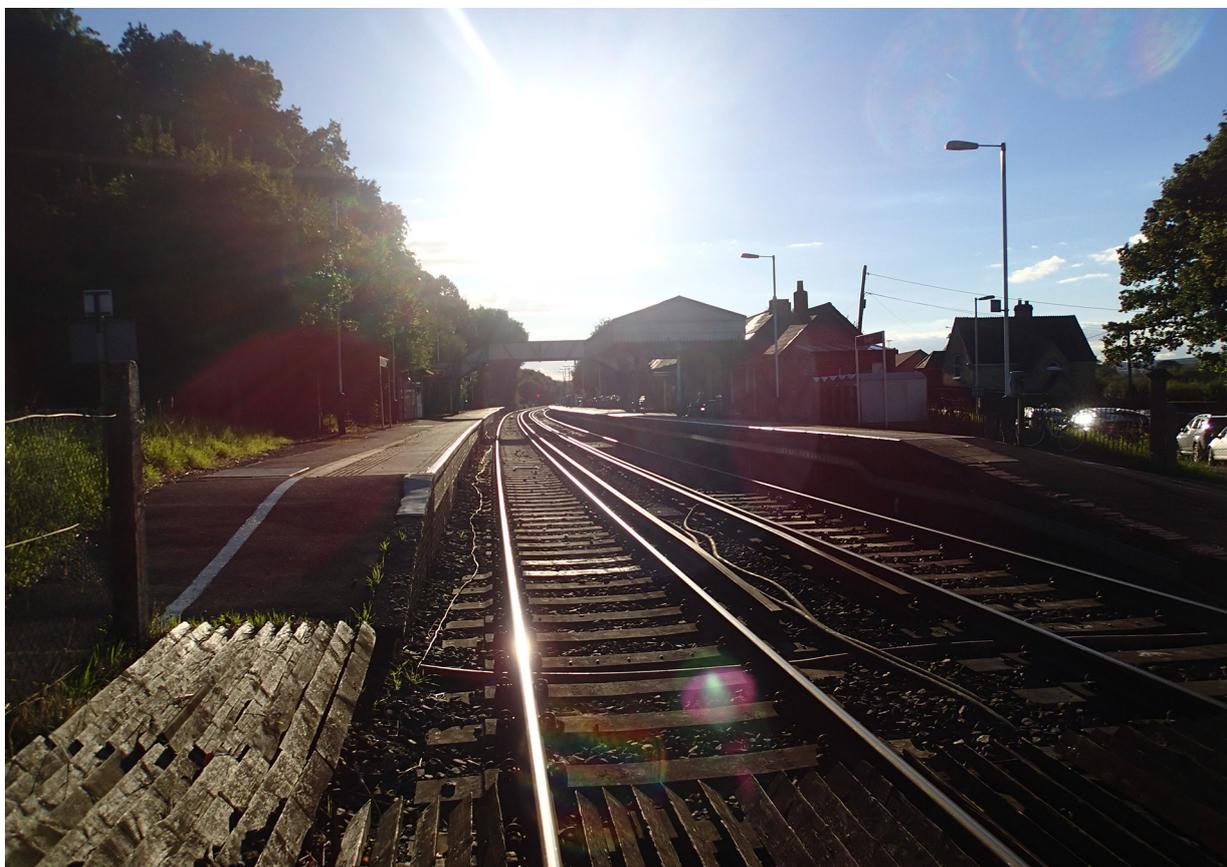
Figure 13: view from the southern end of the crossing decking, taken at the same time of day as the accident, showing the effect of sun glare

- 57 If deciding to cross when the front of the mobility scooter was at the white line, it is possible that the user did not look towards the approaching train during the last two seconds before the mobility scooter started moving (it is unlikely that the mobility scooter user would have moved off if he was aware that a train was rapidly approaching at the time). This would mean he looked towards the train just before it reached the sighting point. It is possible that he did this because, in the short time after looking in this direction, and before moving off, the user looked at the fence posts and/or crossing surface in order to control his mobility scooter properly. He may also have been looking for trains approaching from the opposite direction at that time.

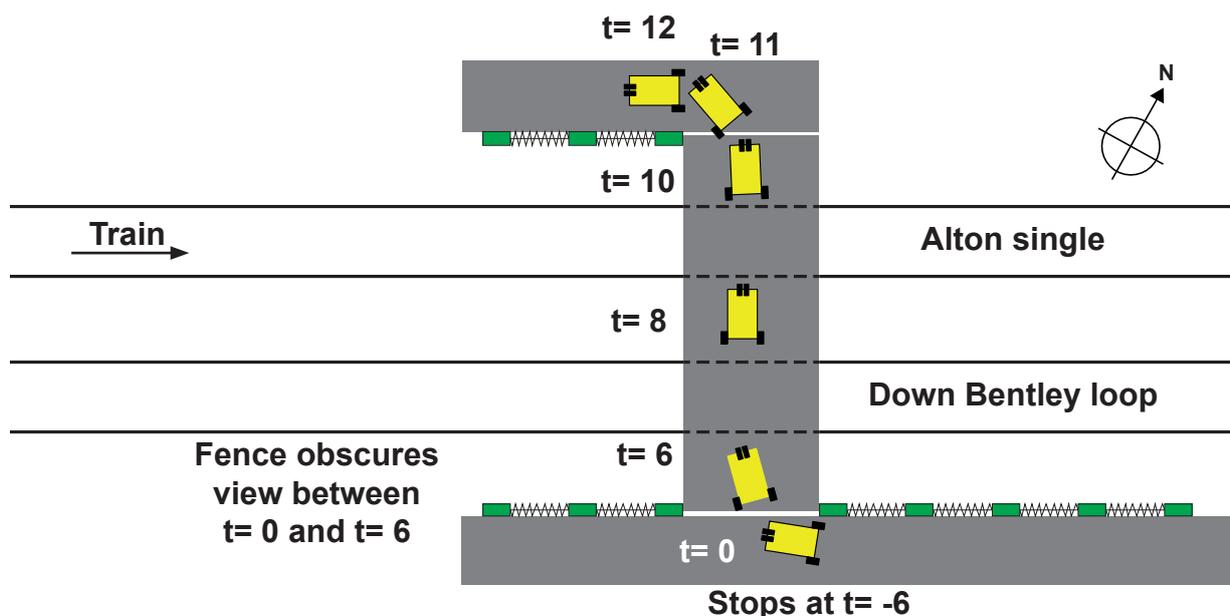
Figure 14: the scooter's trajectory at Alice Holt footpath crossing, had the accident not occurred

75 The September 2015 risk assessment did not make provision for the additional 50% traverse time applicable to vulnerable users (paragraph 80). It calculated the standard traverse time as 7.57 seconds, close to the 7.25 seconds calculated by the RAIB after the accident. Adding the 50% allowance would have given a traverse time of 11.35 seconds. This is less than the 12.9 seconds warning time available to users looking towards Alton from the south side of the crossing (the accident situation). As a result, consideration of vulnerable users crossing only from the south side of the railway would not have resulted in a change in crossing arrangements.

- 76 However, consideration of vulnerable users crossing from the north side could have resulted in changes to arrangements at the crossing. The traverse time of 11.35 seconds required for vulnerable users is longer than the 9.7 seconds warning time available to users at the north side of the crossing (table 1). If changes had been made to accommodate vulnerable users on the north side of the crossing, it is possible that these would have altered the circumstances of the accident.

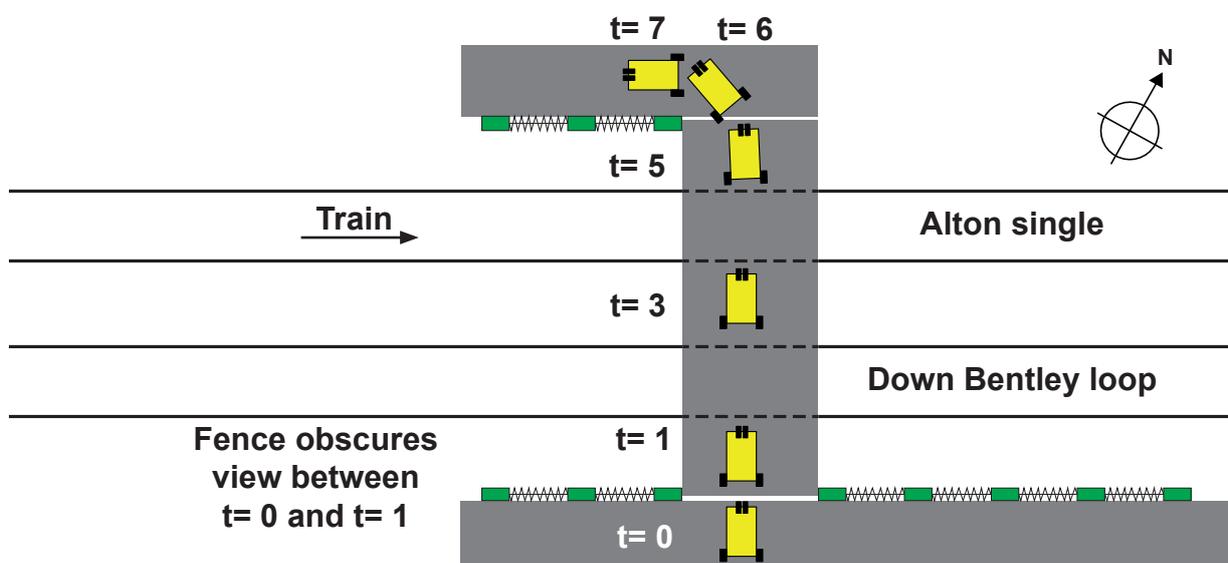
Figure 15: positions of the mobility scooter at key times during the crossing, if the scooter did not have to turn after starting moving

- 85 A modification allowing a decision with the scooter at right angles to the railway would have reduced the traverse time to 6 seconds on the RAIB possible timeline (figure 15). If the fences had not been lowered, it would also have resulted in a substantial reduction in the period of time when the fence obscured the user's view of trains approaching from Alton.

- 84 As an alternative or complementary action, the approach to the crossing could have been modified so that mobility scooter users could position themselves at right angles to the railway before making their decision to cross. Network Rail's Access & Inclusion Manager stated after the accident at Alice Holt that this is the position which mobility scooter users should try to reach before making their decision to cross. The approach path on the south side of the decking at Alice Holt crossing was too narrow (figures 16 and 17) to achieve this without partially passing over the white line at the gap in the fence and then reversing. It is possible that making this manoeuvre would appear more dangerous to the mobility scooter user than making a decision from a position at an angle to the line.
