Protocols for Improving the Proficiency of Material Testing Laboratories in Mozambique

Report on Initial Laboratory Visits and Protocol for
the PTS (Final)

Project No. MOZ2094A

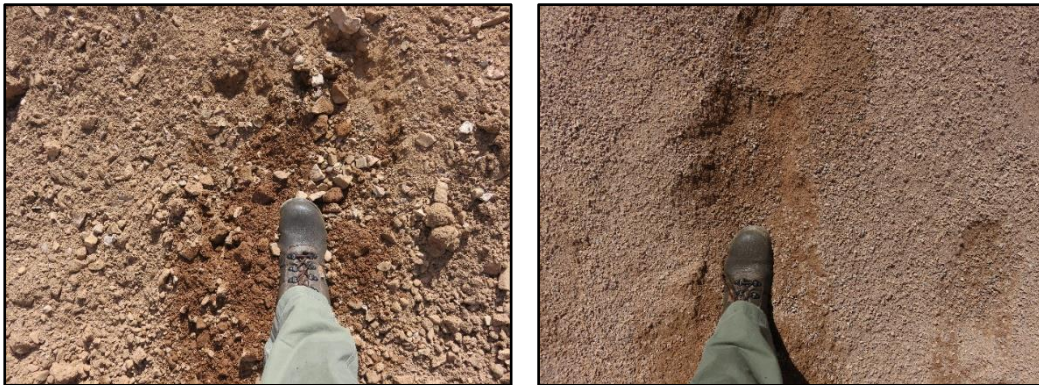
Figure 7.1: Granular material at JJR Facility

1. Crushed material is most likely to be non-plastic (NP). (A sample of a plastic material (only -0.425 mm fraction) will be sourced in Inhambane to test the laboratories' capabilities for testing plastic materials).
2. Concrete stone can be used for grading, FI & 10% FACT samples. ALD samples are not available at the quarry.
3. Good sand source that can be used for SE (Sand Equivalent) if required.
