THE HOOPSTAD STABILIZED KALAHARI SAND LTPP EXPERIMENT AFTER 55 YEARS

VOLUME 1 : FINAL REPORT

**AFCAP-EMUK10636A –
GEN 2013B – SC 15395**

DECEMBER 2017

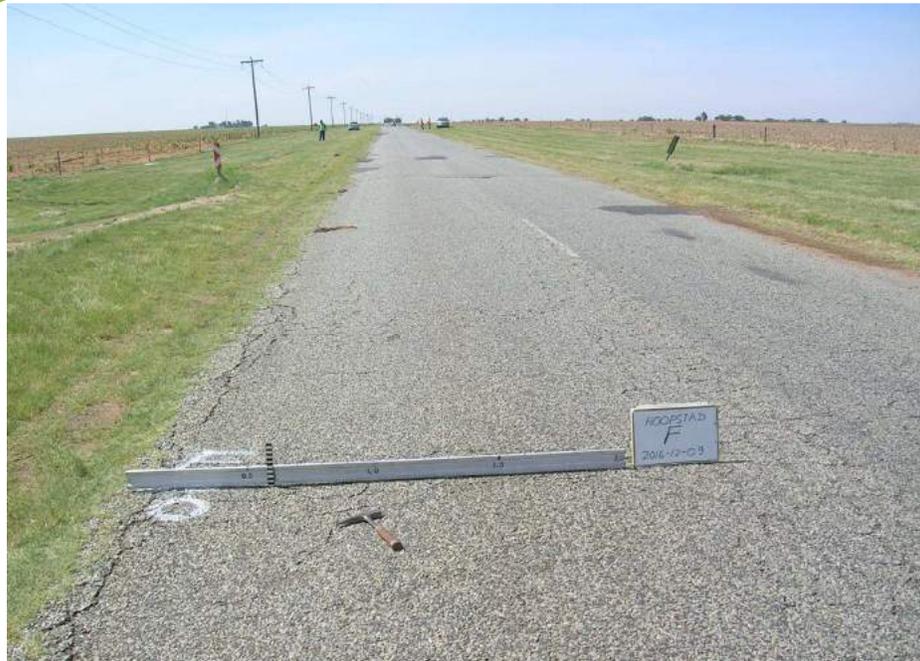
Cover photo: General view towards Bultfontein of Section F (sand plus 5 % PBFC base) and others towards Section K in December 2016 after 55 years and about 1.5M E80 per lane.

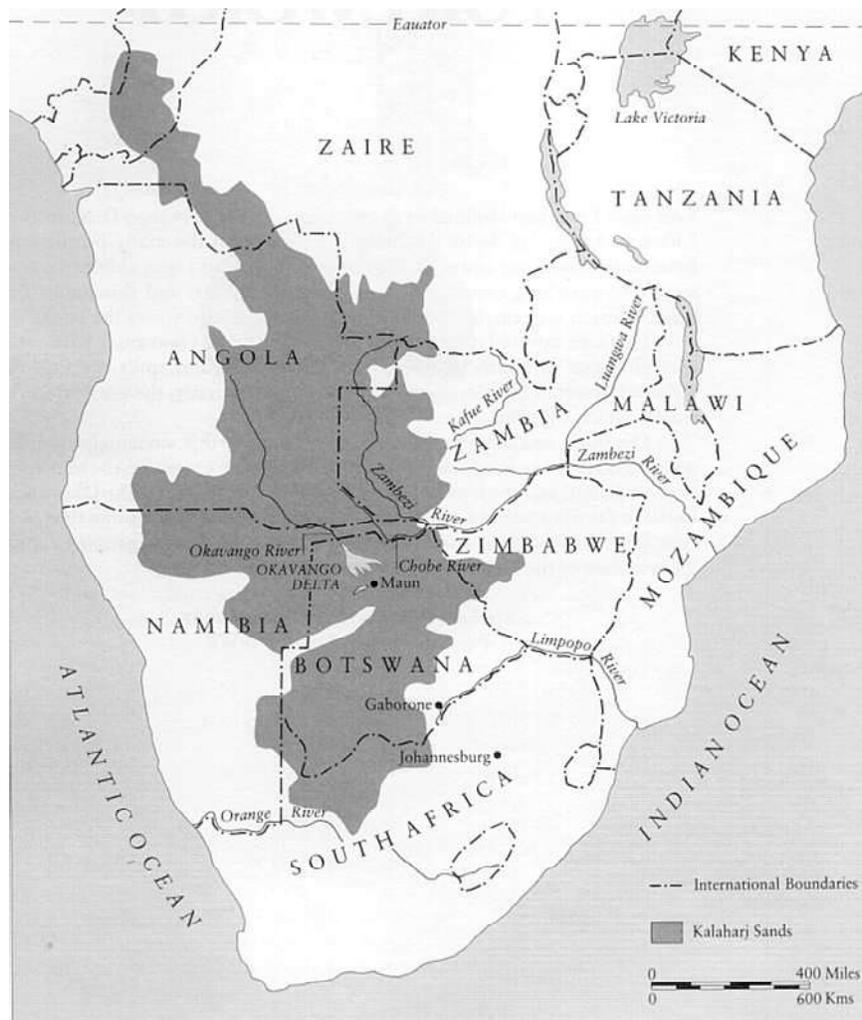
Figure 1. Distribution of Kalahari Sands
(Main 1987, in Botswana Roads Department 2010)

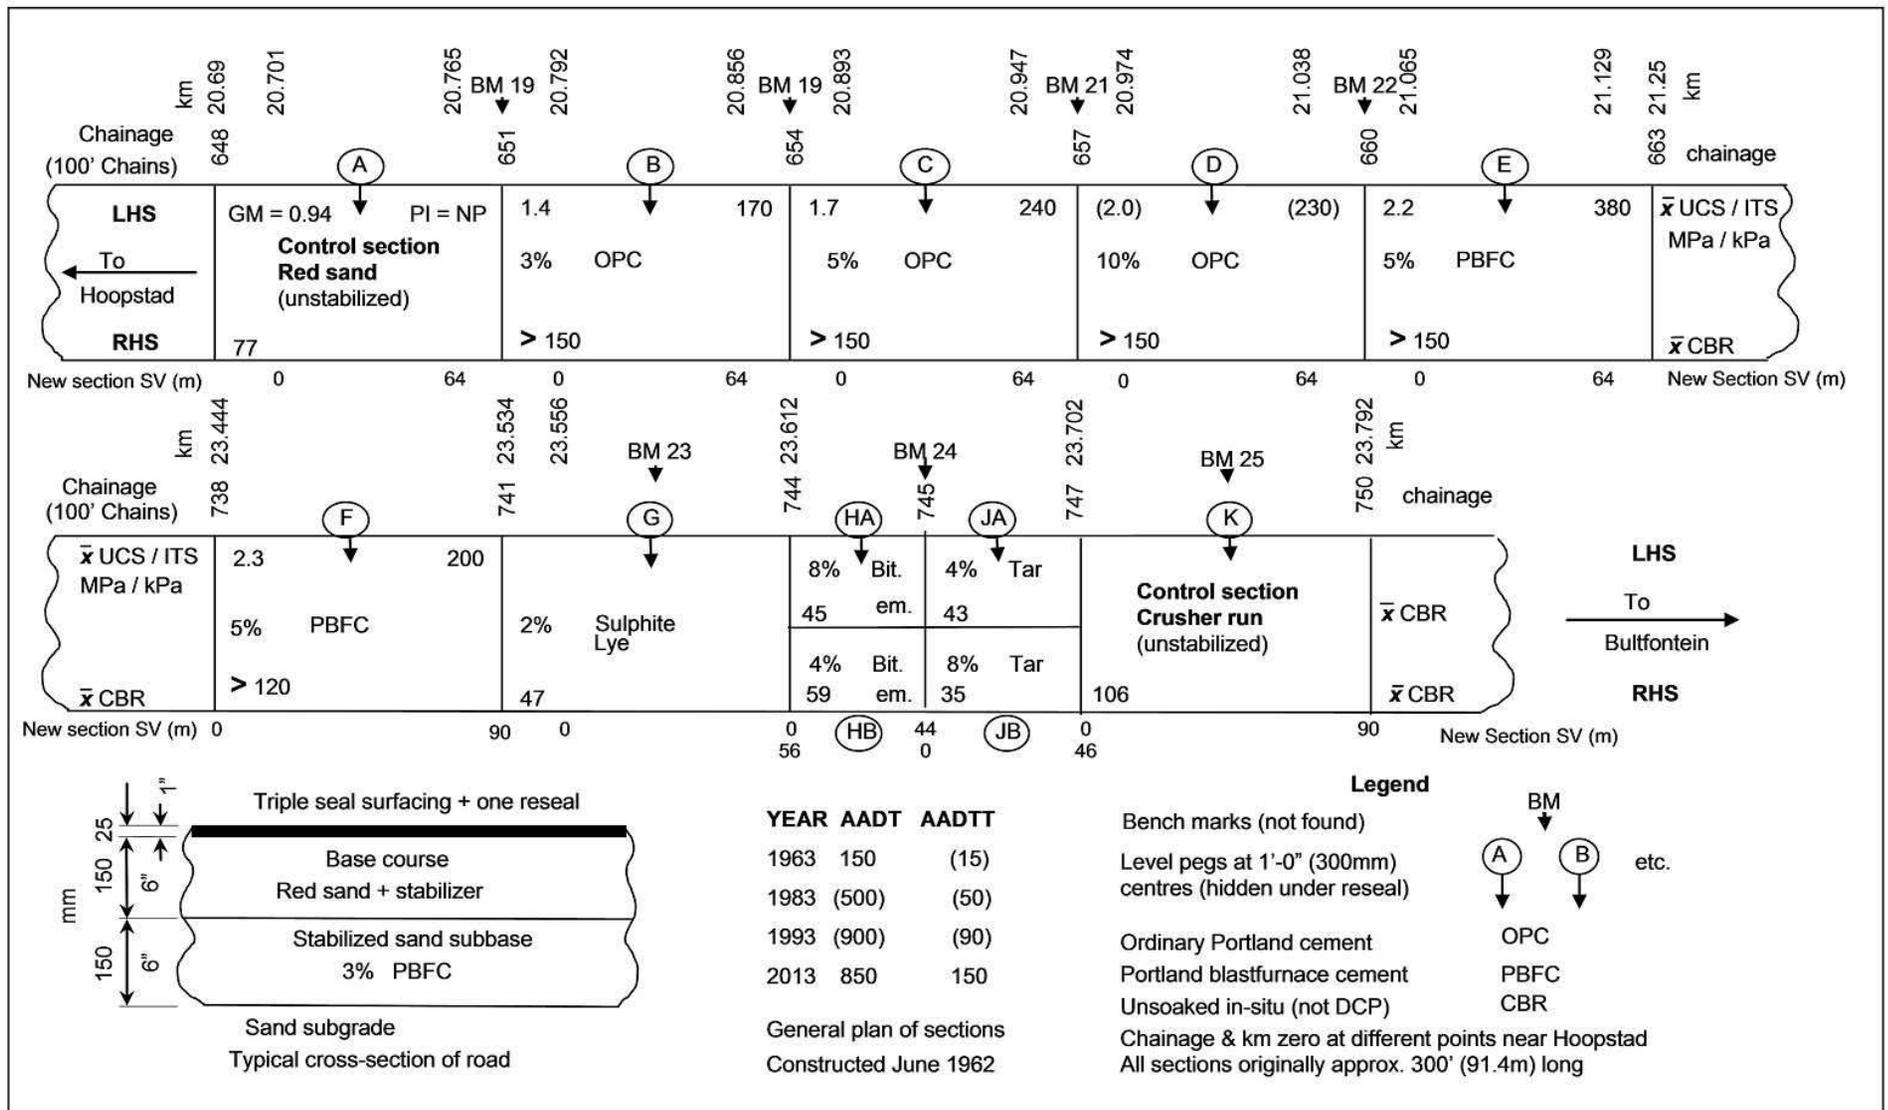
Figure 2 Kalahari sand stabilization experiment on Hoopstad-Bultfontein road showing mean as-built base course strengths, traffic history, and new section SVs with their corresponding current log kms

The location, layout and as-built test results compiled by the author mostly from Gregg (1963) are shown in **Figure 2 and Tables 1 and 2**.

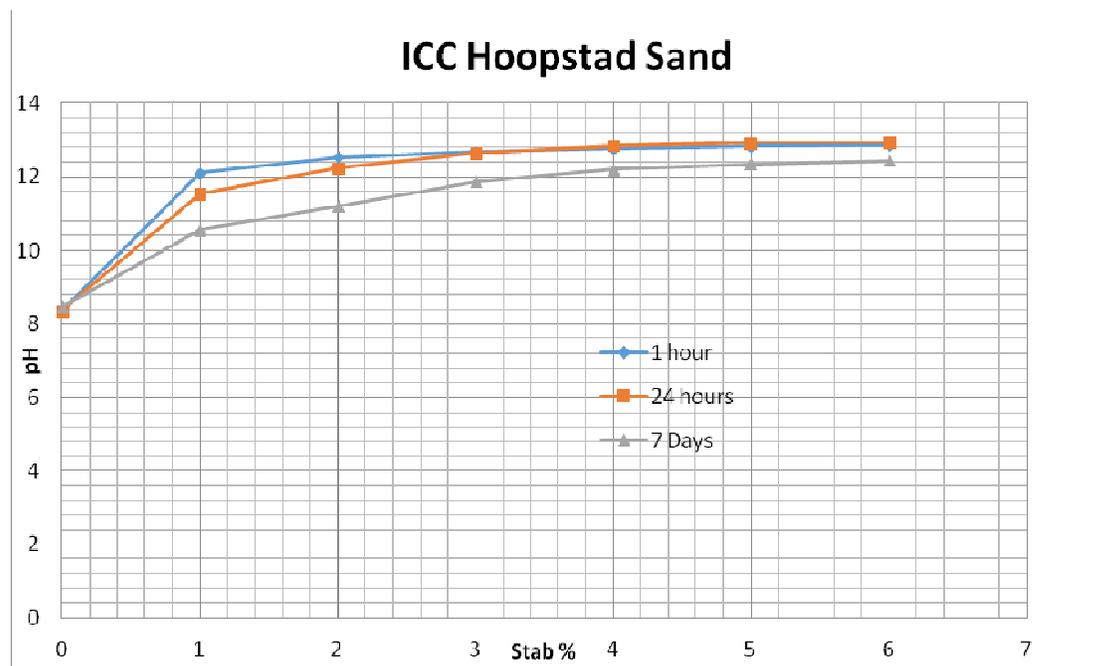
Figure 3. Initial Consumption of Cement by the pH Method

The ICC was therefore about 3.5 – 4.0% or, conservatively, 4.0%. In the absence of the requested pH on the pure cement or at least on a 10% mix the 7-day test must be regarded as invalid because the maximum pH reached was only 12,4 and was still increasing.

Although this test was carried out according to the SANS method – including oven-drying of the raw sand (air-drying was requested) – buffers of 7 and only 10 and not the required 12 were used. This and not having kept the specimens sealed for 7 days may account for the low pH recorded. Although not required by the method, the specimens were disturbed at regular intervals to prevent them forming solid lumps.
