SAFETY FLYER TO THE FISHING INDUSTRY

**Fishing boat *Illustris* (B119) fatal man overboard after boarding,
12 November 2017**

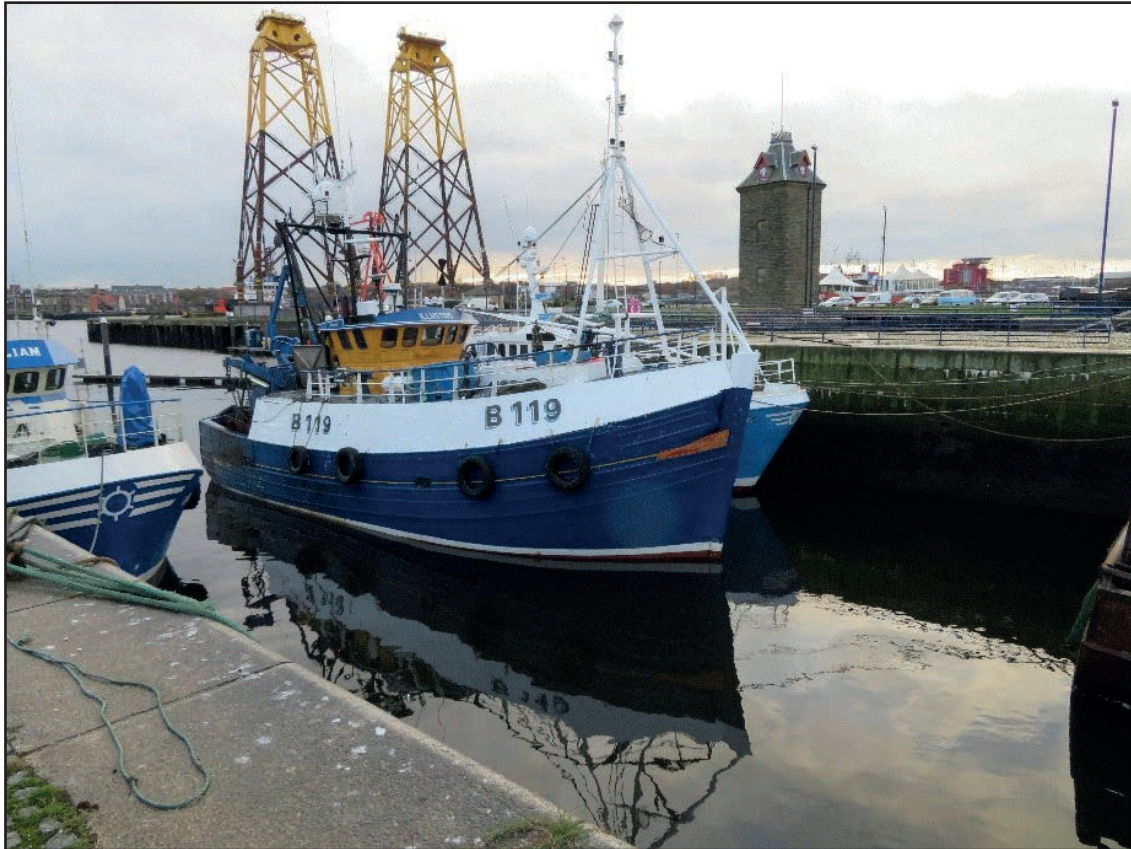
Illustris alongside another fishing vessel
