PROJECT
**Plank Lane
Water Orton
Warwickshire**

TITLE
**Topographical
Survey**

PROJECT
Plank Lane Water Orton Warwickshire

TITLE
Underground Utility Survey

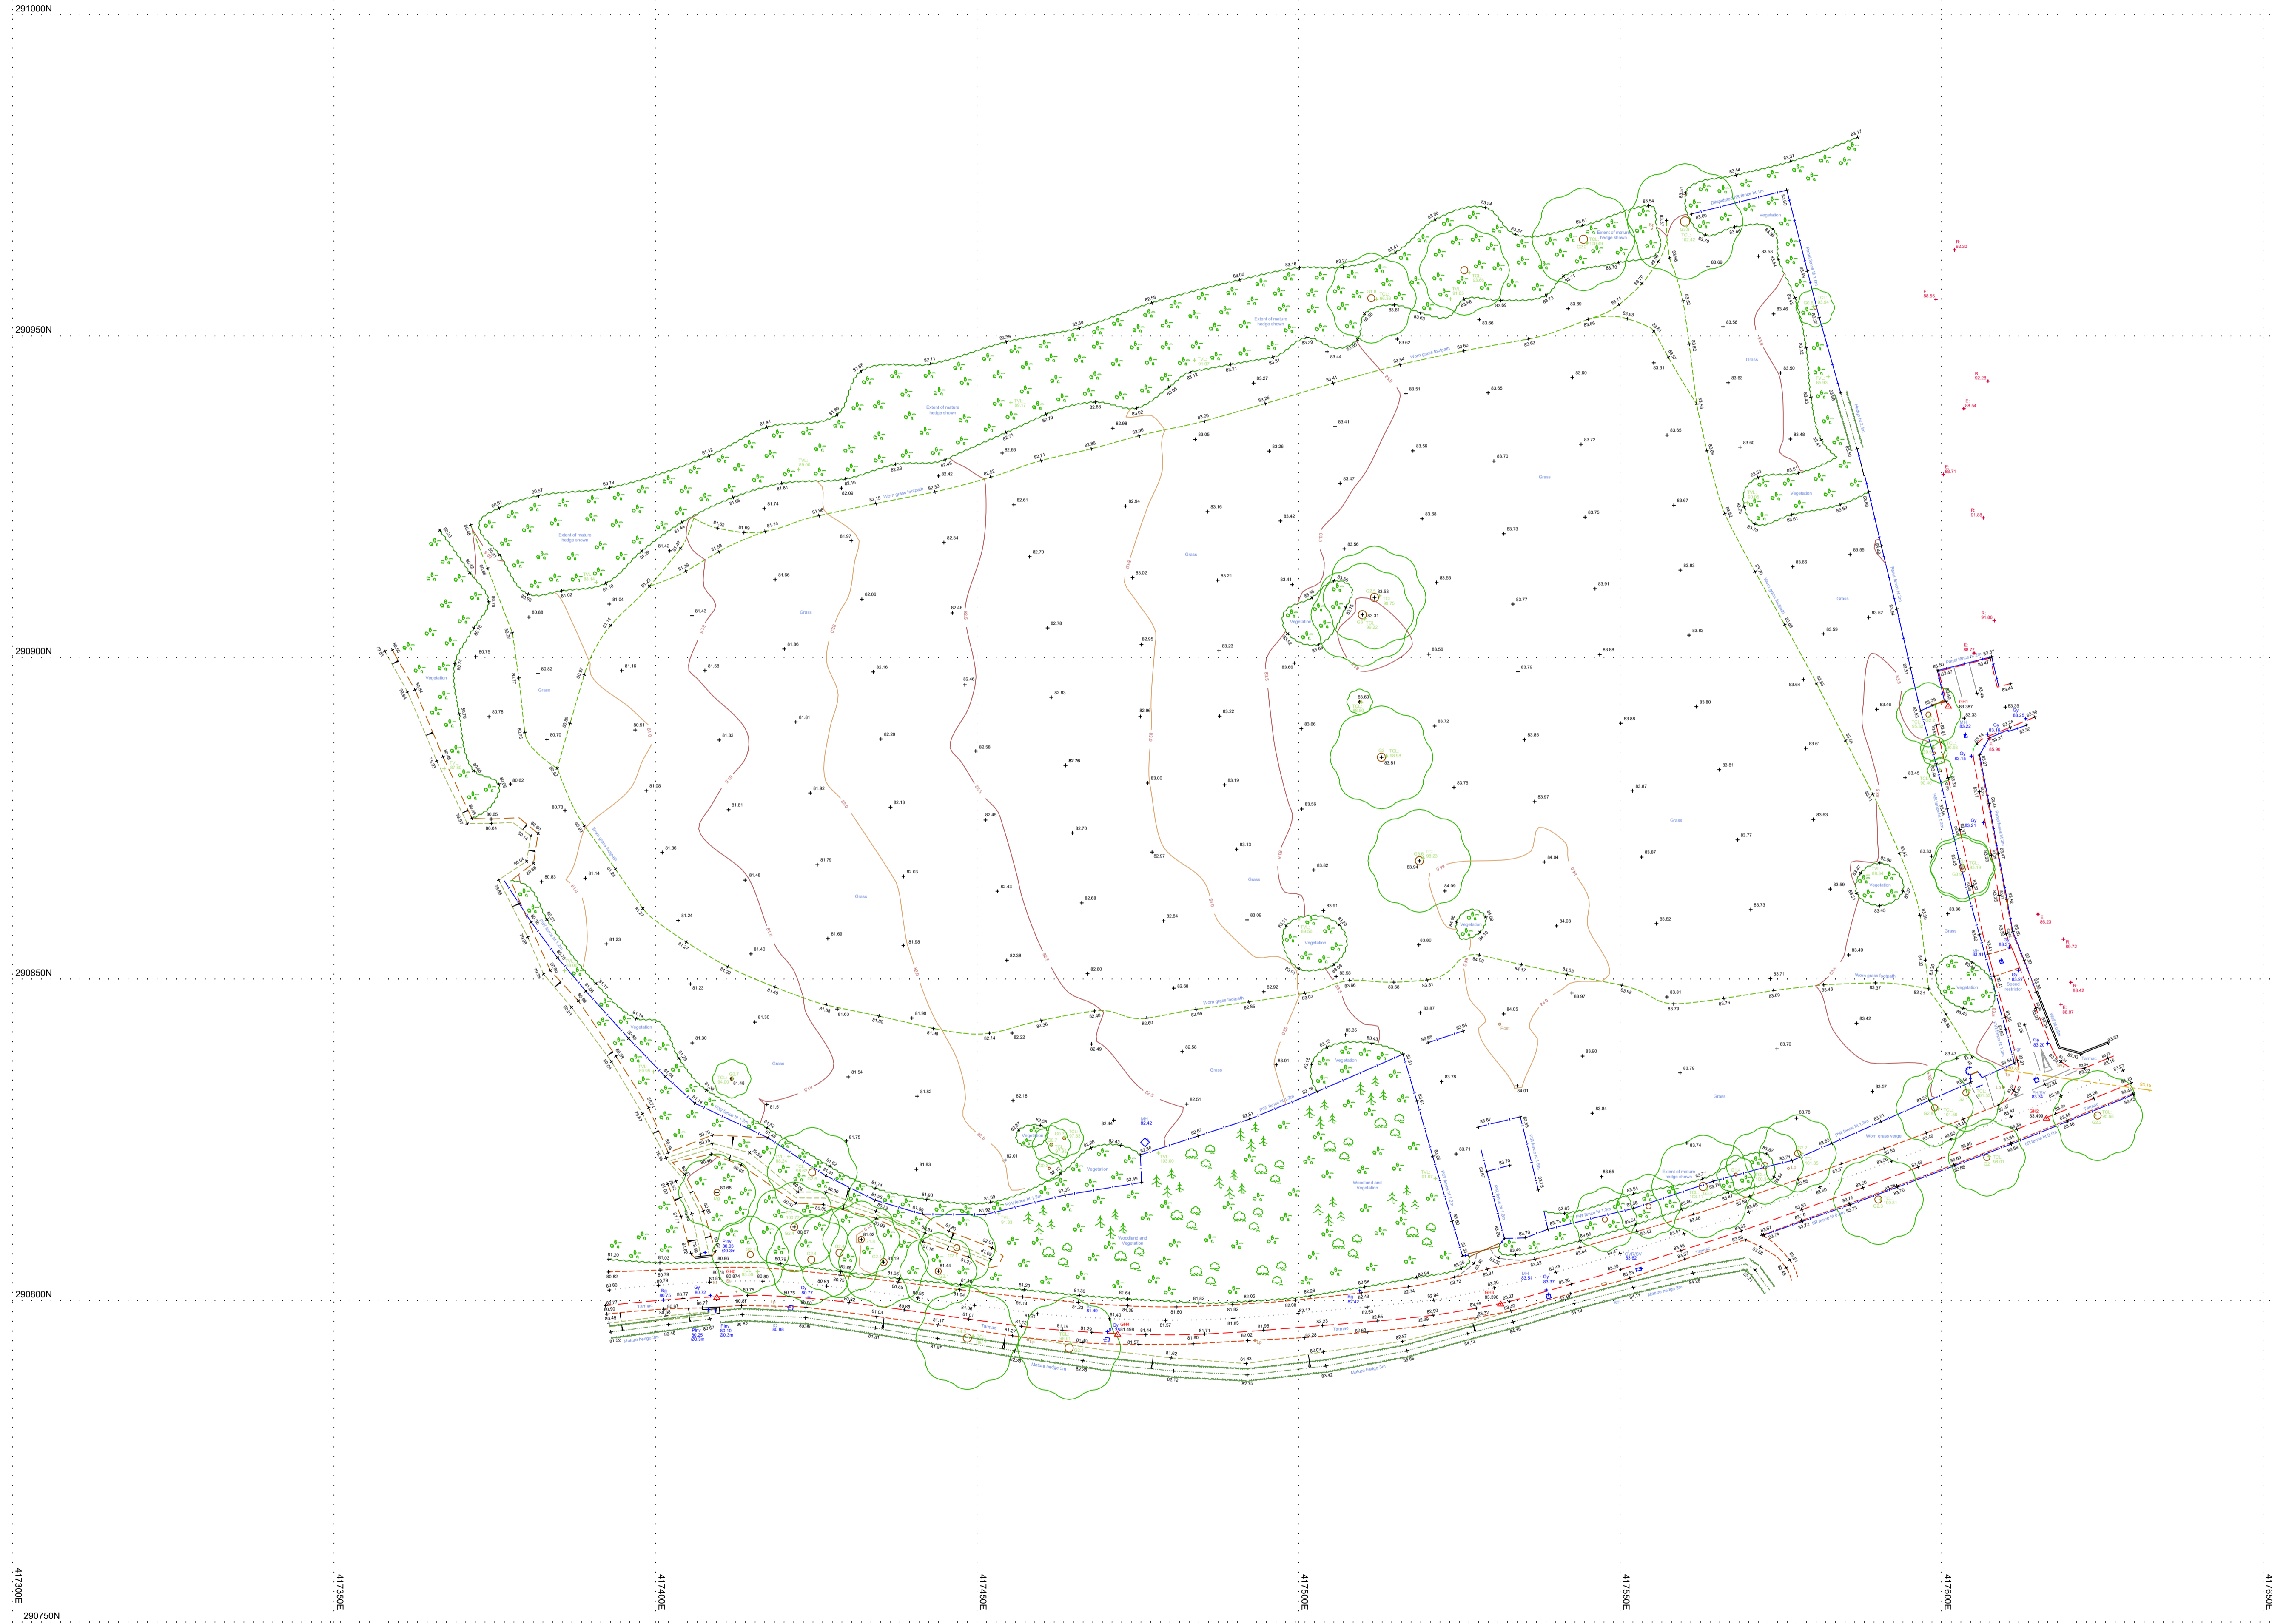
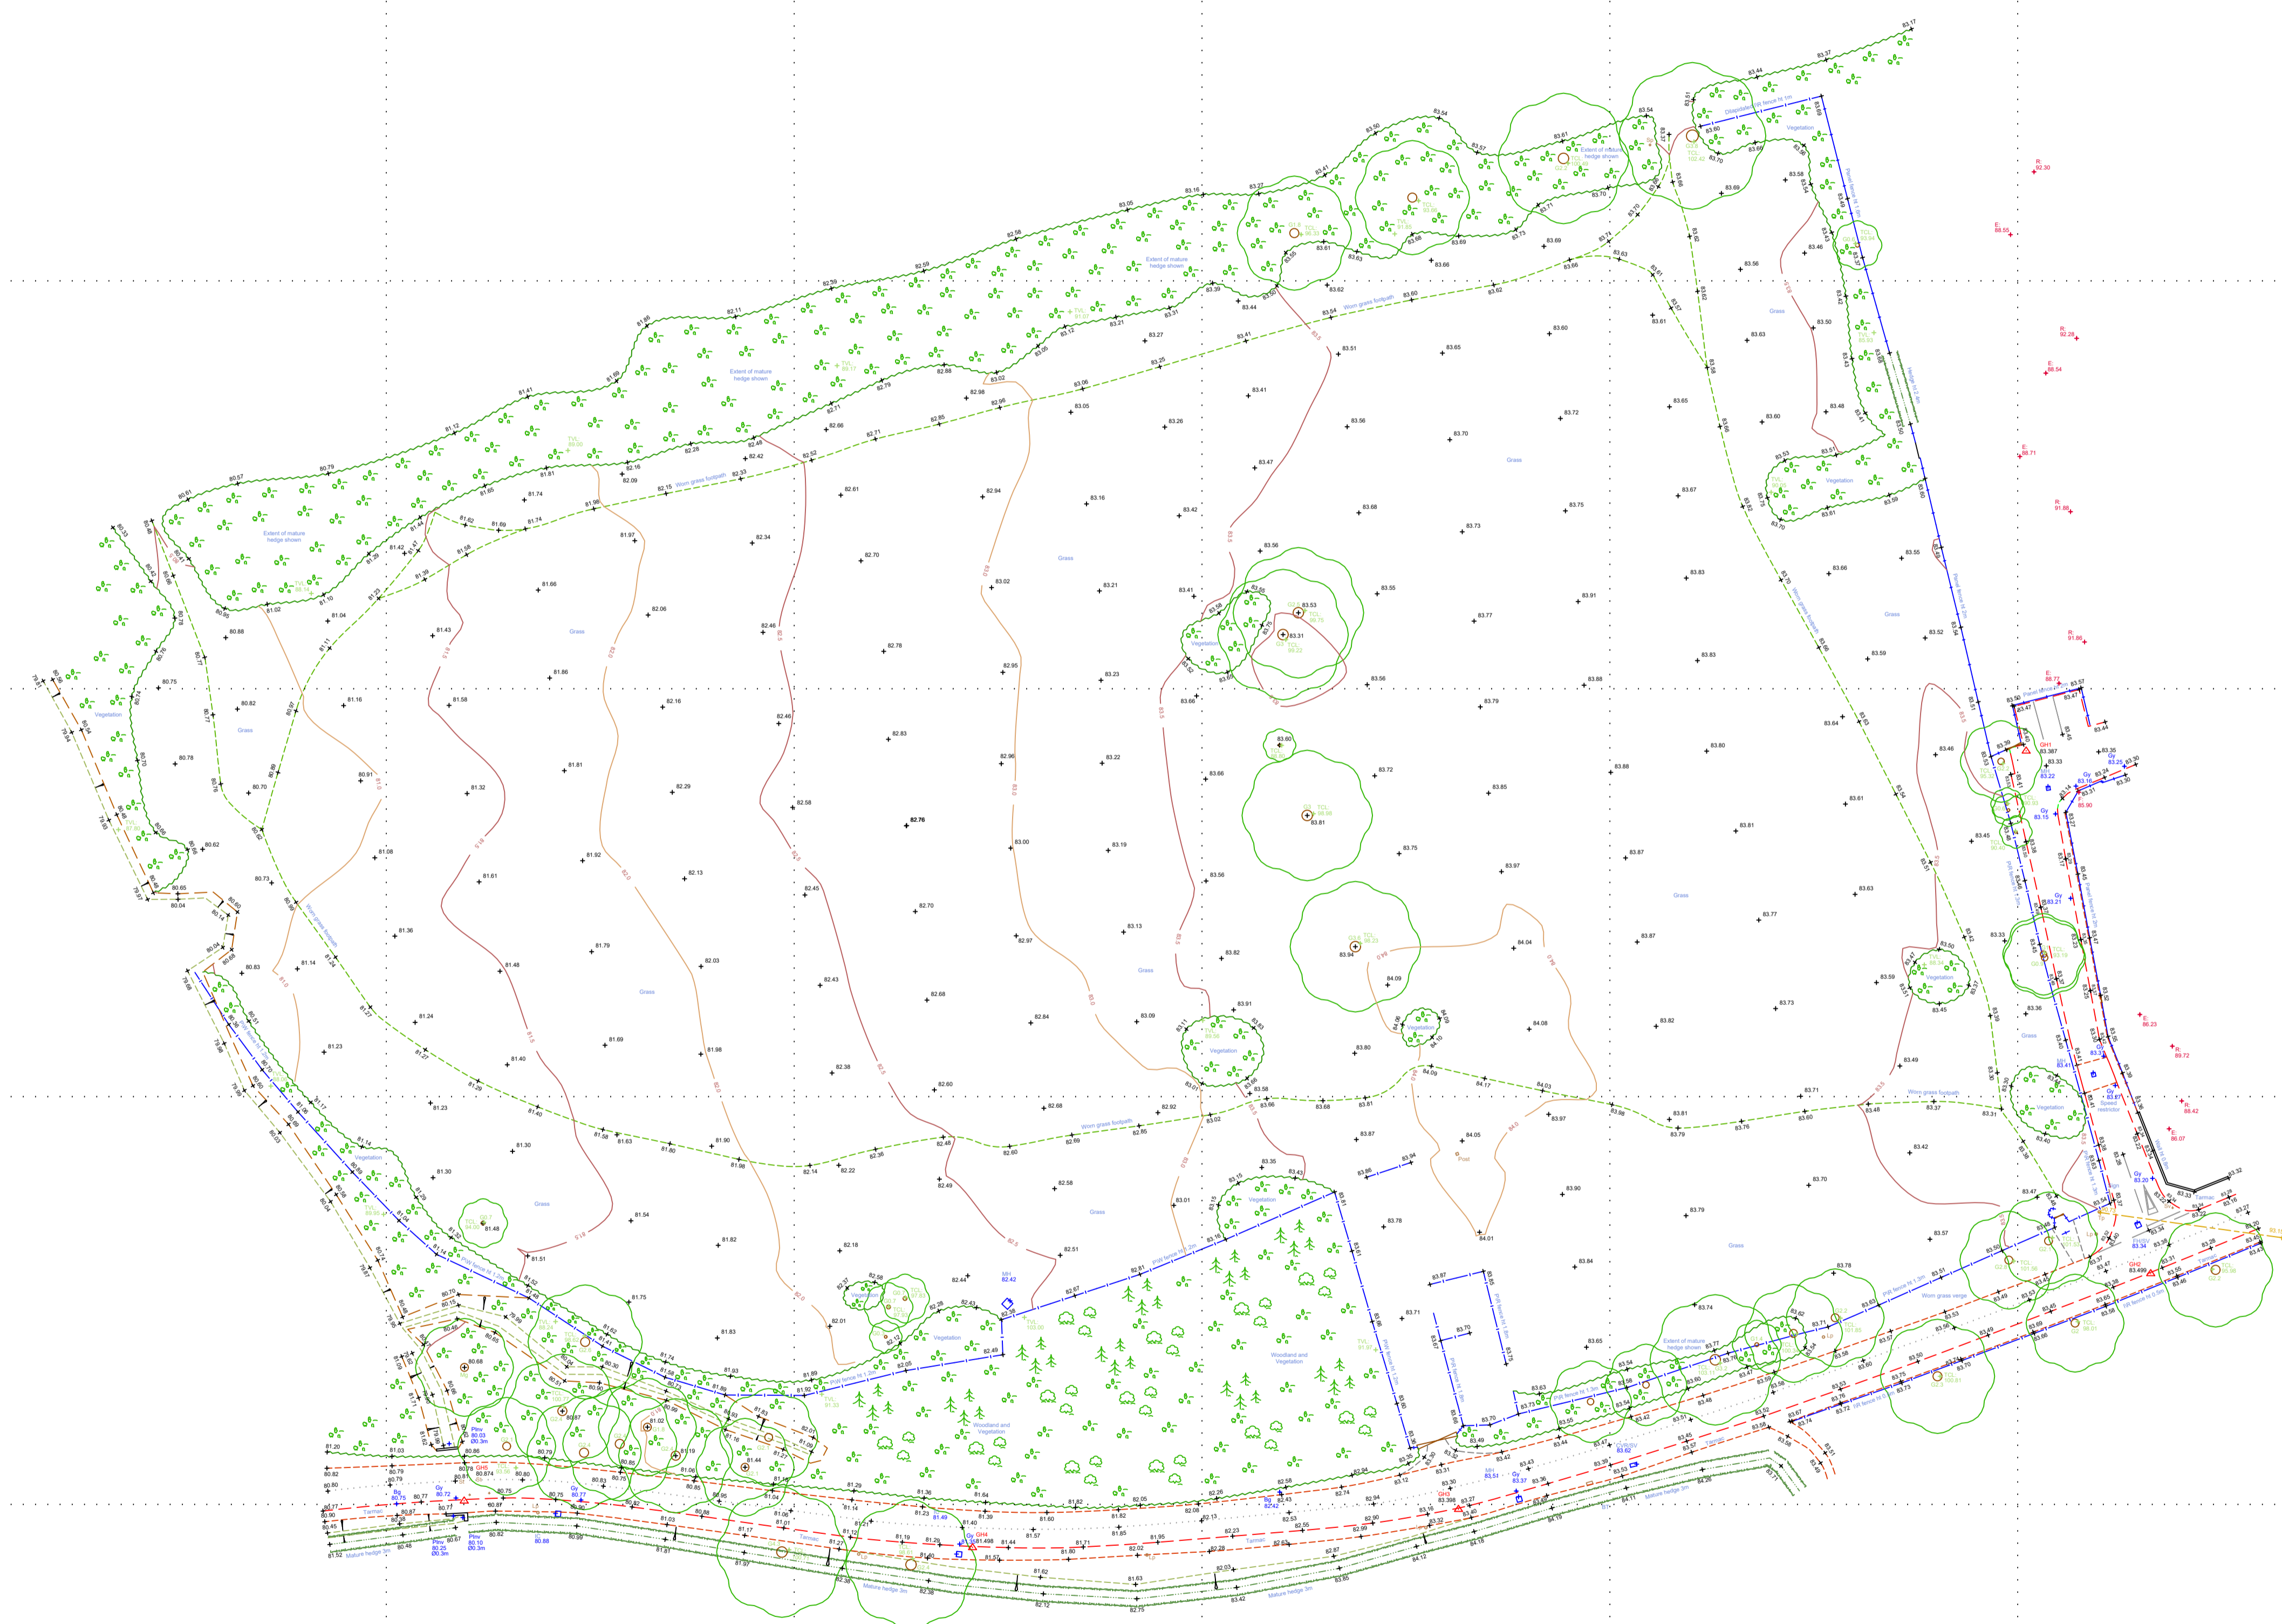
Drawing No.	24216_T	Rev.	0
-------------	---------	------	---

OS Note:
Some services may have been omitted due to parked vehicles.
The Ordnance Survey title is to be used as a guide only.

This survey has been oriented to the Ordnance Survey (OS) National Grid (OSGB36 15) via Global Navigational Satellite Systems (GNSS) and the O.S. Active Network (OS Net).
A true OSGB36 coordinate has been established near to the site centre via a transformation using the OSTN15GB & OSGM15GB transformation models.
The survey has been correlated to this point and a further one or more OSGB36 (15) points established to create a true O.S. bearing for angle orientation.
No scale factor has been applied to the survey therefore the coordinates shown are arbitrary & not true O.S. Coordinates which have a scale factor applied.
Please refer to Survey Station Table to enable establishment of the on-site grid and datum.

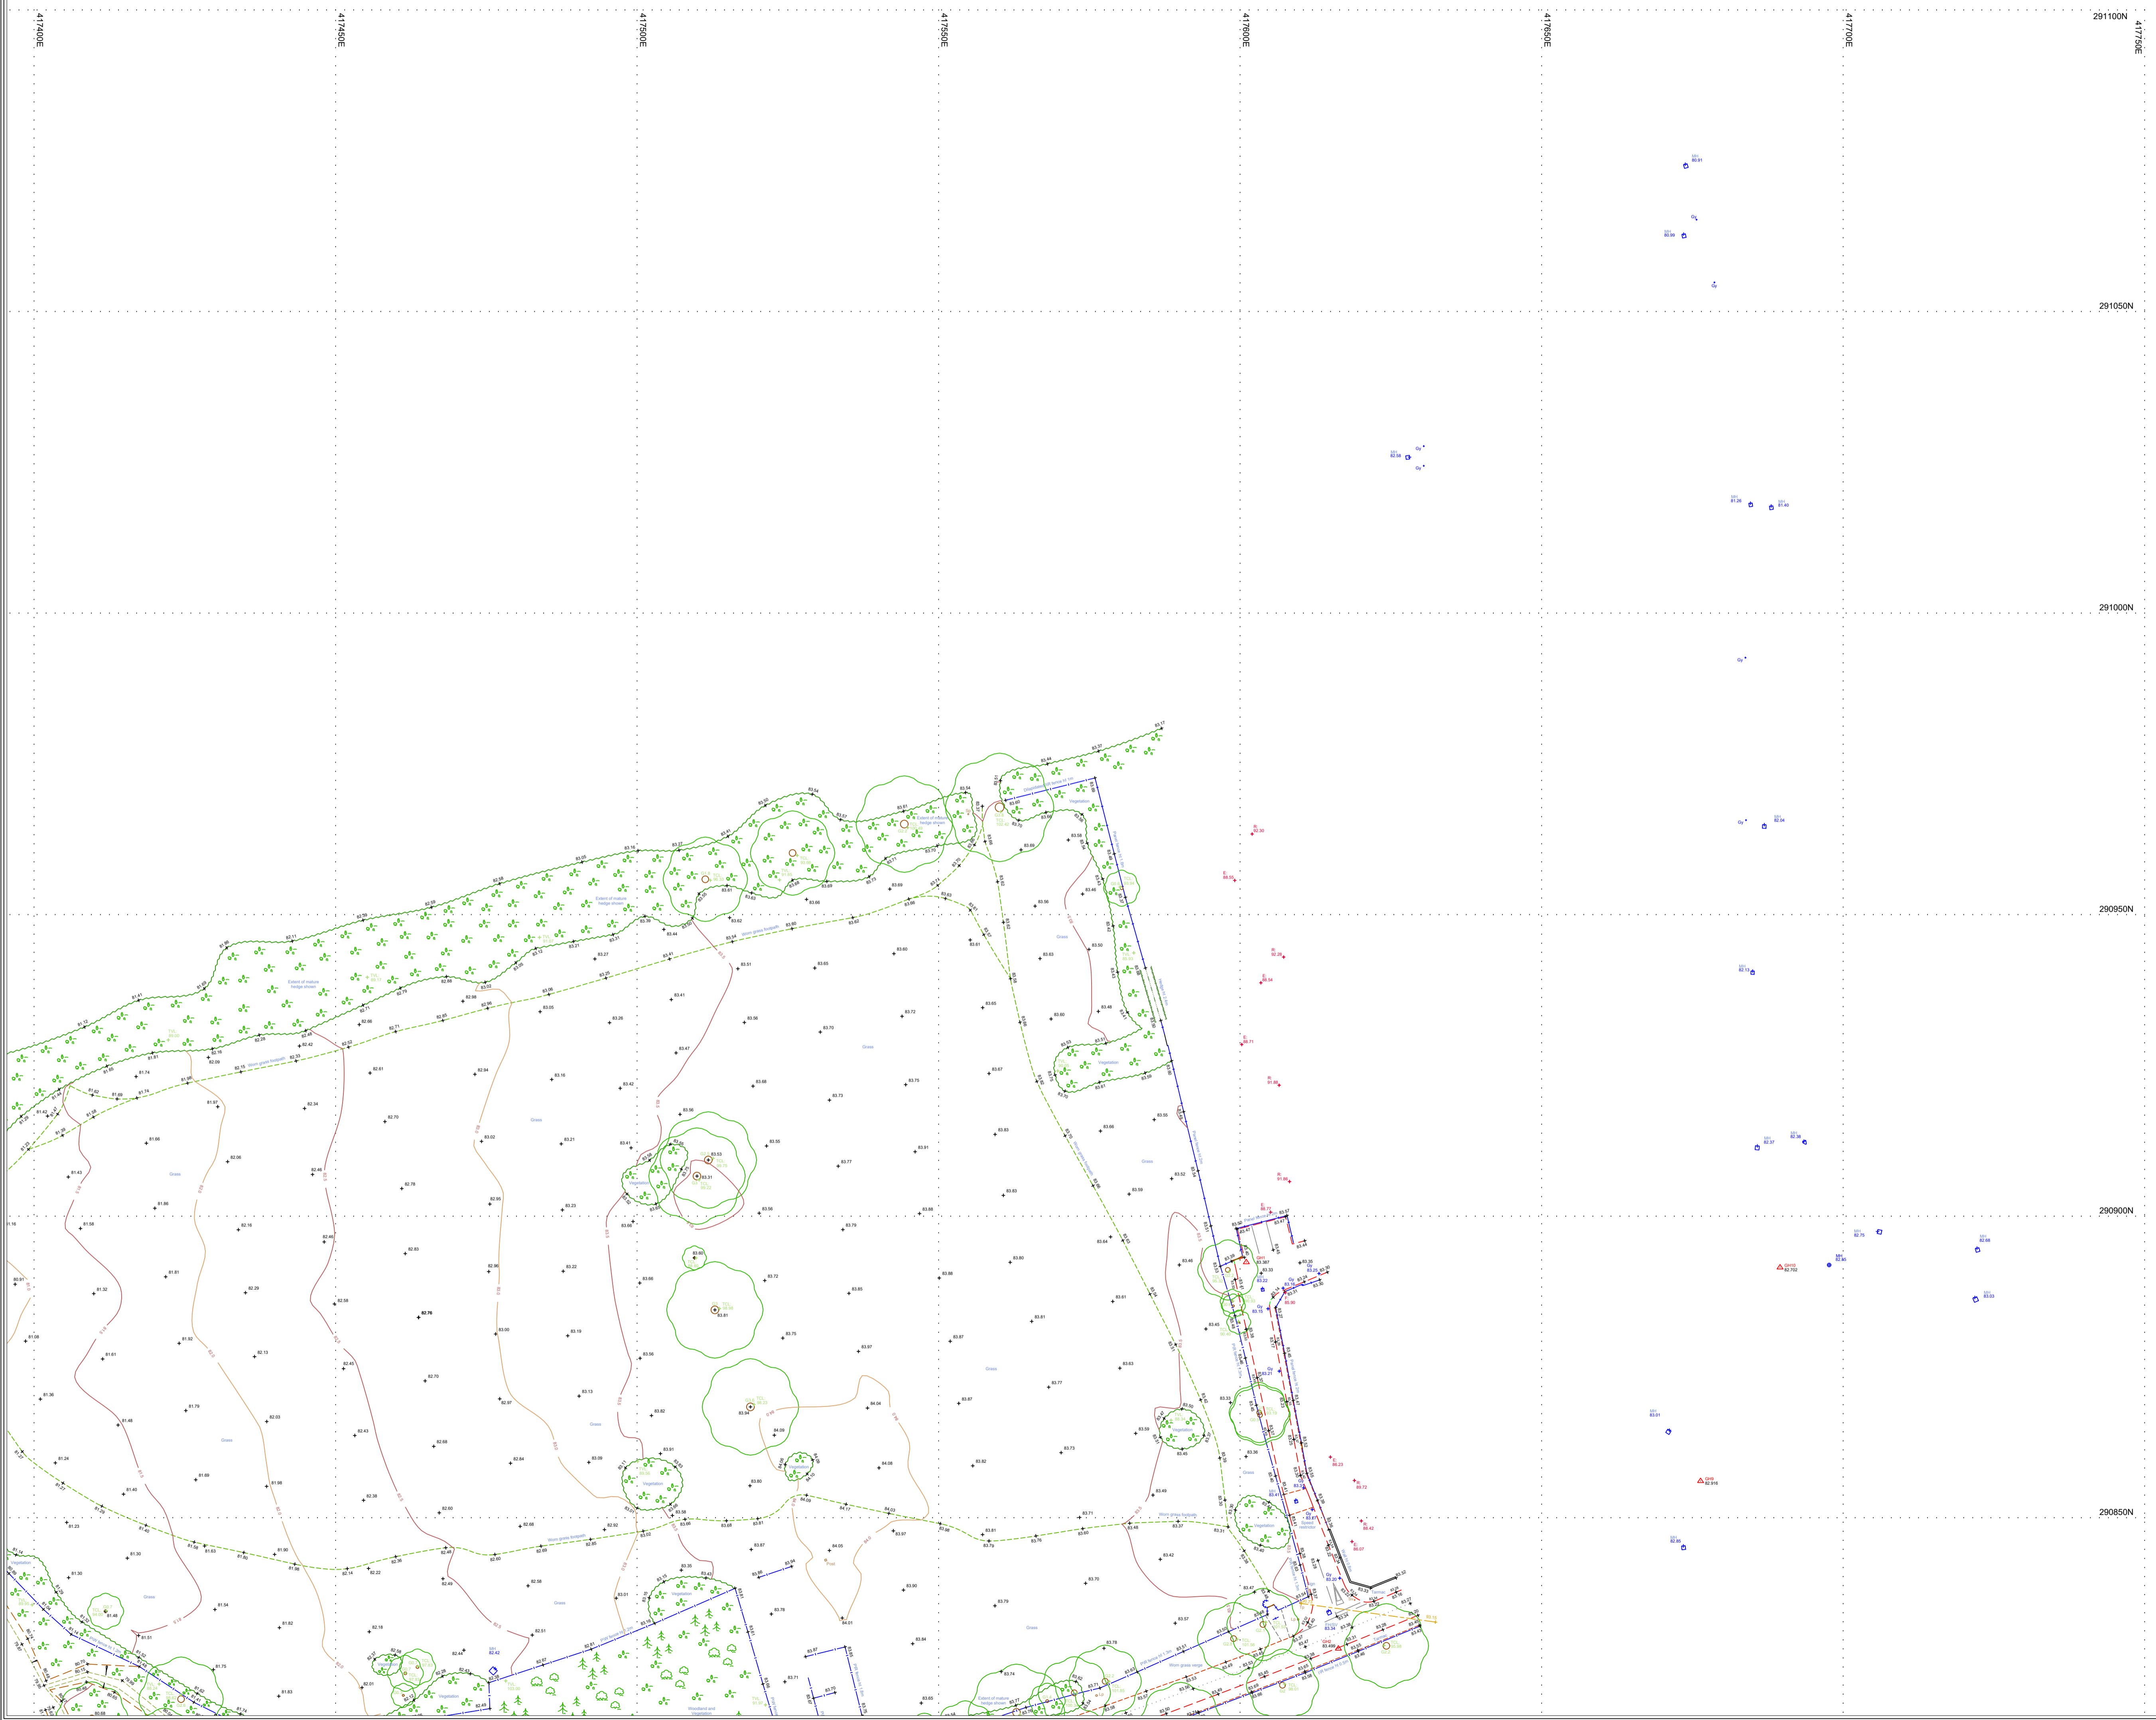
Level datum: See note
 Grid orientation: See note
 Job number: 24216
 Drawing No: 24216_T
 Rev: 0

OS Note:
 Some services may have been omitted due to parked vehicles. The Ordnance Survey title is to be used as a guide only.

This survey has been orientated to the Ordnance Survey (OS) National Grid (OSGB36) via Global Navigational Satellite Systems (GNSS) and the O.S. Active Network (OS Net). A true OSGB36 coordinate has been established near to the site centre via a transformation using the OSTN15GB & OSGM15GB transformation models. The survey has been correlated to this point and a further one or more OSGB36 (15) points established to create a true O.S. bearing for angle orientation. No scale factor has been applied to the survey therefore the coordinates shown are arbitrary & not true O.S. Coordinates which have a scale factor applied. Please refer to Survey Station Table to enable establishment of the on-site grid and datum.

TITLE
Topographical Survey

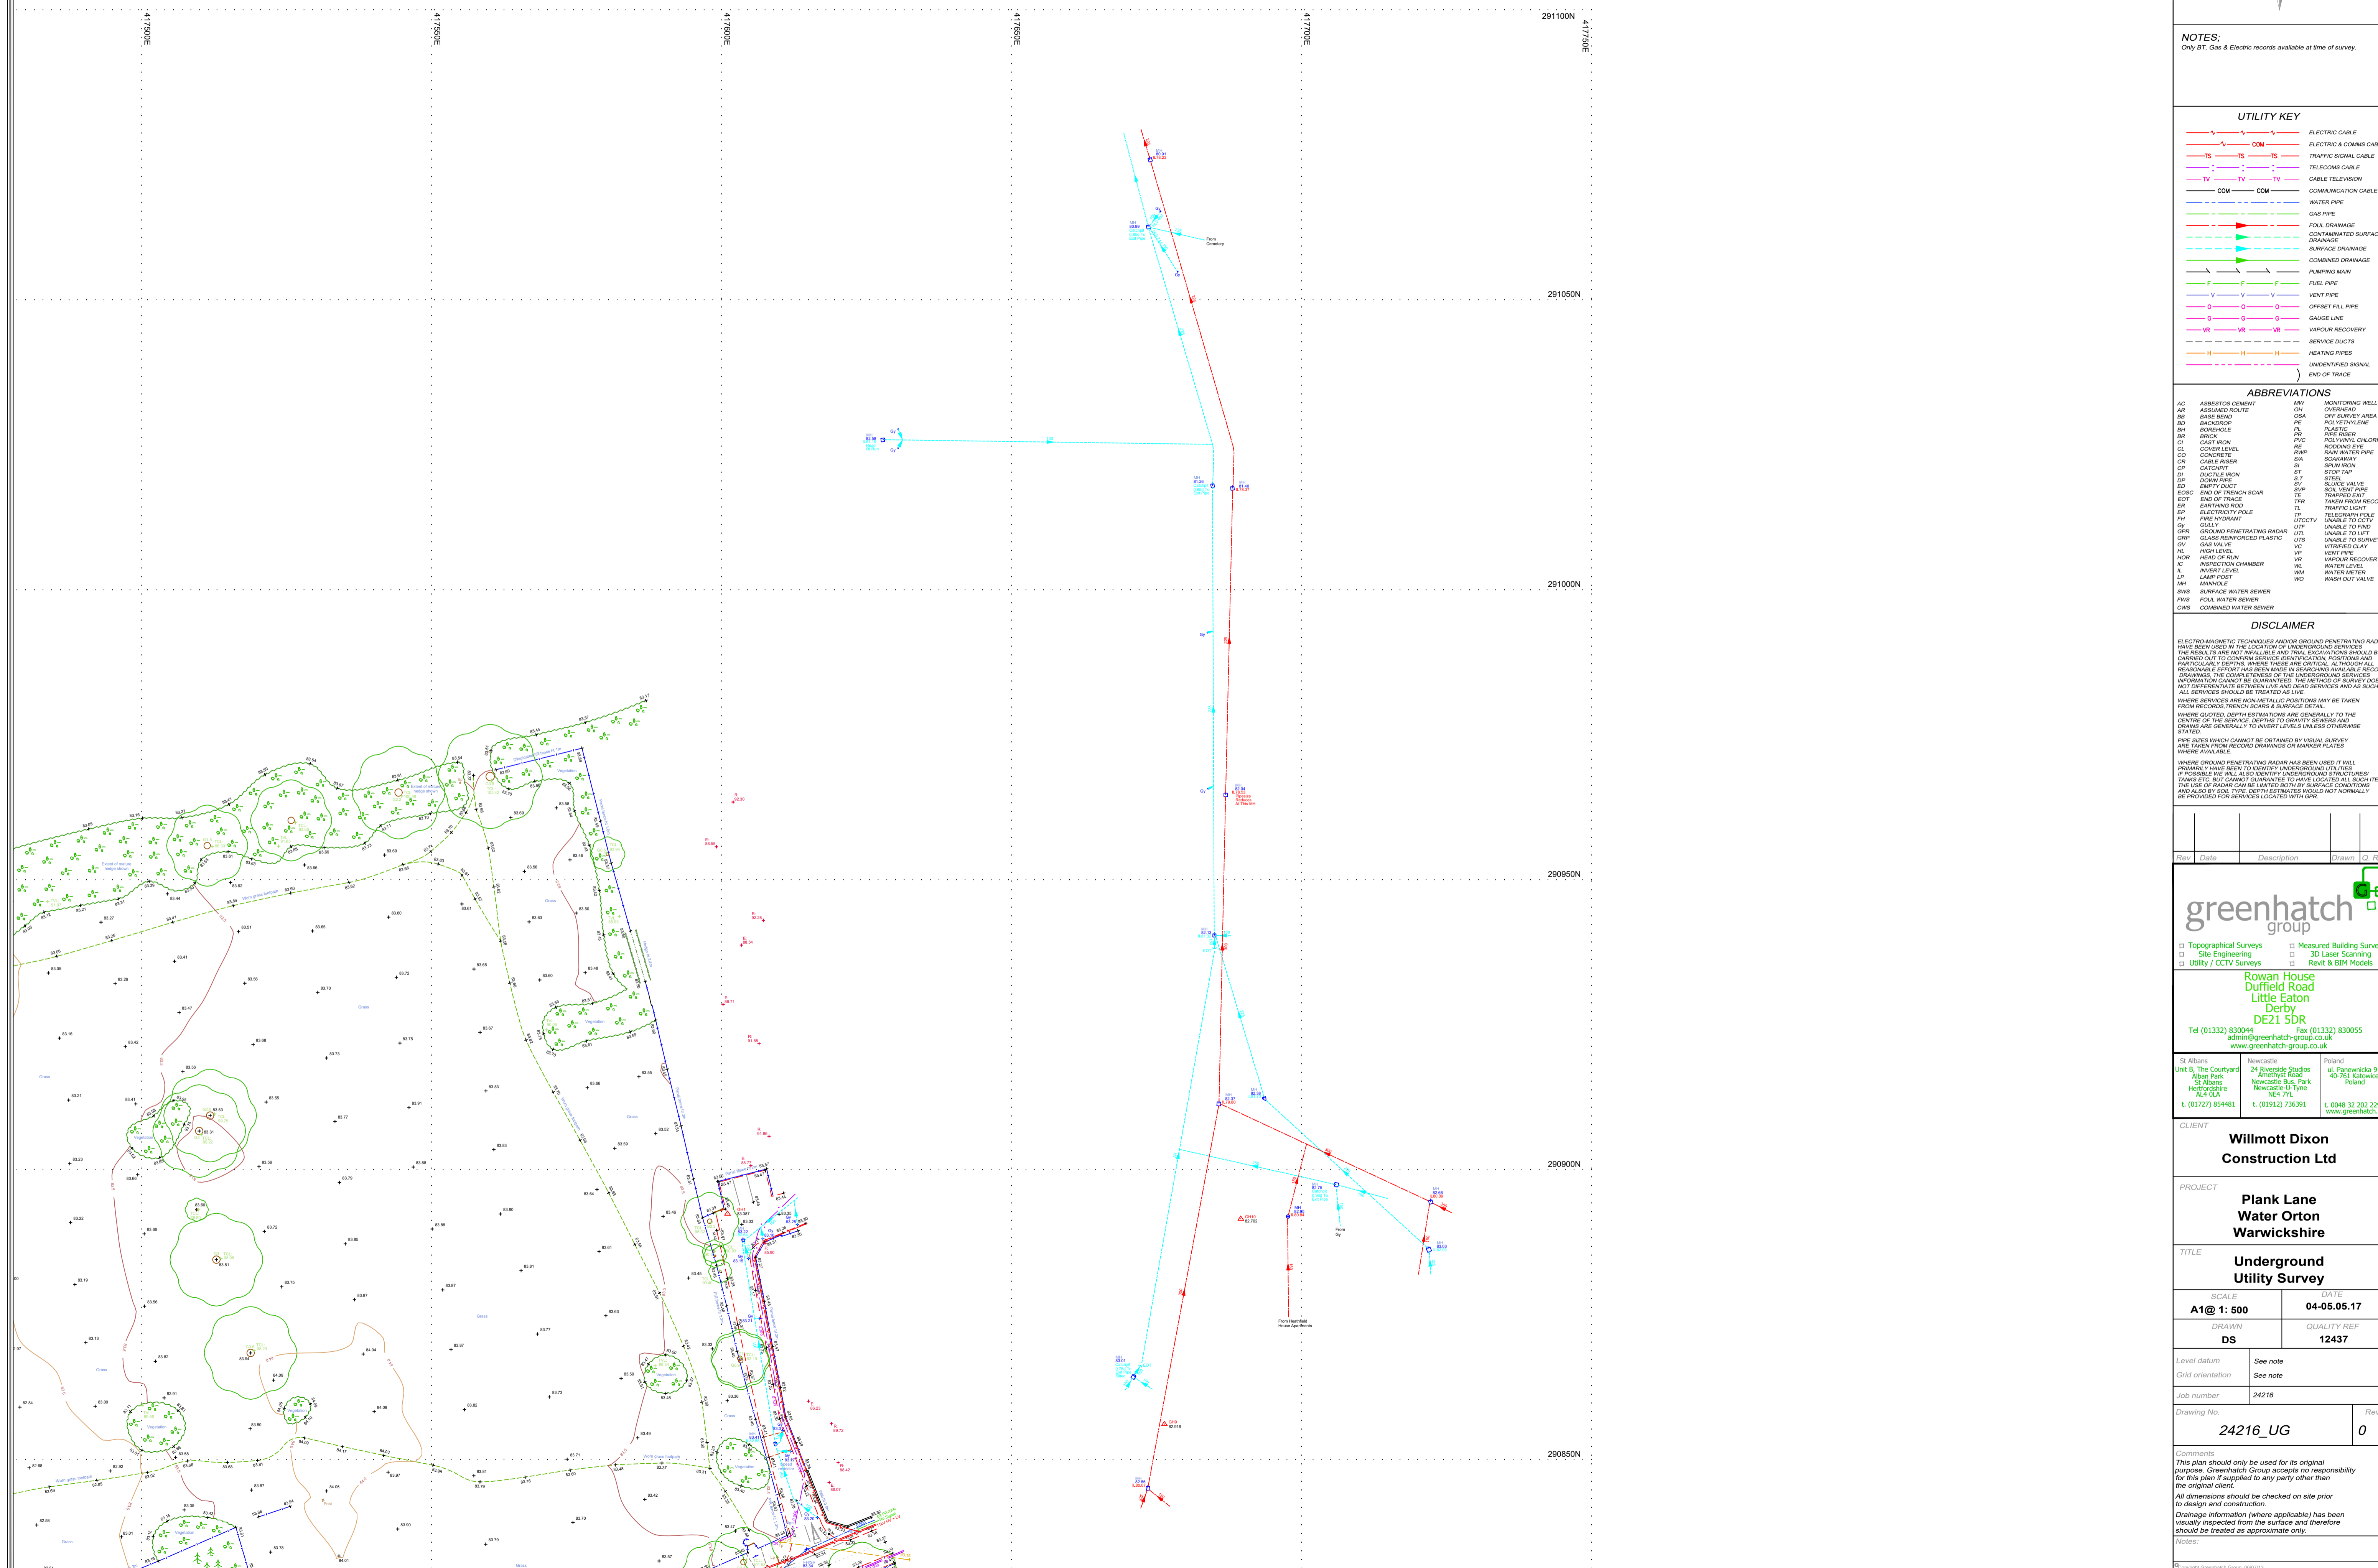
Drawing No 24216_UG	Rev. 0
-------------------------------	------------------

NOTES:
Only BT, Gas & Electric records available at time of survey.

ELECTROMAGNETIC TECHNIQUES AND/OR GROUND PENETRATING RADAR HAVE BEEN USED IN THE LOCATION OF UNDERGROUND SERVICES AND THE RESULTS ARE NOT RELIABLE AND THEIR LOCATIONS SHOULD BE CARRIED OUT TO CONFIRM SERVICE IDENTIFICATION POSITIONS AND PARTICULAR DEPTHS WHERE THESE ARE CRITICAL. AS THERE IS NO REASONABLE EFFORT HAS BEEN MADE IN SEARCHING AVAILABLE RECORDS, DRAWINGS, THE COMPLETENESS OF THE UNDERGROUND SERVICES INFORMATION CANNOT BE GUARANTEED. THE METHOD OF SURVEY DOES NOT DIFFERENTIATE BETWEEN LIVE AND DEAD SERVICES AND AS SUCH ALL SERVICES SHOULD BE TREATED AS LIVE.

WHERE SERVICES ARE NON-METALLIC POSITIONS MAY BE TAKEN FROM RECORDS, TRENCH SCARES & SURFACE DETAIL.

WHERE QUOTED DEPTH ESTIMATIONS ARE GENERALLY TO THE CENTRE OF THE SERVICE, DEPTHS TO GRADUITY SEWERS AND BRANS ARE GENERALLY TO INVERT LEVELS UNLESS OTHERWISE STATED.

WHERE GROUND PENETRATING RADAR HAS BEEN USED IT WILL PRIMARILY HAVE BEEN TO IDENTIFY UNDERGROUND UTILITIES (UNDER TANKS ETC.) BUT CANNOT GUARANTEE TO HAVE LOCATED ALL SUCH ITEM. THE USE OF RADAR CAN BE LIMITED BOTH BY SOIL CONDITIONS AND ALSO BY SOIL TYPE. DEPTH ESTIMATES WOULD NOT NORMALLY BE PROVIDED FOR SERVICES LOCATED WITH GPR.

TITLE
Underground Utility Survey
