Project name:
Tower 4ZC030T – Update on Flow
Dynamics and Geomorphology

Project ref:
60534513

Date:
26 January 2017

Memo

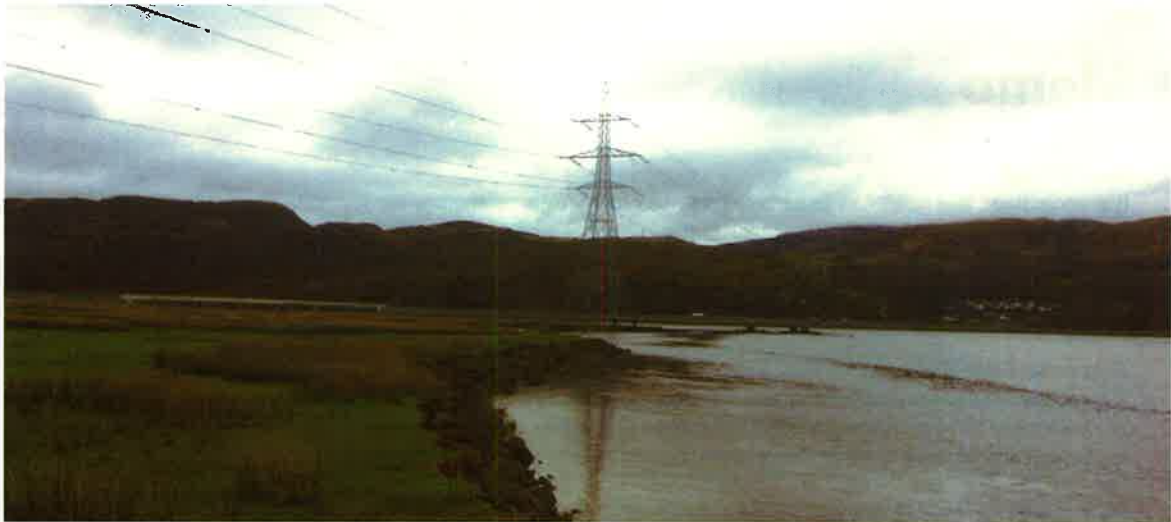
- The previously observed mechanism of saltmarsh erosion is a progressive process that has continued to occur (Photos 1, 3 and 4);
- Scouring of fine sand fill material from within the cofferdam has occurred behind the seaward face thus removing potential saltmarsh habitat (Photo 2);
- At the location of the Tower, the saltmarsh edge has receded to point approximately half-way between the seaward and landward face of the cofferdam (Photo 3);

Photo 1. Tower 4ZC030T with ongoing erosion of saltmarsh edge in foreground

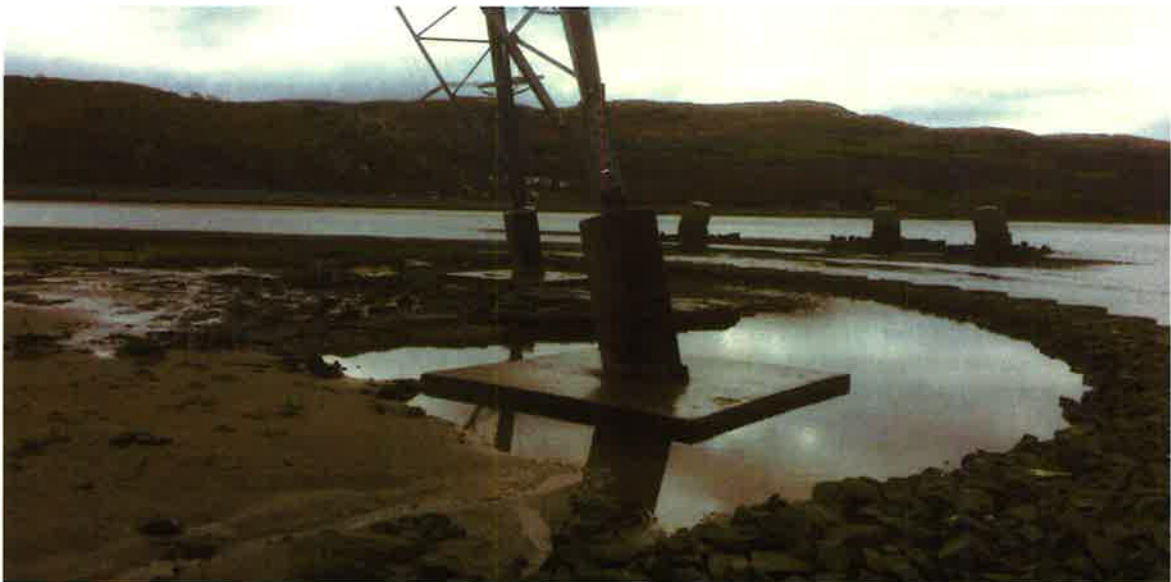
Photo 2. Loss of fine sand within cofferdam due to scour and washout

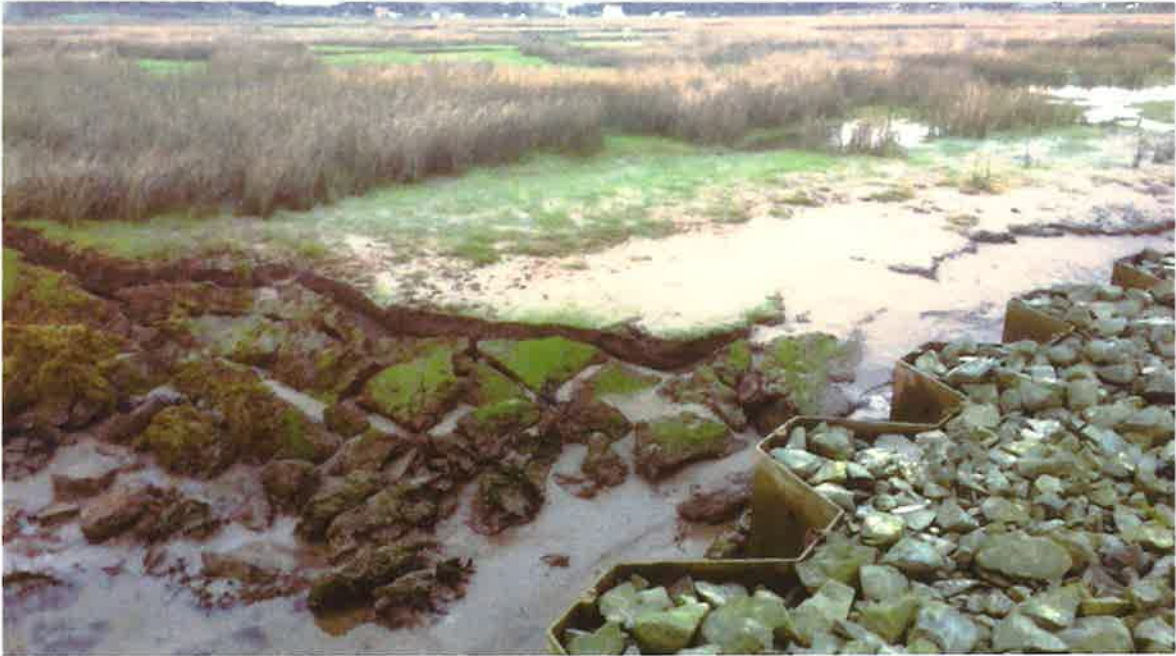
Immediately to the west of the Tower, the rate of retreat of the saltmarsh edge has increased to approximately 3m/yr which was previously calculated to be 2m/yr based on the limited data available. To the east of the Tower the rate of erosion appears to be consistent with the previously assumed rate of approximately 3m/yr.

Photo 3. Ongoing erosion to the west of the cofferdam

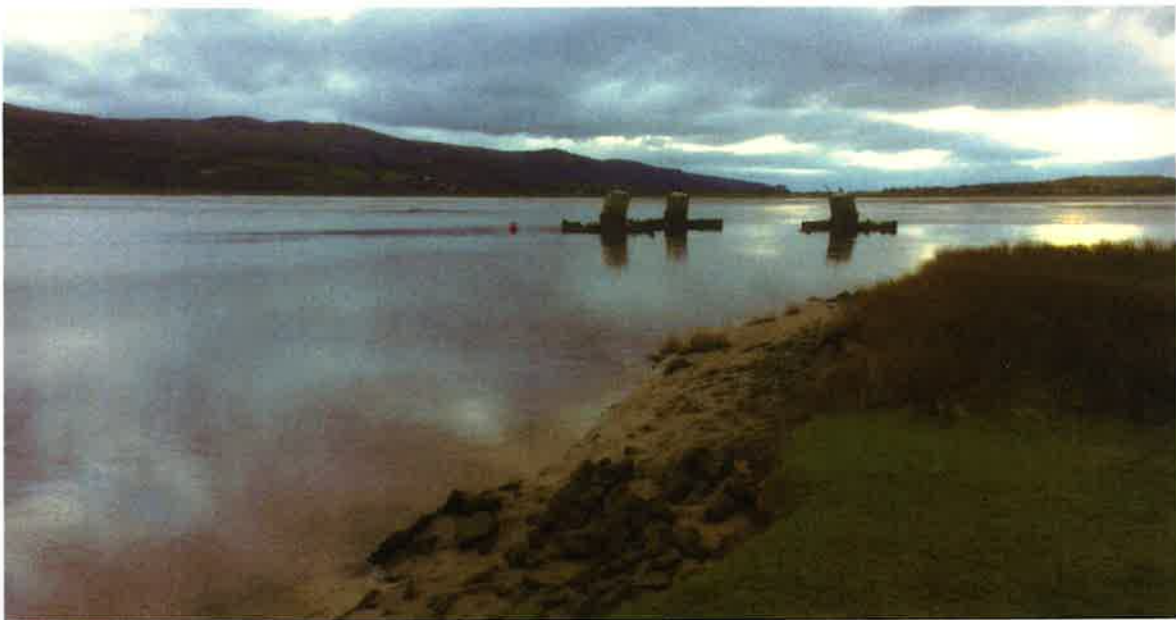
Photo 4. Ongoing erosion to the east of the cofferdam
