# Causal analysis and testing

Railway Accident Investigation Seminar

Richard Harrington, RAIB

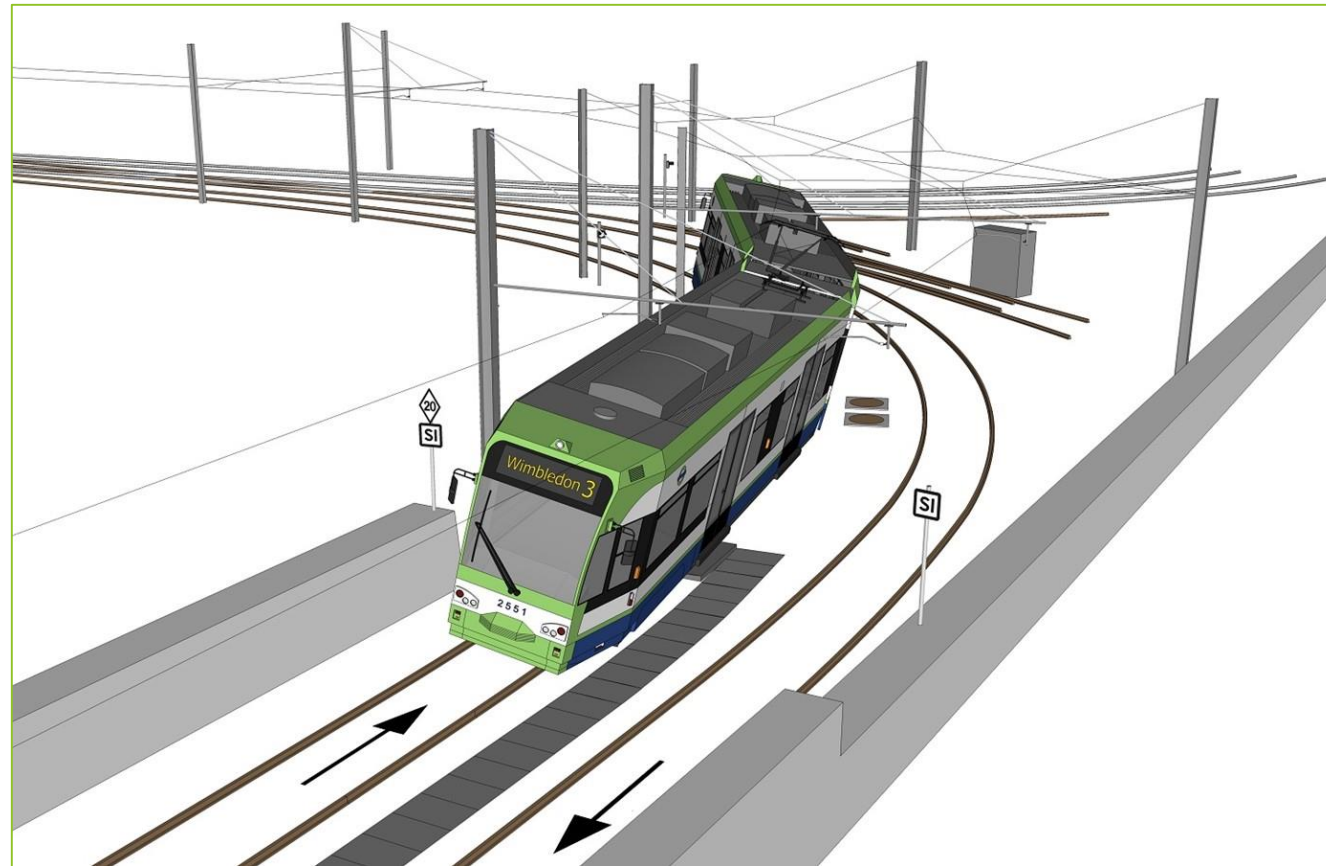
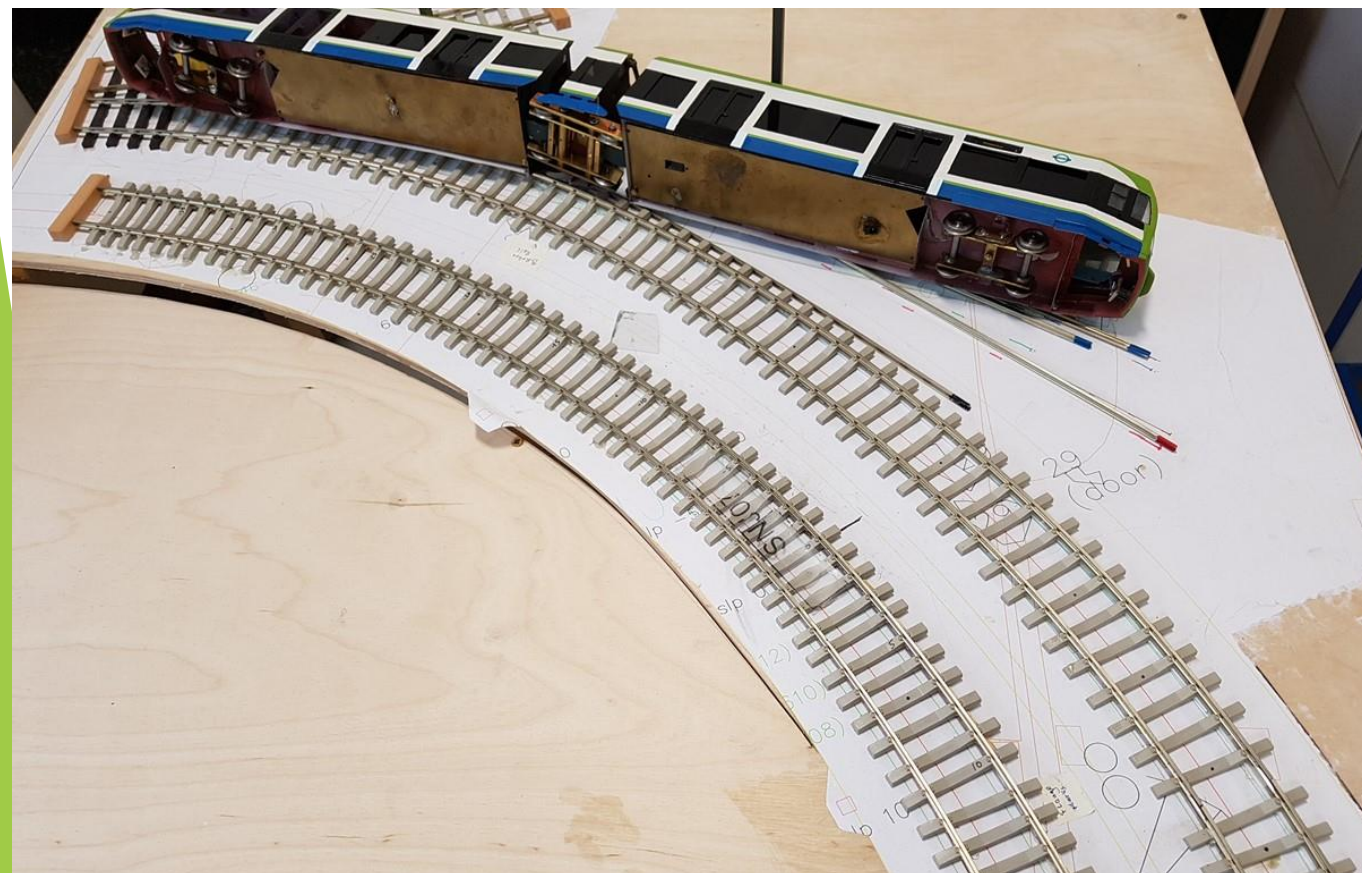
# Modelling and surveys

## Evidence marks (in appropriate sequential order)

| 2 | Impact mark on overhead line dropper caused by pantograph |
| 3 | Scuff marks on track crossing caused by rear bogie suspension |
| 5 | Broken concrete in walkway |
| 7 | Broken rail on outbound line |

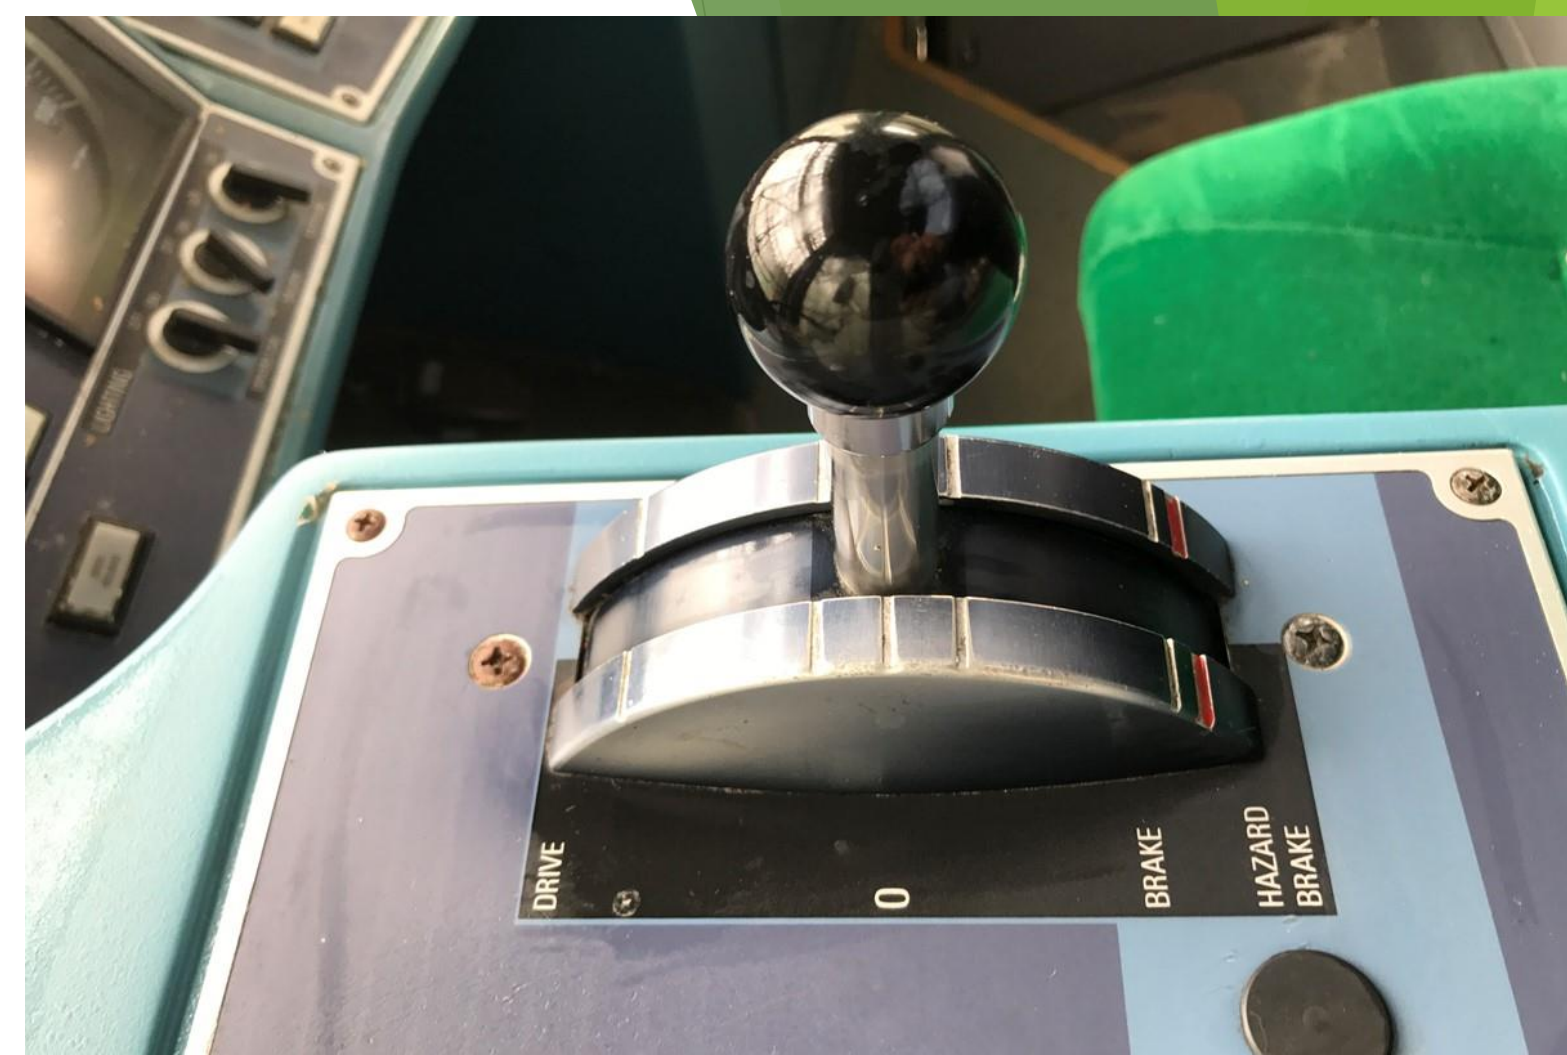
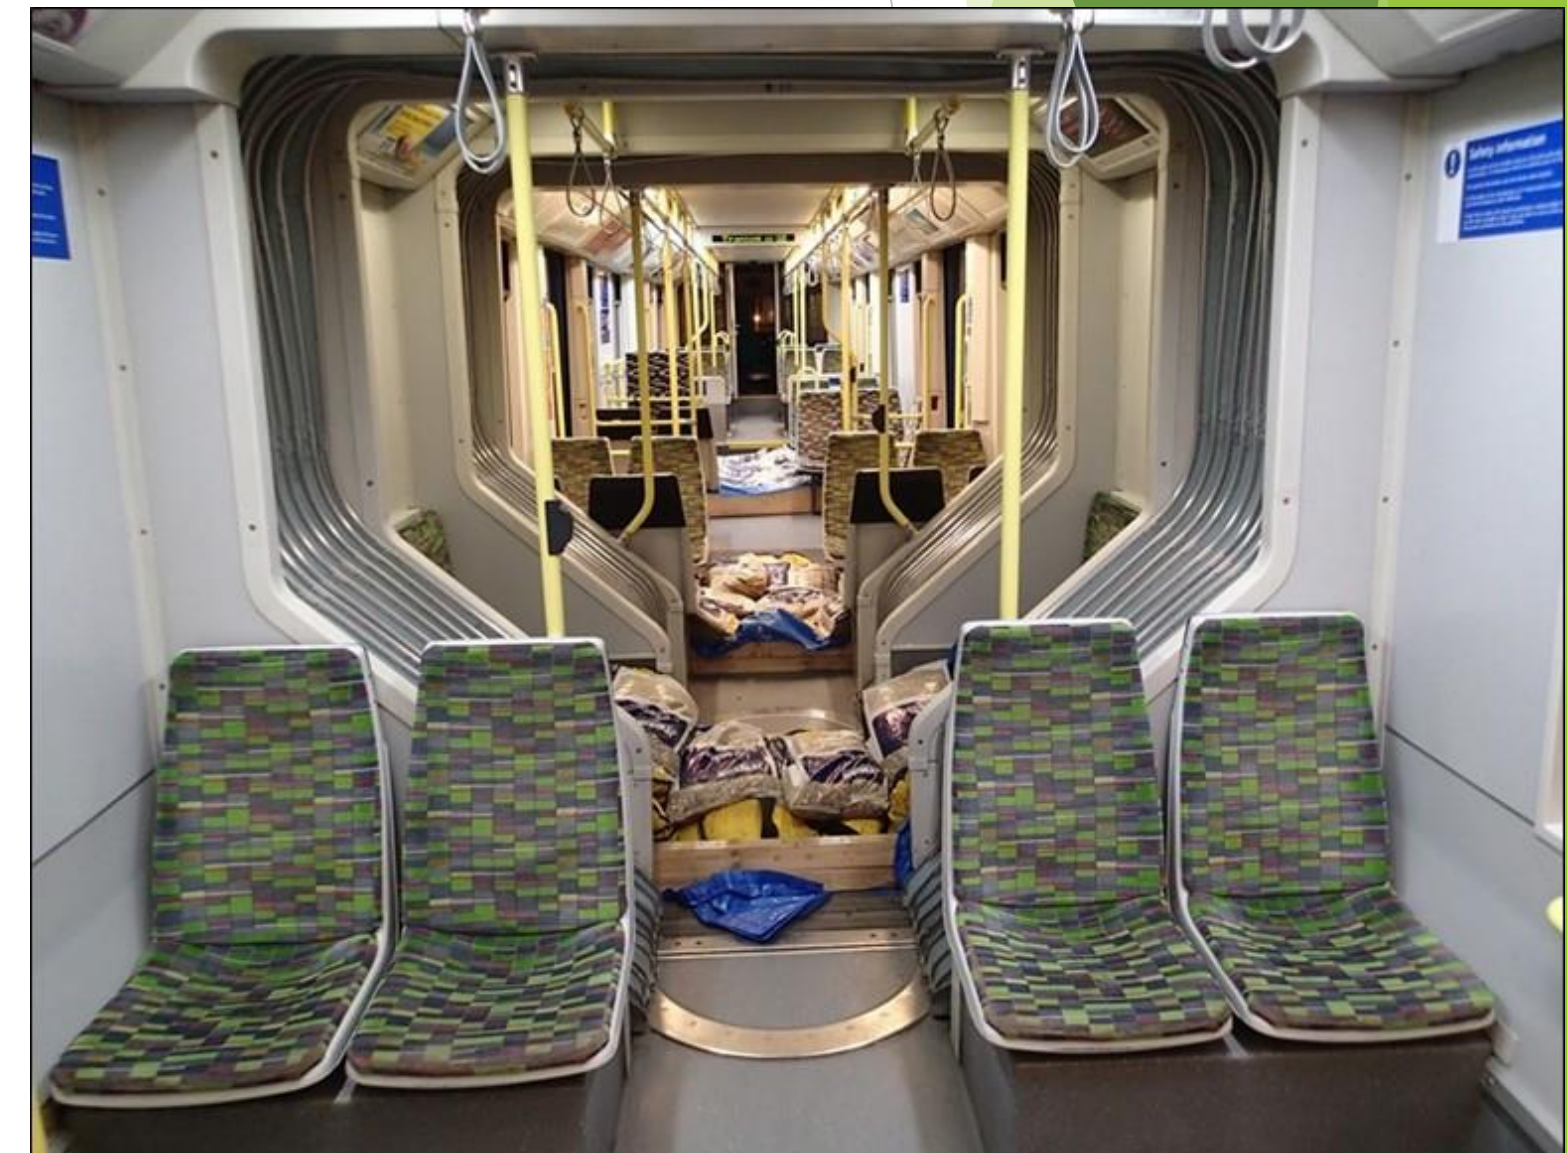
# Tram testing

- ▶ Ten week programme of >220 individual tests (static)
- ▶ Dynamic brake testing with loaded tram for OTDR data analysis of braking performance
- ▶ Tram testing essential to show if:
  - ▶ brakes system functioning
  - ▶ brake controller functioning
  - ▶ dead man's operative
  - ▶ tram able to negotiate curve

- ▶ no faults with the tram that could have either caused or contributed to the causes of the accident, and the dead man's device functioned as designed
